## Investigation Update

November 2024

This document provides an update on the CSB's investigation of the September 29, 2024, incident at Bio-Lab, Inc. in Conyers, Georgia.

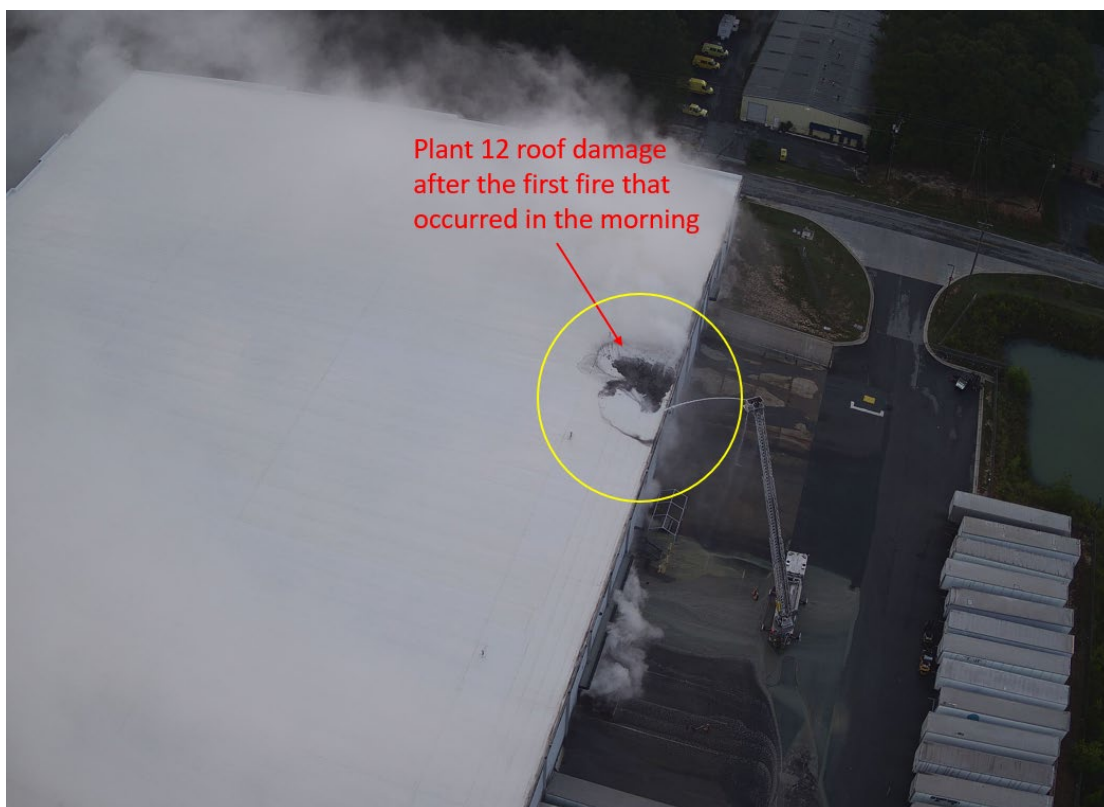
- By 6:30 a.m., flames were visible through the roof above the area where the employees had first observed the chemical reaction and off-gassing. The first shelter-in-place order was issued at approximately 7:40 a.m. The fire was extinguished at approximately 8:10 a.m. by the Rockdale County Fire Rescue (**Figure 1**).

**Figure 1.** Plant 12 warehouse roof damage at approximately 8:10 a.m. after flames were extinguished (Credit: Rockdale County Fire Rescue)

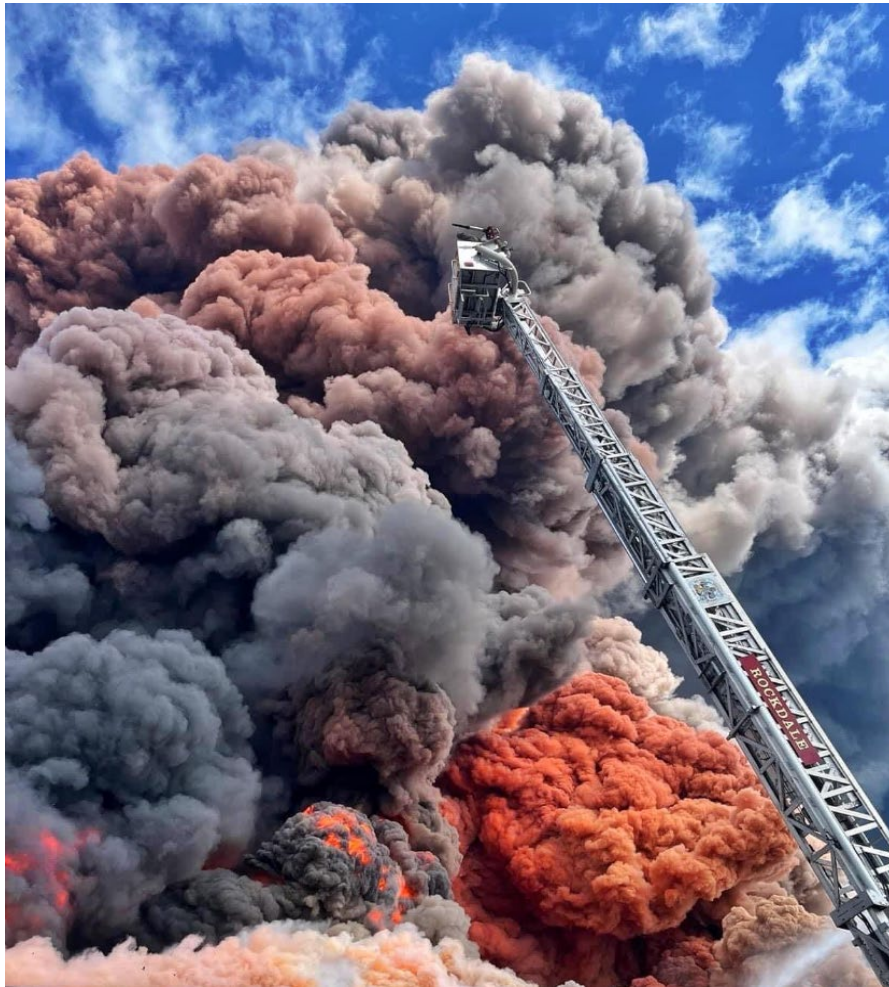
- Around noon, a second fire erupted, producing thick black smoke, followed by multicolor plumes of smoke (**Figure 2**). An emergency responder described his observations of the scene as “major chemical reactions.”

**Figure 2.** Multicolor plumes of smoke observed after the second fire at Bio-Lab on September 29, 2024 (Credit: Ross/11Alive)

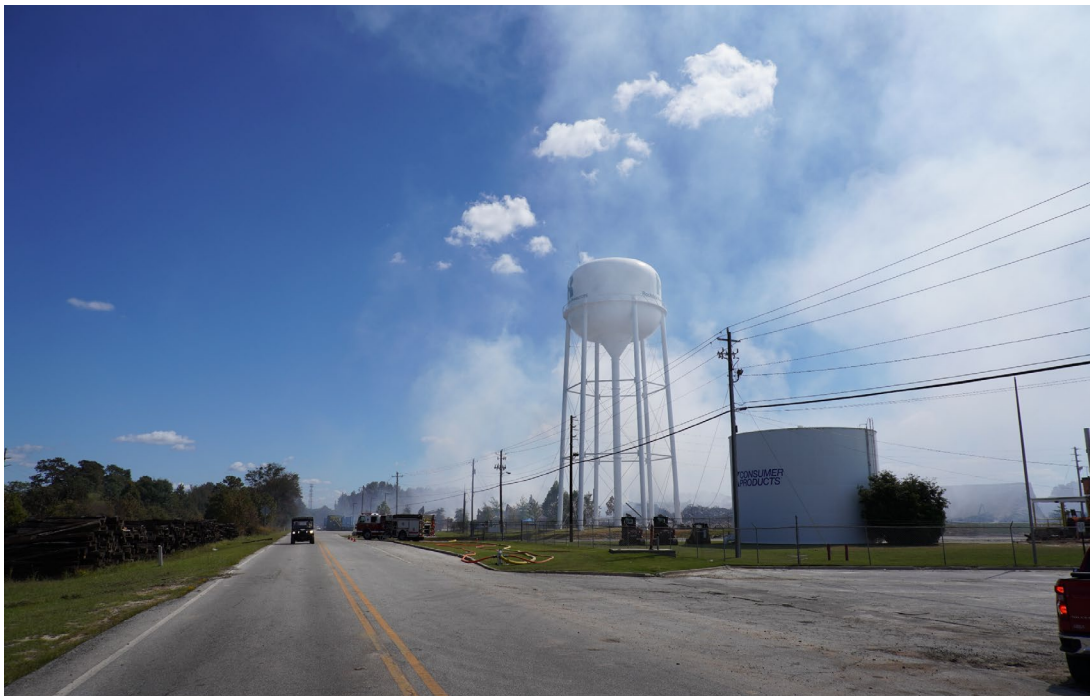
- The extended period of off-gassing from the site occurred because residual TCCA product remained onsite, including beneath the collapsed walls and structure debris, requiring the use of heavy equipment to access and remove the material for treatment. **Figure 3** shows the ongoing off-gassing from the building site during cleanup activities in the days after the incident.

**Figure 3.** Ongoing off-gassing observed from the site during cleanup operations on October 2, 2024, several days after the incident. (Credit: CSB)
