FINAL INVESTIGATION REPORT

CARIBBEAN PETROLEUM TANK TERMINAL EXPLOSION AND MULTIPLE TANK FIRES

CARIBBEAN PETROLEUM CORPORATION (CAPECO)

REPORT NO. 2010.02.I.PR
U.S. CHEMICAL SAFETY AND HAZARD INVESTIGATION BOARD

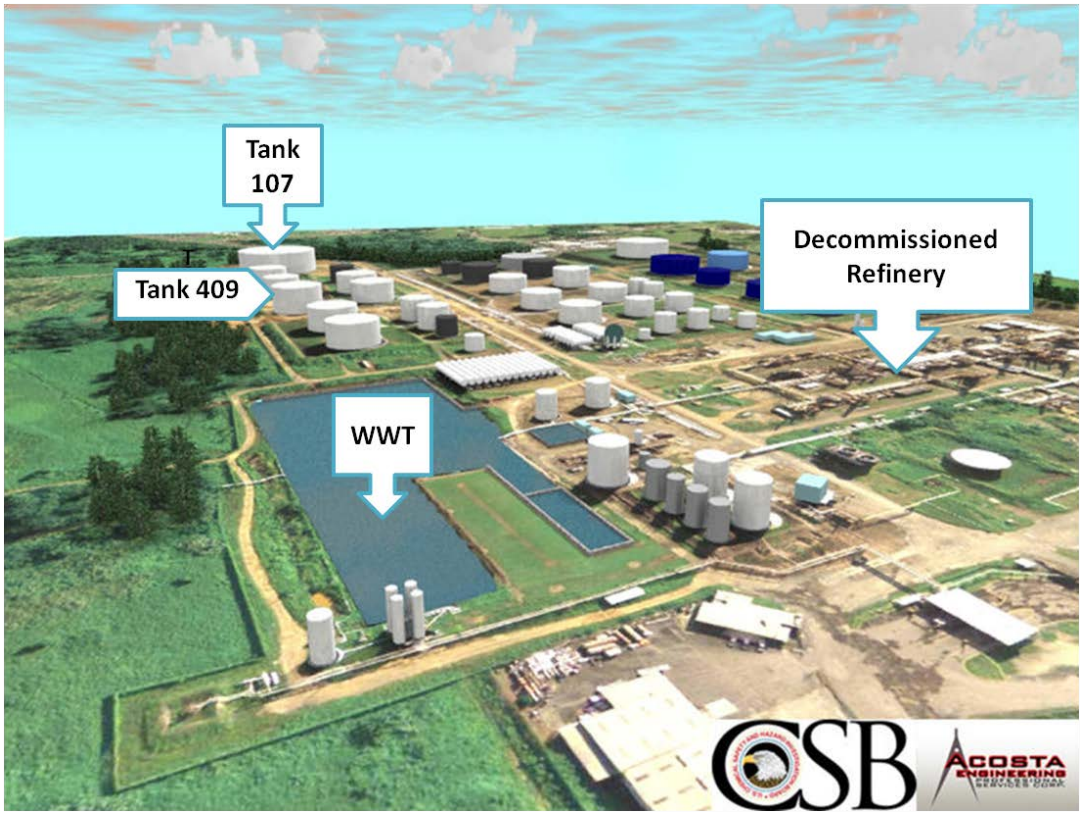
Figure 1: CAPECO tank farm, WWT, and decommissioned refinery overview

The CAPECO site covered 179 acres, 115 of which were developed into four areas: a tank farm, the decommissioned refinery, an administration area, and a wastewater treatment (WWT) plant. (See Figure 1.) The facility also owned and operated a loading dock on San Juan Bay in Guaynabo, 2.5 miles northeast of the site. (See Figure 2.) At the time of the incident, CAPECO employed 65 people.

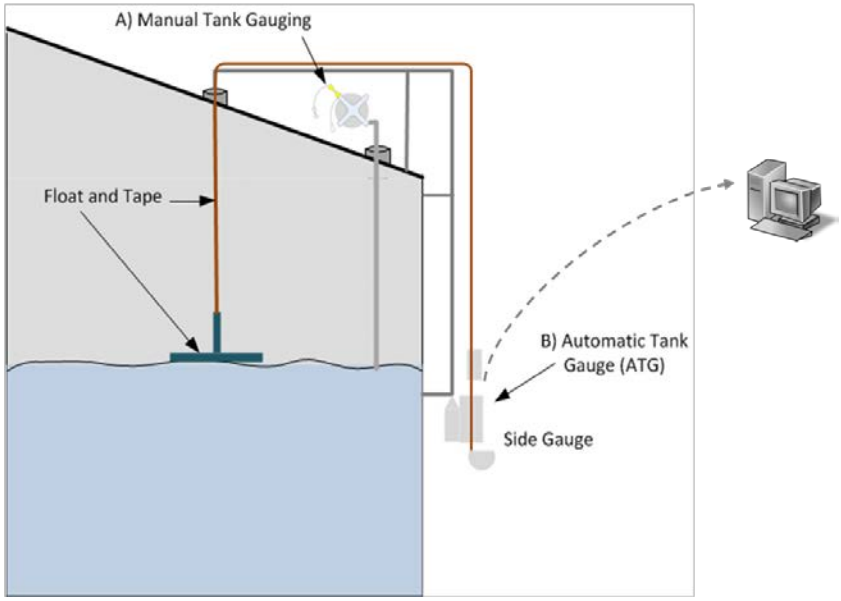
Figure 3: Manual and Automatic Tank Gauging. (A) Manual Gauging requires an operator to use a tape and measure to determine the liquid levels inside the tank. (B) Automatic Tank Gauging (ATG) requires an operator to read a level measurement from a tank gauge mounted to the side of the tank.

Prior to the start and end of filling operations, the independent inspector manually measured the fuel tank levels by lowering a gauging tape[12] into the tank. (Figure 3.) A CAPECO operator verified the measurements by comparing the tank liquid level to the strapping table[13] for that tank. The independent inspector and the operator placed car seals on various block valves of receiving tanks to prevent flow into or out of the tank before measuring the level in the tank and

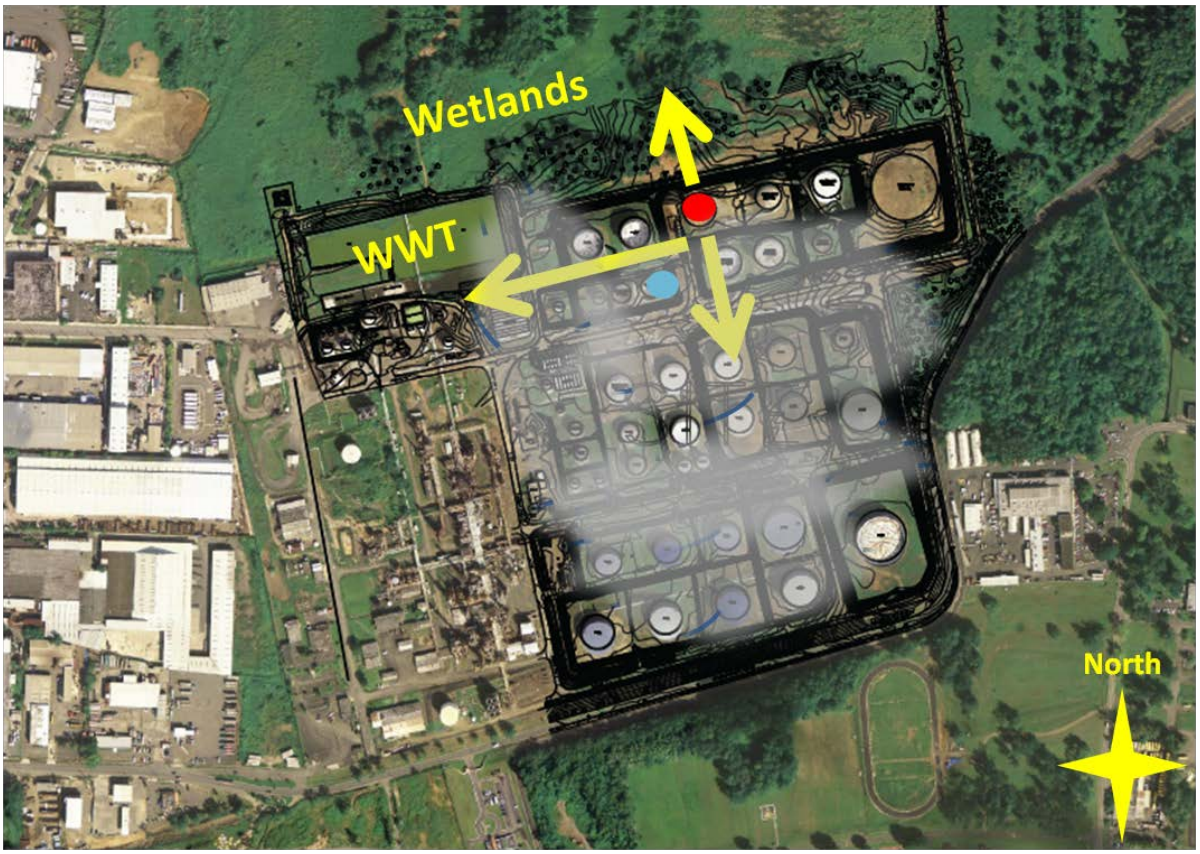
At the 11 p.m. walk-around, the tank farm operator observed the gauge on Tank 409 during his hourly check. The operator called the level into the supervisor who calculated once again that the tank should be full at 1 a.m.; however, between the 11 p.m. and 12 a.m. check, Tank 409 began to overflow. Fuel gushed from the vents, creating a spray of gasoline that formed a vapor cloud and pooled in the secondary containment dike.

At midnight, the tank farm operator started to perform the hourly check of Tank 409, but before reaching the tank, he observed a vapor cloud and a strong smell of gasoline. He contacted the dock operator to halt the flow of gasoline to the tank and notified the WWT operator and his supervisor to meet at the western edge of the terminal. Despite the lack of illumination, they observed a white fog approximately three feet above the ground but could not hear or see gasoline overflowing from the vents on Tank 409 due to lack of lighting and the topography of the tank farm.[18] As they approached the fog, the men noticed the air cool as the fog condensed on their hands, despite the 79ºF temperature. Noting the potential danger, the supervisor sent one operator to the security gate, while the supervisor and another operator drove around the facility attempting to find the source of the leak and developing vapor cloud.

Figure 7. Topographic Survey of CAPECO Tank Farm showing the gasoline vapor cloud migration from higher elevation (Tank 409-Red and Tank 411-Blue) toward low-lying areas by the WWT plant, the south eastern end of the refinery and wetlands to the north. The cloud indicates the approximate area where the vapor cloud migrated based on surveillance footage.

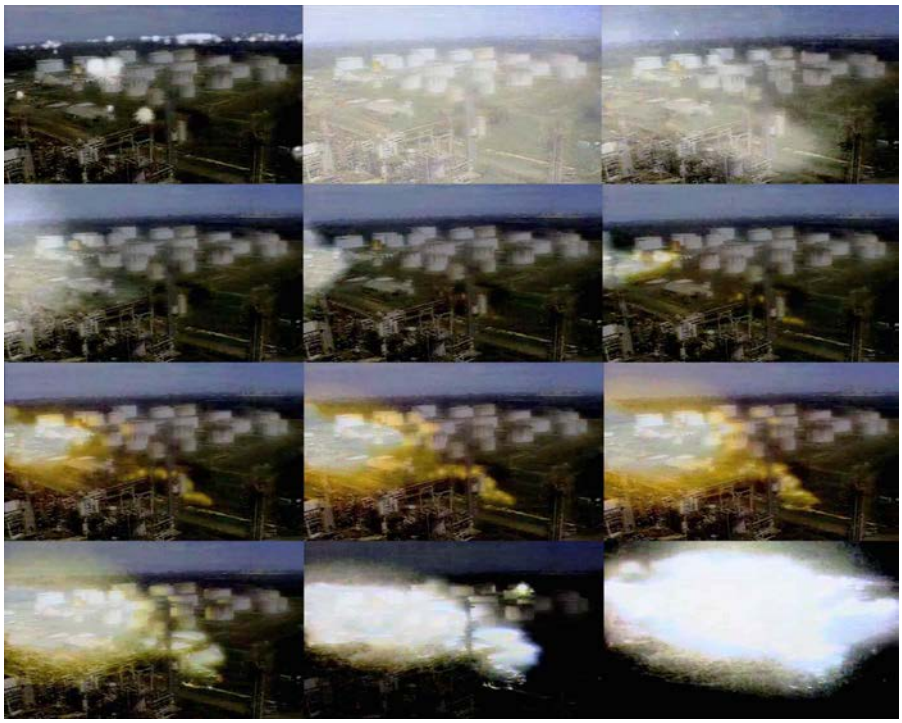
At 12:23 a.m., on October 23, 2009, security cameras at CAPECO and neighboring facilities recorded the ignition of the vapor cloud in the WWT area. About seven seconds after ignition, the vapor cloud exploded, creating a pressure wave that damaged hundreds of homes and businesses up to 1.25 miles from the site. The fire propagated through the vapor cloud and ignited multiple subsequent tank explosions registering 2.9 on the Richter scale.[19]

Figure 8: CAPECO surveillance footage of flame propagation during October 23, 2009 CAPECO explosion

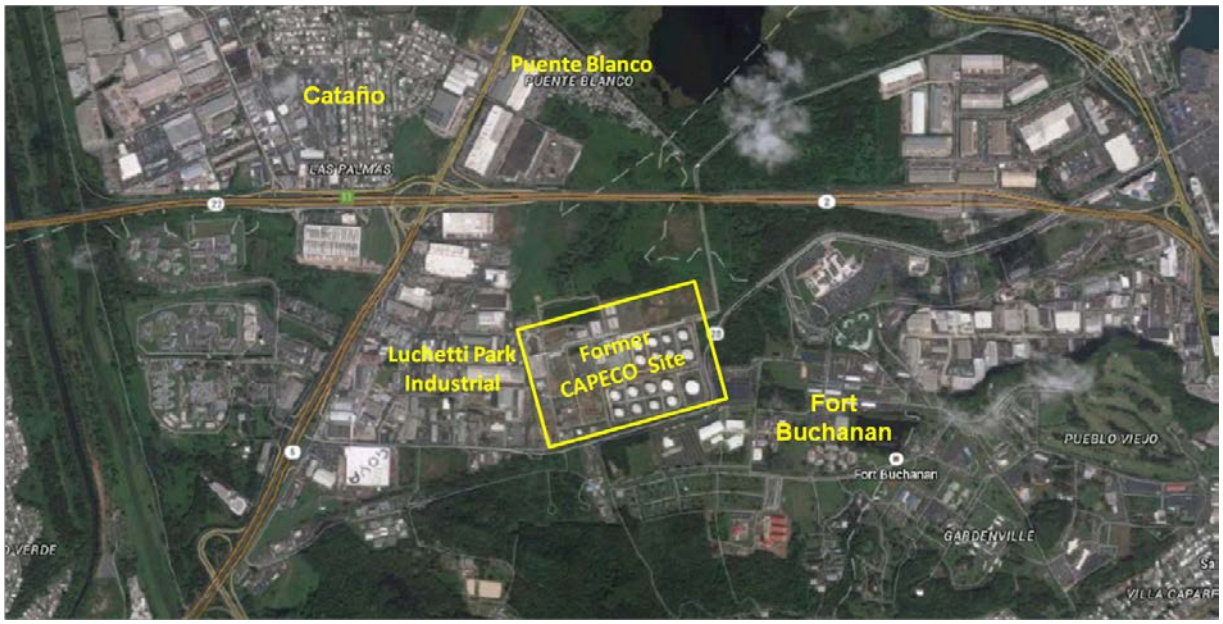
Fort Buchanan experienced the most severe damage—suffering an estimated $5 million in repair costs. Community impact assessments[37] found most of the structural damage occurred in the Puente Blanco neighborhood where PREMA and the Department of Housing (DOH) found damage to 232 of the 266 homes assessed; 139 were repaired and 6 were demolished by November 2009.[38] The Puente Blanco community also experienced environmental contamination to several surface water bodies, including federally protected wetlands and streams surrounding the CAPECO site. After assessing 289 homes damaged by the explosion in the Cataño community, the Small Business Administration (SBA)[39] designated 25 single-family homes as destroyed or severely damaged at or beyond 40% of their fair market value. (See Figure 10.)

Figure 10: Community damage surrounding the CAPECO facility

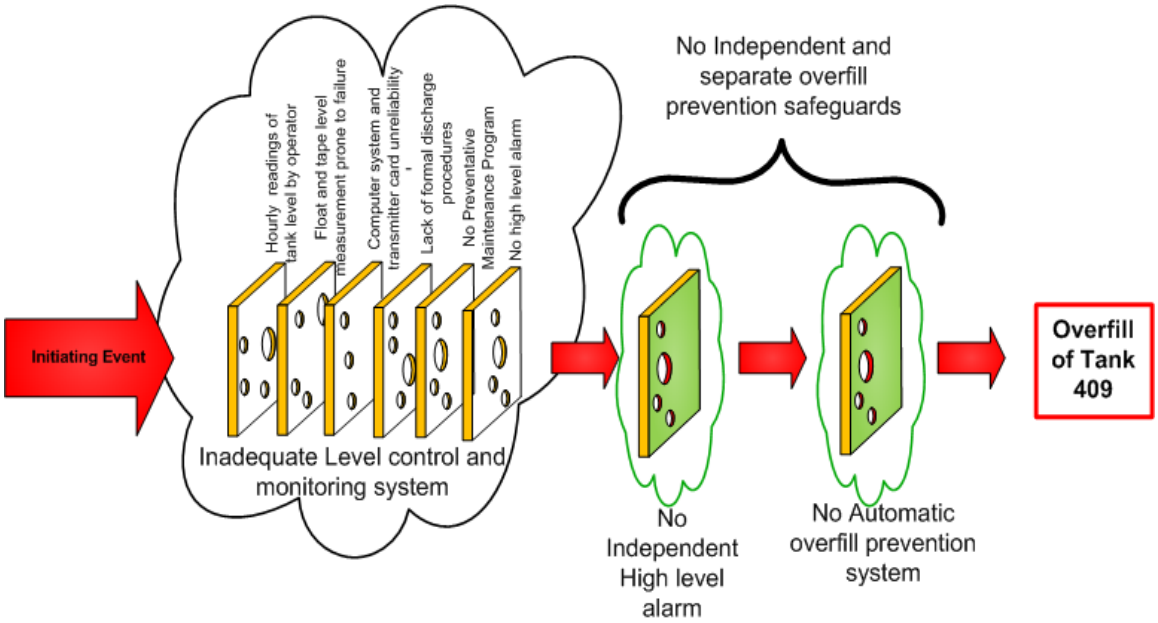
The CSB determined that numerous technical and systemic failures contributed to the explosion and multiple tank fires at the CAPECO tank terminal. The CSB found that multiple layers of protection failed within the level control and monitoring system at the same time in addition to a lack of independent safeguards. James Reason's Swiss Cheese Model best demonstrates these systemic failures that led to the accident.[48] Reason postulates that an accident results from the breakdown of the "interaction between latent failures[49] and a variety of local triggering events (active failures)"[50] and although rare, the "adverse conjunction of several causal factors" from various layers.[51] The deficiencies or holes at each layer of protection are constantly increasing or decreasing based on management decisions and operational deviations.[52]

Figure 12: Contributing to the October 2009 overfill incident at CAPECO were multiple failures of the level control and monitoring system in addition to a lack of safeguards like a high level alarm, an independent level alarm and an automatic overfill prevention system that allows for automatic shutdown or diversion.

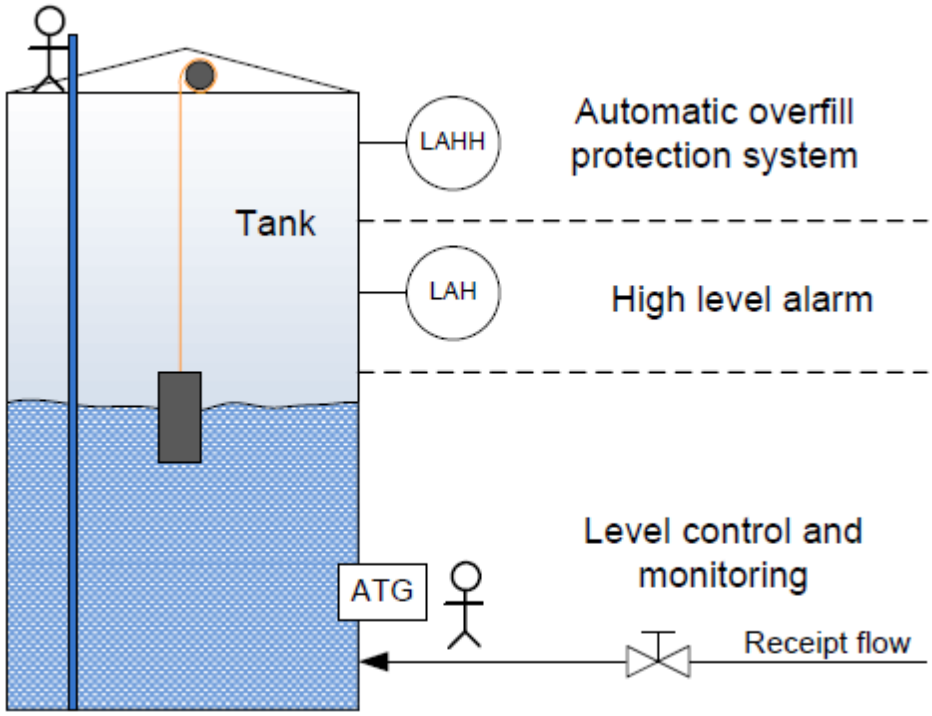
Figure 13: A comprehensive overfill prevention system includes the ATG, high level alarm (LAH), and automatic overfill prevention system (LAHH), in addition to the operator and facility procedures that govern, monitor, and control the flow of fuel into a tank.

CAPECO lacked a reliable automatic level control and monitoring system for measuring tank levels. (See Figure 12 and Figure 13.) The automatic gauging system at CAPECO, described in Section 3.6.3, had a history of repeated failures and prolonged out-of-service periods. On the night of the incident, the float and tape device inside Tank 504 became stuck and the transmitters for Tanks 107 and 409 were not receiving data from the side gauge on Tank 409; therefore, data

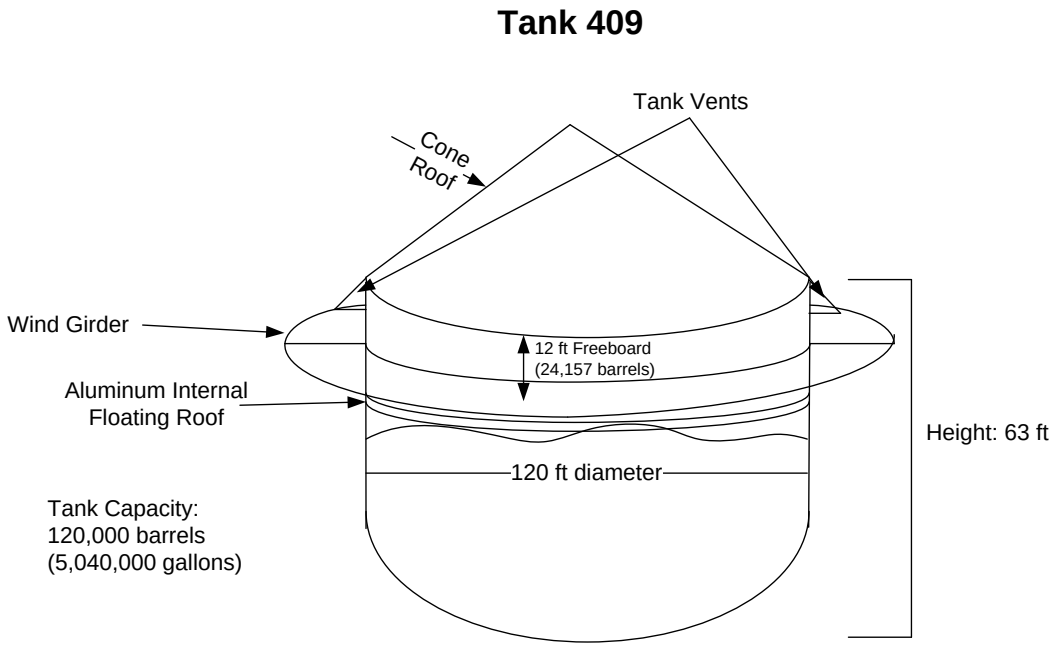
The CSB found that other factors might have contributed to the accident, such as the construction and limitations of the Tank 409 internal floating roof and the variable flow rates and line pressures into Tank 409.

API MPMS Ch. 3.1A discusses the impact of the floating roof on tank volume. On the night of the incident, the final reading likely occurred when the floating roof was floating freely. When floating roofs are in the free-floating position, they displace the amount of liquid equal to the weight of the roof and attached deadwood. The only accurate way to obtain volume in the critical zone is by a liquid calibration procedure. API MPMS Ch. 3.1A advises that facilities calculate roof displacement by considering the roof weight, temperature, and density of the liquid of tank contents in the critical zone. CAPECO did not calculate the roof displacement of Tank 409.

Figure 12: Tank 409 Specifications

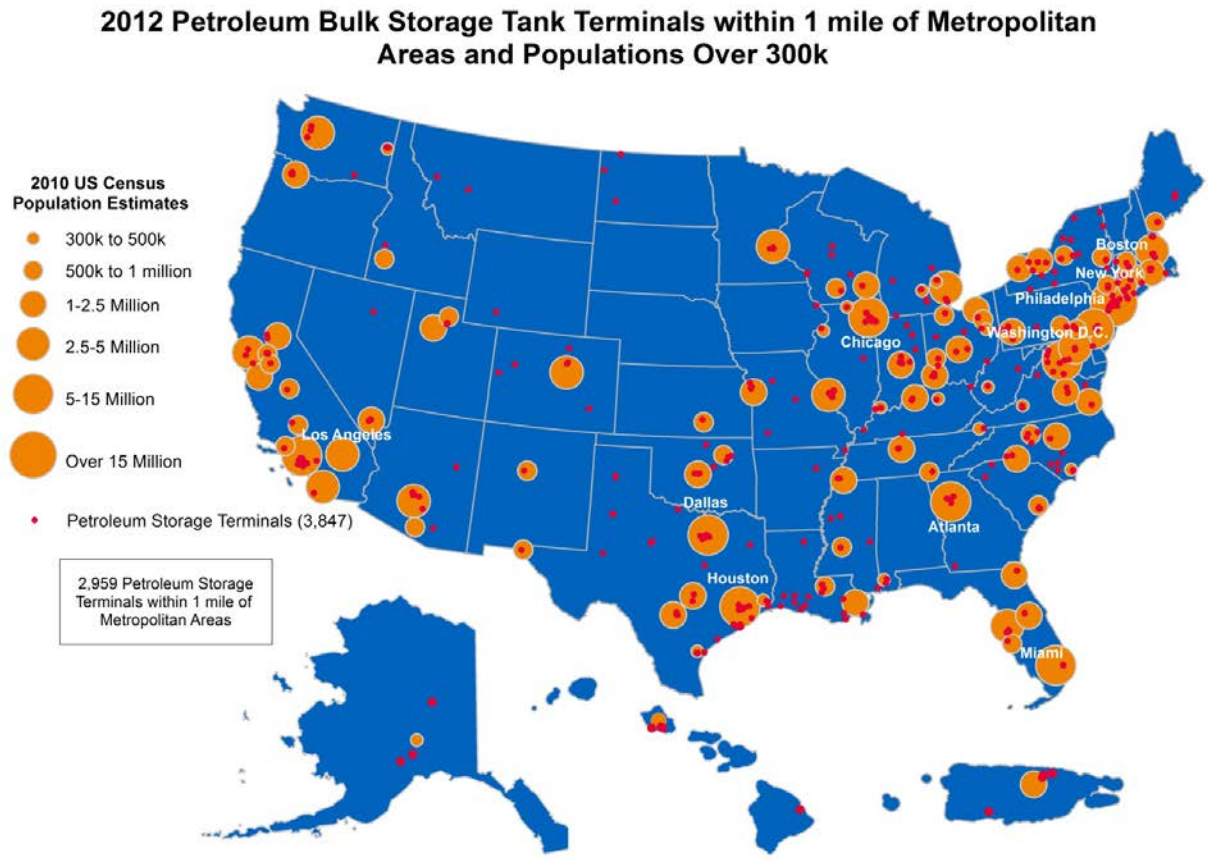
Tank terminals are located throughout the US in both rural and urban areas. Figure 16 illustrates the location of bulk petroleum tank terminals in all 50 states in 2012. In 2009, 3,807 bulk liquid storage facilities registered a release with the EPA Toxic Release Inventory (TRI).[87,88] The CSB mapped 3,847 bulk petroleum storage tank terminal locations obtained from the EPA TRI database for 2012 and found 2,959 bulk petroleum storage terminals within one mile of communities with over 300,000 residents (Figure 16).

Figure 16: Tank terminals distributed across the US in 2012 in proximity to 2010 population data. (EPA TRI Database, 2012)
