FINAL INVESTIGATION REPORT

CARIBBEAN PETROLEUM TANK TERMINAL EXPLOSION AND MULTIPLE TANK FIRES

CARIBBEAN PETROLEUM CORPORATION (CAPECO)

REPORT NO. 2010.02.I.PR
U.S. CHEMICAL SAFETY AND HAZARD INVESTIGATION BOARD

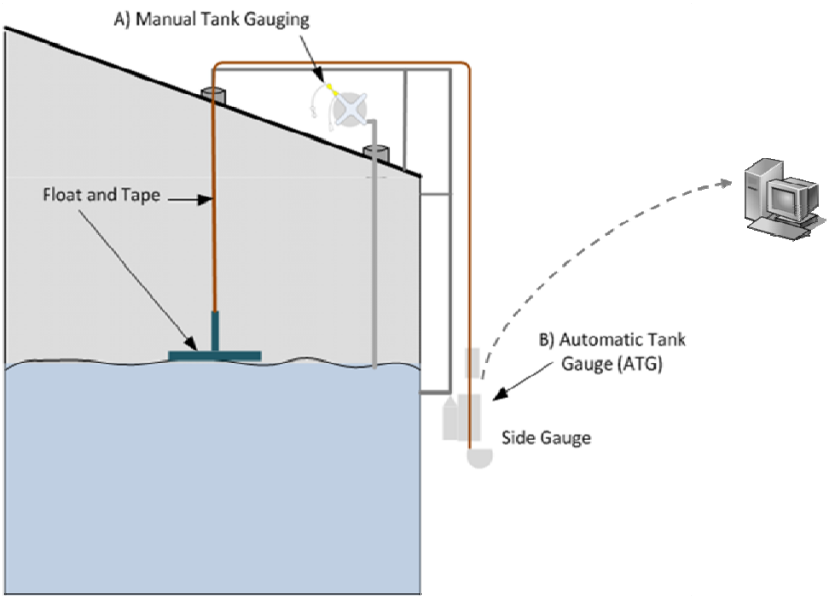
Figure 3: Manual and Automatic Tank Gauging. (A) Manual Gauging requires an operator to use a tape and measure to determine the liquid levels inside the tank. (B) Automatic Tank Gauging (ATG) requires an operator to read a level measurement from a tank gauge mounted to the side of the tank.

Prior to the start and end of filling operations, the independent inspector manually measured the fuel tank levels by lowering a gauging tape[12] into the tank. (Figure 3.) A CAPECO operator

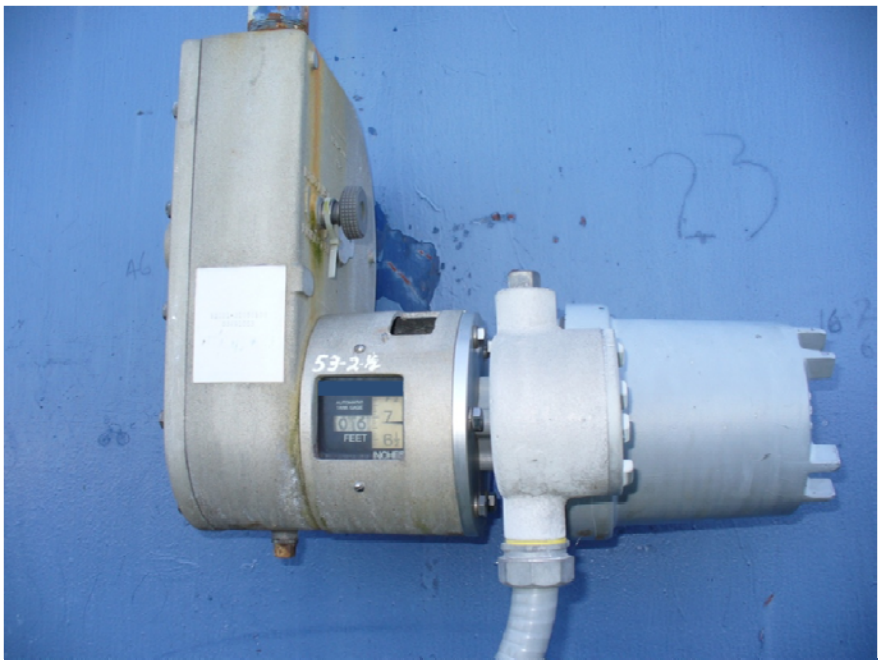
A typical float and tape gauge consists of depth-indicating dials, a motor, a long metal tape, and a sealed hollow cylinder called a float, which floats on the surface of the liquid in the tank. One end of the long metal tape attaches to the float, while at the other end, a motor winds the tape into a coil to maintain constant tension on the tape. As the liquid level in the tank falls, the weight of the float pulls the tape, and the motor allows the tape to extend farther into the tank. As the liquid level in the tank rises, the motor senses looseness in the tape and winds the tape into a coil to maintain the required tension. As the tape winds and unwinds, the mechanical dial rotates to indicate the total depth of liquid in the tank and displays the value on the side gauge (Figure 4).[18] Section 6.5 analyzes the failure of the ATG system in the incident.

Figure 4: Side gauge: mounted on the side on a tank and displaying the amount of liquid in the tank

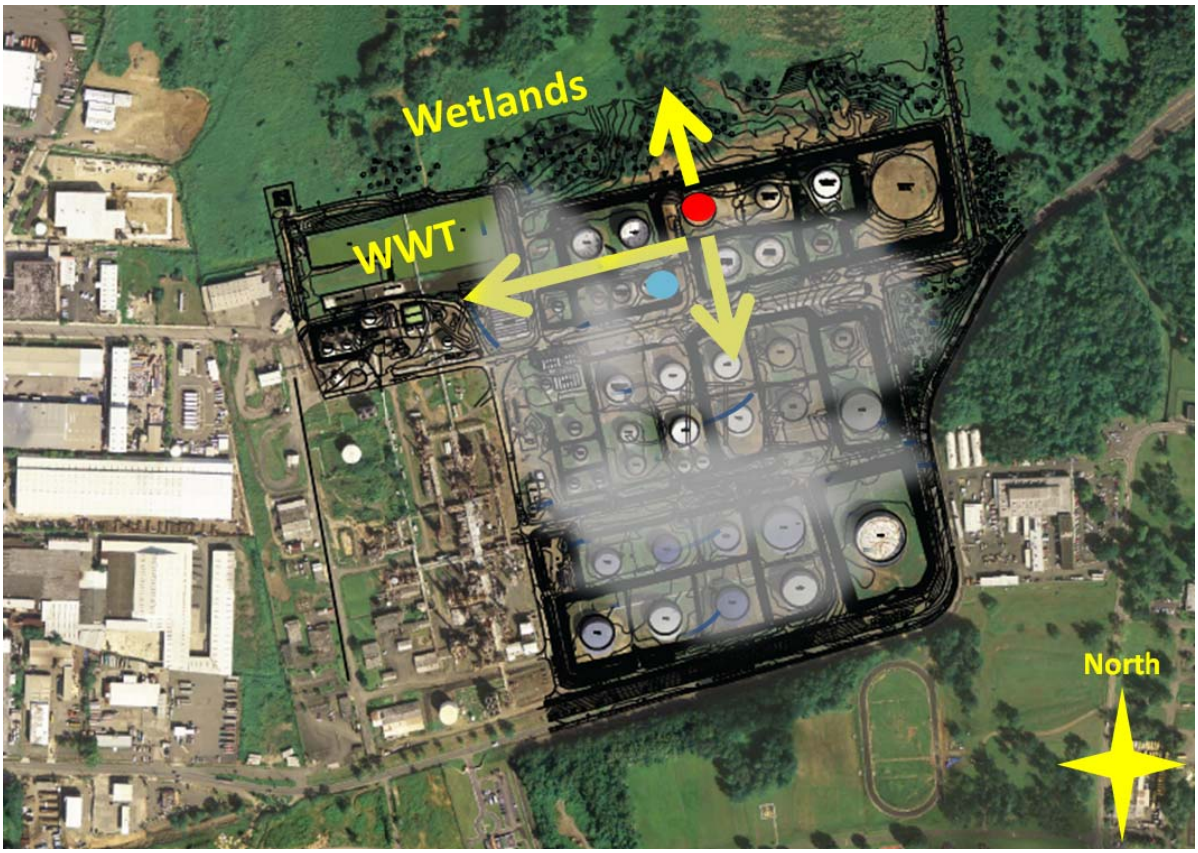
Figure 7. Topographic Survey of CAPECO Tank Farm showing the gasoline vapor cloud migration from higher elevation (Tank 409-Red and Tank 411-Blue) toward low-lying areas by the WWT plant, the south eastern end of the refinery and wetlands to the north. The cloud indicates the approximate area where the vapor cloud migrated based on surveillance footage.

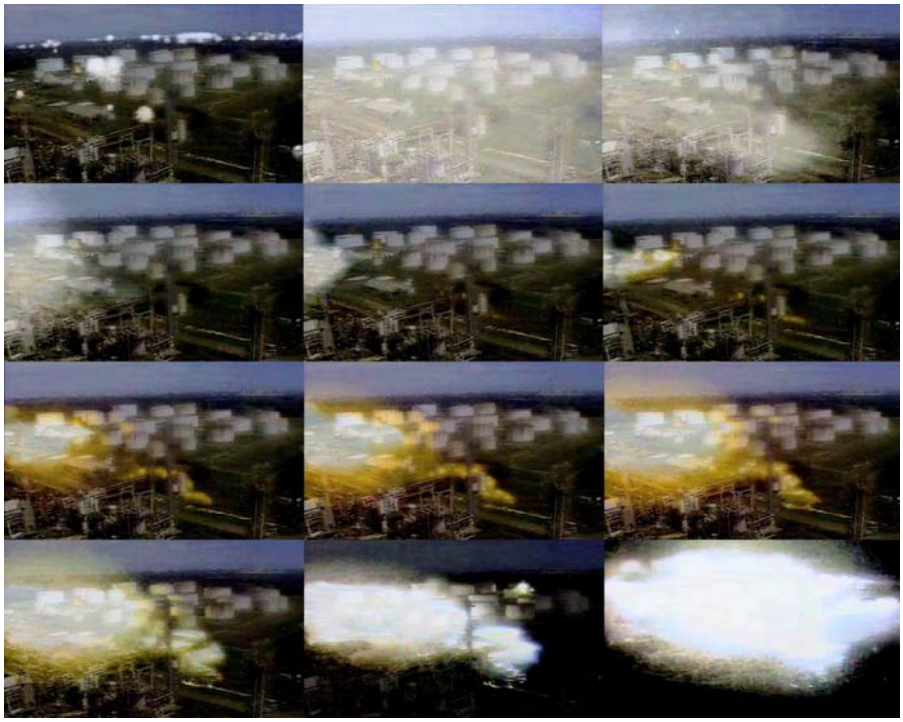
At 12:23 a.m., on October 23, 2009, security cameras at CAPECO and neighboring facilities recorded the ignition of the vapor cloud in the WWT area. About seven seconds after ignition, the vapor cloud exploded, creating a pressure wave that damaged hundreds of homes and businesses up to 1.25 miles from the site. The fire propagated through the vapor cloud and ignited multiple subsequent tank explosions registering 2.9 on the Richter scale.[20]

Figure 8: CAPECO surveillance footage of flame propagation during October 23, 2009 CAPECO explosion

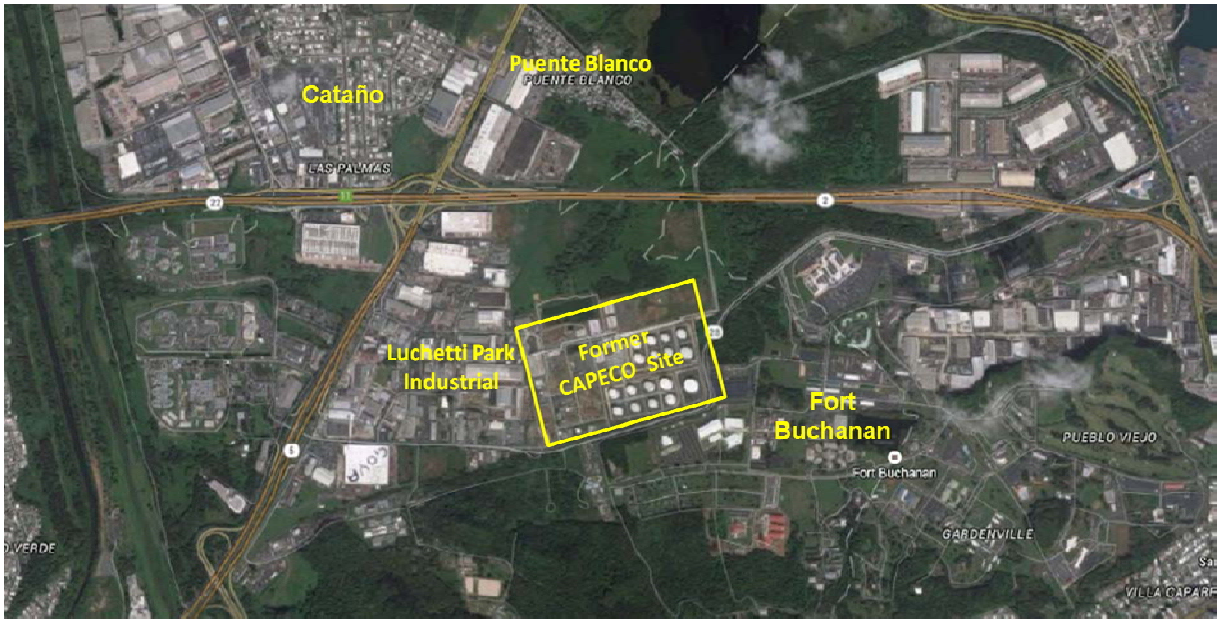
Figure 9: Communities neighboring the CAPECO facility

The incident caused the governor of Puerto Rico to request federal assistance, and on October 24, 2009, the President signed an emergency declaration[29] providing assistance for the municipalities of Bayamón, Cataño, Guaynabo, San Juan, and Toa Baja (Figure 9). The federal emergency declaration activated 17 FEMA Emergency Support Function Annexes (ESF)[30] and enabled FEMA to provide logistical support, Direct Federal Assistance (DFA), and public assistance grants to state and local municipalities.[31] Logistical support included setting up a more

Despite approximately 1,600 people residing adjacent to the CAPECO facility in the Puente Blanco community[38] and about 48,500 residents living in Cataño three miles from the incident site (Figure 9), the 2009 explosion and fires did not result in any fatalities. However, shrapnel and glass from the blast caused minor injuries to three people at Fort Buchanan. Nearby residents of the surrounding communities were awakened by the blast and ensuing fire. The CSB learned, regulatory authorities in Puente Blanco issued unclear evacuation orders by bullhorn as they drove through the community. With no planned evacuation routes or shelters, residents crowded into the narrow streets. Some members of other nearby communities evacuated voluntarily to escape damaged homes and potential health effects from the smoke and vapors generated by the fire.

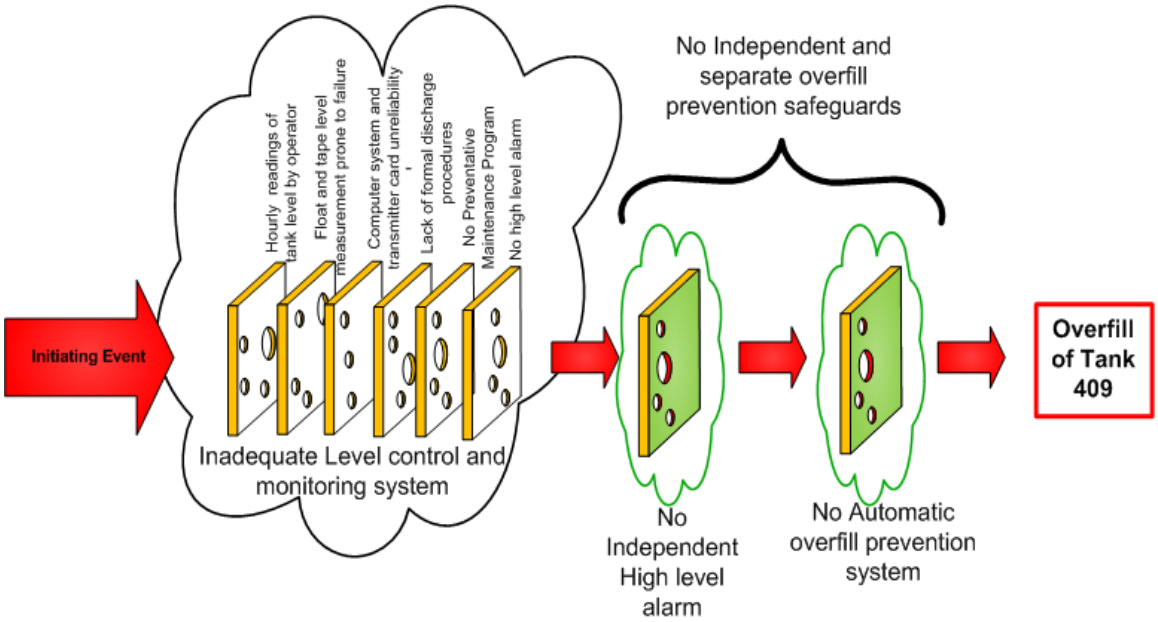
The CSB determined that numerous technical and systemic failures contributed to the explosion and multiple tank fires at the CAPECO tank terminal. The CSB found that multiple layers of protection failed within the level control and monitoring system at the same time. In addition a lack of independent safeguards contributed to the overfill. James Reason's Swiss Cheese Model best demonstrates these systemic failures that led to the accident.[50] Reason postulates that an accident results from the breakdown of the "interaction between latent failures[51] and a variety of local triggering events (active failures)"[52] and although rare, the "adverse conjunction of several

Figure 12: Contributing to the October 2009 overfill incident at CAPECO were multiple failures of the level control and monitoring system in addition to a lack of safeguards like a high level alarm, an independent level alarm and an automatic overfill prevention system that allows for automatic shutdown or diversion.

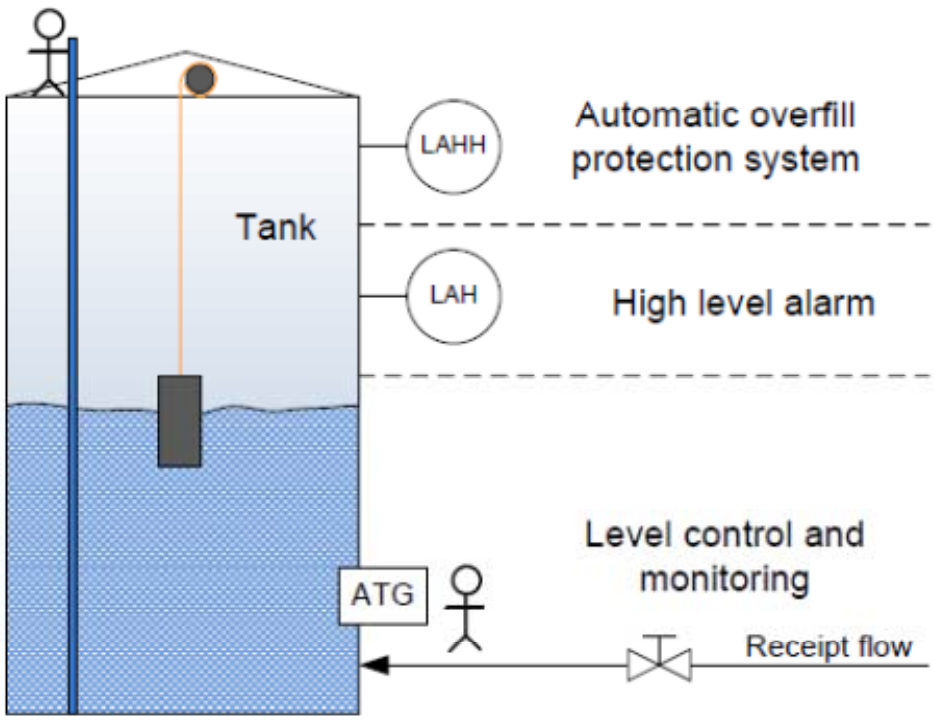
Figure 13: A comprehensive overfill prevention system includes the ATG, high-level alarm (LAH), and automatic overfill protection system (LAHH), in addition to the operator and facility procedures that govern, monitor, and control the flow of fuel into a tank.

CAPECO lacked a reliable automatic level control and monitoring system for measuring tank levels. (See Figure 13.) The automatic gauging system at CAPECO, described in Section 3.6.3, had a history of repeated failures and prolonged out-of-service periods. On the night of the incident, the float and tape device inside Tank 504 became stuck and the transmitters for Tanks 107 and 409 were not receiving data from the side gauge on Tank 409; therefore, data on the tank liquid level and a calculated fill rate into 409 were not available in real time on the computer. The computer monitoring system was often compromised by outages from lightning strikes and accidental breakage of the computer cables after maintenance activities in the tank farm area. In addition, the transmitters[56] that sent the data to the computer were also susceptible to electromagnetic interference and frequently needed replacing after lightning storms.

Records show, CAPECO took weeks to replace the faulty transmitters. Therefore, CAPECO operators found the computer monitoring system to be unreliable. After completing hourly rounds, the operator reported the tank level back to the shift supervisor, who then manually calculated the time it would take to fill the tank. The CSB learned that CAPECO operators had been calculating the tank levels by hand for decades. This method of monitoring the level in the tanks was unreliable given the 15 prior tank spill incidents at the facility and the extended time that the level detection equipment remained out of service due to failure.

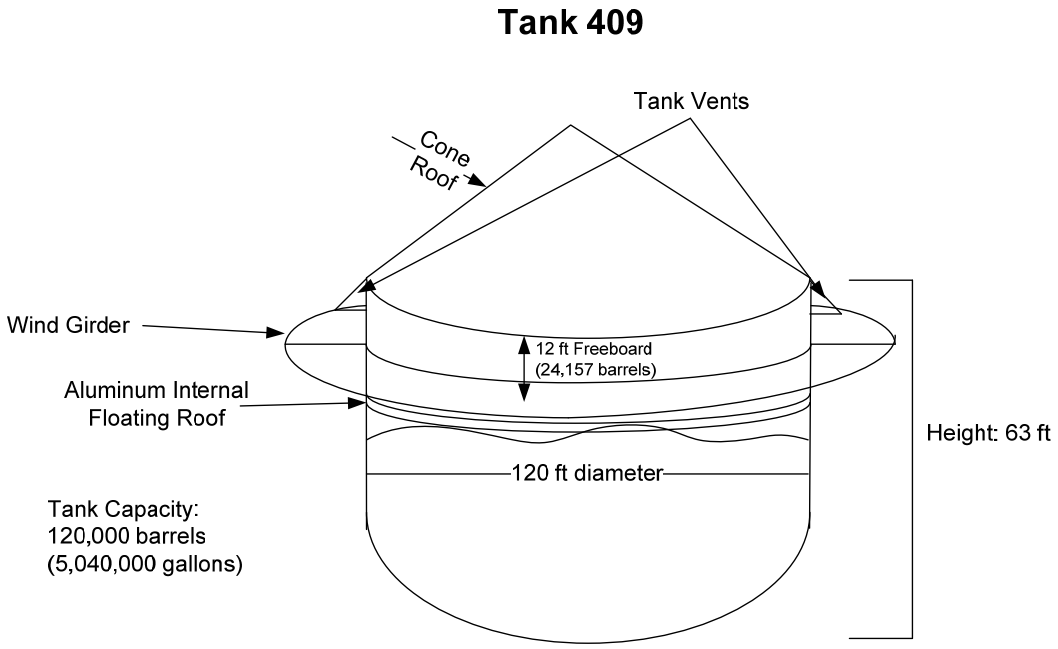
Figure 14: Tank 409 Specifications

Tanks 409 and 410 were located within the same secondary containment dike.[23] Similar to the Buncefield incident,[24] during the overflow, gasoline sprayed from the tank vents, hitting the Tank 409 wind girder and aerosolized, [25] forming a vapor cloud. [26] A CSB topographic survey of the site shows that Tanks 409 and 411 were located at the highest point within the tank farm area, allowing the vapor cloud to spread to lower lying areas in the direction of the WWT (Figure 7). See Figure 14, Tank 409 Specifications.

The destruction of the Tank 409 internal floating roof in the explosion prevented the CSB from determining if it failed during filling operations. Therefore, internal floating roof failure might have contributed to the overfilling of Tank 409. The roof construction of Tank 409 was subject to numerous operational limitations. Tank 409 had a fixed cone roof with an aluminum internal floating roof (IFR), and a freeboard[71] of 12 feet (24,157 bbls). (See Figure 14 for Tank 409 specifications.) Aluminum IFRs are prone to corrosion when exposed to caustic liquids but sufficient for petroleum and organic materials. An internal floating roof can fail by means of turbulence,[72] roof submersion,[73] seal issues, and fatigue.[74]

API MPMS Ch. 3.1A discusses the impact of the floating roof on tank volume. On the night of the incident, the final reading likely occurred when the floating roof was floating freely. When floating roofs are in the free-floating position, they displace the amount of liquid equal to the weight of the roof and attached deadwood. The only accurate way to obtain volume in the critical zone is by a liquid calibration procedure. API MPMS Ch. 3.1A advises that facilities calculate roof displacement by considering the roof weight, temperature, and density of the liquid of tank contents in the critical zone. CAPECO did not calculate the roof displacement of Tank 409.
