U.S. CHEMICAL SAFETY AND HAZARD INVESTIGATION BOARD

FINAL INVESTIGATION REPORT

CHEVRON RICHMOND REFINERY
PIPE RUPTURE AND FIRE

REPORT NO. 2012-03-I-CA
JANUARY 2015

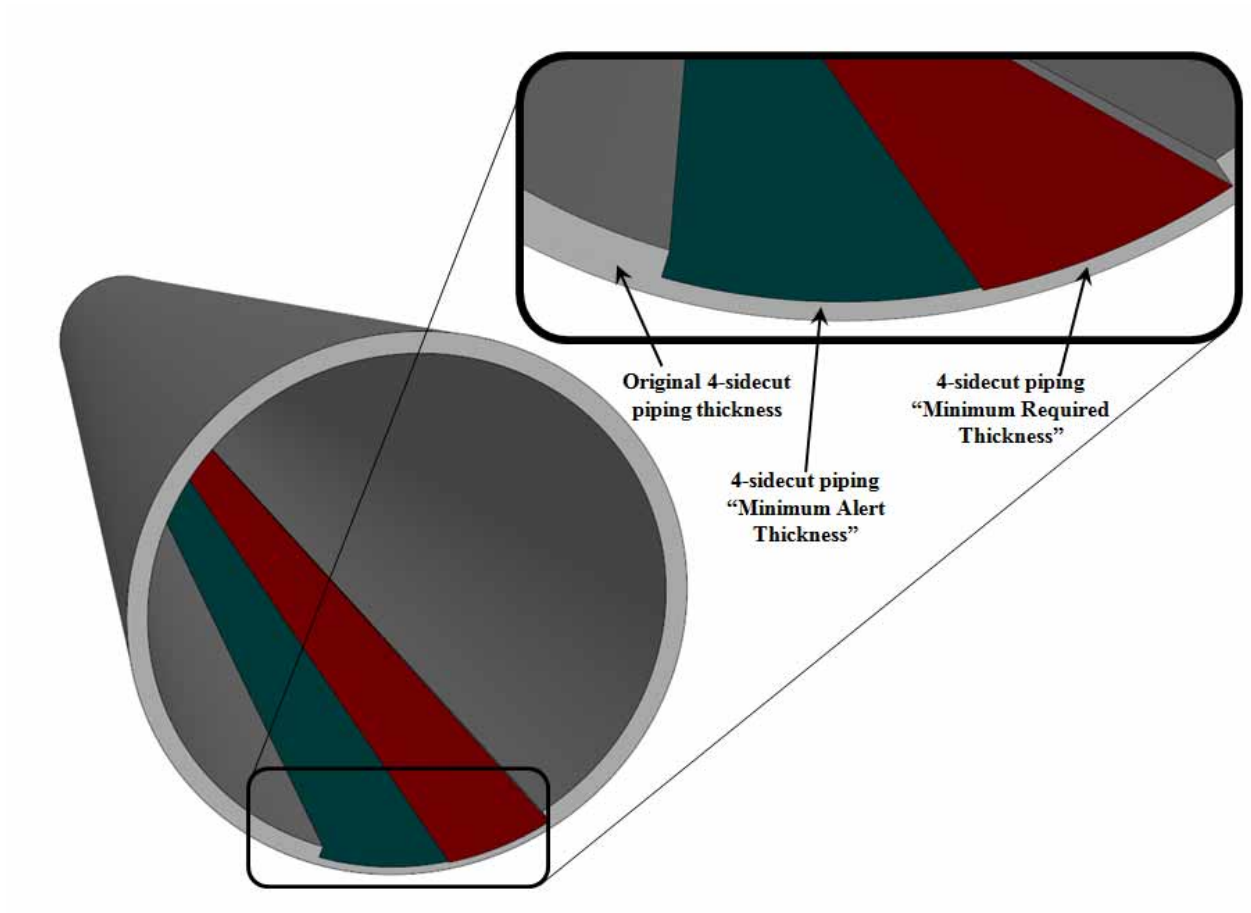
Figure 1. To-scale schematic of 4-sidecut piping identifying key wall thickness values. These include the original wall thickness (0.322-inch), "Minimum Alert Thickness" (0.13-inch), and "Minimum Required Thickness" (0.11-inch) using *API RP 574* default values.

16. Inspection data obtained during the 2011 Crude Unit turnaround identified that components of the 12-inch portion of the 4-sidecut piping had become so thin due to sulfidation corrosion that much of it had to be replaced during the turnaround. Even though the 12-inch 4-sidecut piping was manufactured from the same specification of carbon steel, contained the same process fluid, and experienced similar process conditions[30] as the 8-inch 4-sidecut piping, Chevron turnaround management did not consider that components in the 8-inch 4-sidecut piping could also be too thin to allow the piping to continue in operation. Chevron personnel involved with the decision to replace portions of the 12-inch 4-sidecut piping concluded, based upon available inspection data, that all of the 8-inch 4-sidecut piping that had not been inspected, including the 52-inch component that ultimately failed, was acceptable for continued operation. (See Section 5.1.2.2.1.)

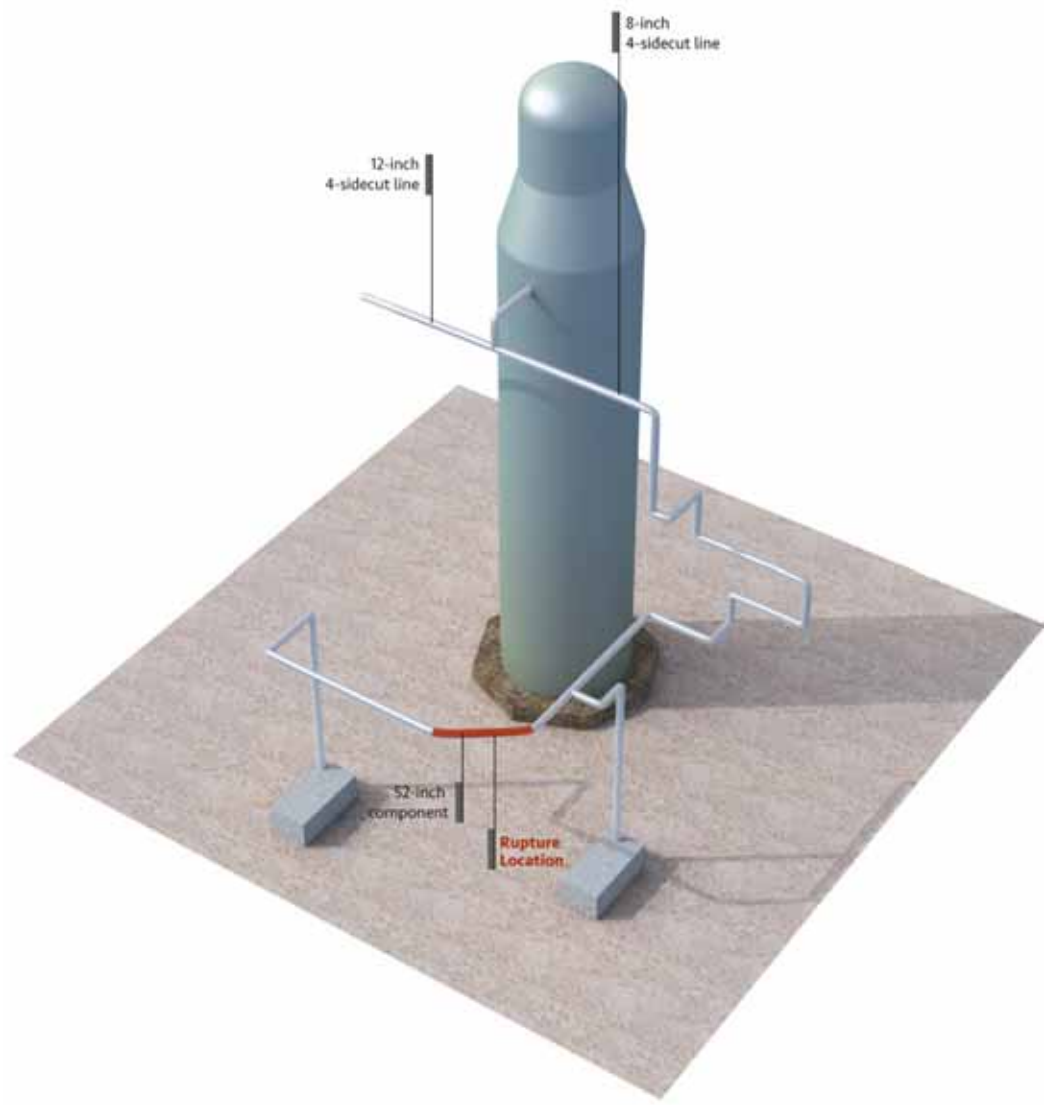
Figure 4. 4-sidecut line configuration and rupture location.

Figure 5. Photo of rupture on 4-sidecut 52-inch component.

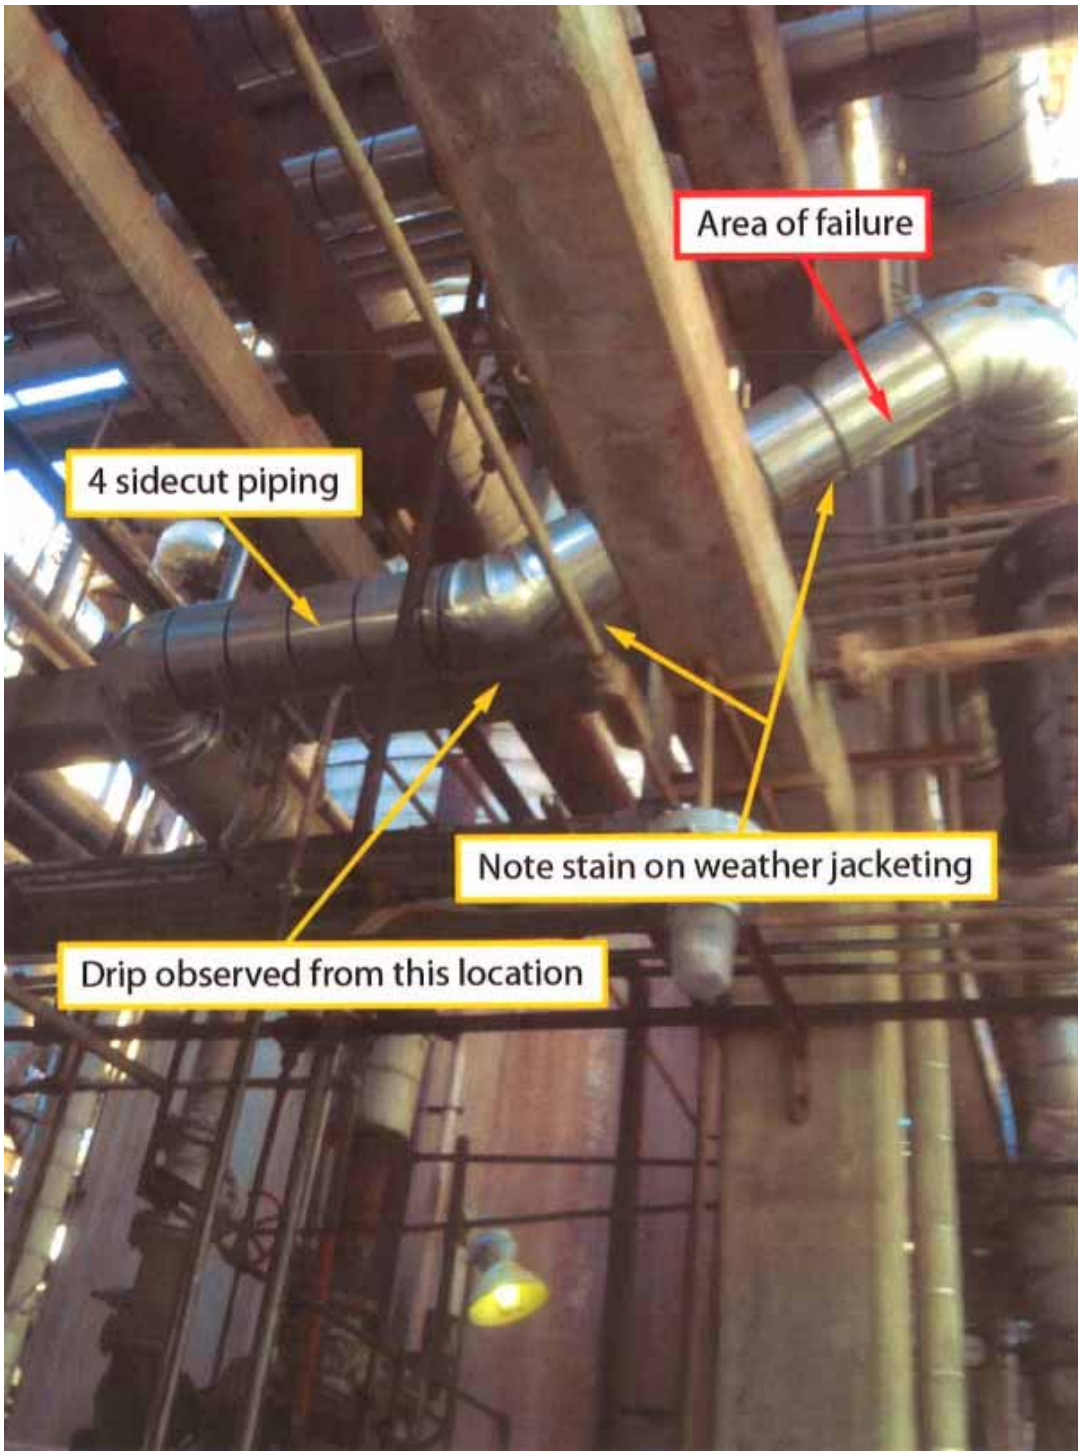
Figure 7. Photo taken of the leaking 4-sidecut pipe on August 6, 2012, at the Chevron Richmond Refinery.[49] Insulation obscured the actual leak location. Stain signifies where hydrocarbon process fluid was leaking from the 4-sidecut piping.

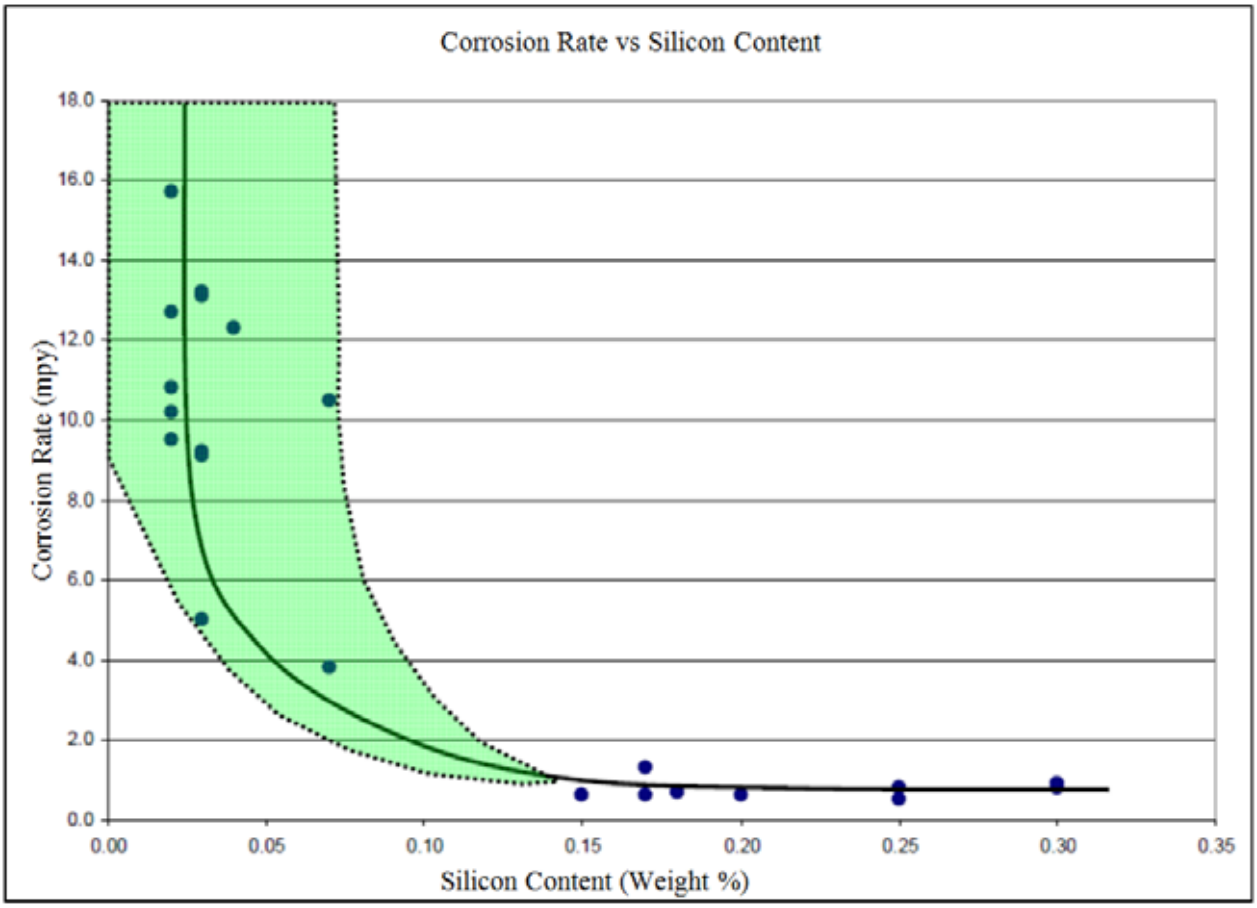
Figure 17. Graph of sulfidation corrosion rates with respect to silicon content in carbon steel. This graph shows how corrosion rates increase in carbon steel containing decreasing percentages of silicon. This information can be found in Annex C of *API RP 939-C*.[67]

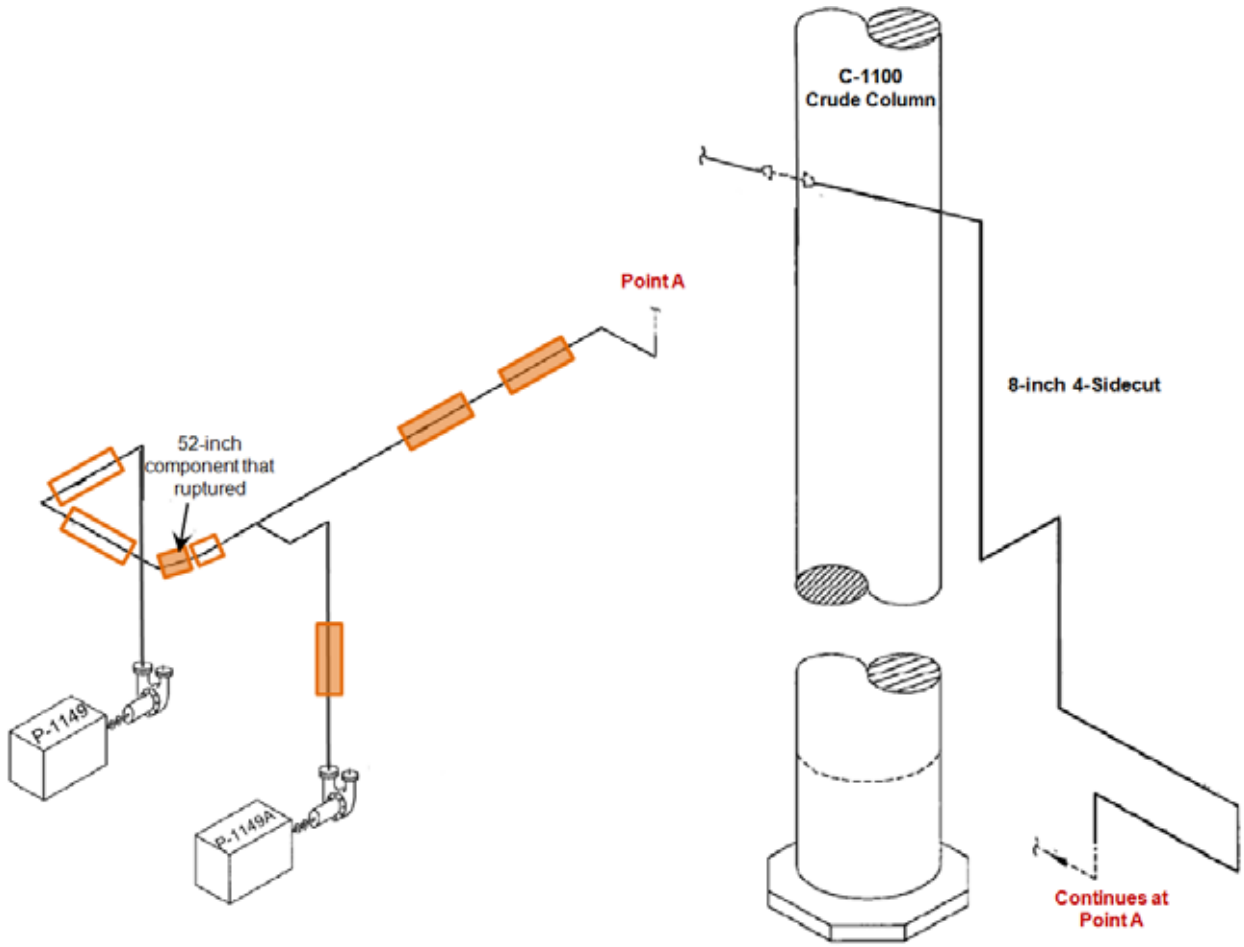
Figure 18. Locations of metallurgical samples taken from 8-inch 4-sidecut piping post-incident. The seven samples taken are boxed in orange. Four of the seven components sampled (shown with an orange fill) were found to have a silicon content less than 0.10 weight percent.

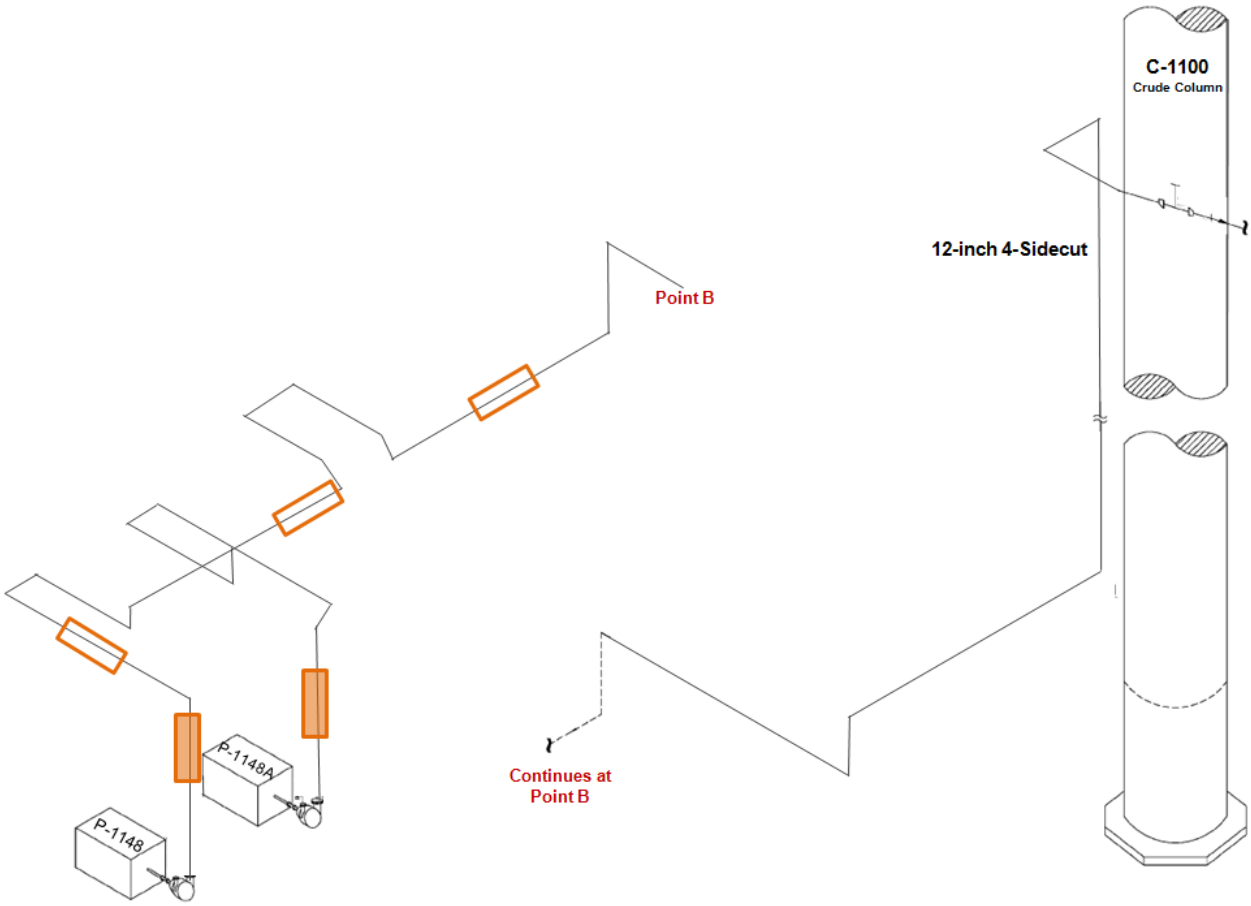
Figure 19. Locations of metallurgical samples taken from 12-inch 4-sidecut piping post-incident. The five samples taken are boxed in orange. Two of the five components sampled (shown with an orange fill) were found to have a silicon content less than 0.10 weight percent.

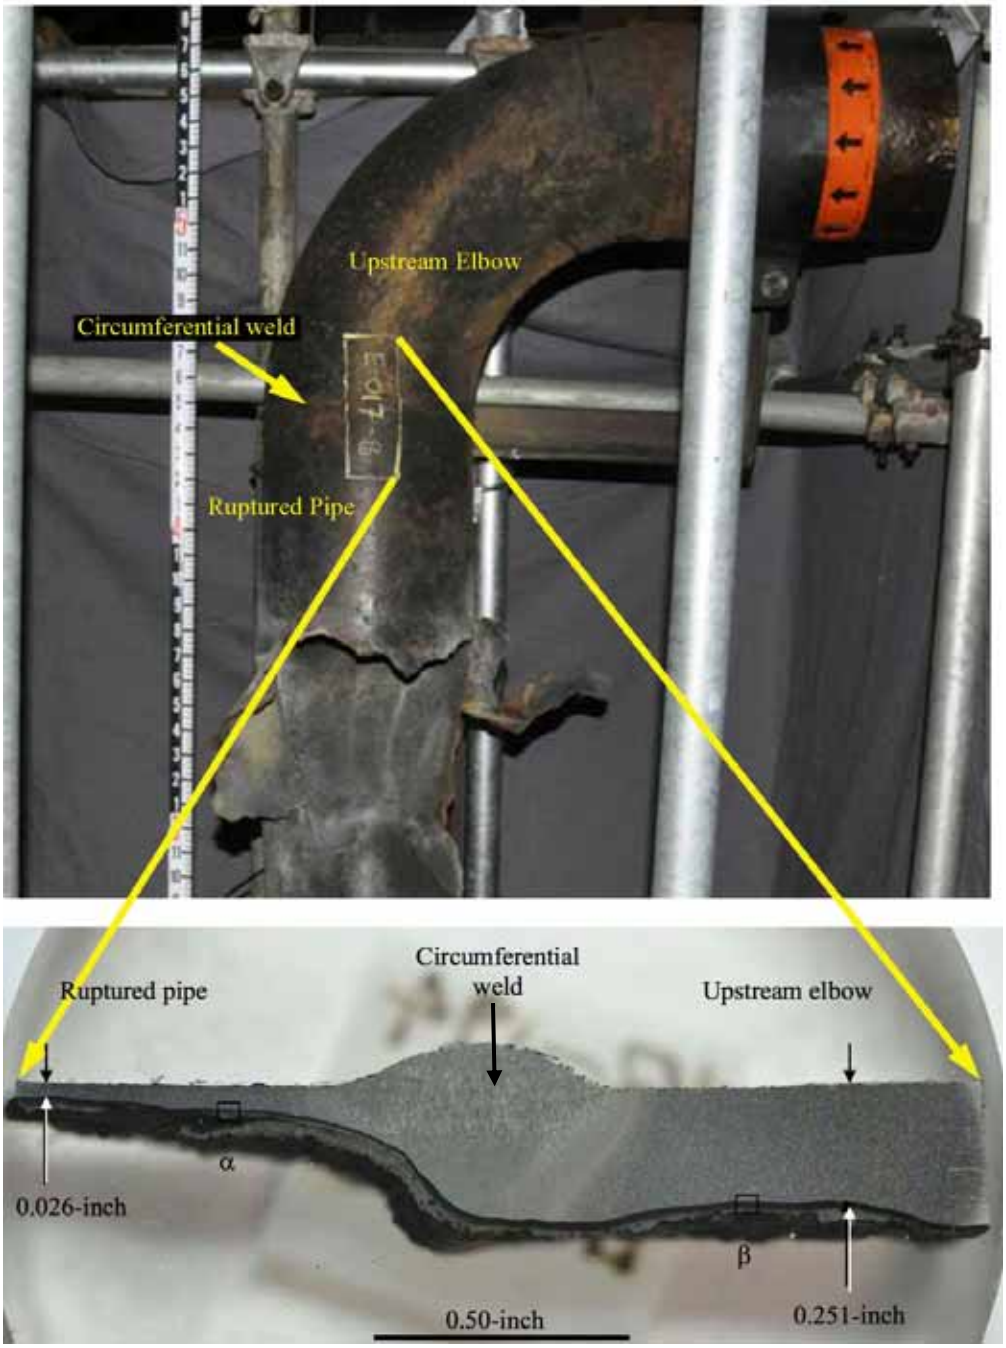
Figure 20. 4-sidecut piping sample (E-017-8) analyzed by Anamet Labs showing the relative thickness of low silicon piping on the left and the high silicon piping on the right. The ruptured 52-inch pipe component (left) contained 0.01 weight percent silicon, and the upstream elbow component (right) contained 0.16 weight percent silicon.[75] The initial nominal thickness of this piping was 0.322-inch.

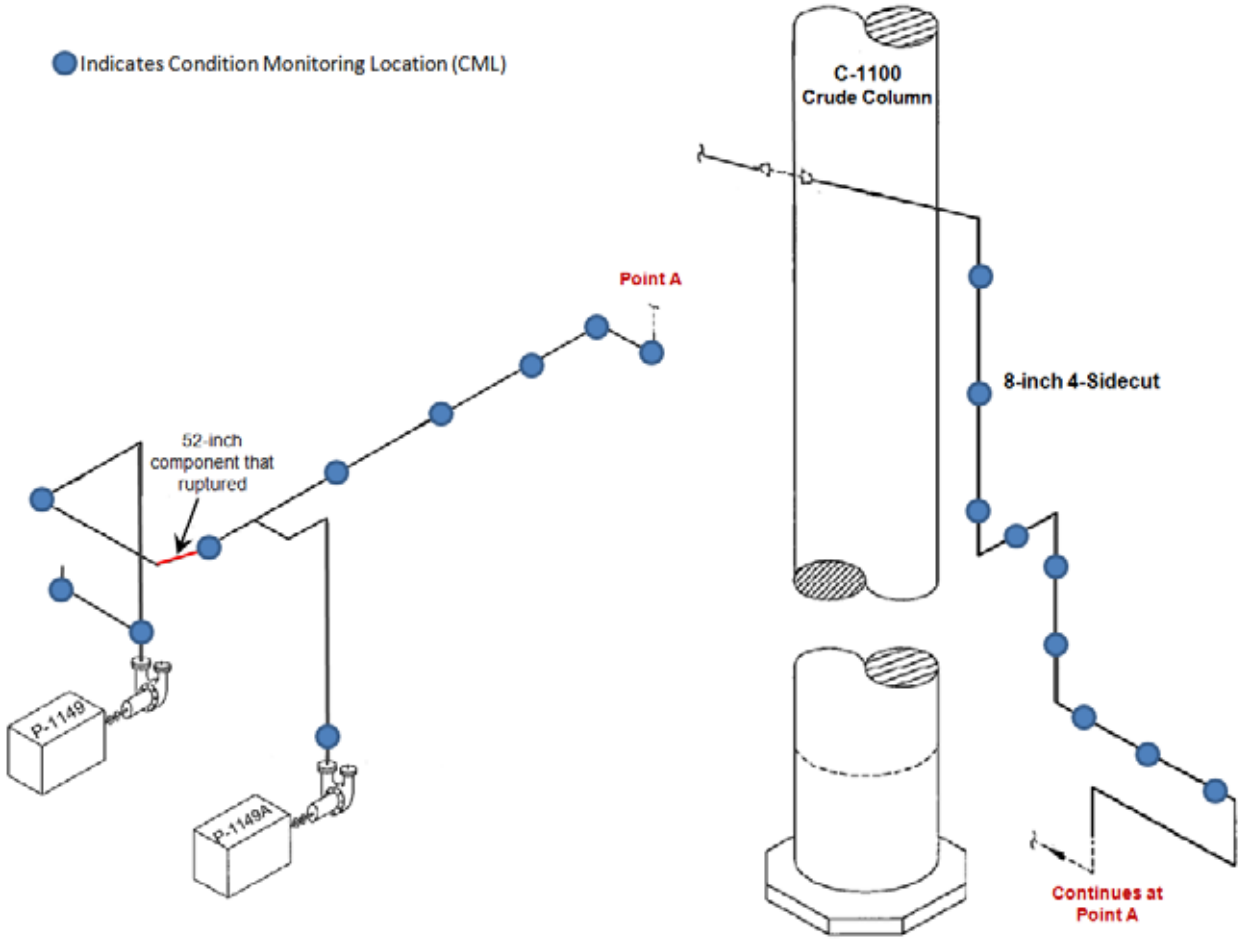
Figure 21. CML placement on 8-inch 4-sidecut piping. Nineteen CMLs were used to monitor corrosion rates in the 8-inch 4-sidecut piping. A CML was not placed on the 52-inch component that ultimately failed. A CML was placed, however, on the upstream elbow adjacent to the 52-inch component.

This inspection data gathered using the 19 CMLs did not reflect the corrosion rates of the quickly corroding, low-silicon components of the 4-sidecut piping. As illustrated by the Chevron incident, traditional inspection techniques alone—using only a limited amount of CMLs—may not accurately identify the most aggressive sulfidation corrosion rates throughout an entire circuit of carbon steel piping.

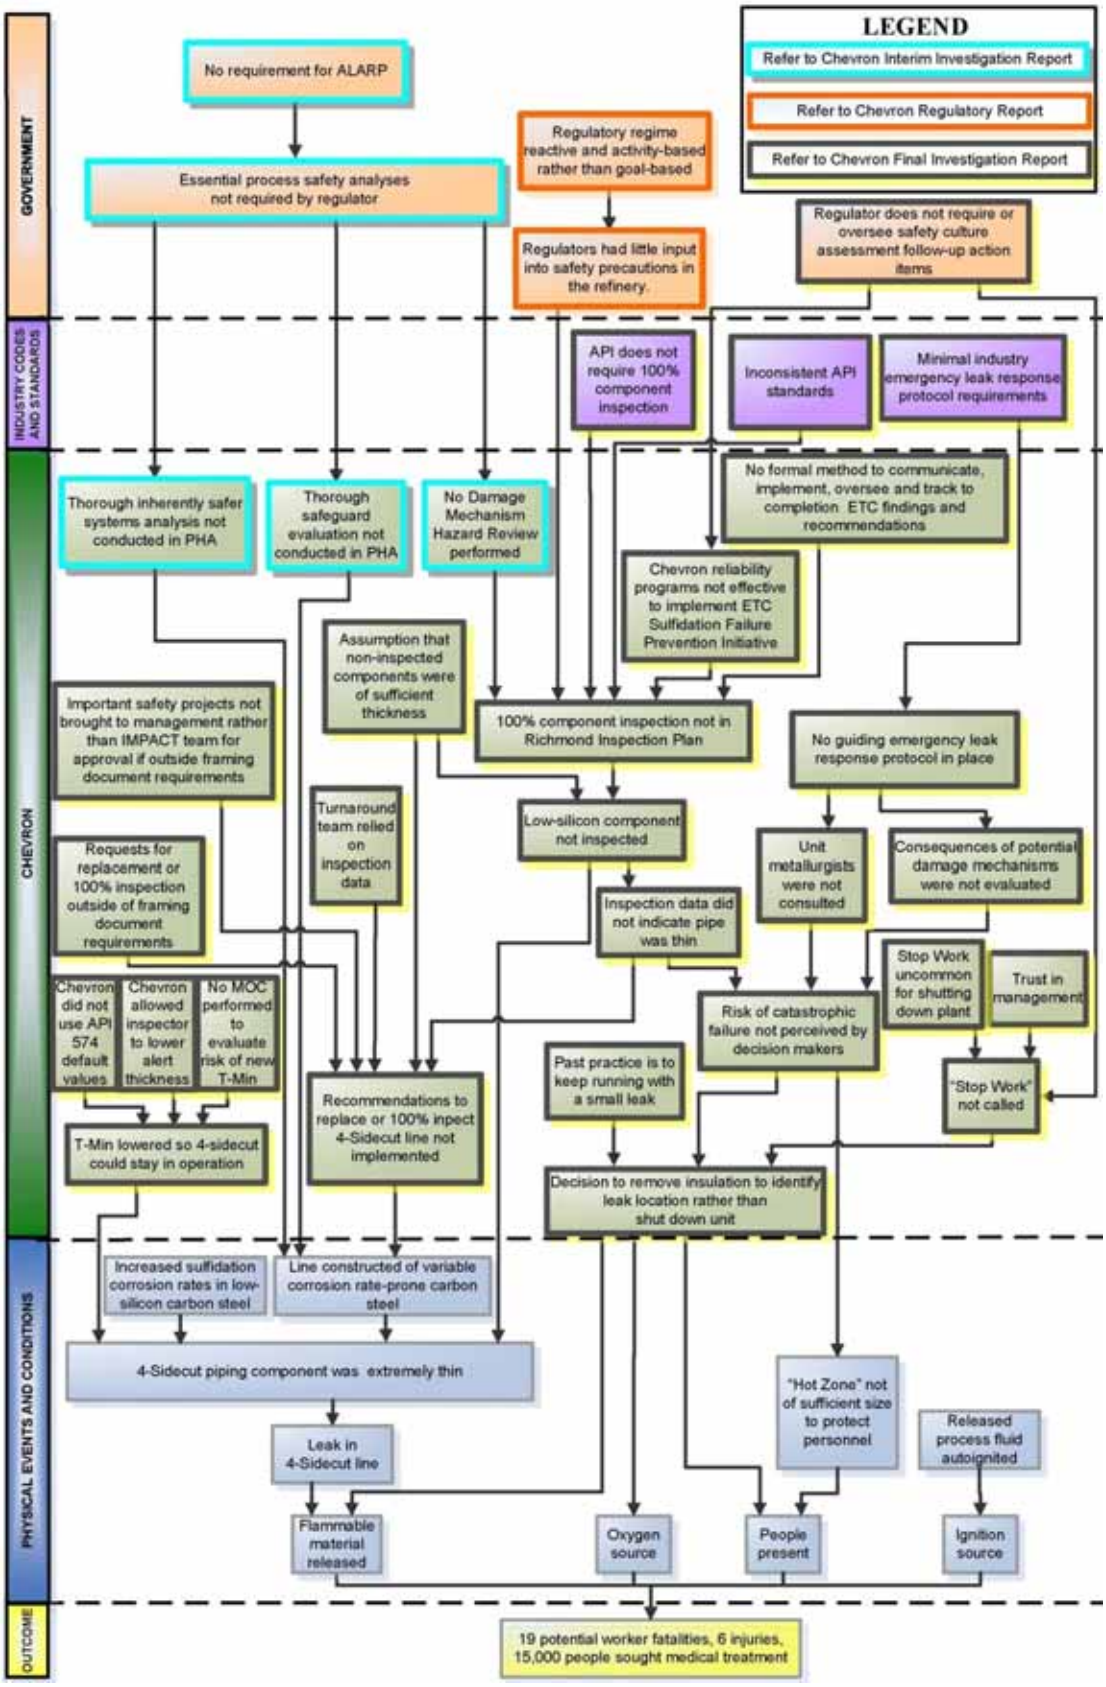
The CSB investigation team developed an accident map (AcciMap)[114] for the Chevron investigation (Figure 24). The AcciMap is a multilayered causal diagram that depicts immediate causes[115] as well as higher level contributing causes at the corporate, governmental, and regulatory levels. This diagram includes five levels:

Figure 24. Acci-Map of August 6, 2012, Chevron Refinery Fire.

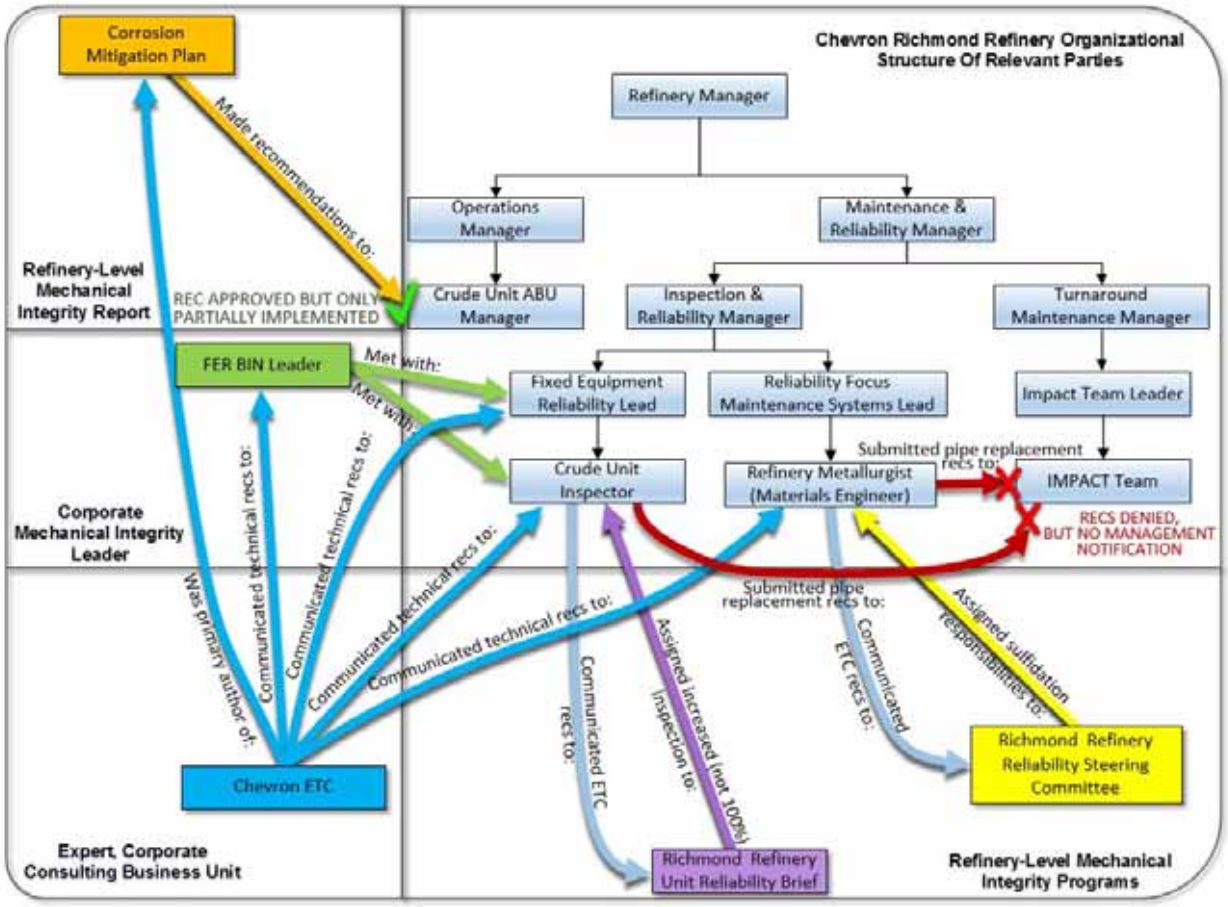
In the ten years prior to the incident, a small number of Chevron personnel with knowledge and understanding of sulfidation corrosion made recommendations to increase inspections or upgrade the material of construction in the 4-sidecut piping. Their recommendations were not effectively implemented. The process to implement important, safety-critical projects within the Chevron Richmond Refinery was not fully effective. As discussed in the following sections and depicted in Figure 25, a combination of (1) reliance on a turnaround management program that depended on only a fraction of necessary data to make important process safety decisions, (2) an unsuccessful bottom-up approach—with no management oversight or accountability—for implementing a crucial safety program, and (3) no formal method to track to completion the Chevron expert group's findings and recommendations ultimately caused these recommendations to not be implemented.

Figure 25. Organizational decision-making schematic showing attempts to have carbon steel 4-sidecut piping 100 percent component inspected or replaced with a higher chromium steel alloy. Attempts failed due to lack of accountability and lack of authority to ensure recommendation implementation, and a rigid turnaround planning process that could not approve the 4-sidecut piping replacement recommendations.

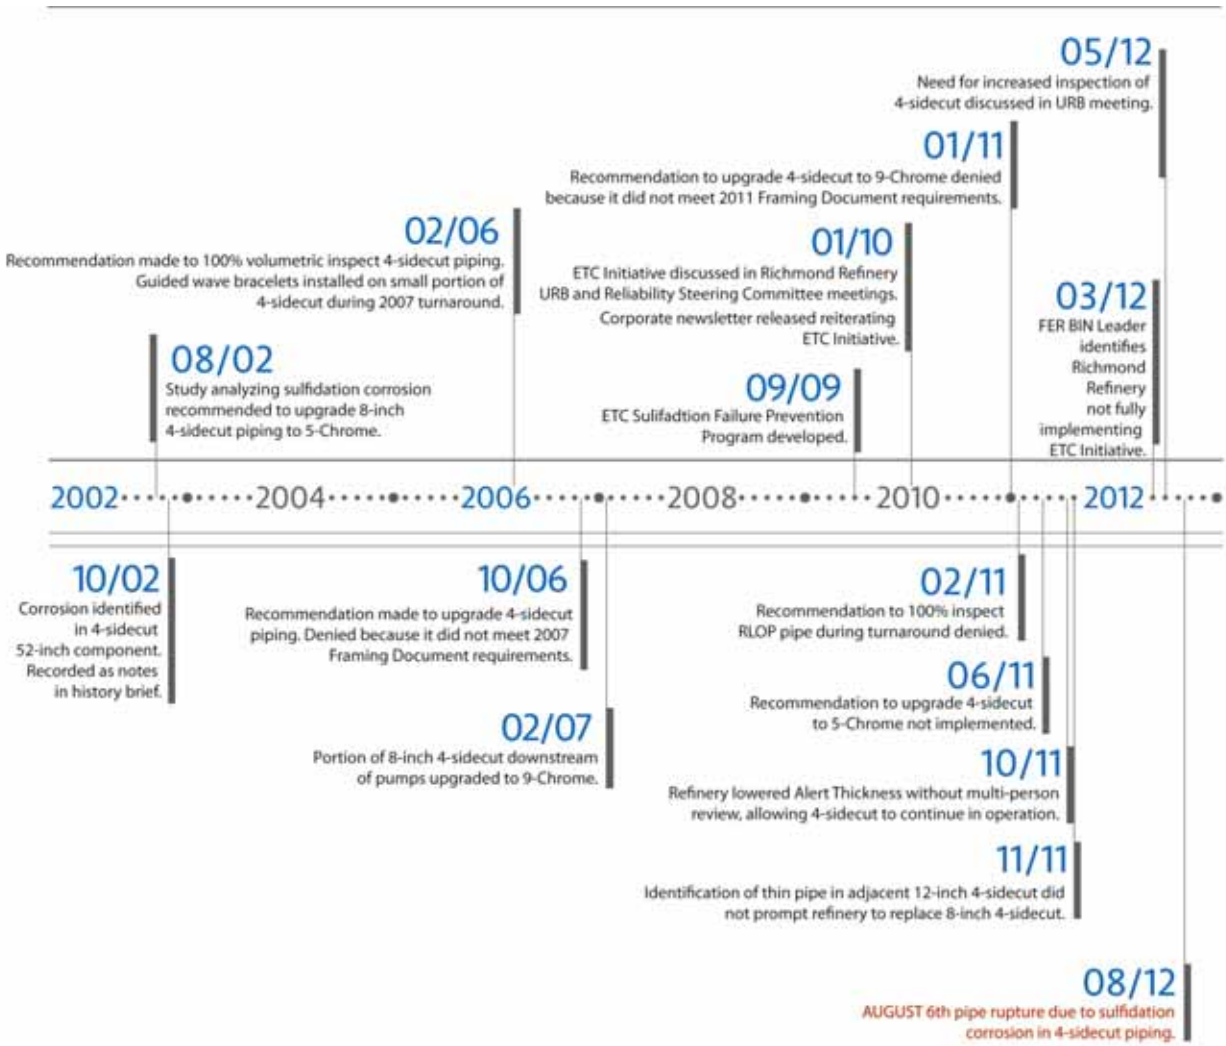
Figure 26 shows the sequence of sulfidation corrosion-related recommendations and events within Chevron Corporation and the Chevron Richmond Refinery between 2002 and the day of the incident. These events are discussed in subsequent sections of this report.

Figure 26. Key events at the Richmond refinery between 2002 and 2012.

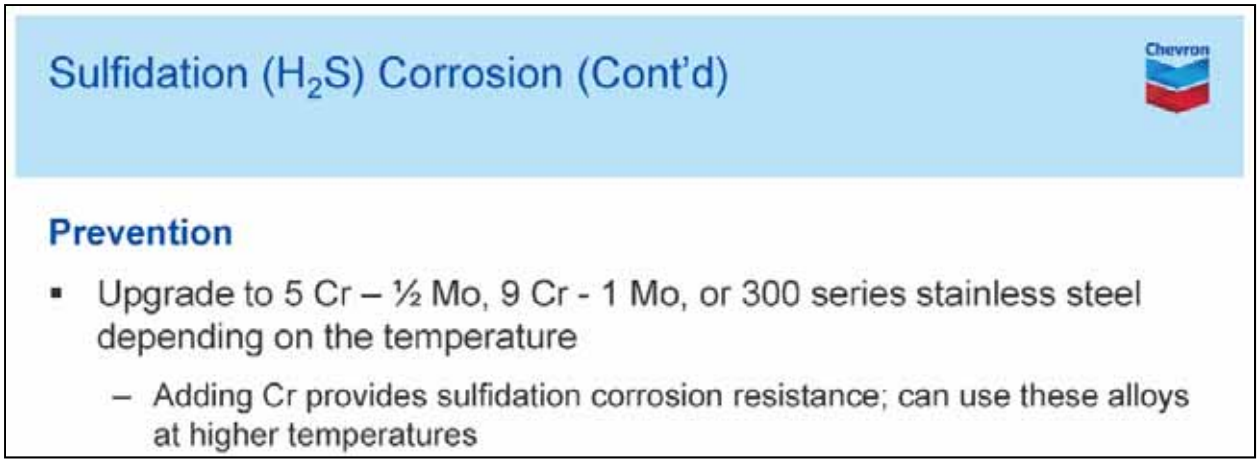
Figure 30. Presentation slide of ETC training course that guided refinery staff on ways to reduce risk from sulfidation corrosion.

[118] Shown in Figure 30, ETC's senior inspector and analysis training taught inspectors that sulfidation corrosion resistance could be improved by upgrading susceptible piping circuits to steels containing higher percentages of chromium.

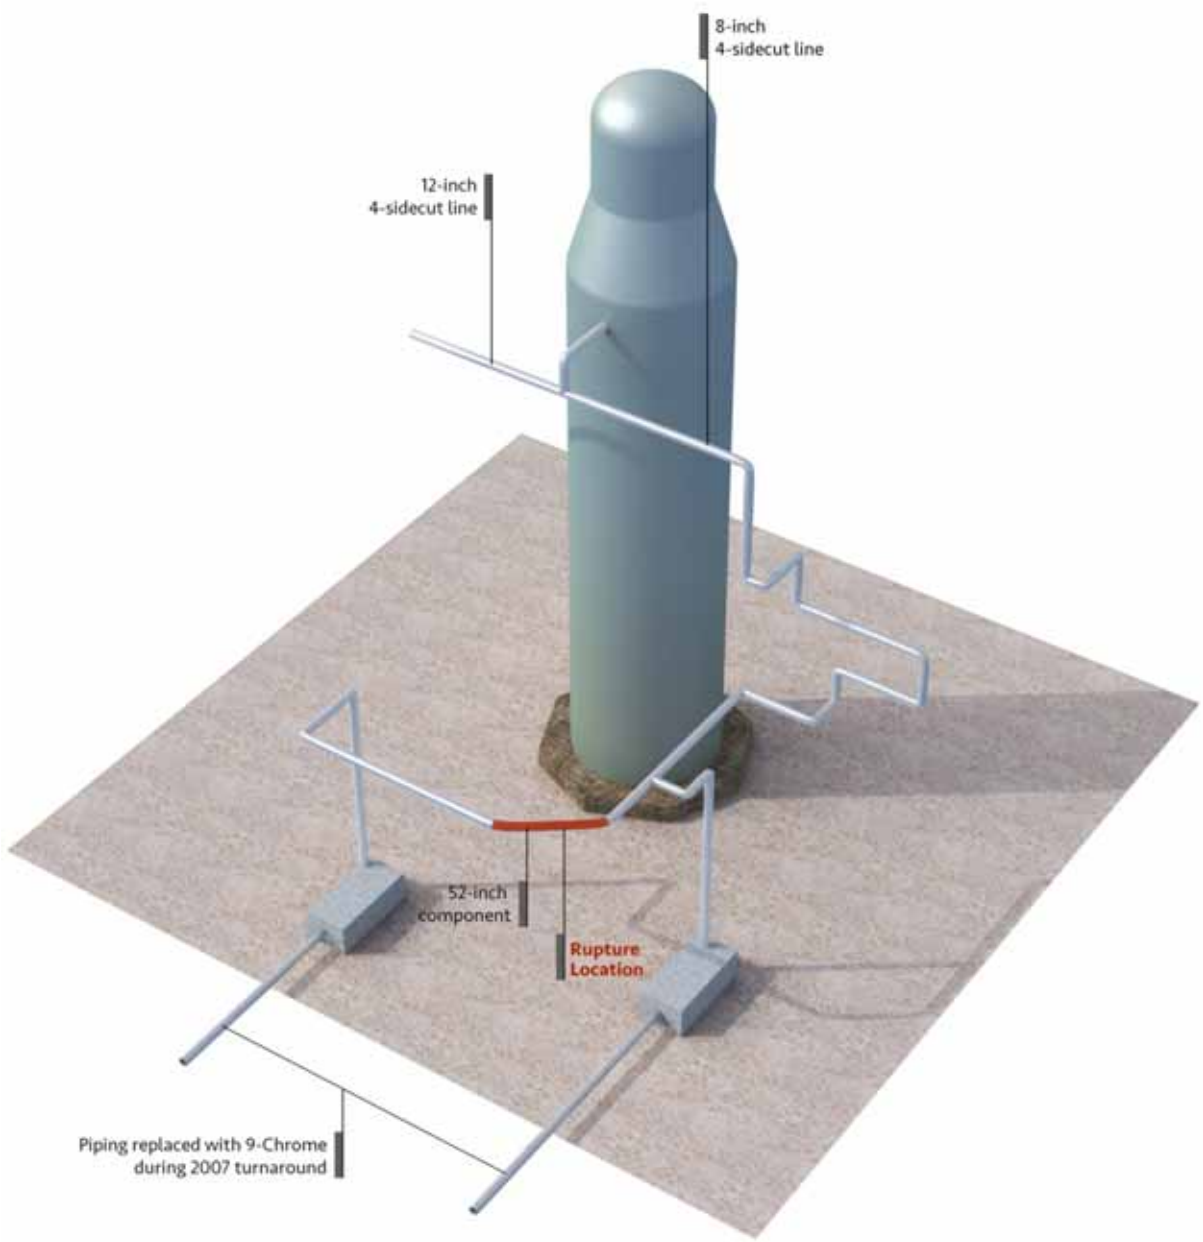
Figure 33. Crude column schematic indicating the piping downstream of the 4-sidecut pumps that was replaced during the 2007 Crude Unit turnaround. The portion of the carbon steel line containing the component that failed on August 6, 2012 was not replaced.

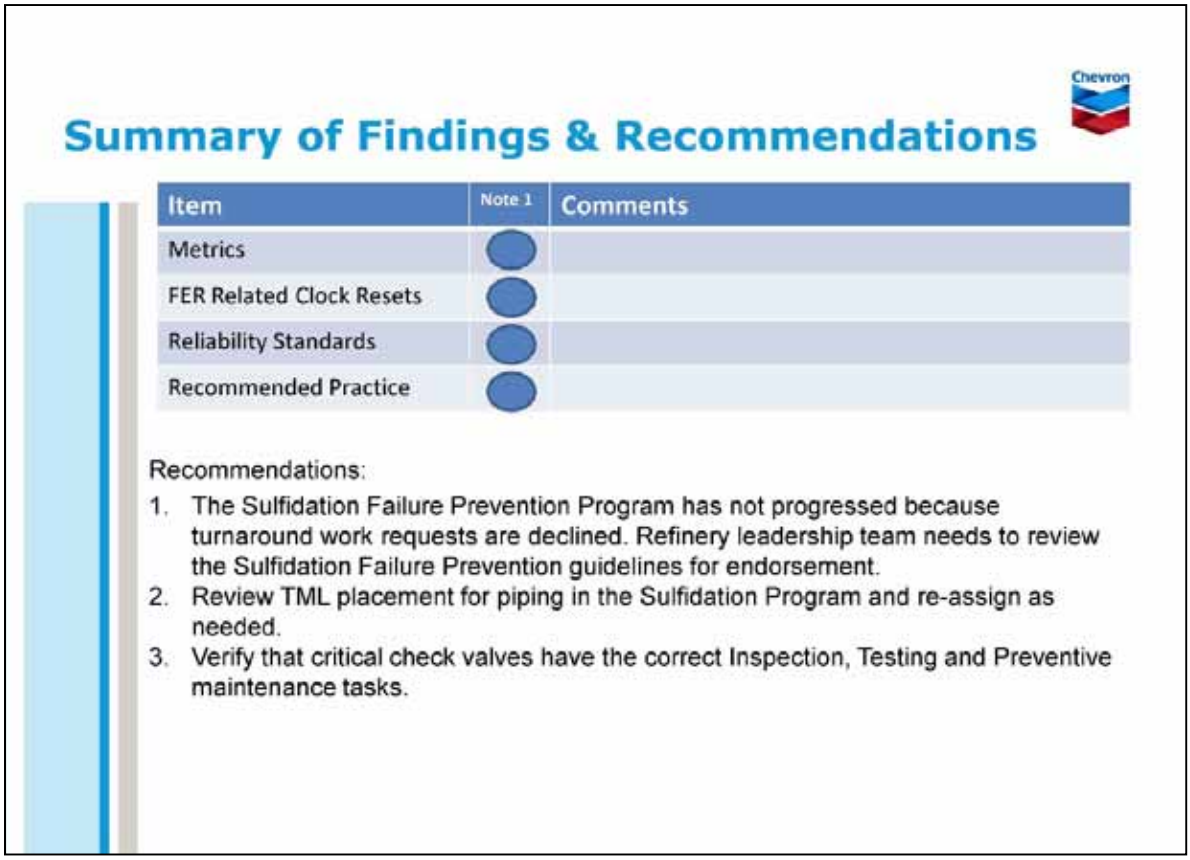
In March 2012, five months prior to the incident, the FER BIN Leader visited the Chevron Richmond refinery and identified that inspection of all carbon steel components susceptible to sulfidation corrosion was not being performed as recommended by the ETC Sulfidation Failure Prevention Initiative (Figure 35). In addition to identifying that CML placement for piping may need to be reassigned, this review found that the IMPACT team was denying critical inspection recommendations during the turnaround planning process. The FER BIN Leader identified that Richmond refinery leadership needed to review and implement the 2009 Chevron ETC Sulfidation Failure Prevention Initiative report and recommendations.

Figure 35. Presentation slide showing corporate reliability leader's findings that the Richmond Refinery was not complying with the ETC Sulfidation Failure Prevention Initiative.

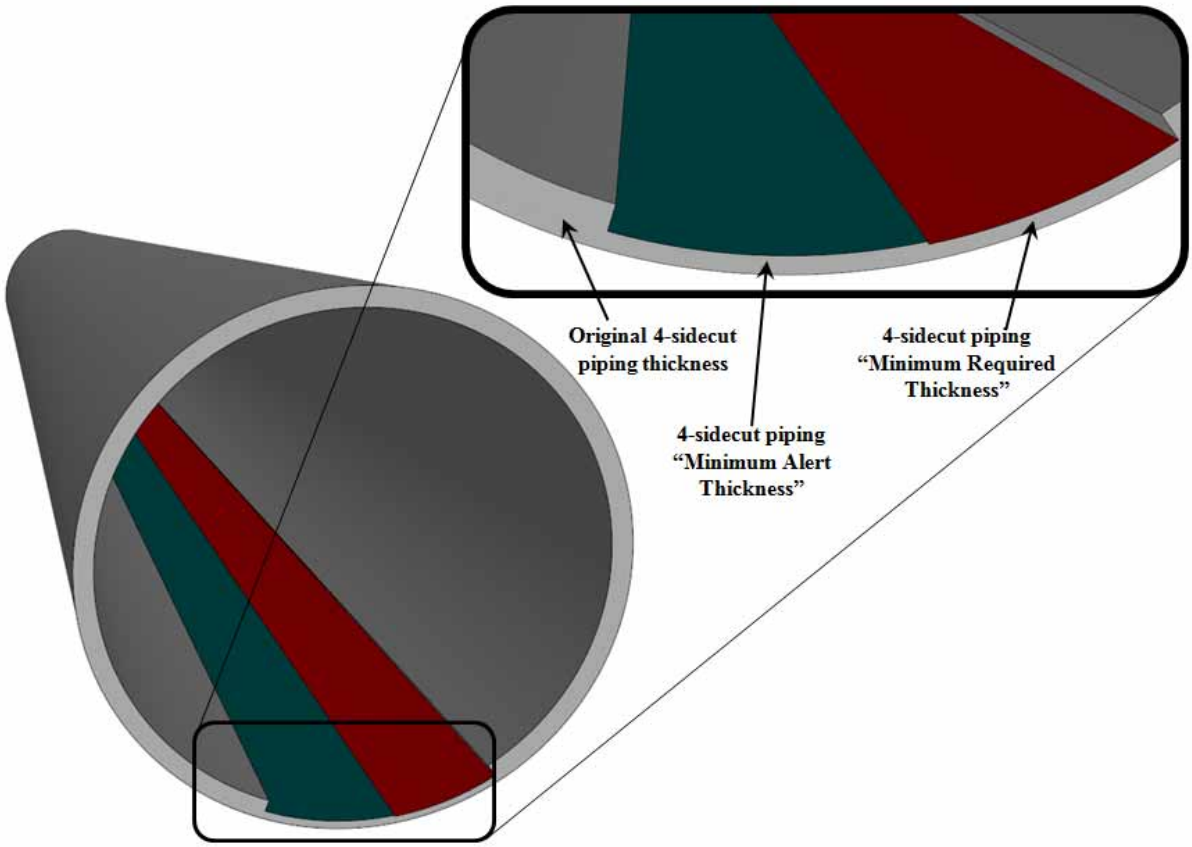
Figure 36. To-scale schematic of 4-sidecut piping original wall thickness (0.322-inch), Minimum Alert Thickness (0.13-inch), and Minimal Required Thickness (0.11-inch) using *API RP 574* default values.

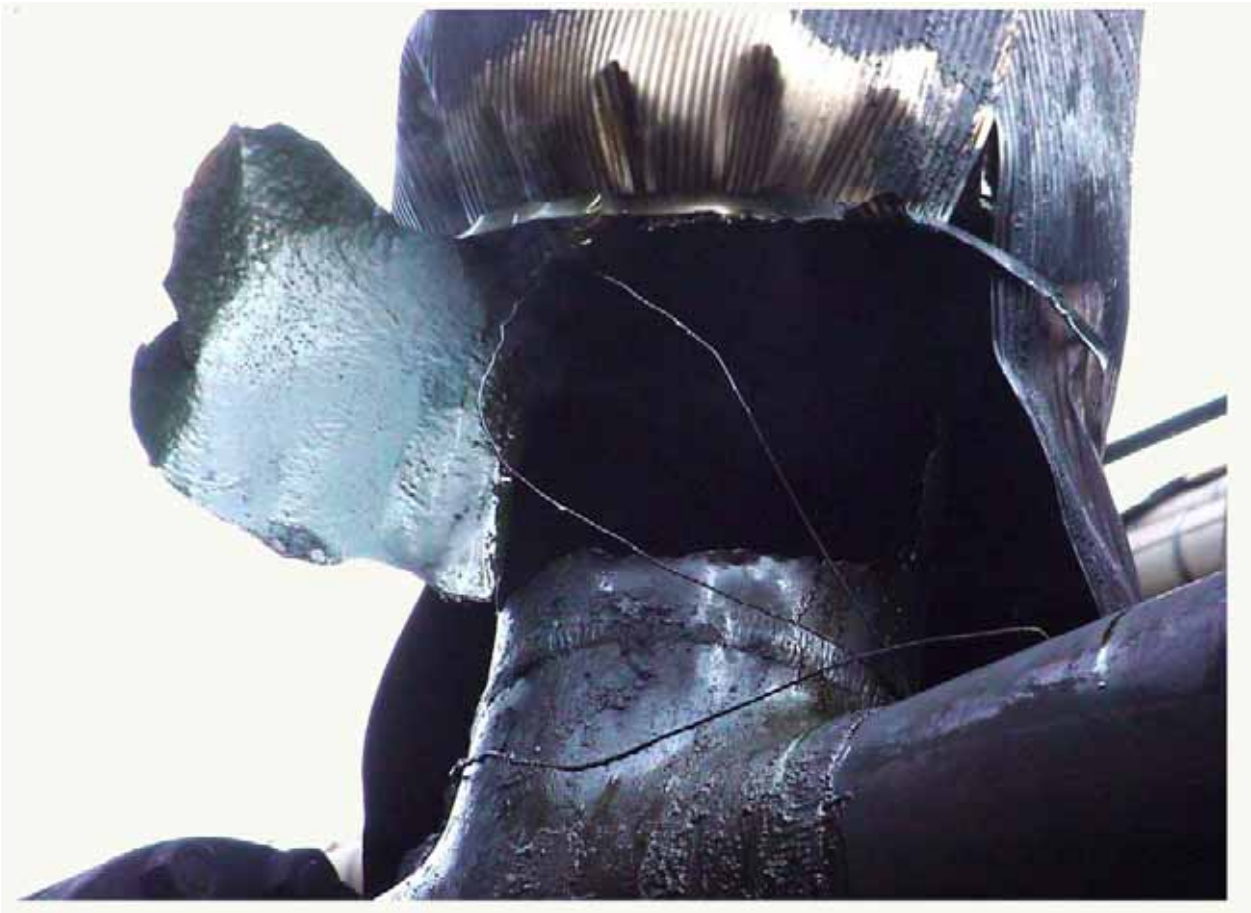
Figure 38. Photo from *API RP 939-C* of a low-silicon pup piece that ruptured at a BP refinery. The surrounding piping had higher silicon content, and the pup piece's accelerated corrosion rate was unmonitored.

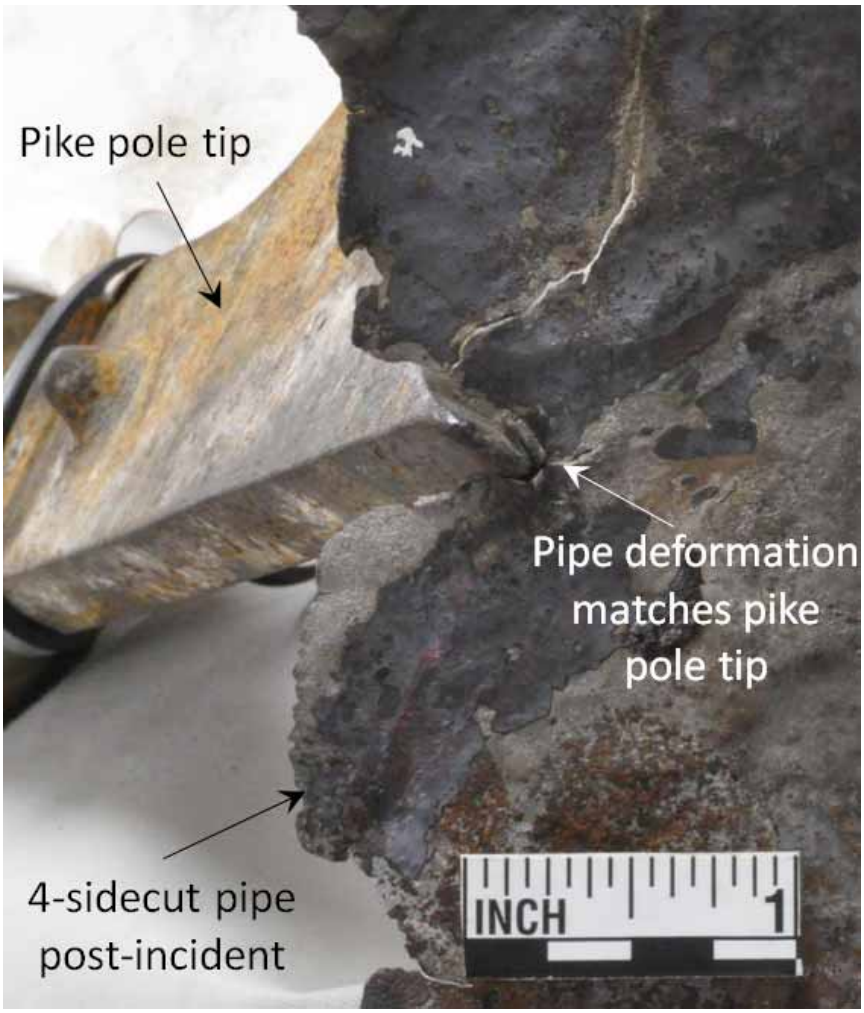
Figure 41. Photo showing that tip of fire pole matches apparent puncture location in failed 52-inch component of 4-sidecut piping.
