U.S. CHEMICAL SAFETY AND HAZARD INVESTIGATION BOARD

FINAL INVESTIGATION REPORT

CHEVRON RICHMOND REFINERY
PIPE RUPTURE AND FIRE

CHEVRON RICHMOND REFINERY #4 CRUDE UNIT

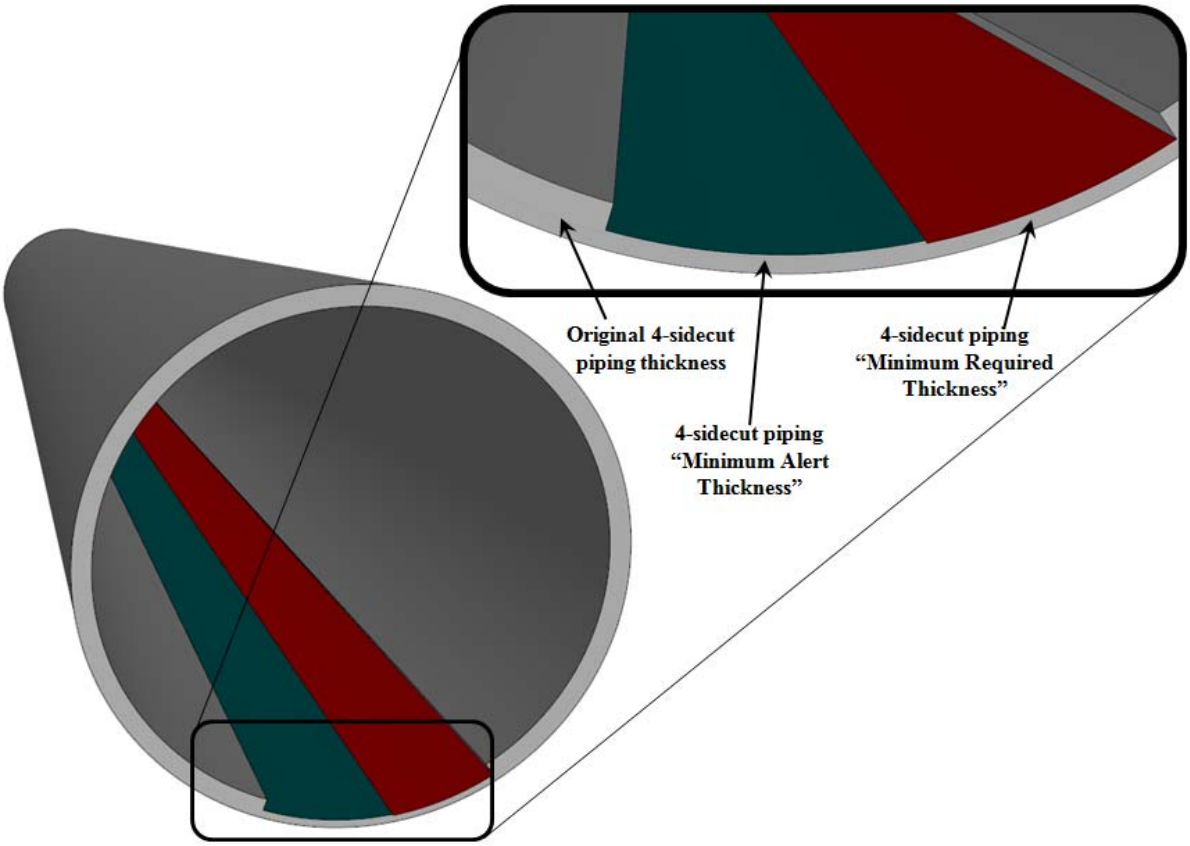
Figure 1. To-scale schematic of 4-sidecut piping identifying key wall thickness values. These include the original wall thickness (0.322-inch), "Minimum Alert Thickness" (0.13-inch), and "Minimum Required Thickness" (0.11-inch) using *API RP 574* default values.

16. Inspection data obtained during the 2011 Crude Unit turnaround identified that components of the 12-inch portion of the 4-sidecut piping had become so thin due to sulfidation corrosion that much of it had to be replaced during the turnaround. Even though the 12-inch 4-sidecut piping was manufactured from the same specification of carbon steel, contained the same process fluid, and experienced similar process conditions[30] as the 8-inch 4-sidecut piping, Chevron turnaround management did not consider that components in the 8-inch 4-sidecut piping could also be too thin to allow the piping to continue in operation. Chevron personnel involved with the decision to replace portions of the 12-inch 4-sidecut piping concluded, based upon available inspection data, that all of the 8-inch 4-sidecut piping that had not been inspected, including the 52-inch component that ultimately failed, was acceptable for continued operation. (See Section 5.1.2.2.1.)

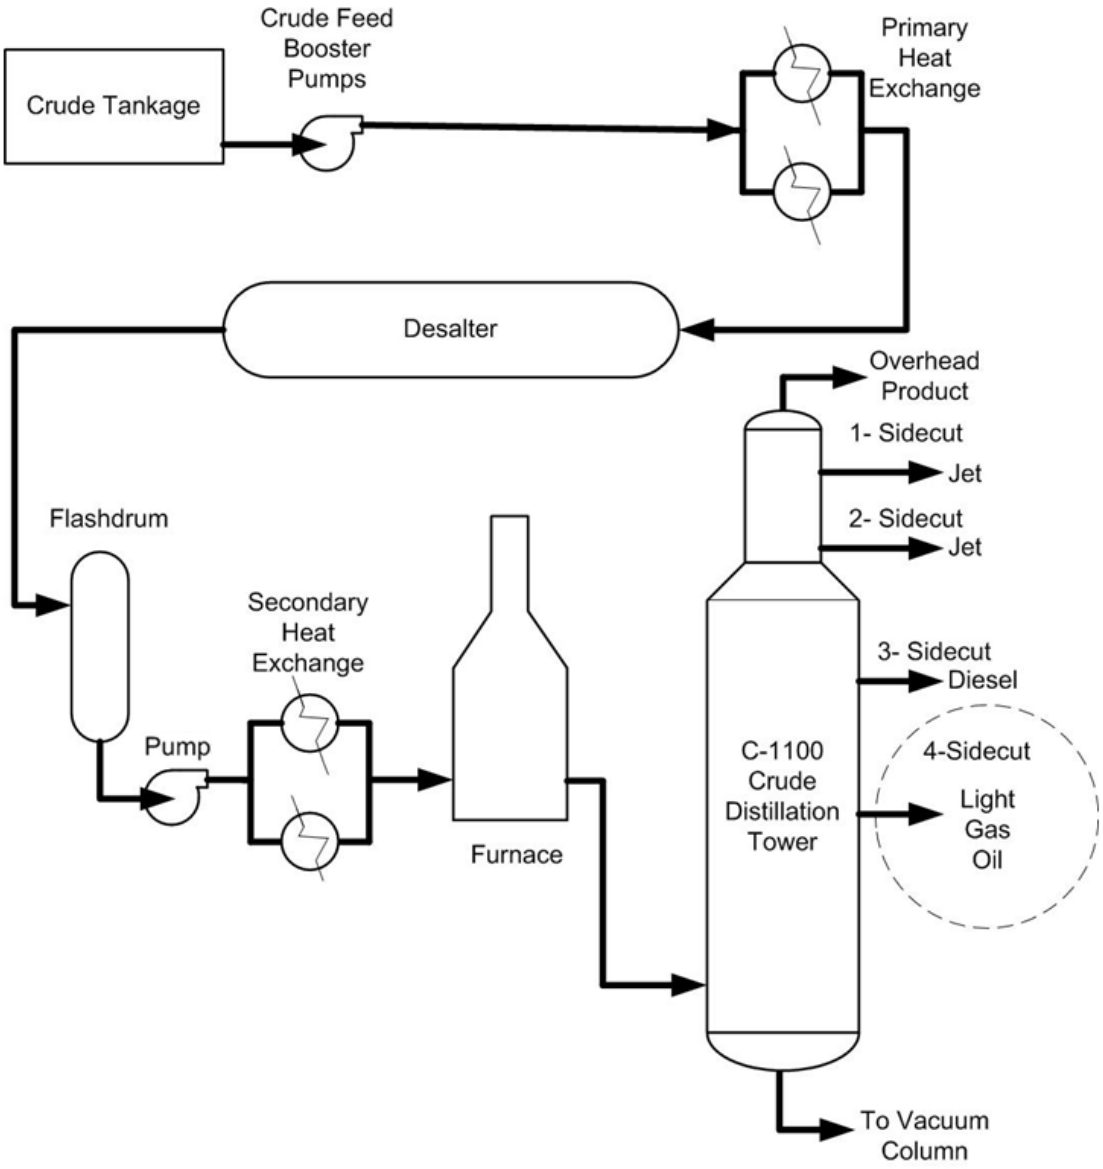
Figure 3. Schematic of C-1100 Crude Unit atmospheric column and upstream process equipment.

The August 6, 2012, incident occurred from the piping referred to as the "4-sidecut" line, one of several process streams exiting the Crude Column (Figure 3).[43] As shown in Figure 4, light gas oil, the Crude Unit 4-sidecut process fluid, exits the atmospheric column via a 20-inch nozzle and is split into a 12-inch line and an 8-inch line. The pipe rupture (Figure 5) occurred on a 52-inch long component[44] of the 4-sidecut 8-inch line (the 52-inch component). The line operated at a temperature near 640°F[45,46] and had an operating pressure of approximately 55 pounds per square inch gauge (psig) at the rupture location. At the time of the incident, light gas oil was flowing through the 8-inch line at a rate of approximately 10,800 bpd.[47]

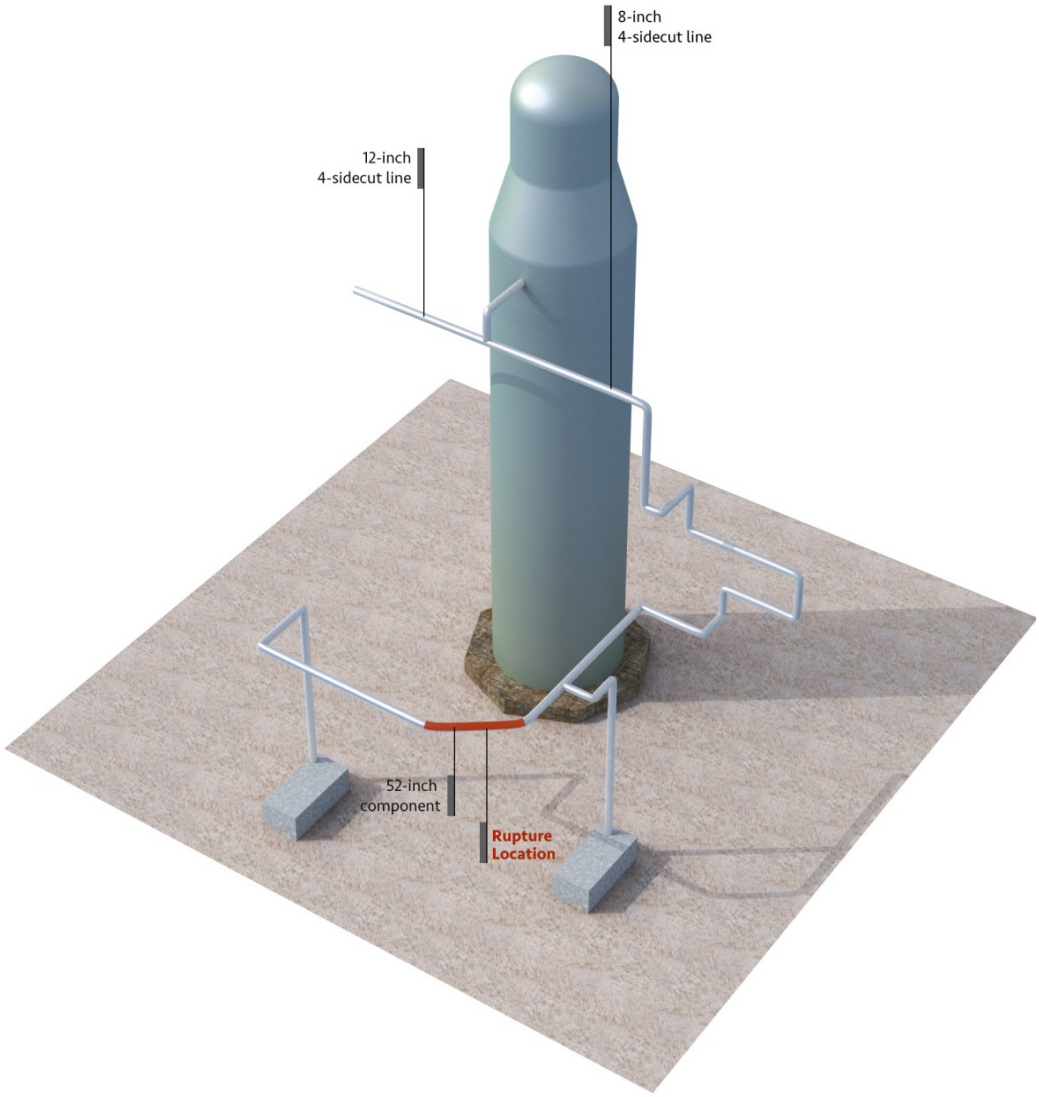
Figure 4. 4-sidecut line configuration and rupture location.

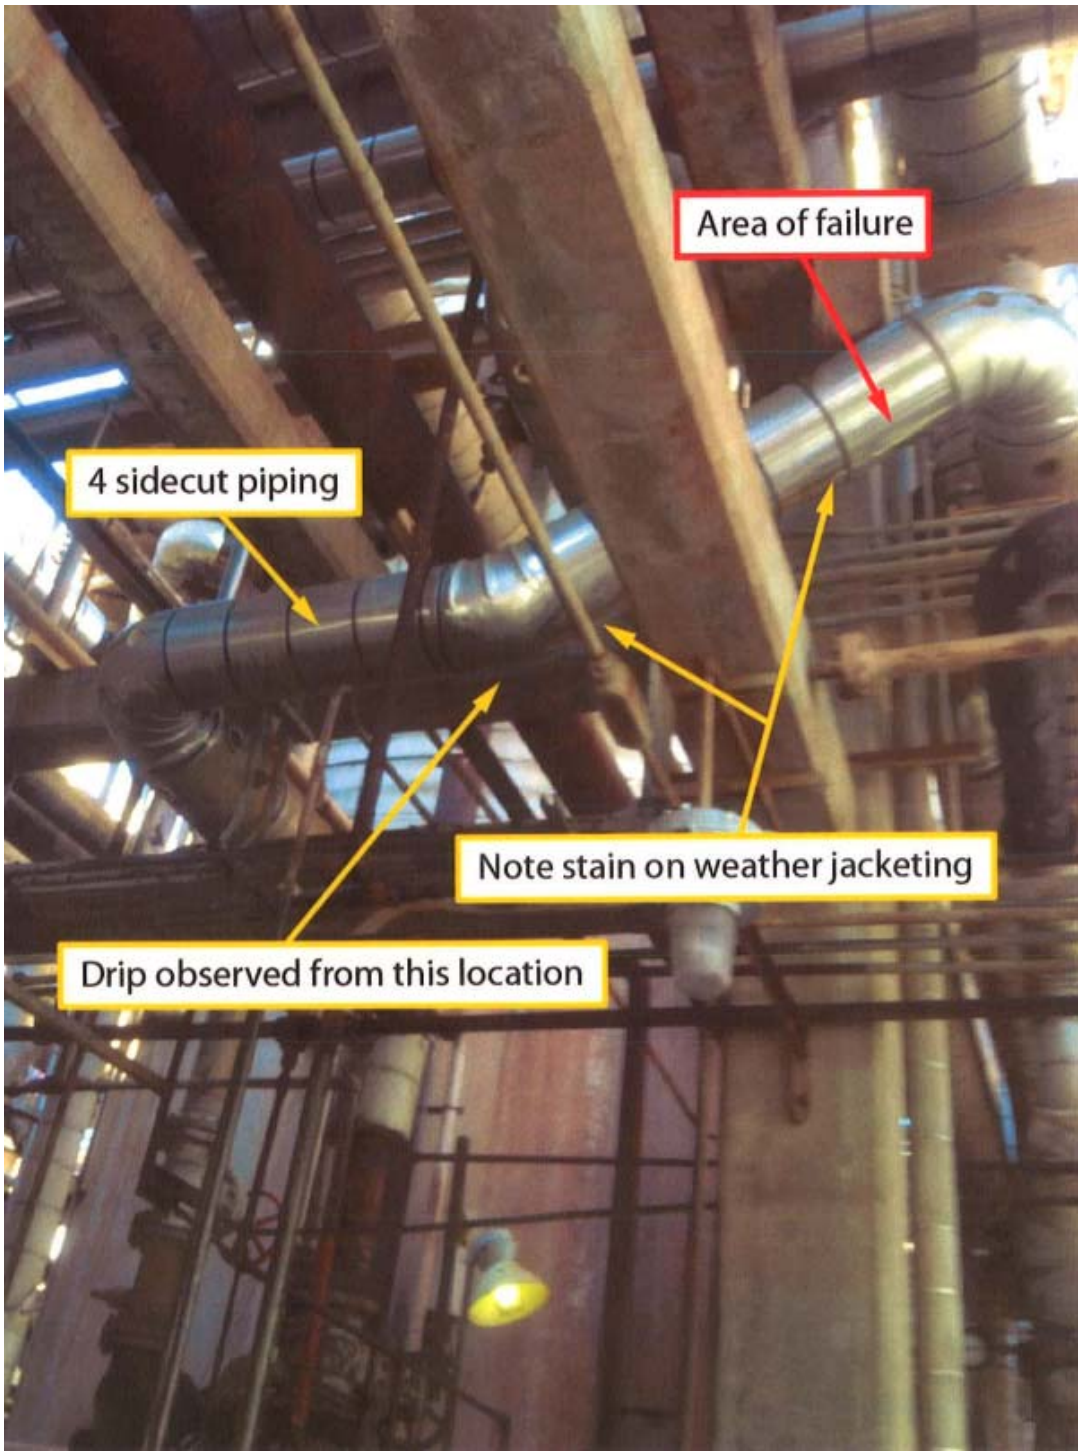
Figure 7. Photo taken of the leaking 4-sidecut pipe on August 6, 2012, at the Chevron Richmond Refinery.[49] Insulation obscured the actual leak location. Stain signifies where hydrocarbon process fluid was leaking from the 4-sidecut piping.

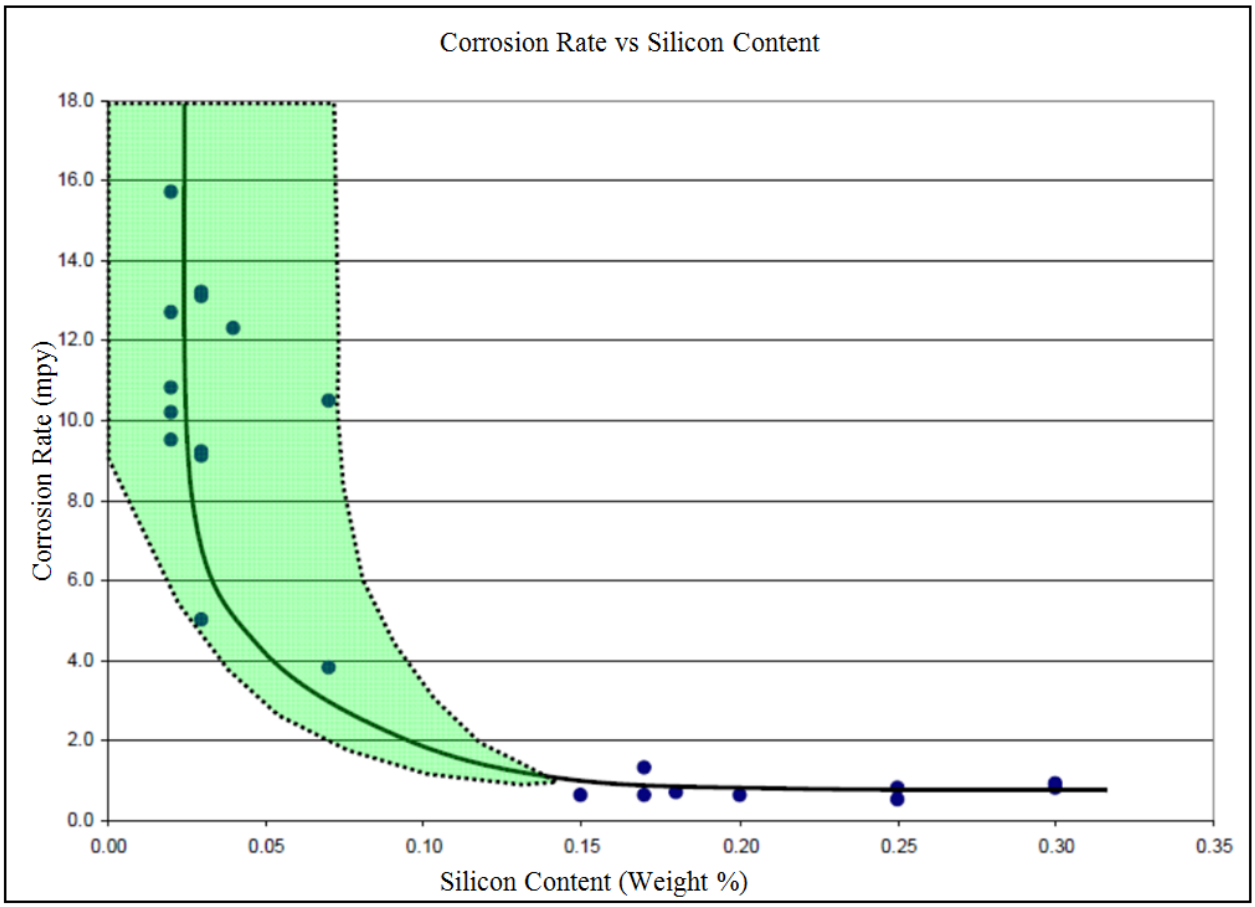
Figure 17. Graph of sulfidation corrosion rates with respect to silicon content in carbon steel. This graph shows how corrosion rates increase in carbon steel containing decreasing percentages of silicon. This information can be found in Annex C of *API RP 939-C*.[67]

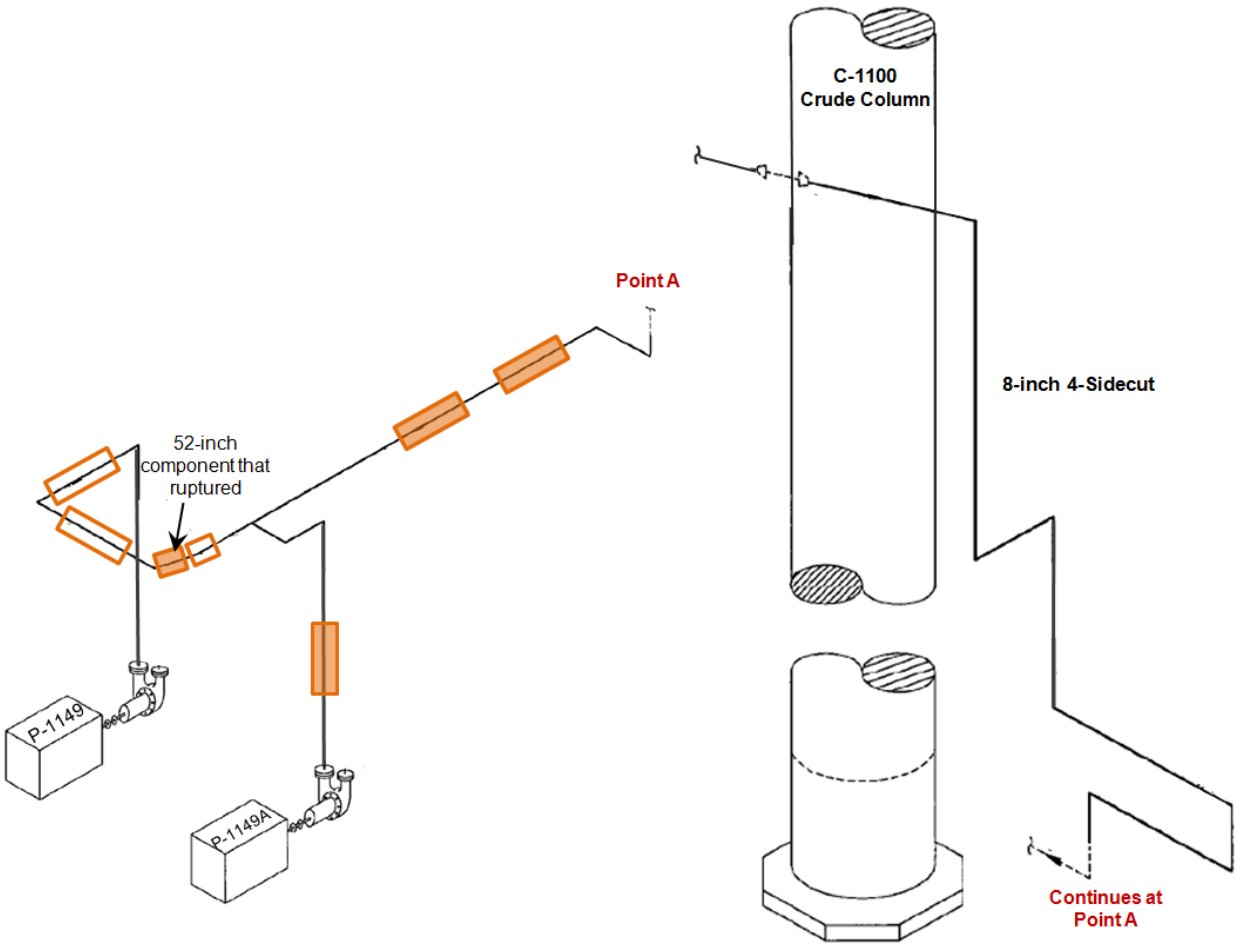
Figure 18. Locations of metallurgical samples taken from 8-inch 4-sidecut piping post-incident. The seven samples taken are boxed in orange. Four of the seven components sampled (shown with an orange fill) were found to have a silicon content less than 0.10 weight percent.

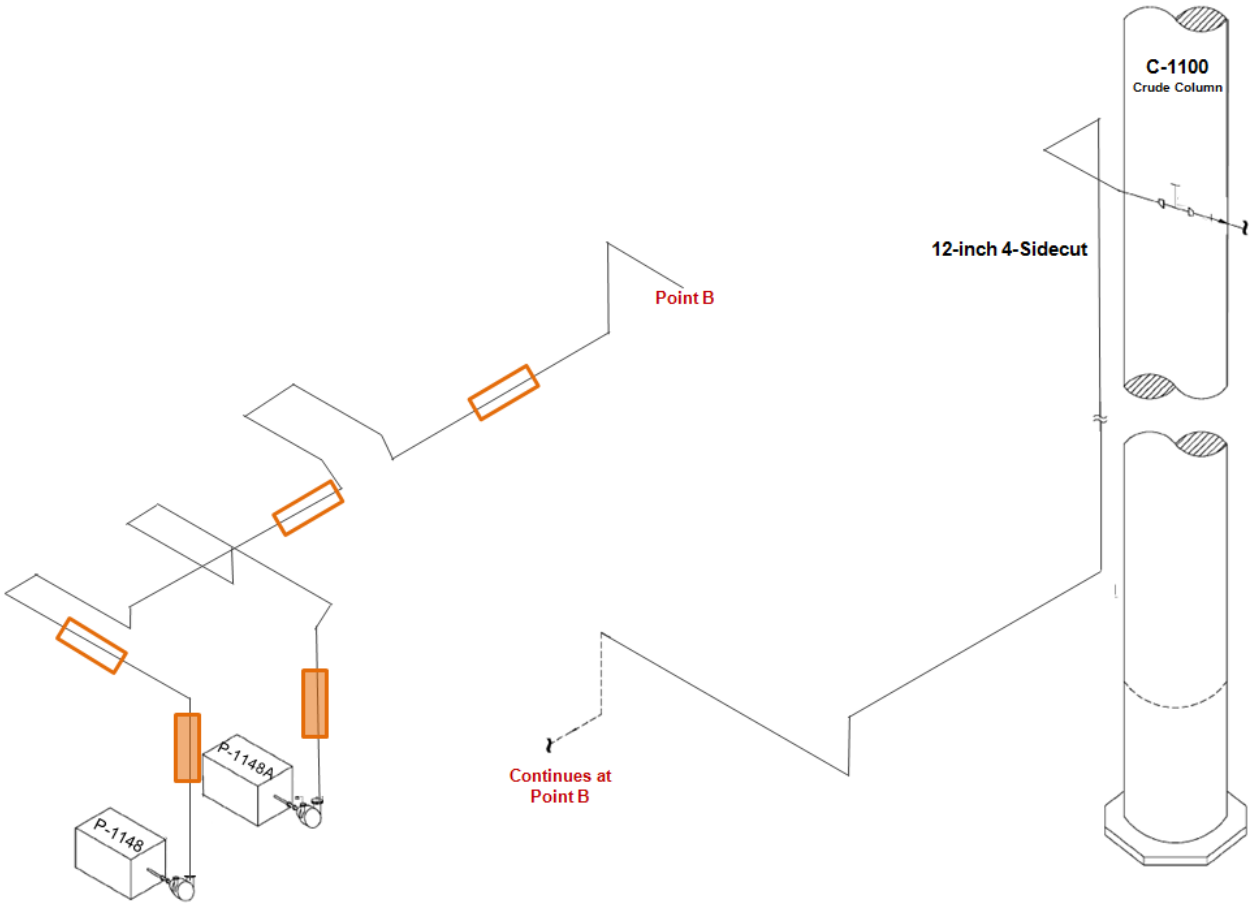
Figure 19. Locations of metallurgical samples taken from 12-inch 4-sidecut piping post-incident. The five samples taken are boxed in orange. Two of the five components sampled (shown with an orange fill) were found to have a silicon content less than 0.10 weight percent.

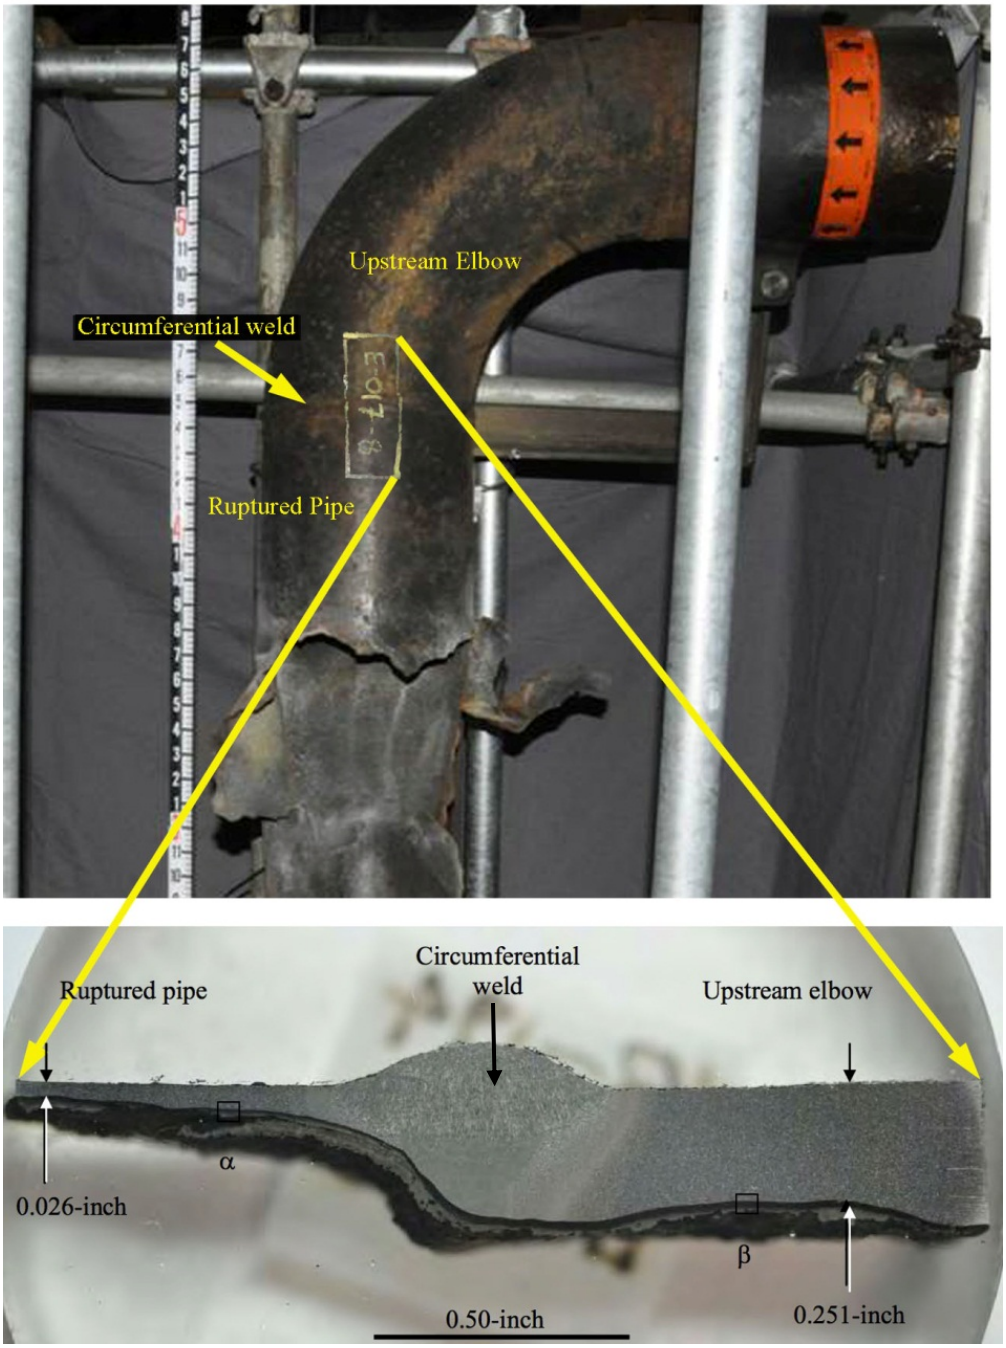
Figure 20. 4-sidecut piping sample (E-017-8) analyzed by Anamet Labs showing the relative thickness of low silicon piping on the left and the high silicon piping on the right. The ruptured 52-inch pipe component (left) contained 0.01 weight percent silicon, and the upstream elbow component (right) contained 0.16 weight percent silicon.[75] The initial nominal thickness of this piping was 0.322-inch.

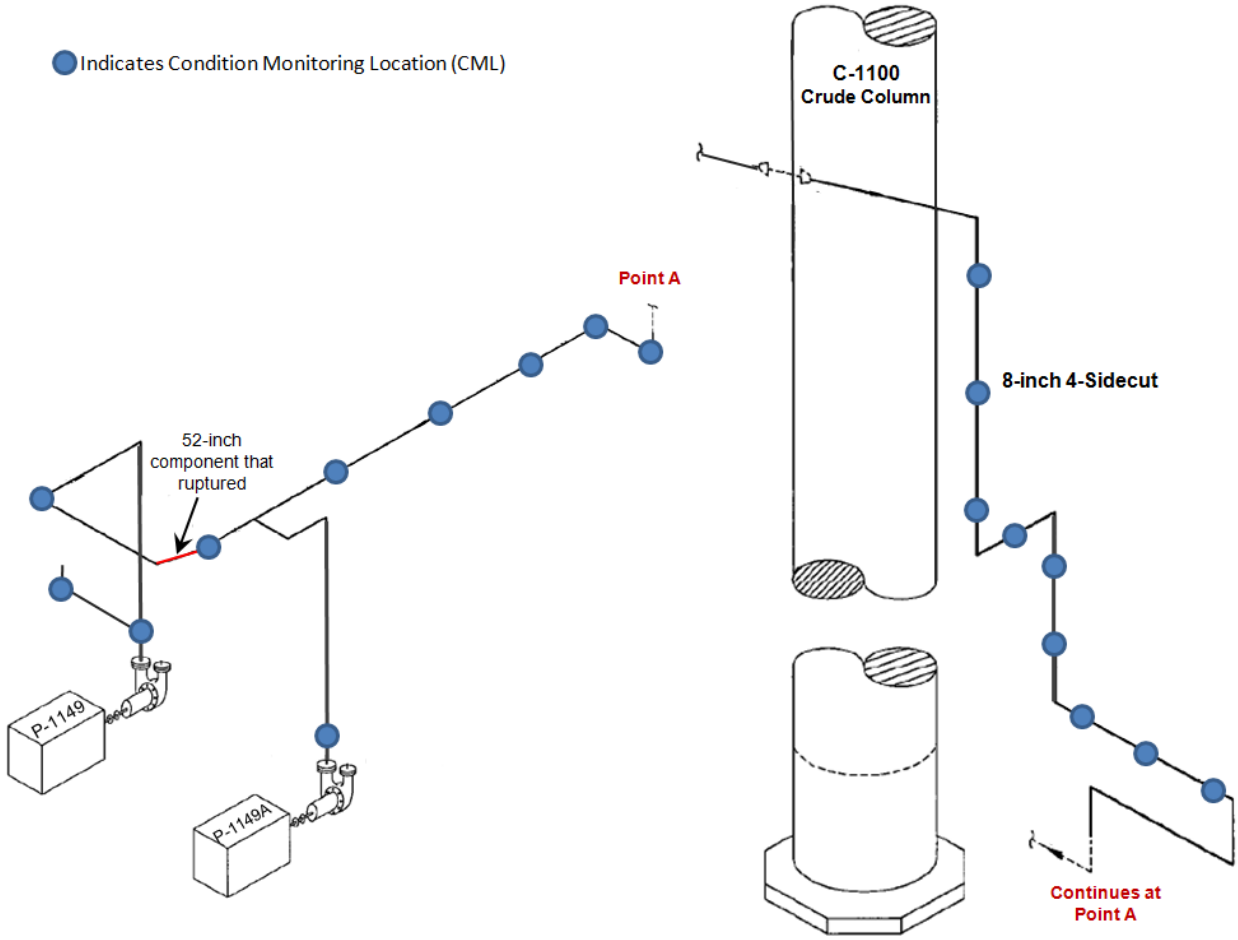
Figure 21. CML placement on 8-inch 4-sidecut piping. Nineteen CMLs were used to monitor corrosion rates in the 8-inch 4-sidecut piping. A CML was not placed on the 52-inch component that ultimately failed. A CML was placed, however, on the upstream elbow adjacent to the 52-inch component.

This inspection data gathered using the 19 CMLs did not reflect the corrosion rates of the quickly corroding, low-silicon components of the 4-sidecut piping. As illustrated by the Chevron incident, traditional inspection techniques alone—using only a limited amount of CMLs—may not accurately identify the most aggressive sulfidation corrosion rates throughout an entire circuit of carbon steel piping.

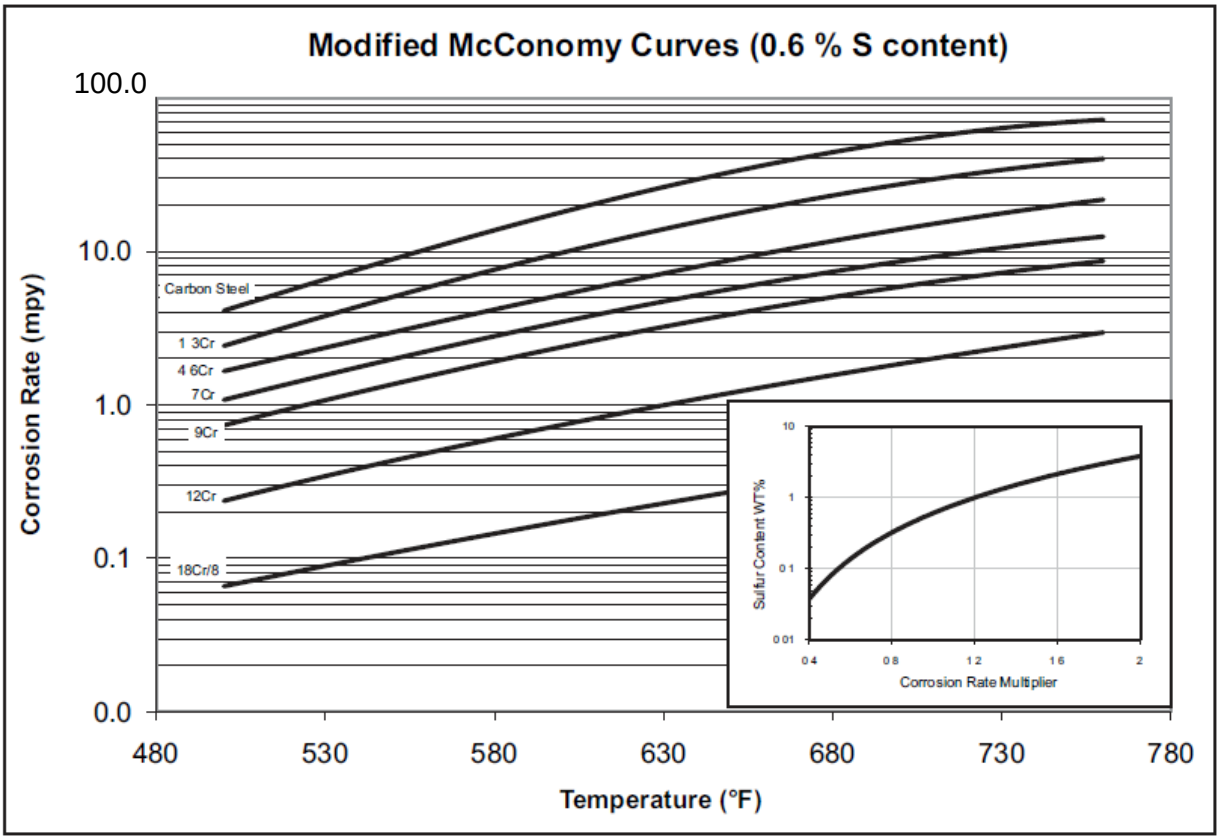
Figure 22. Modified McConomy Curves from API RP 939-C.

greatly reduced. Carbon steel[99] corrodes approximately nine times faster than 9-Chrome steel, which contains 9 percent chromium, and carbon steel corrodes approximately 120 times faster than stainless steel, which contains 18 percent chromium.[100,101]

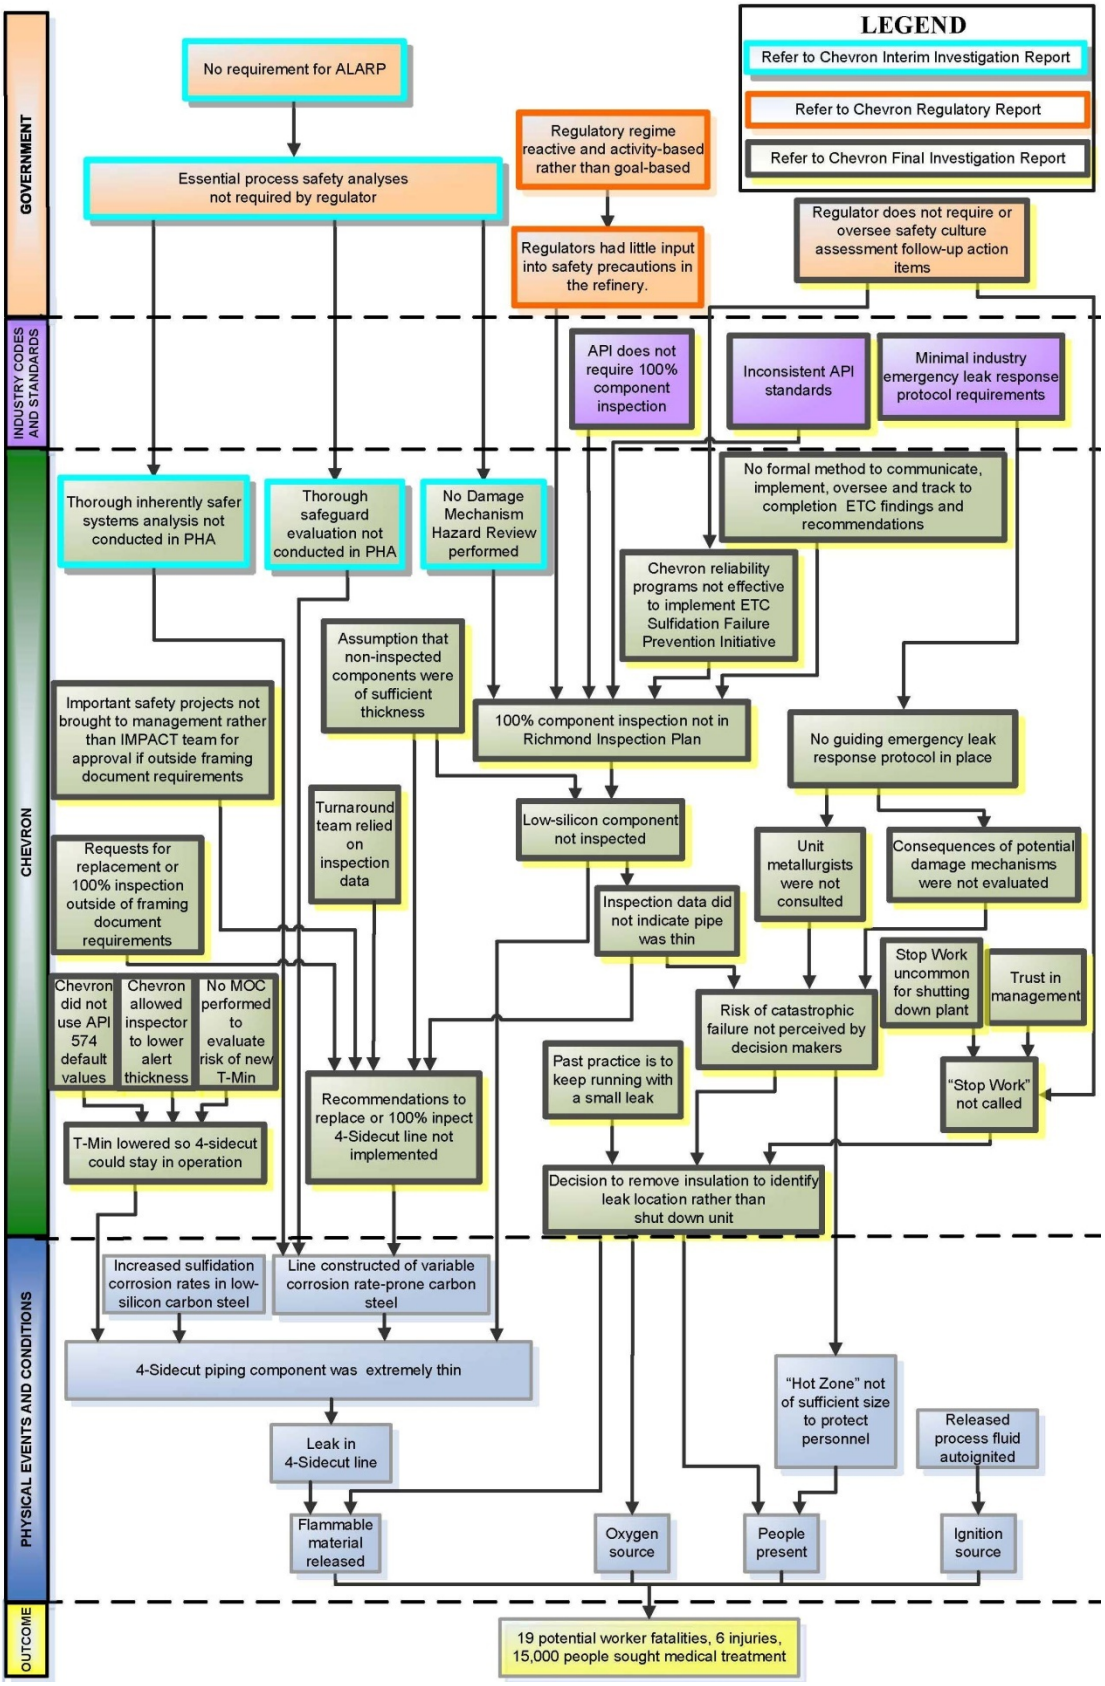
Figure 24. Acci-Map of August 6, 2012, Chevron Refinery Fire.

The CSB investigation team developed an accident map (AcciMap)[114] for the Chevron investigation (Figure 24). The AcciMap is a multilayered causal diagram that depicts immediate causes[115] as well as higher level contributing causes at the corporate, governmental, and regulatory levels. This diagram includes five levels:

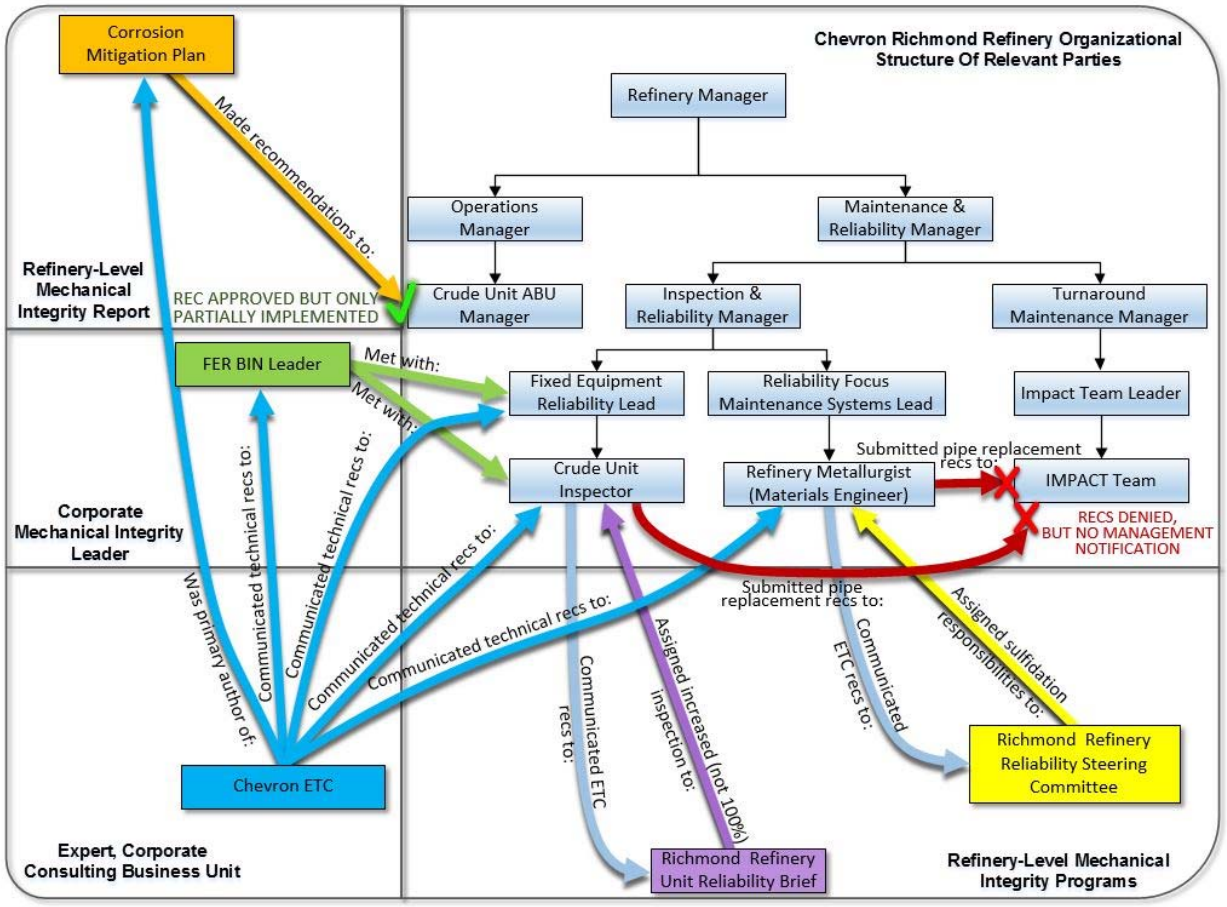
In the ten years prior to the incident, a small number of Chevron personnel with knowledge and understanding of sulfidation corrosion made recommendations to increase inspections or upgrade the material of construction in the 4-sidecut piping. Their recommendations were not effectively implemented. The process to implement important, safety-critical projects within the Chevron Richmond Refinery was not fully effective. As discussed in the following sections and depicted in Figure 25, a combination of (1) reliance on a turnaround management program that depended on only a fraction of necessary data to make important process safety decisions, (2) an unsuccessful bottom-up approach—with no management oversight or accountability—for implementing a crucial safety program, and (3) no formal method to track to completion the Chevron expert group's findings and recommendations ultimately caused these recommendations to not be implemented.

Figure 25. Organizational decision-making schematic showing attempts to have carbon steel 4-sidecut piping 100 percent component inspected or replaced with a higher chromium steel alloy. Attempts failed due to lack of accountability and lack of authority to ensure recommendation implementation, and a rigid turnaround planning process that could not approve the 4-sidecut piping replacement recommendations.

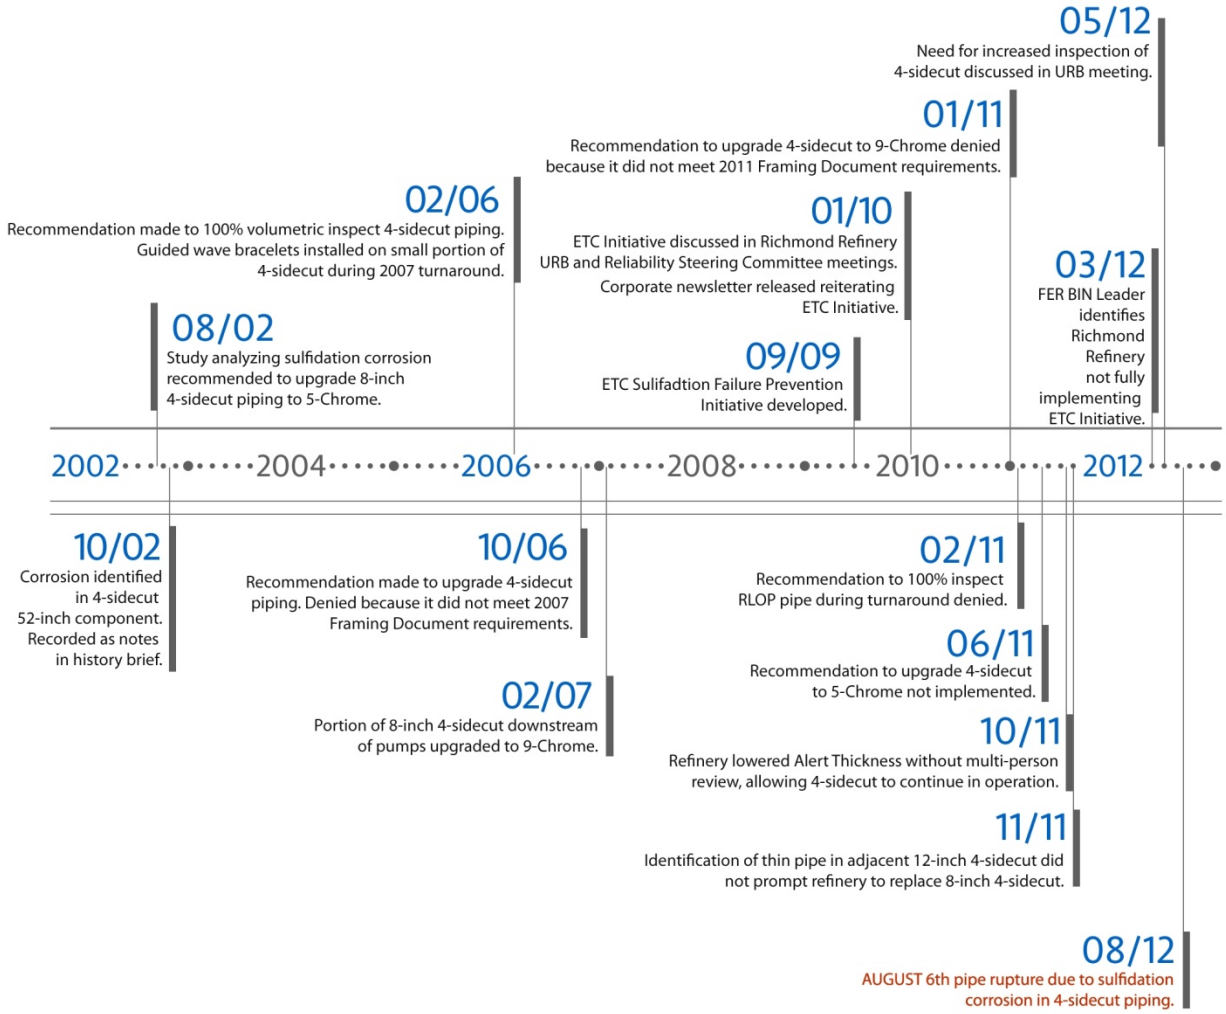
Figure 26. Key events at the Richmond refinery between 2002 and 2012.

Figure 26 shows the sequence of sulfidation corrosion-related recommendations and events within Chevron Corporation and the Chevron Richmond Refinery between 2002 and the day of the incident. These events are discussed in subsequent sections of this report.

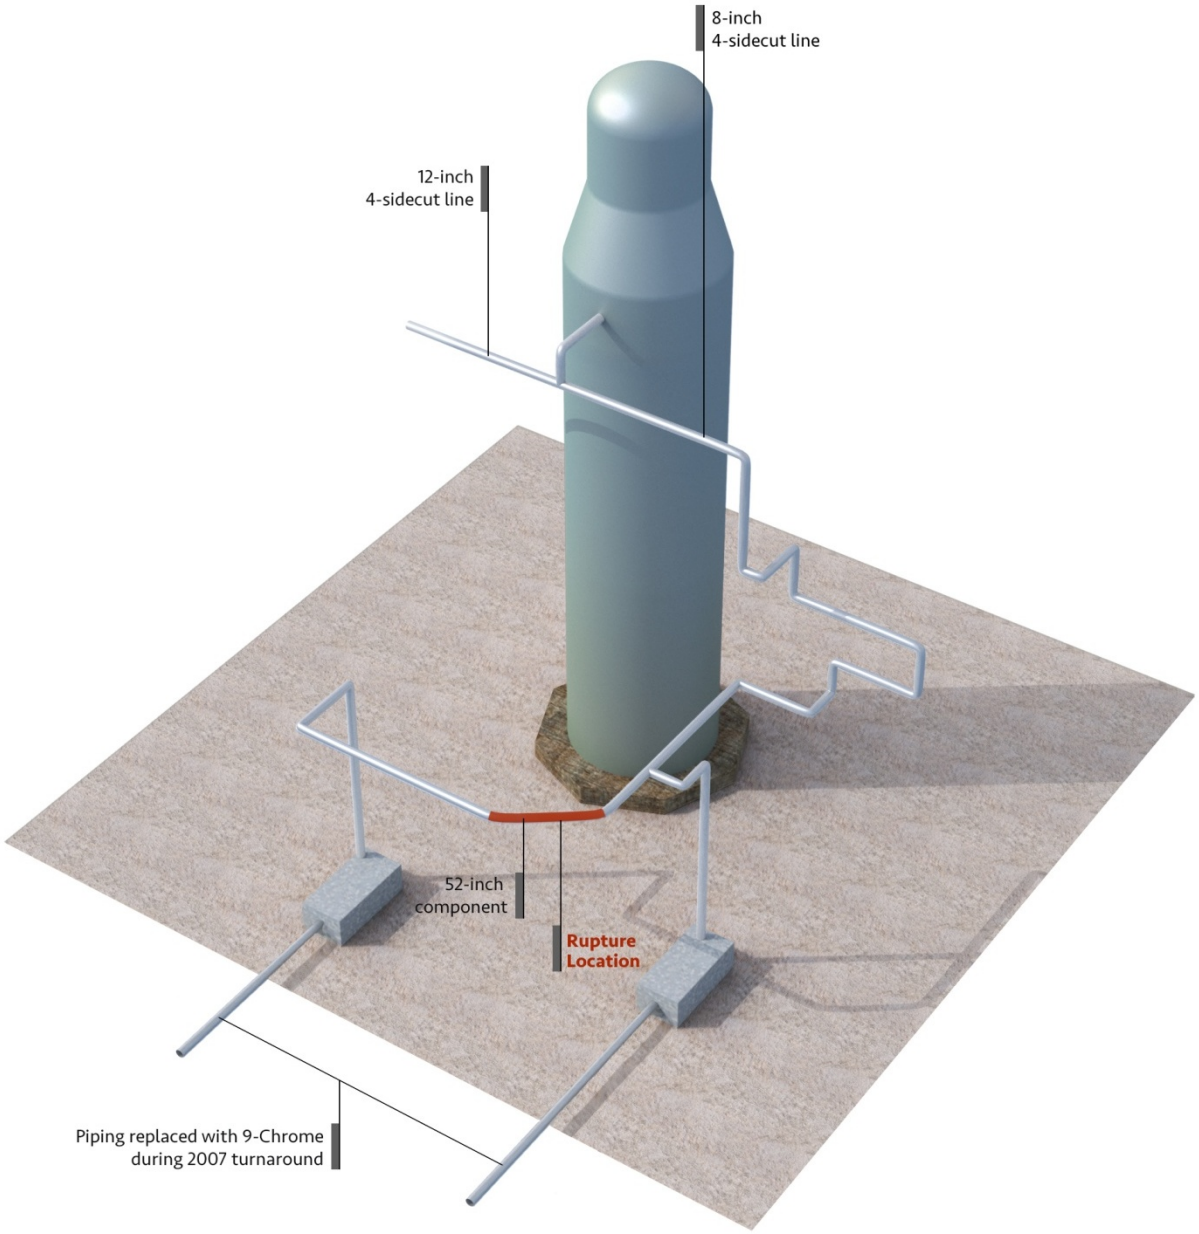
Figure 33. Crude column schematic indicating the piping downstream of the 4-sidecut pumps that was replaced during the 2007 Crude Unit turnaround. The portion of the carbon steel line containing the component that failed on August 6, 2012 was not replaced.

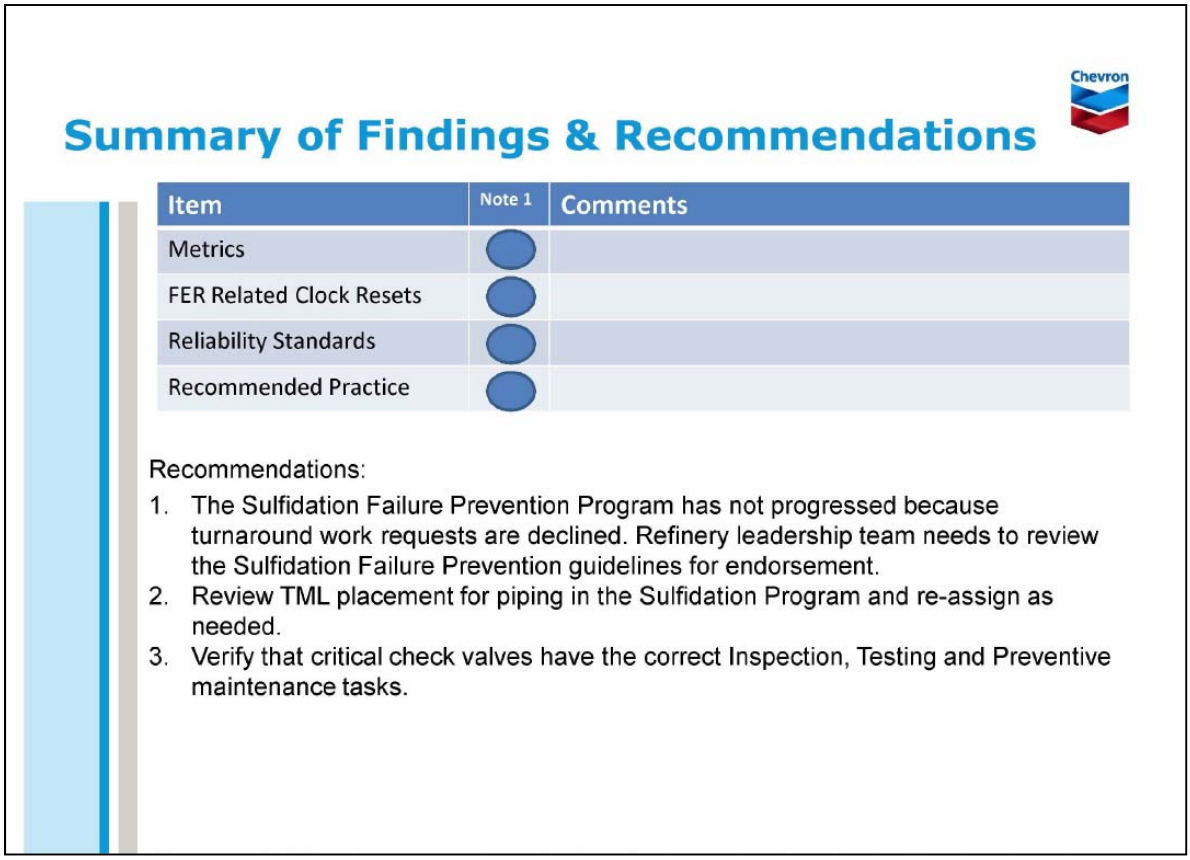
In March 2012, five months prior to the incident, the FER BIN Leader visited the Chevron Richmond refinery and identified that inspection of all carbon steel components susceptible to sulfidation corrosion was not being performed as recommended by the ETC Sulfidation Failure Prevention Initiative (Figure 35). In addition to identifying that CML placement for piping may need to be reassigned, this review found that the IMPACT team was denying critical inspection recommendations during the turnaround planning process. The FER BIN Leader identified that Richmond refinery leadership needed to review and implement the 2009 Chevron ETC Sulfidation Failure Prevention Initiative report and recommendations.

Figure 35. Presentation slide showing corporate reliability leader's findings that the Richmond Refinery was not complying with the ETC Sulfidation Failure Prevention Initiative.

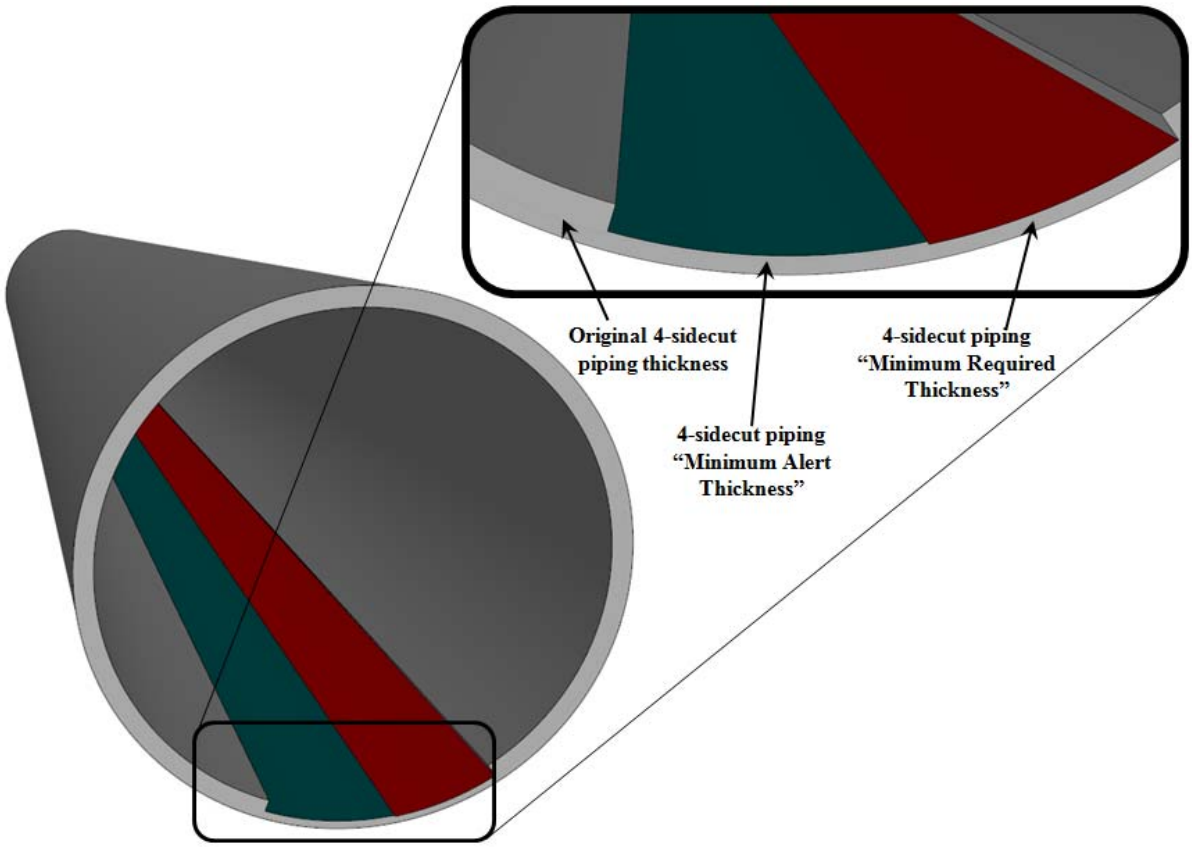
Figure 36. To-scale schematic of 4-sidecut piping original wall thickness (0.322-inch), Minimum Alert Thickness (0.13-inch), and Minimal Required Thickness (0.11-inch) using *API RP 574* default values.
