U.S. CHEMICAL SAFETY AND HAZARD INVESTIGATION BOARD

FINAL INVESTIGATION REPORT

CHEVRON RICHMOND REFINERY
PIPE RUPTURE AND FIRE

CHEVRON RICHMOND REFINERY #4 CRUDE UNIT

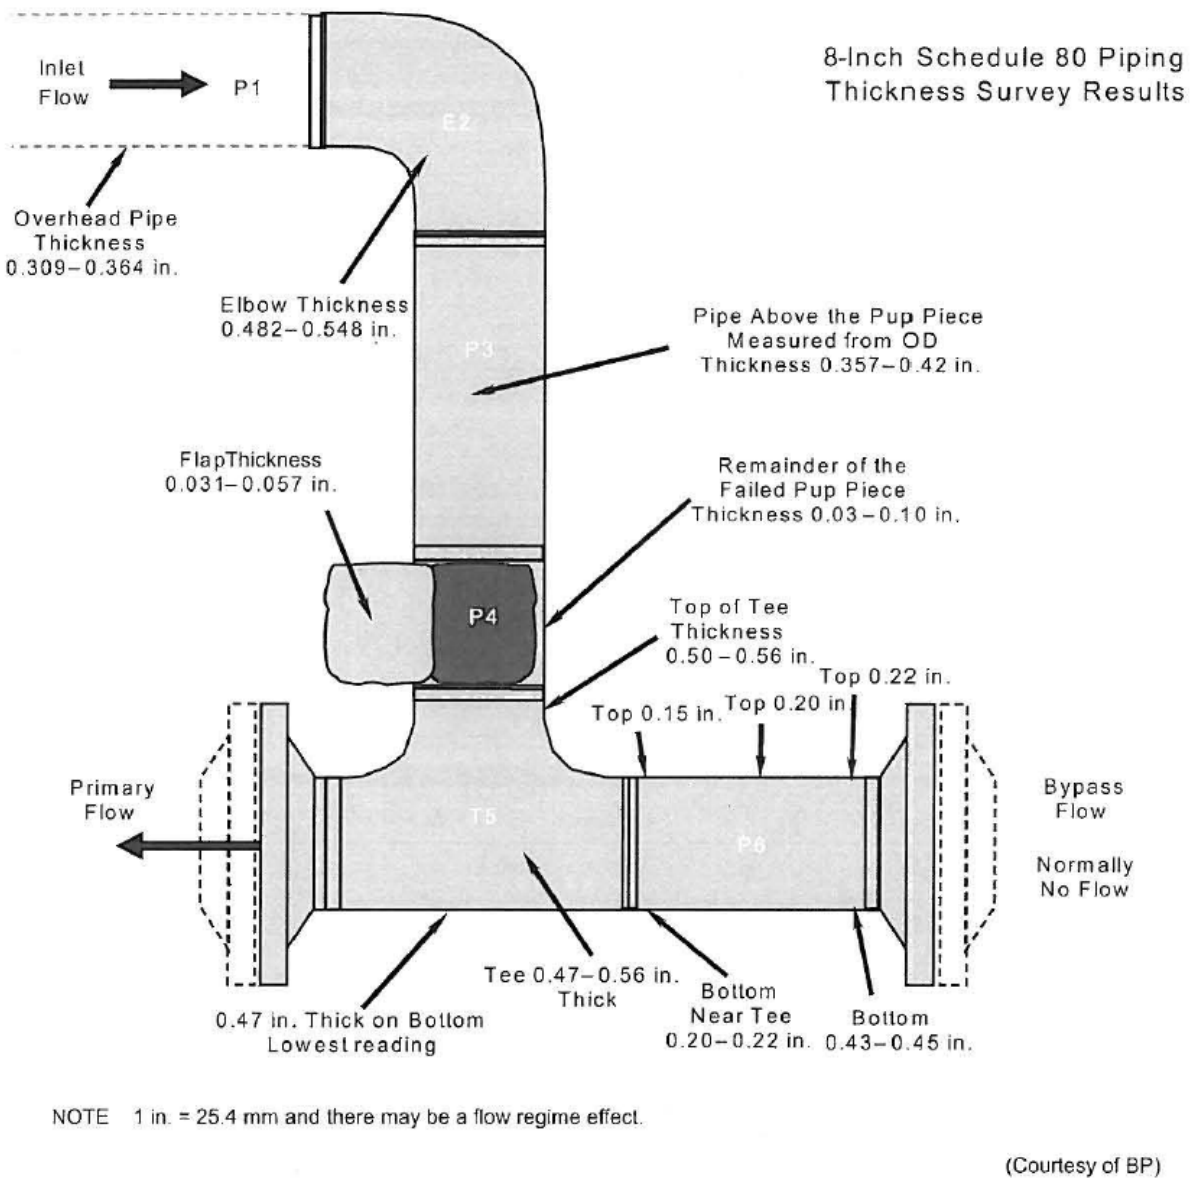
Figure 39. Schematic from *API RP 939-C* of the piping shown in Figure 38. The piping component that ruptured was significantly thinner than the surrounding piping.

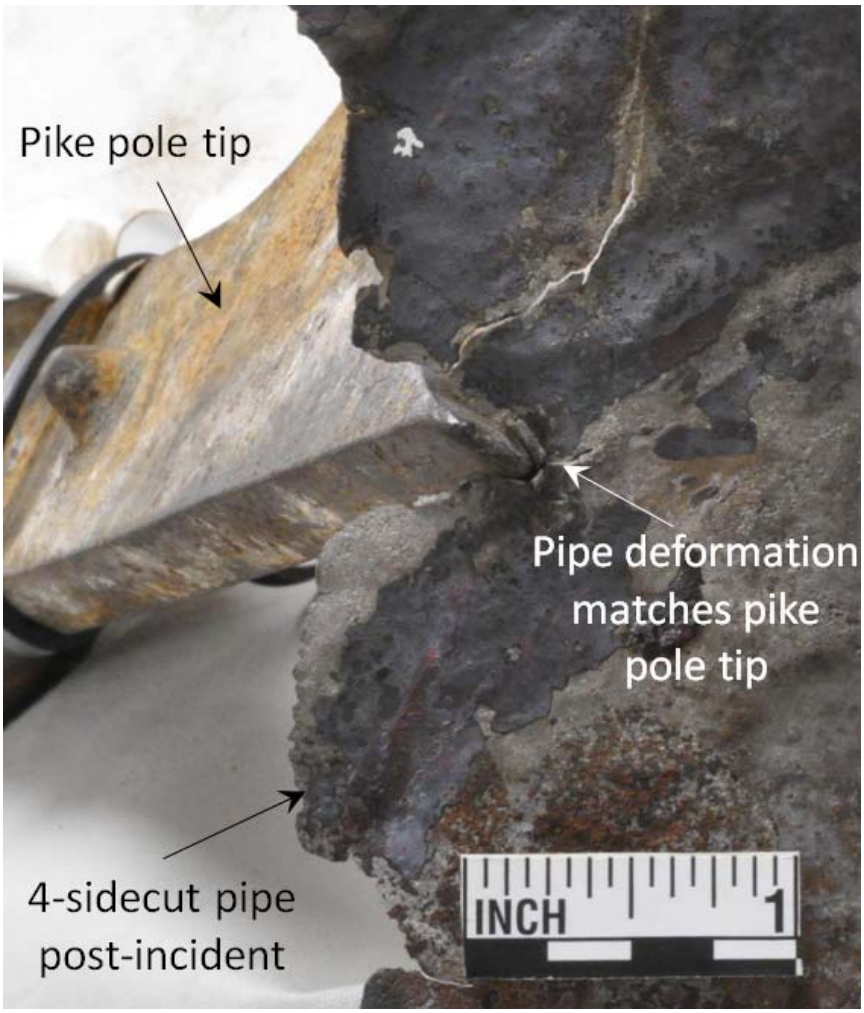
Figure 41. Photo showing that tip of fire pole matches apparent puncture location in failed 52-inch component of 4-sidecut piping.
