# Investigation Report

Published: December 2022

## SAFETY ISSUES:

On November 27, 2019, a series of explosions occurred at the TPC Group (TPC) Port Neches Operations (PNO) facility, located in Port Neches, Texas, after highly flammable butadiene released from the process unit. The explosions caused a process tower to propel through the air and land within the facility, other process towers to fall within the unit, extensive facility damage, and fires that burned for more than a month within the facility. The butadiene unit was destroyed, forcing the facility to cease butadiene production operations indefinitely. As of the date of this report, the butadiene production operations remain shut down. Two TPC PNO employees and a contractor reported minor injuries, and according to media reports, at least five local residents reported injuries. Officials in Jefferson County, Texas declared the county to be in a state of disaster and issued a mandatory four-mile radius evacuation order that affected people in the cities of Port Neches, Groves, Nederland, and a portion of Port Arthur. The explosion also led to reduced usage of the Sabine-Neches Waterway, the nation's third largest waterw

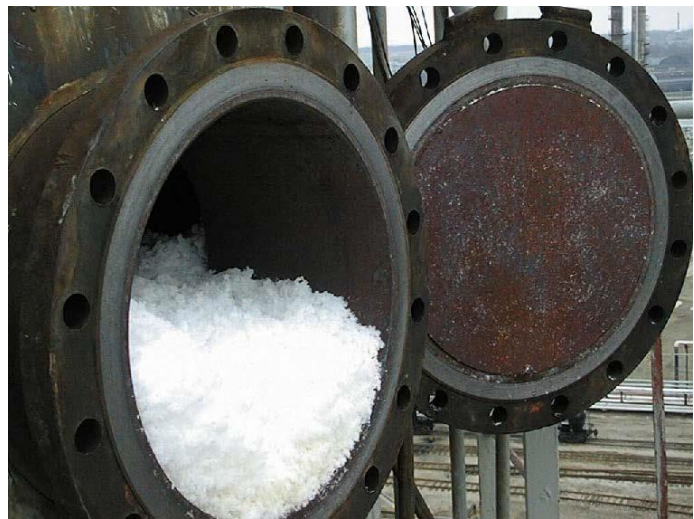
Equipment that handles high-purity butadiene (typically > 80% purity) is highly susceptible to the development of a potentially hazardous substance called “popcorn polymer” [4, p. 32].<sup>a</sup> Popcorn polymer can be hazardous because when popcorn polymer accumulates inside equipment, its continued growth and expansion can generate high pressures that may ultimately rupture equipment [4, p. 32]. The physical appearance of popcorn polymer resembles “cauliflower or popcorn [7, p. 32].” Popcorn polymer can also “take the form of glassy, friable crystals; fluffy, needle-like crystals; or hard, clear gel [4, p. 32].” **Figure 4** shows an example of popcorn polymer from an undisclosed facility.<sup>b</sup>

**Figure 4.** Popcorn polymer in a manway from an undisclosed facility (Credit: International Institute of Synthetic Rubber Producers Inc. [8, p. 261])

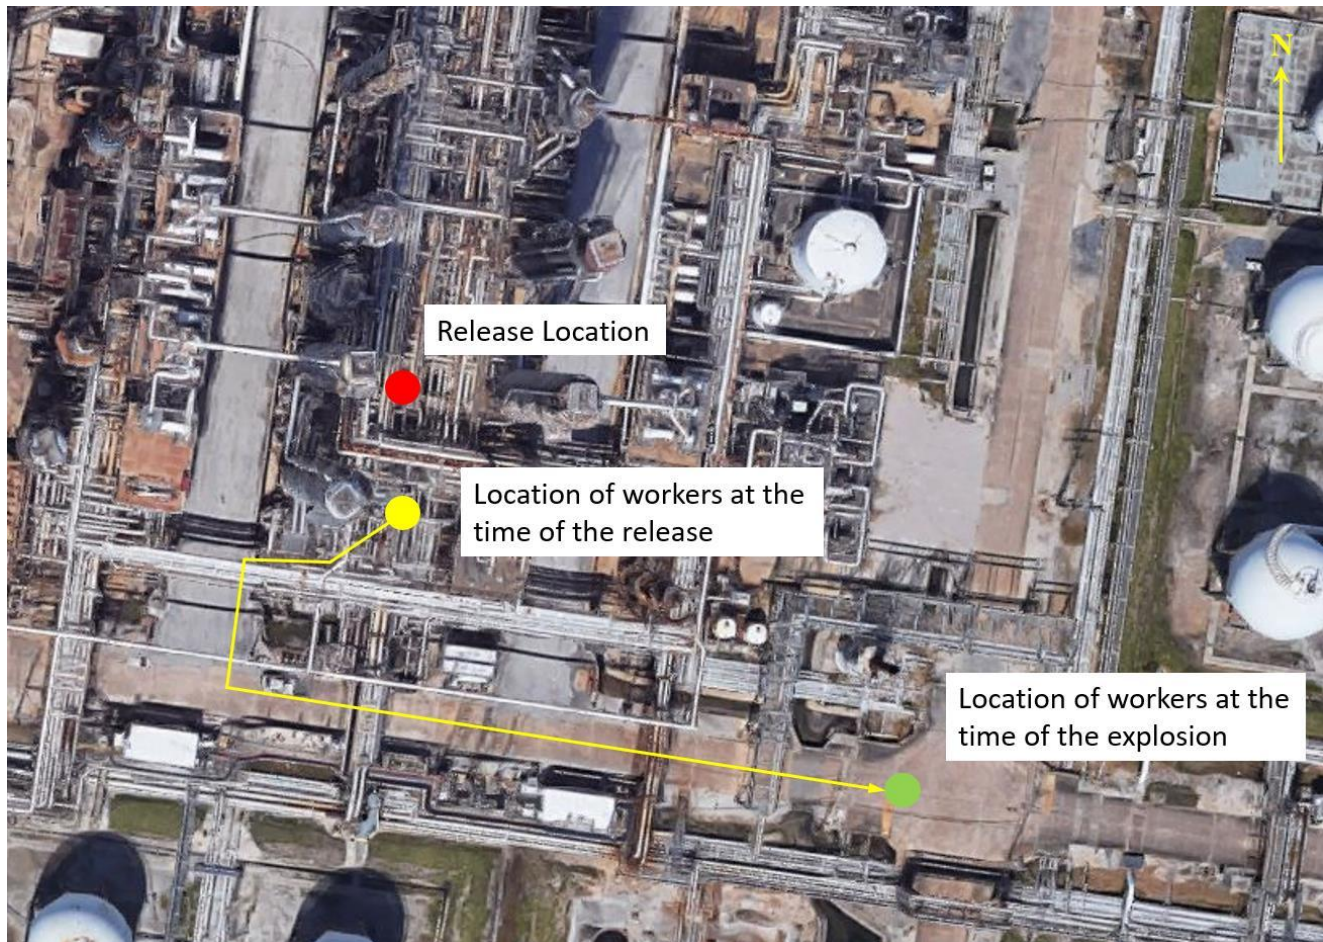
Three workers were present in the unit at the time of rupture, two of which were facing directly toward the Final Fractionator A. Both of these workers told the CSB after the incident that they witnessed a pipe rupture. One of the two workers identified the release point to be on the suction piping between the Final Fractionator A and the Primary Pump. The third worker, who turned toward the sound of the rupture after it occurred, also believed the release point to be the suction piping between the Final Fractionator A and the Primary Pump. The workers' observations were consistent with the unit's recorded distributed control system (DCS) data shown in **Figure 10**. Immediately following the loss of containment, the three workers quickly departed the unit. **Figure 11** shows their locations during the event.

**Figure 11.** Worker locations during the incident. (Source: Google Maps; CSB)

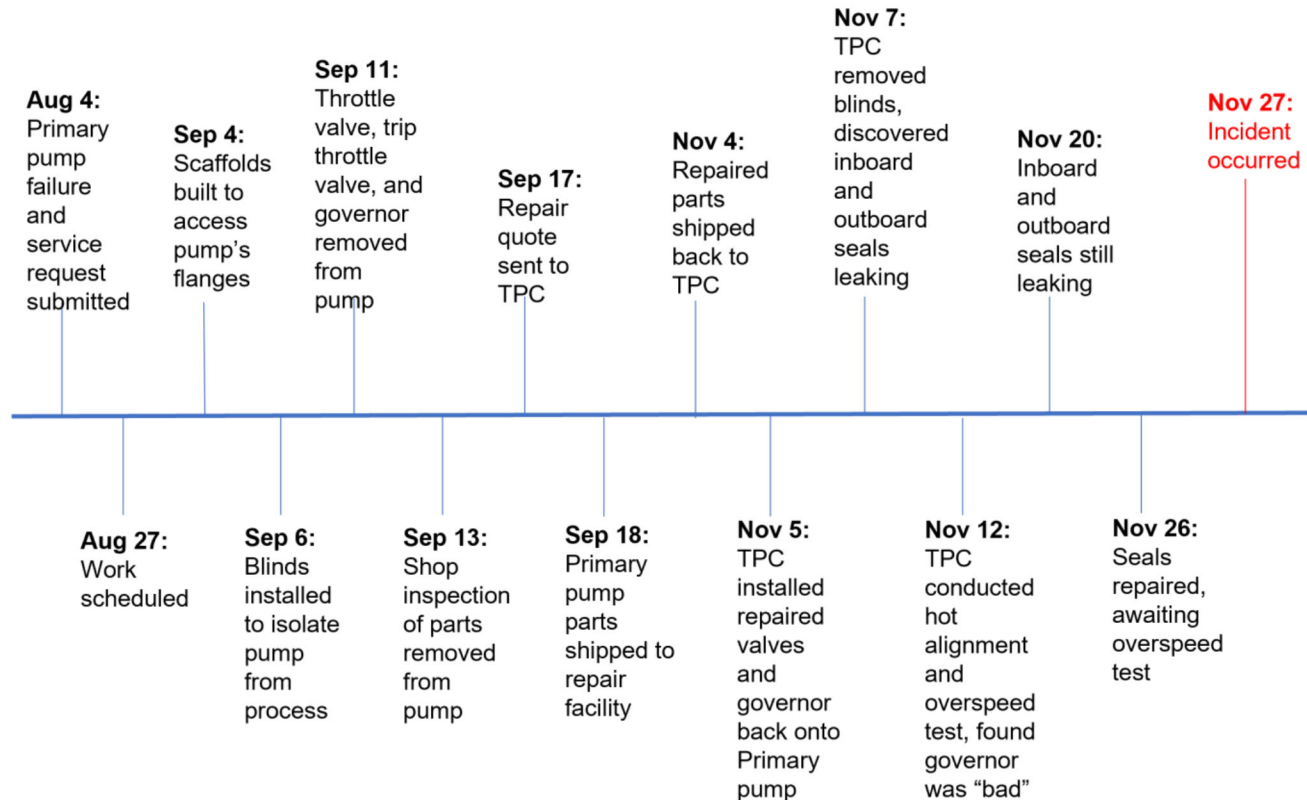
The CSB found that although TPC PNO originally established the maintenance priority for the out-of-service Primary Pump as “urgent,” on August 5, 2019, TPC PNO changed the priority of the pump repair to “routine.” TPC PNO indicated to CSB investigators that the Primary Pump repair was not classified as “emergency” or “urgent” due to the existence of the Spare Pump. One TPC PNO employee stated that the repair urgency was not elevated because TPC PNO did not “have the...parts to repair it.” The employee also stated the following about the operation of the spare pump while the primary pump was out of service: “If you lost the common spare [i.e., the Final Fractionator A/B Spare Pump, which was also a spare for an adjacent absorber column], then the whole unit’s down. Then your production’s down. Then you know, every...everything is down.” The timeline of the Final Fractionator A/B Primary Pump maintenance activities is depicted below in **Figure 21**.

**Figure 21.** Primary Pump repair timeline. (Credit: CSB)

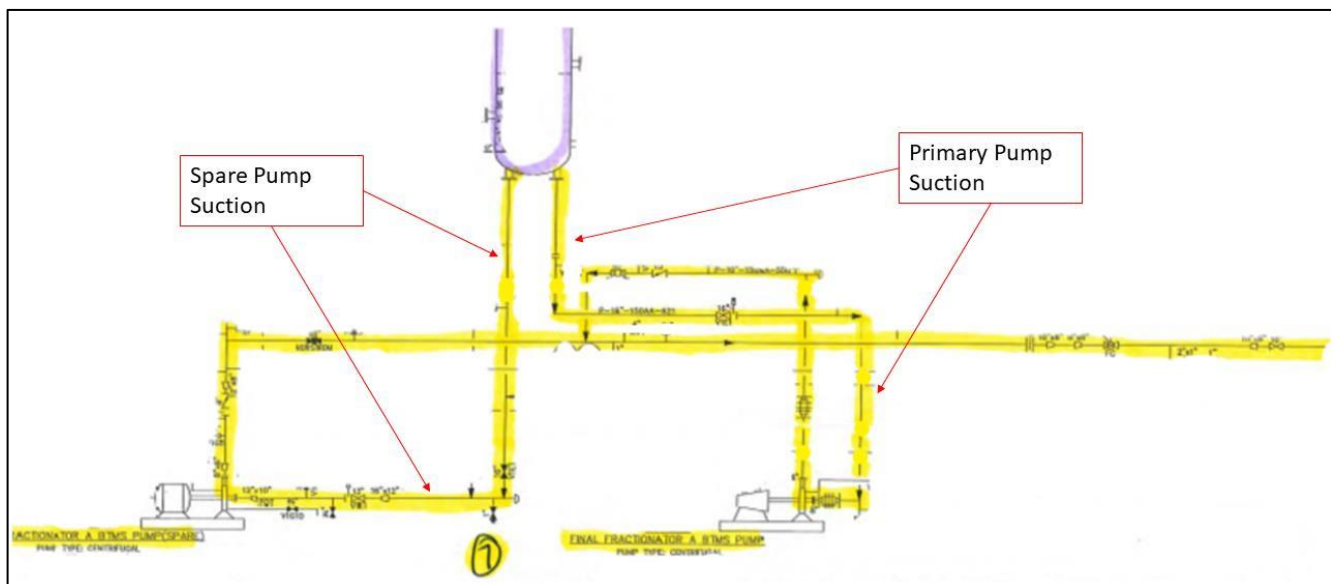
The CSB reviewed the two previous Process Hazard Analysis (PHA) revalidations for TPC PNO’s butadiene process (performed in 2011 and 2016), which included the final fractionation process. TPC PNO defined an analysis section, or node, that extended from the Final Fractionator A outlet to the Final Fractionator B inlet (see **Figure 22**). This node included both the Primary Pump and the Spare Pump. The PHA teams analyzed “no/low flow” as a potential deviation caused by Primary Pump failure. The consequence identified for this deviation was “possible unit upset causing off-test product resulting in economic impact,” and one of the claimed safeguards was the existence of a Spare Pump (see **Figure 23**). Neither PHA team identified the potential consequence of popcorn polymer accumulation, piping failure, and release to atmosphere for the no/low flow deviation for this node.

**Figure 22.** Excerpt from TPC PNO's 2016 PHA revalidation of the butadiene process depicting the node encompassing the Primary Pump and the Spare Pump. (Credit: TPC, annotated by CSB)

Despite not identifying the pipe rupture consequence for the node shown in Figure 22, in an earlier node analyzed during the PHA, the PHA team found that no/low flow could be caused by popcorn polymer formation, resulting in “possible line rupture with hydrocarbon release to atmosphere ... resulting in potential environmental/economic impact/personnel exposure and/or fire.” Based on this analysis, the PHA team made a recommendation that TPC PNO “assure that when equipment in high-purity [butadiene] service is [out of service] for maintenance, the lines are still flushed monthly” (see Figure 24). The PHA team felt this needed to be emphasized in the existing “Dead Legs in High Purity Butadiene Service” procedure. As the PHA acknowledges, this procedure was originally implemented in response to a popcorn polymer rupture incident that occurred at the site in 1999.<sup>a</sup> TPC PNO accepted this recommendation and assigned a targeted due date for implementation of December 7, 2016, almost three years before the incident. TPC PNO did not implement this recommendation, however.

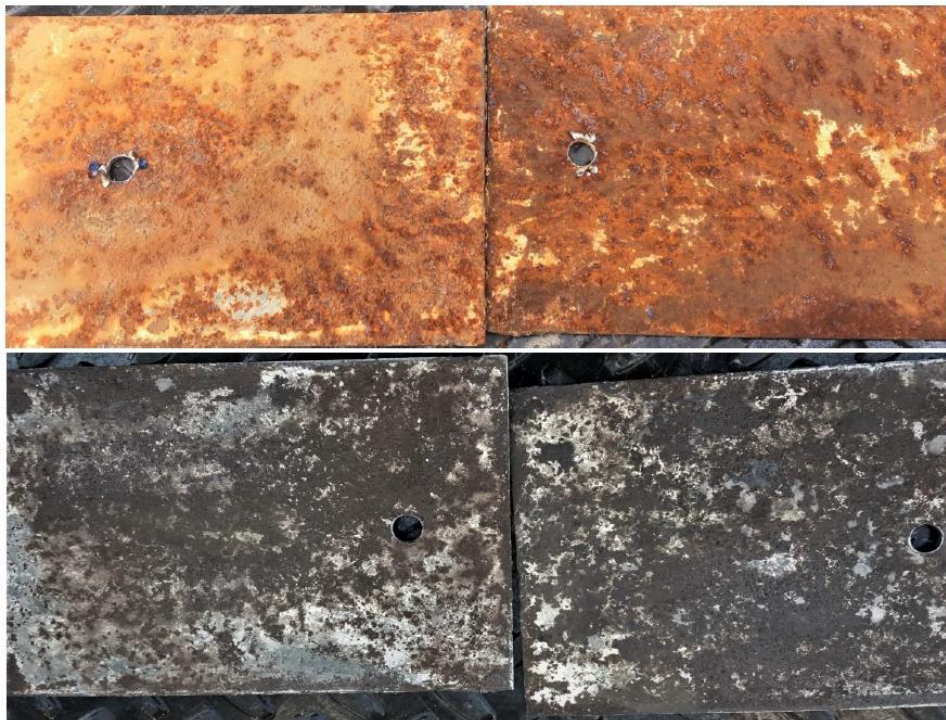
TPC PNO told the CSB that the TPC PNO facility began passivating equipment called butadiene finish tanks in May 2019. TPC PNO also completed passivating the overhead condensers for Final Fractionator A in June 2019. However, other equipment within the unit were not yet passivated, including both the Final Fractionator A and B columns and the Final Fractionator A overhead accumulator, which were scheduled to be passivated during the next outage. **Figure 25** shows photos of the Final Fractionator A, and **Figure 26** shows photos of the Final Fractionator A overhead accumulator, both taken during TPC PNO’s 2017 turnaround. Both figures show rust formed on the steel equipment walls, which is known to contribute to the formation of popcorn polymer. **Figure 27** shows photos of passivation coupons that were used to determine the efficacy of the passivation operation for the Final Fractionator A overhead condensers. This figure also illustrates how effective passivation can be for neutralizing rust.

**Figure 27.** Photos showing passivation coupons that were used to determine the efficacy of the passivation operation for the Final Fractionator A overhead condensers. Before passivation (top) and 19 hours after passivation (bottom). (Credit: TPC)

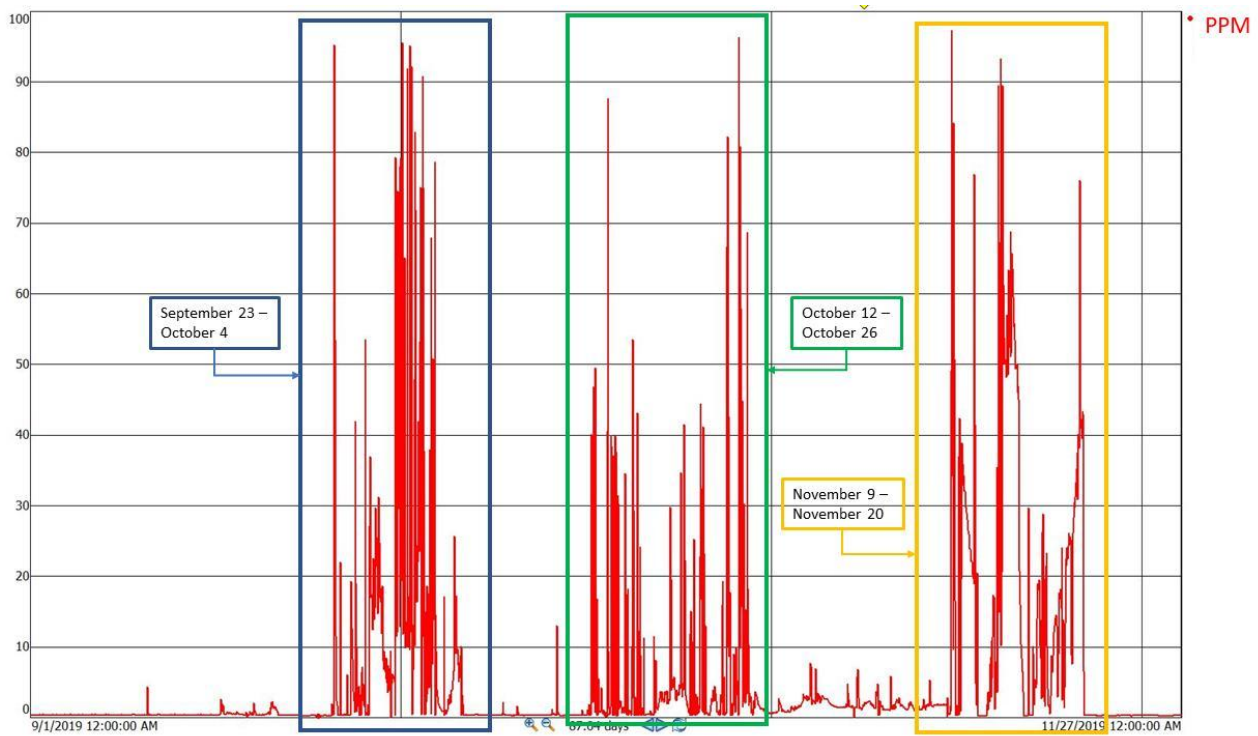
TPC PNO measured the oxygen concentration in the Final Fractionator using an analyzer attached to the vapor space of its reflux accumulator (**Figure 28**). The TPC PNO Tower Profile procedure specified a maximum oxygen concentration of 5 ppm.<sup>a</sup> This procedure further stated that manually venting the reflux accumulator “can be used if [oxygen] content is high in the overhead [accumulator],” though TPC PNO relied on continuous condenser venting to ensure oxygen removal. Between September 1, 2019, and the time of the incident, this analyzer indicated elevated oxygen concentration levels greatly exceeding the 5 ppm maximum, at some points reaching over 90 ppm, during three separate long-term periods (**Figure 29**).

**Figure 29.** Process trend data graph showing the oxygen concentration levels (in ppm) in the Final Fractionator reflux accumulator from September 1, 2019, until the time of the incident. (Credit: CSB)

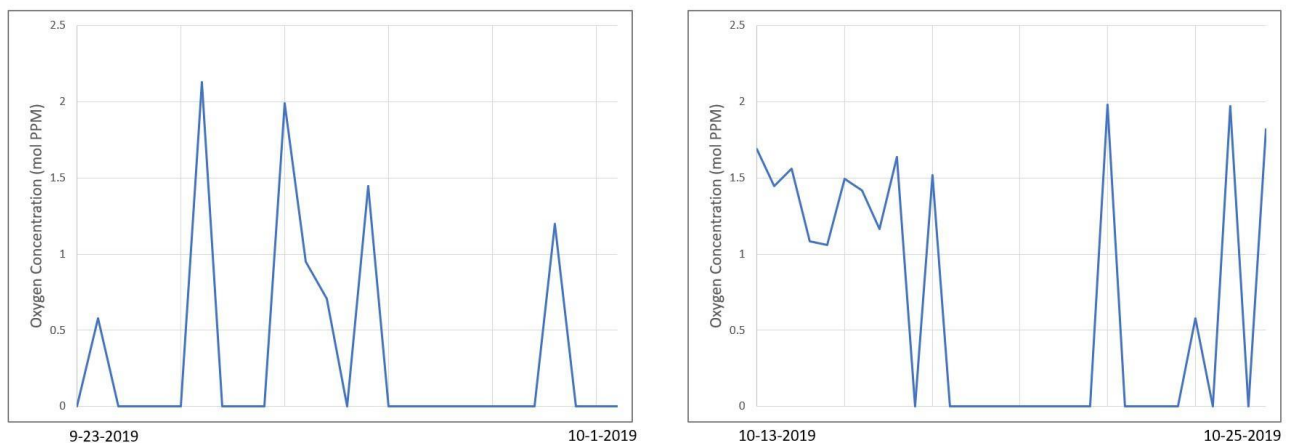
TPC PNO communicated to the CSB that Final Fractionator A accumulator oxygen concentration was also recorded using offline field samples taken twice per day. The laboratory analysis results of these samples are provided in **Figure 30**. These results indicate the oxygen level never exceeded 2.5 ppm in the samples. The CSB was not able to determine the reason for the large disparity between the analyzer readings and the laboratory analysis results. TPC PNO communicated that during the first two time periods indicated in **Figure 29**, the high oxygen readings were due to water in the analyzers, but TPC PNO communicated to the CSB that written evidence of this water content was not available, as it was maintained in a building that was destroyed during the incident, and the CSB was unable to confirm the validity of this statement.

**Figure 30.** Oxygen concentration in finished butadiene from September 23, 2019, through October 1, 2019, (left) and from October 13, 2019, through October 25, 2019. (Credit: CSB)

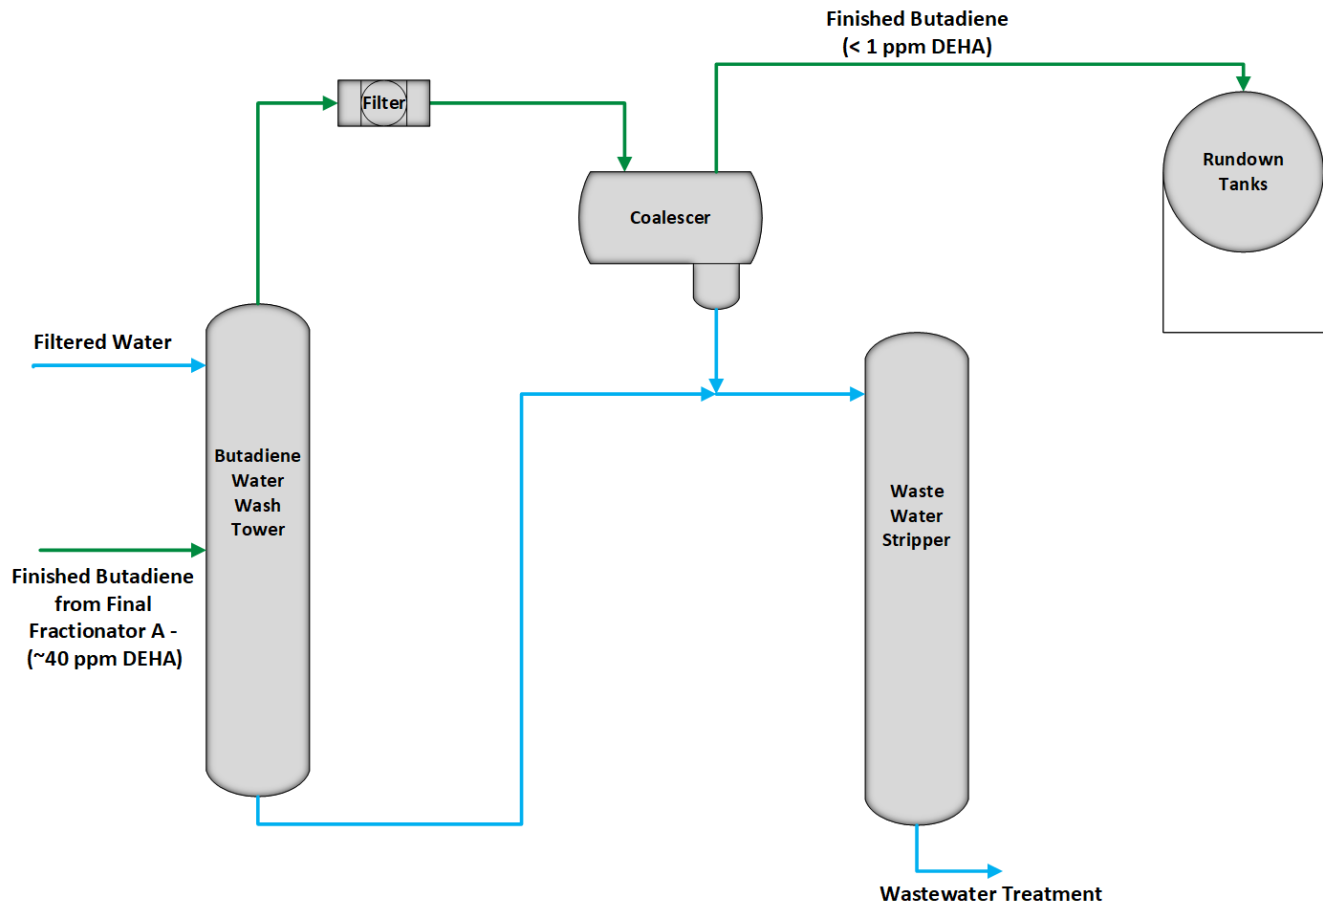
The TPC PNO site has historically experienced popcorn polymer formation at its facility. With some rare exception,<sup>a</sup> the bulk of the facility's popcorn polymer was removed from the equipment depicted in **Figure 31**, which included the butadiene water wash tower and its associated equipment (filter and coalescer), the waste

water stripper, and the finished butadiene storage tanks (also called “rundown” tanks). Since 2011, 95.6%<sup>a</sup> of all disposed popcorn polymer, nearly 20 tons annually, came from the areas shown in **Figure 31**.

**Figure 31.** Flow diagram depicting the butadiene process flow through the butadiene water wash tower to the rundown tanks (until April 2019). (Credit: CSB)

In May 2019, TPC PNO noted an increase in strainer cleanings in the rundown tanks just downstream of the bypassed butadiene water wash tower (**Figure 31**). In a document titled “Current Fouling Threats,” an employee wrote:

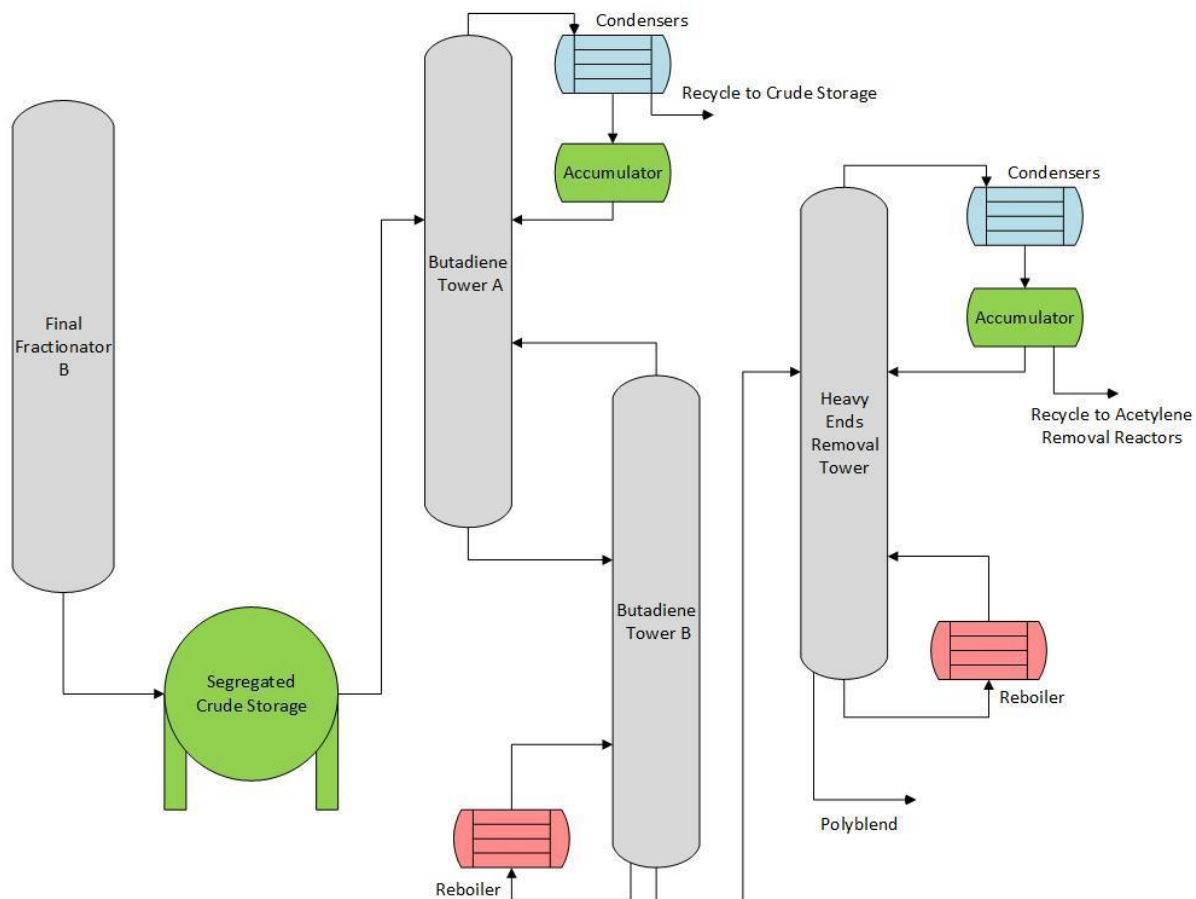
At the end of June 2019,<sup>a</sup> still during the trial in which the water wash tower was permanently bypassed and the amount of DEHA used in the unit was reduced, TPC PNO began to observe popcorn polymer plugging downstream of the Final Fractionator B bottoms, in the segregated crude pumps and the Butadiene Tower A (see **Figure 33**). TPC PNO also experienced popcorn polymer plugging in the bottom of the heavy ends removal tower (see **Figure 33**). The shift handover logs showed multiple popcorn polymer plugging incidents involving the Butadiene Tower B and the heavy ends removal tower throughout the months of July and August.

**Figure 33.** TPC PNO segregated crude unit. (Credit: CSB)

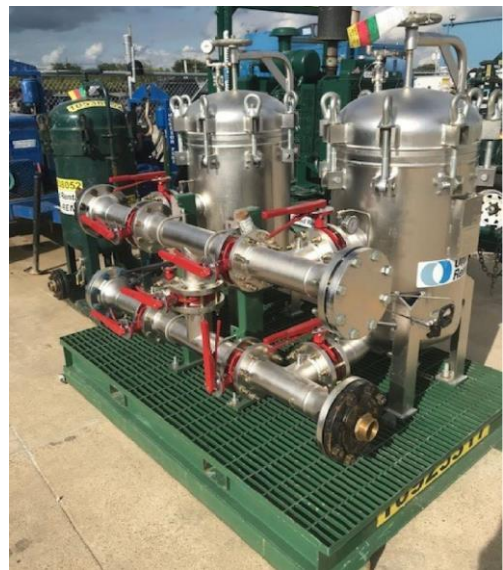
We were able to get the [Final Fractionator B bottoms] filters freed up this morning and have the line moving again. However, the filters fill with popcorn within 30 seconds of putting them online. As it stands, [we are] constantly changing filters as they plug. We’re going to need to make sure that the warehouse is stocked with plenty of filters.

**Figure 35.** Temporary filter skid – exemplar. (Credit: TPC)

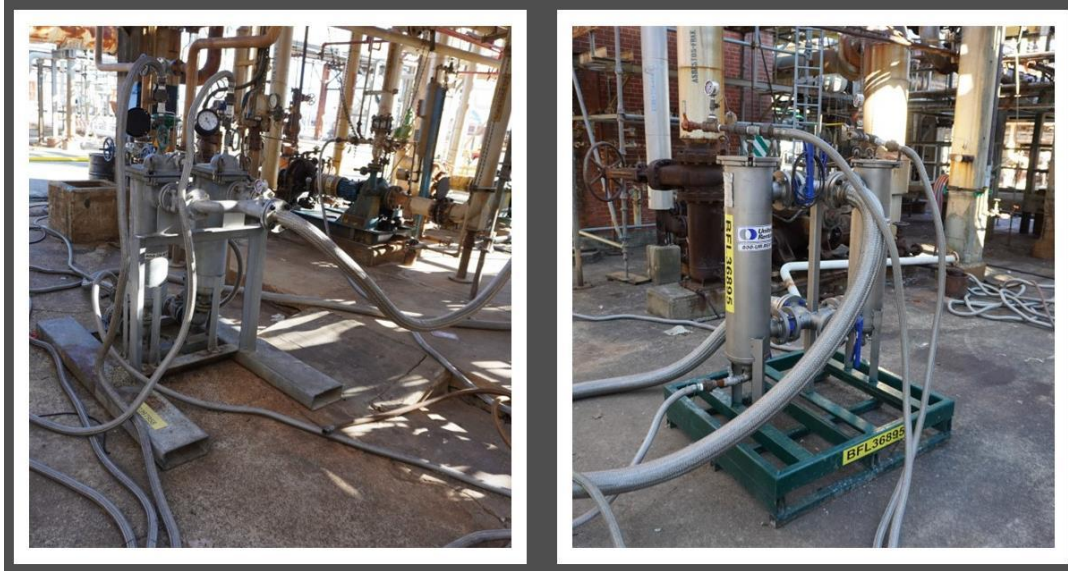
**Figure 36.** Photos of filter skids located elsewhere on the TPC PNO facility. (Credit: CSB)
