Explosion and Fire at KMCO Chemical Facility

Crosby, Texas | Incident Date: April 2, 2019 | No. 2019-02-I-TX

Factual Update

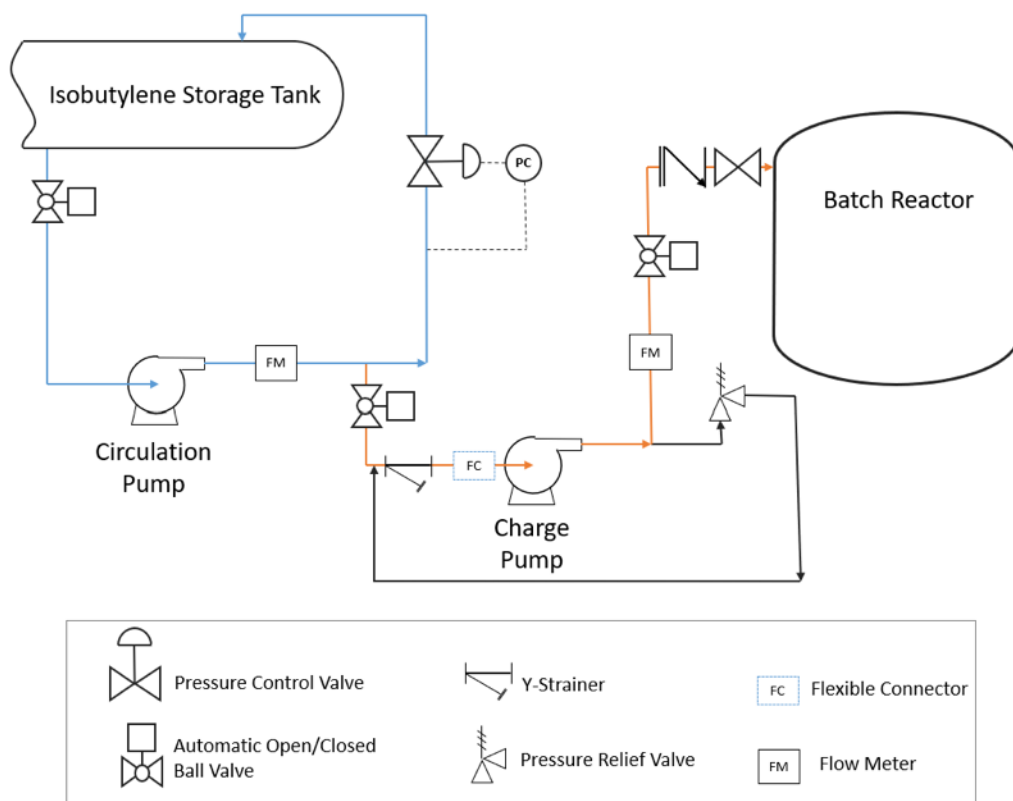
Figure 4. KMCO Isobutylene System. This simplified schematic shows the isobutylene system used to supply (charge) the batch reactor. The circulation pump keeps a steady supply of isobutylene to help provide reliable operation of the charge pump. The failed y-strainer is located on the inlet (suction) piping to the charge pump. (Credit: CSB).

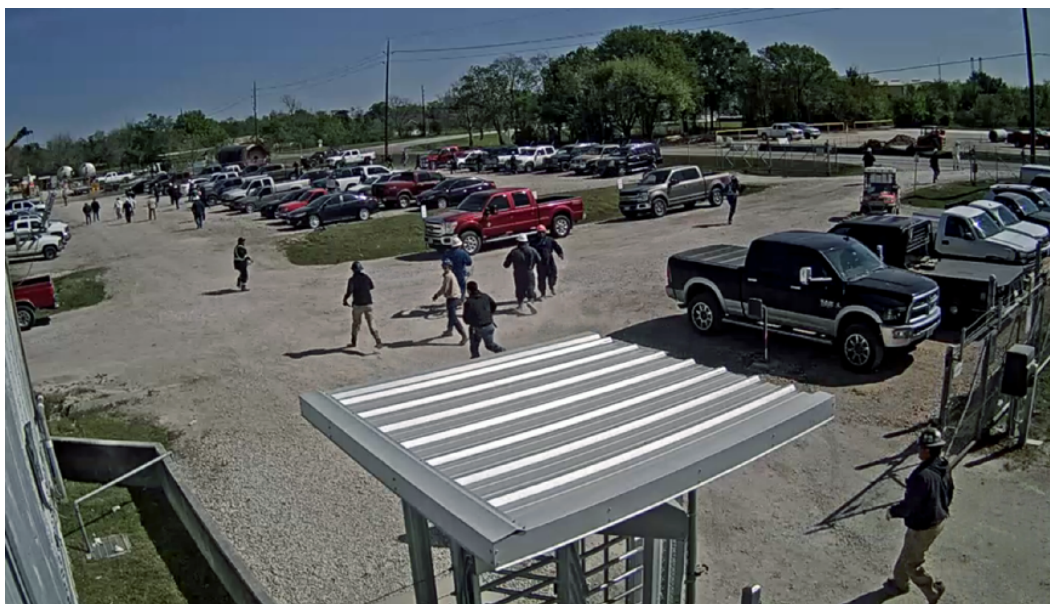
Despite these efforts, the isobutylene vapor cloud exploded. Workers already heading to rally points hurried their evacuation (**Figure 5**). KMCO surveillance cameras visibly shook just after 10:50 am, capturing the time of the explosion.¹⁸

Figure 5. Evacuation. This surveillance camera image shows workers evacuating after the explosion. (Credit: KMCO).
