U.S. Chemical Safety and
Hazard Investigation Board

Chemical Reaction, Decomposition, and Toxic Gas Release at Bio-Lab, Inc.

Westlake, LA | Incident Date: August 27, 2020 | No. 2020-05-I-LA

Investigation Report

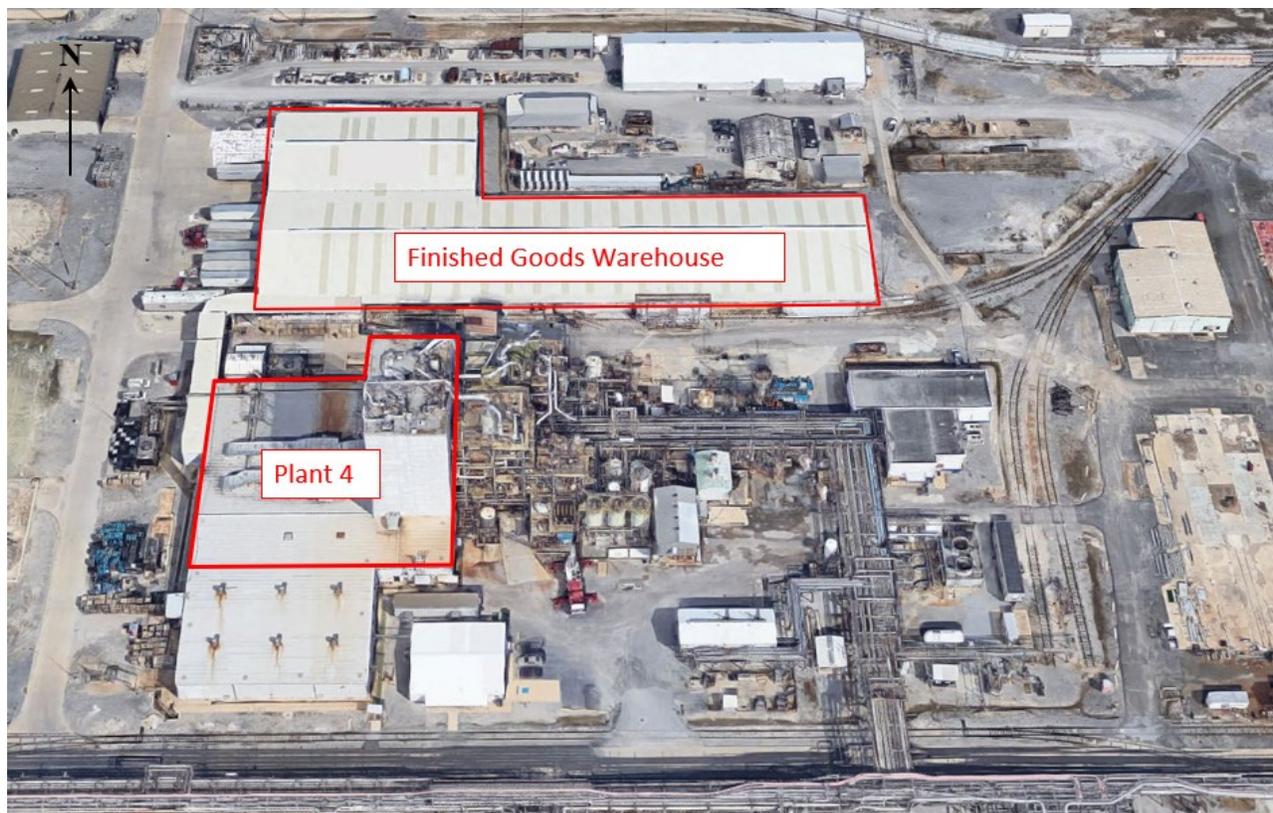
Figure 1. Overhead view of a portion of the Bio-Lab facility with red denoting buildings involved in the incident. (Credit: Google Earth, annotations by U.S. Chemical Safety and Hazard Investigation Board (CSB))

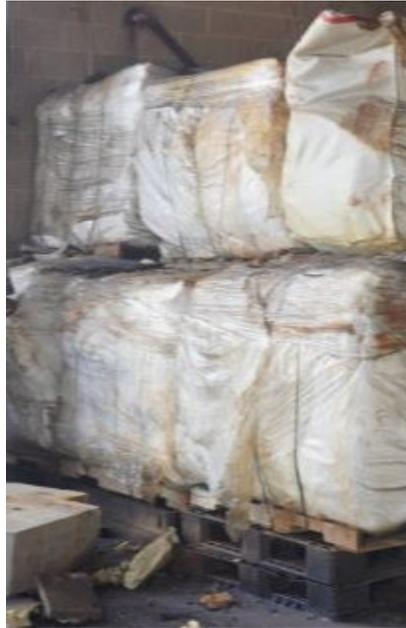
Figure 5. Product stacked as a precaution from floodwater. (Credit: CSB)

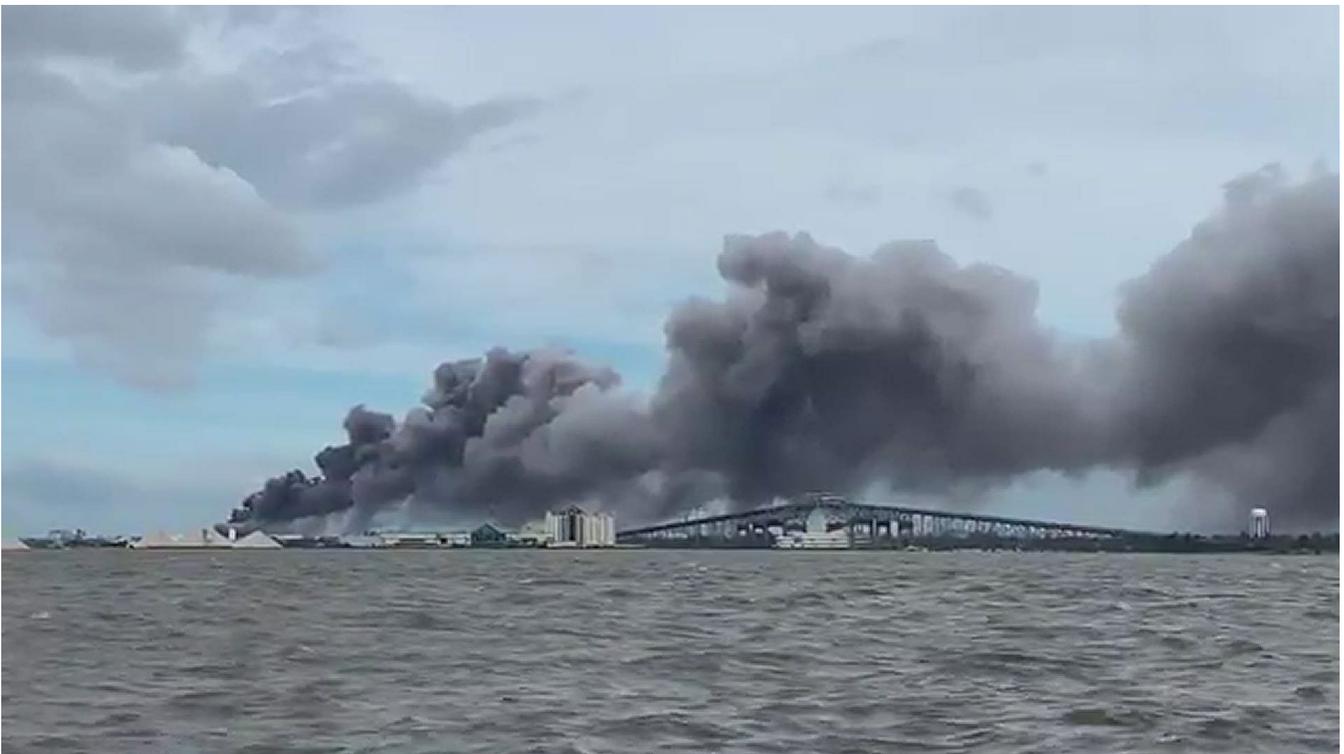
Figure 8. Photo of plume from decomposition in Bio-Lab Plant 4 approaching the Calcasieu River Bridge near the facility. (Credit: CBS 4WWL [23])

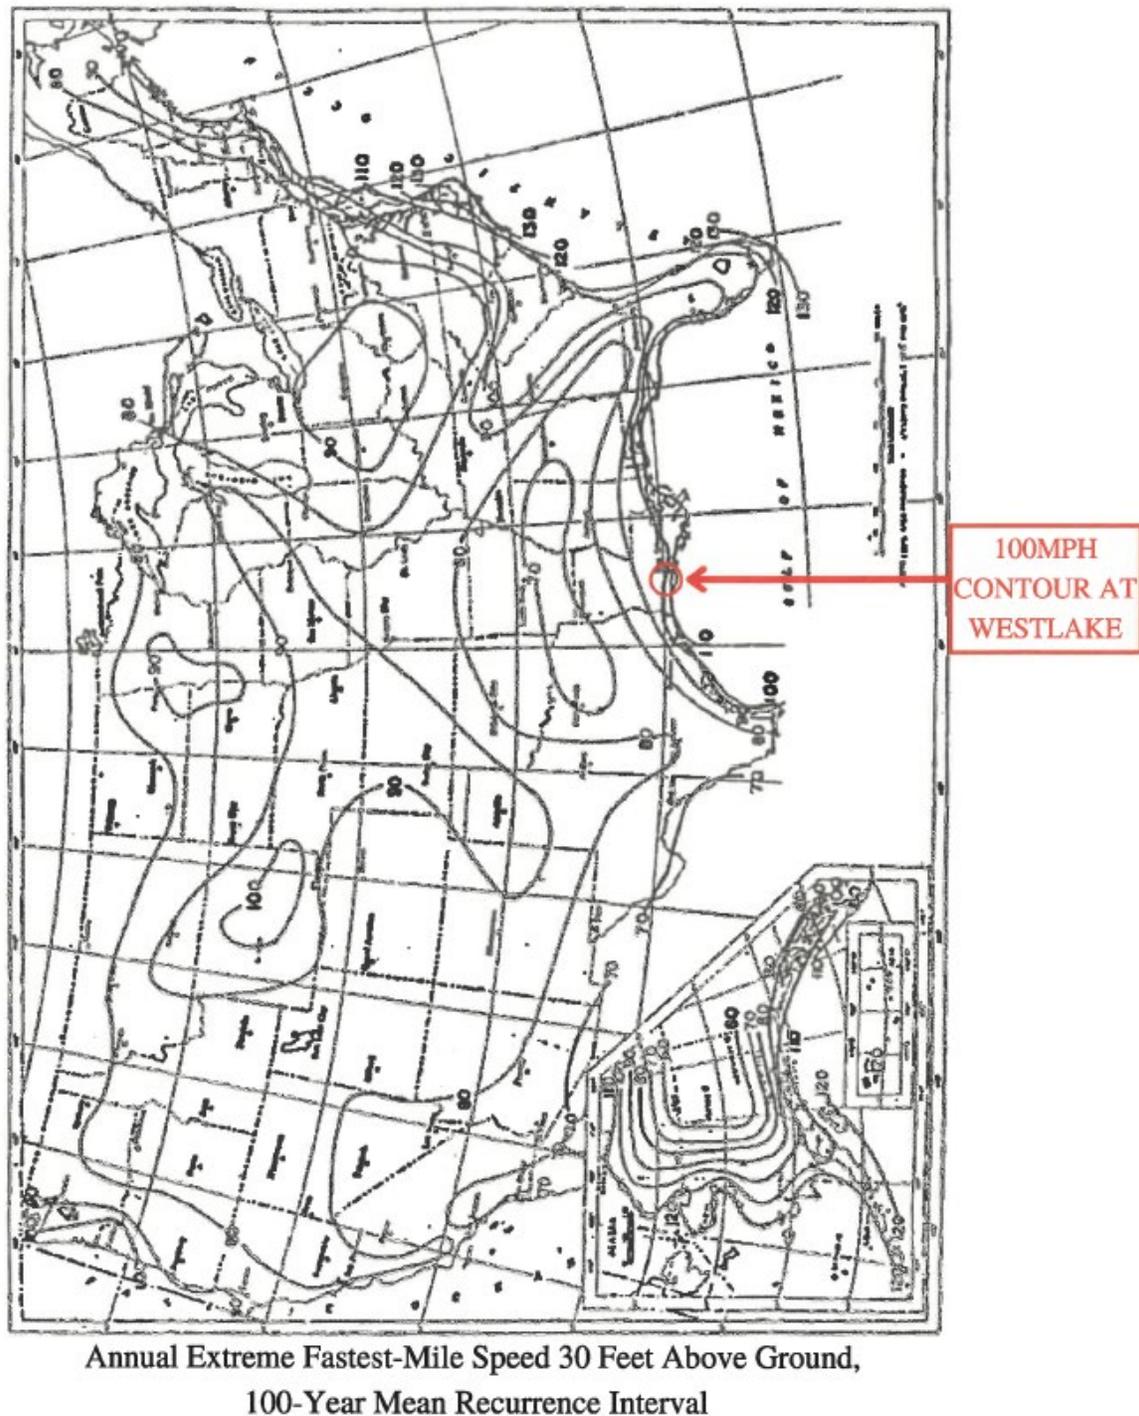
The CSB's discussions with building officials in the Calcasieu Parish and the Cities of Westlake and Lake Charles, Louisiana, suggest that general design standards in the area during the 1970s were largely deferred to the architects and engineers involved. Representatives from the Calcasieu Parish told the CSB that licensed designers in the Parish would potentially look to standard engineering practices, including the prevailing Standard Building Code, for design guidance in the absence of official state adoption of the code. The Standard Building Code in use in 1979 was the 1974 revision of the 1973 edition. Basic design wind speeds are shown in Chapter 12 of that Code, with the Westlake / Lake Charles area falling close to the 100-mph wind speed contour for building design (see **Figure 15** and **Appendix D**).

Figure 15. Basic design wind speeds in the prevailing Standard Building Code in 1979, the year the Bio-Lab facility was constructed. (Credit: 1974 Standard Building Code, annotations by CSB)

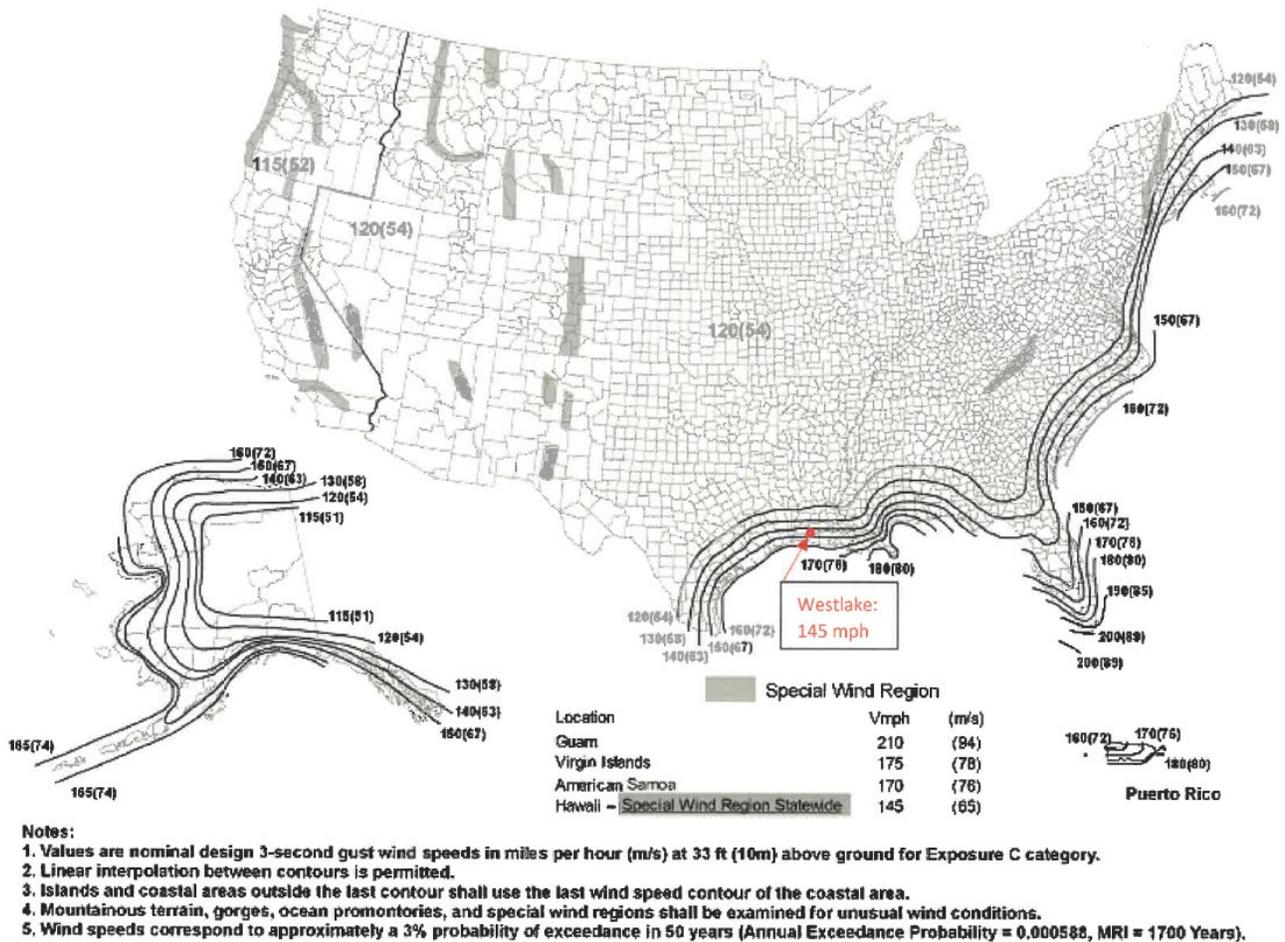
buildings and other structures in the state consistent with the public health, safety, and welfare of its citizens [28].” At the time of the incident (and at present), the LSUCCC adopted the 2015 version of the International Building Code, with amendments,^a as the Louisiana State Uniform Construction Code [29]. Under the 2015 International Building Code requirements for Risk Category IV buildings, the Bio-Lab facility would be required to withstand 145 mph winds (see **Figure 16** and **Appendix D**).

Figure 16. 2015 International Building Code Fig 1609.3(2), Design Wind Speeds for Risk Category III and IV Buildings. (Credit: 2015 International Building Code, annotations by CSB)

The Standard Building Code 1974 design wind speed of 100 mph and the 2015 International Building Code design wind speeds of 145 mph cannot be compared directly. The 2015 International Building Code design wind speeds are coupled with extensive refinements in building codes since 1974, including:

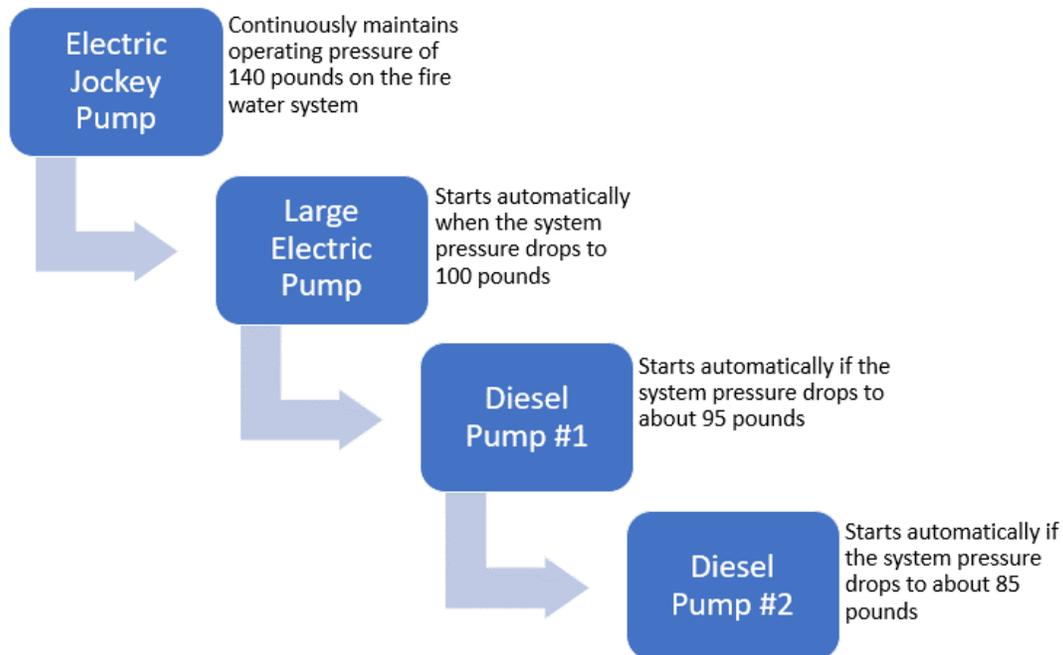
Figure 18. Bio-Lab's fire water pumps automatic start-up sequence. (Credit: Bio-Lab, illustration by CSB)

Hurricane Laura damaged a power grid, causing the Bio-Lab facility and the surrounding area to lose electrical power. Bio-Lab personnel attempted to turn on the rental backup generator to operate the fire protection system. Initially, they could not activate the rental generator, and as a result, neither the electric jockey pump nor the large electric pump could be operated. Later, another employee successfully turned on the generator, but it still could not supply power to the electric pumps. The employees did not have a manual or operating procedure to reference for the rental generator. In addition, one of the diesel pumps was nonfunctional before the hurricane made landfall, resulting in only one fire water pump—a diesel pump—available for use to respond to the decomposition and fire. Once the Fire Department arrived, they also experienced difficulties priming their pump, as discussed in Section 2.3.2. With only one fire water pump, the facility could not achieve adequate pressure to apply water to the decomposing TCCA-based formulation. The incident could not be controlled until the contracted third-party emergency responders arrived, set up their equipment, and successfully flowed sufficient water to the decomposing TCCA-based formulation. The problems with the Bio-Lab fire protection system resulted in a lengthy delay of around five and a half hours before productive emergency response operations began. During this delay, the TCCA-based formulation continued to decompose, releasing large clouds of decomposition products, including chlorine.

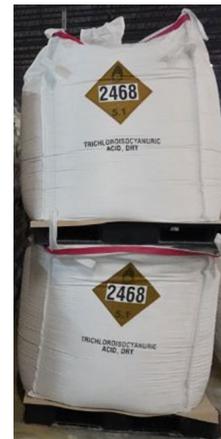
Figure 22. Super sacks storage method inside the Bio-Lab Conyers Plant 6. (Credit: CSB)

^a Bio-Lab stores the TCCA-based formulation products on wood or plastic pallets inside Plant 6. Worker #1 told the CSB that the TCCA-based formulation stored in the area was sitting on wood pallets, similar to exemplar stacked bags shown in **Figure 22** where the reaction and decomposition occurred. The CSB confirmed the height of two wood pallets. One measured approximately seven inches high, and the other was about five inches.

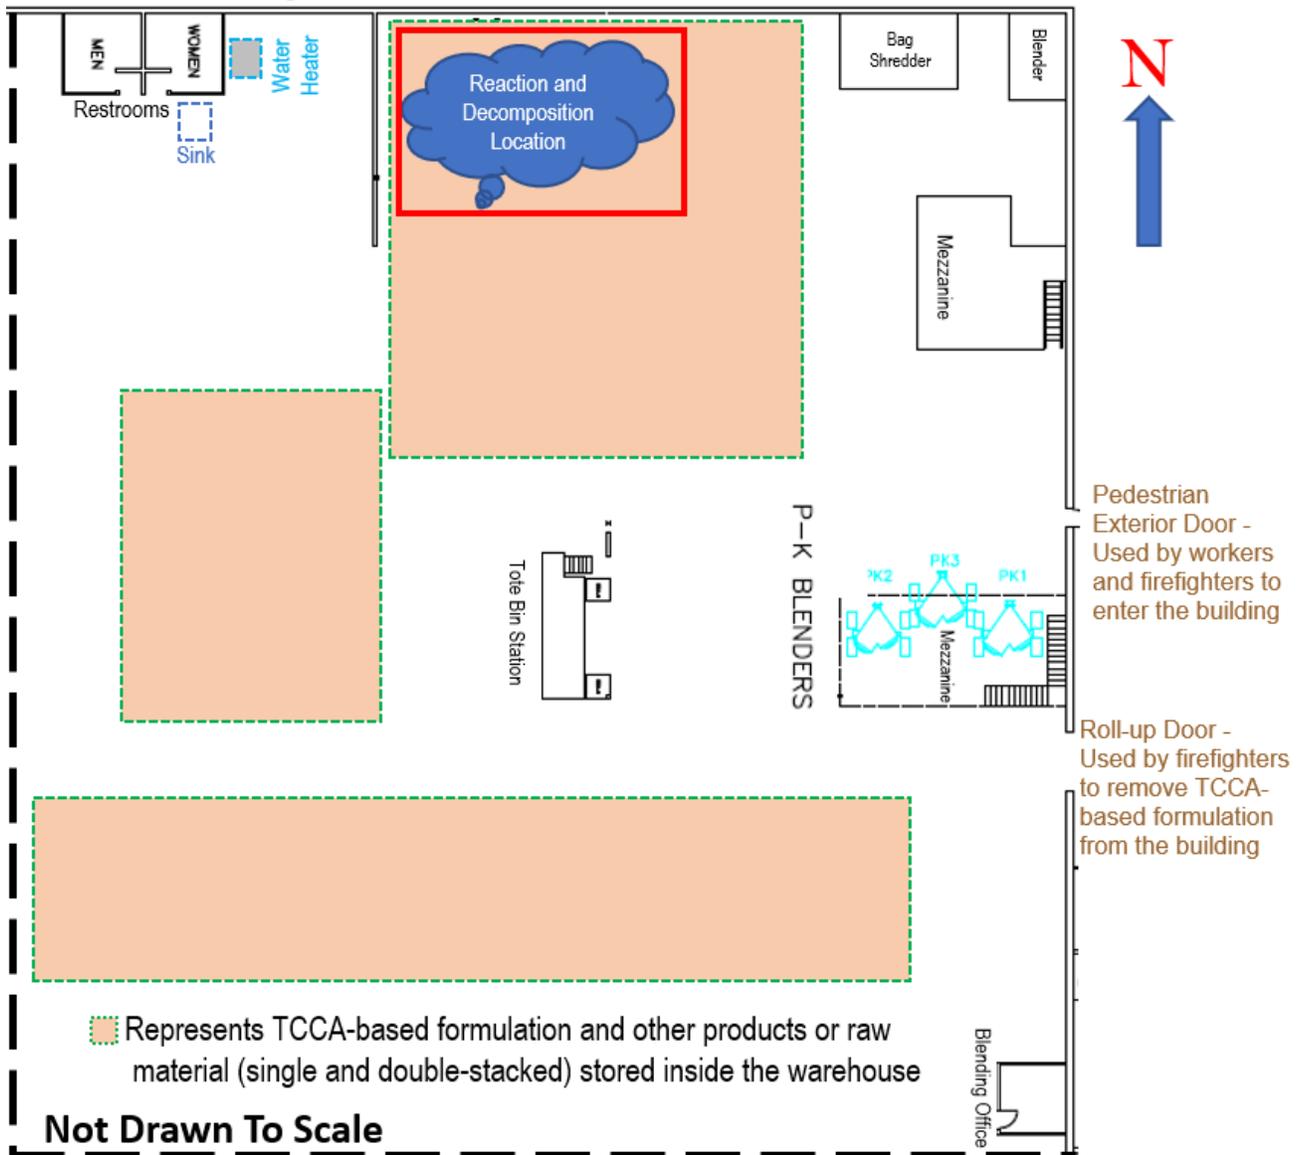
Bio-Lab Conyers Plant 6 North Wall with Exhaust

Figure 23. The configuration of a section of Plant 6 and the incident location (red box). (Credit: Bio-Lab Conyers, annotations by CSB)

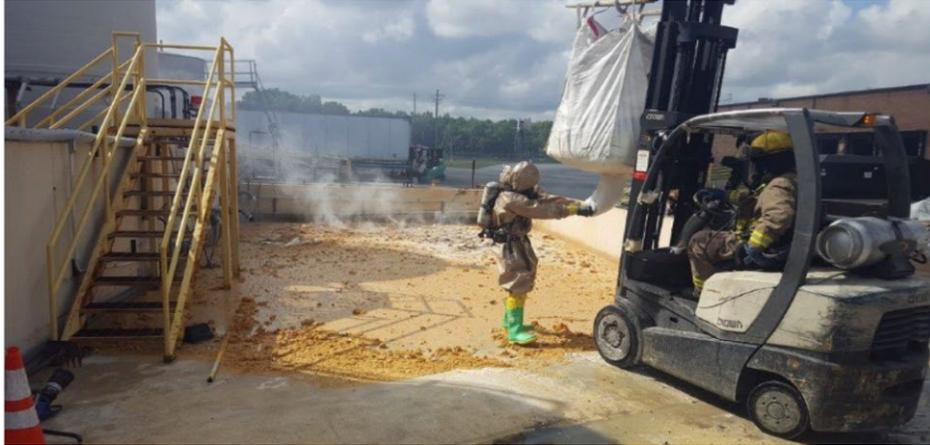
According to the Rockdale County Fire Department, “access to the decomposing pallets was hindered by other surrounding poorly stacked pallets of materials.” The Fire Department also established an external decontamination area (**Figure 26**) and moved decomposing materials to this area using forklifts and skid steers^a to stop the chemical reactions inside the building.^b

Figure 26. External decontamination area outside the Bio-Lab Conyers Plant 6. (Credit: Bio-Lab Conyers)

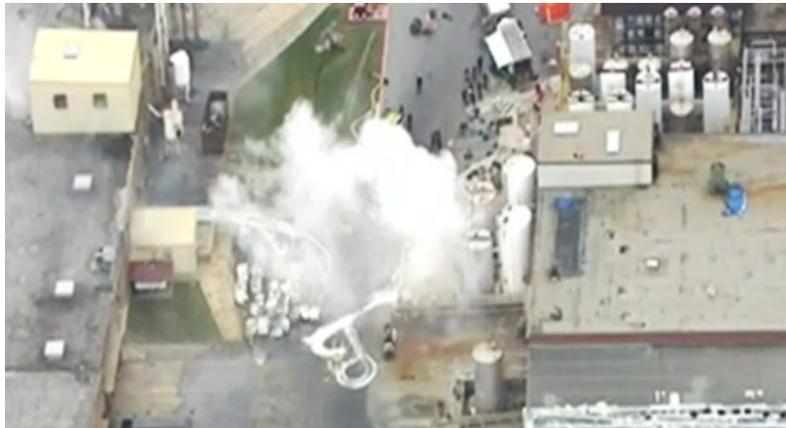
Figure 27. Decomposition products, including chlorine, releasing from the Bio-Lab Conyers facility on September 14. (Credit: WSB-TV Channel 2 Atlanta)

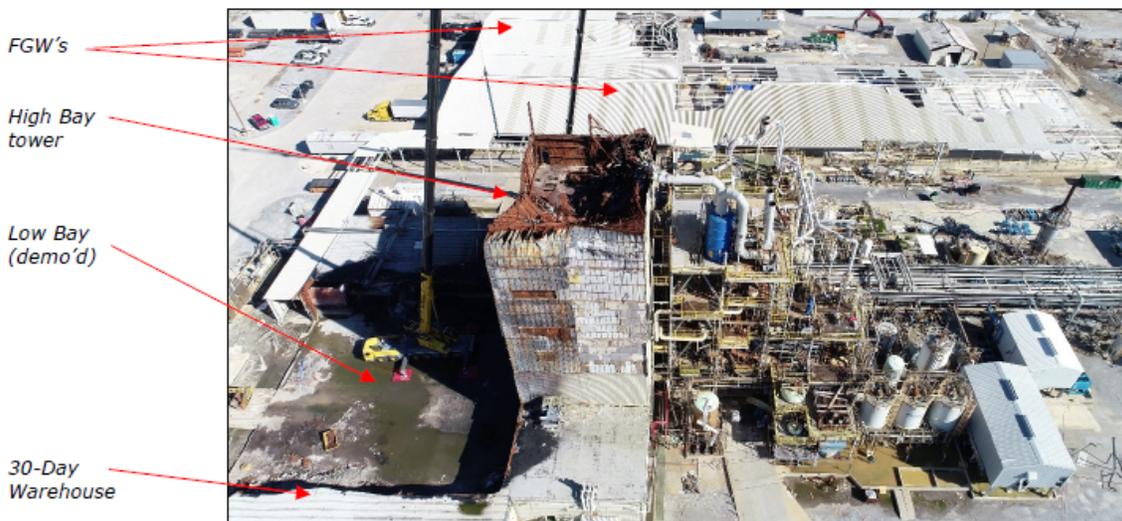
We observed conditions at five damaged buildings at the facility soon after the event. The A-Z Building and the two FGW structures suffered substantial wind damage but were repairable. The Plant 4 Low Bay was destroyed by fire and had been demolished at the time of our site visit. The Plant 4 High Bay tower had severe structural damage. The High Bay was not safe to enter, and was not repairable.

Overview, looking north (Atlas UAV, 9/30/2020)

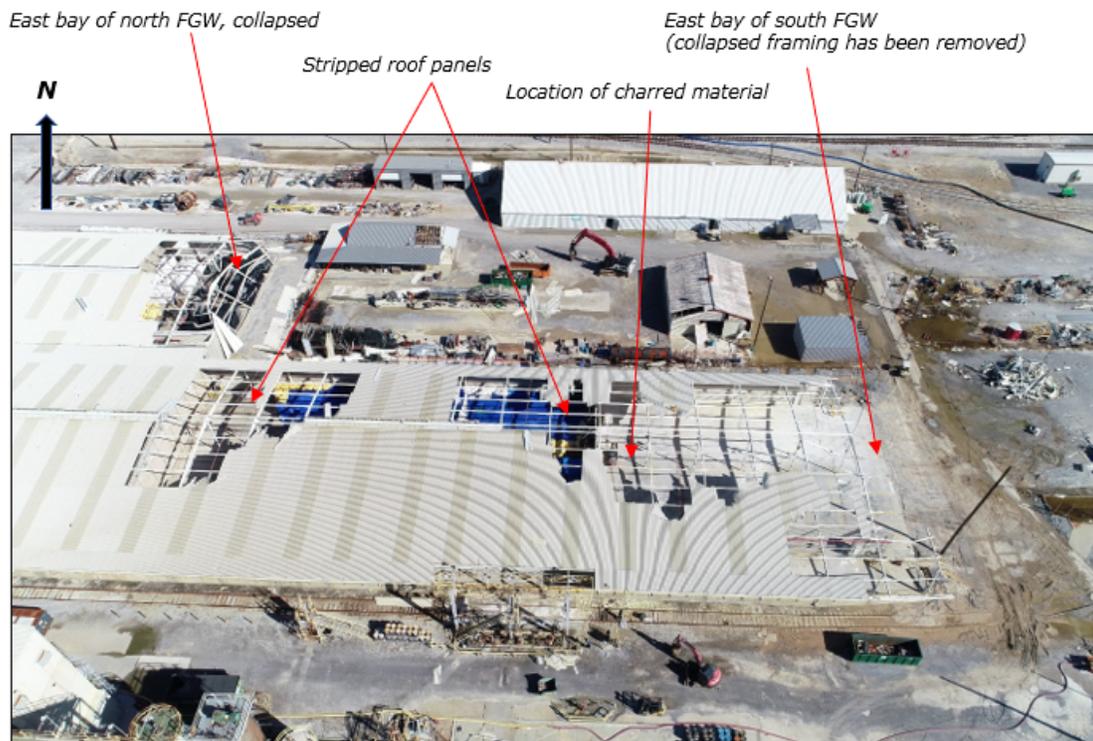
Finished Goods Warehouses (Atlas UAV, 9/30/2020)

Wind Damage – At both FGW’s, the columns at the eastern end-walls collapsed to the west, falling into the eastern building bay and buckling roof purlins and wall girts as they fell. We examined the column bases at these end-walls and found severe corrosion at the anchor bolts. Several anchor bolts had corroded in two, leaving the end-wall columns unattached to the slab, and less able to resist wind loads.

Post-Incident Condition – The buildings were damaged but the structures were relatively stable. Hazards included loose overhead panel debris, damaged framing at the eastern bays, and hanging wires. It was feasible to repair these buildings.

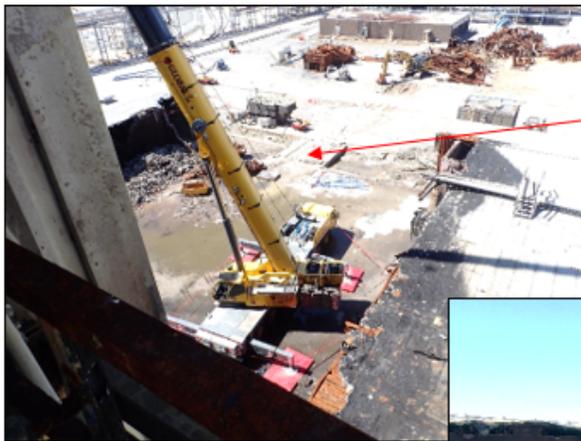
Our information on the Low Bay building is limited. The CSB supplied us with two foundation drawings dated 1977-78, but no other structural plans were available. Most of the Low Bay collapsed during the fire and had been demolished by the time of our site visit. Our understanding of the building is based on earlier photos made by the CSB, and our observations of nearby structures that remained standing, including a small northern section of the Low Bay and the 30-Day Warehouse to the south.

*View from High Bay stair,
looking SW (Atlas, 9/29/2020)*

*Location of demolished
Low Bay building*

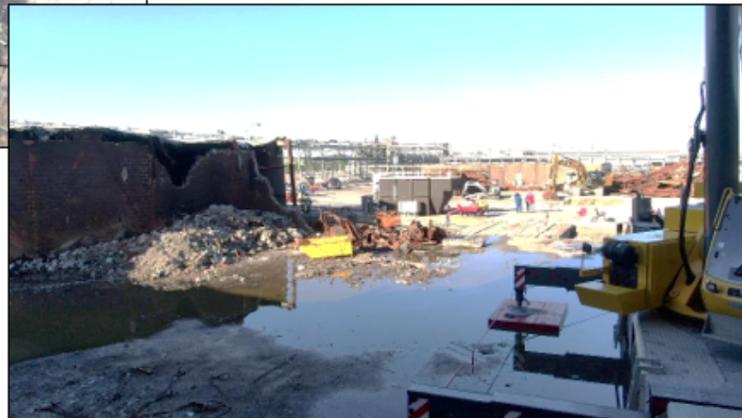
View looking west (Atlas UAV, 9/30/2020)

Wind Damage - Most of the Low Bay building was severely damaged by fire, had collapsed, and been demolished by the time of our site visit. At a small part of Low Bay remaining at the north end, and at the 30-Day Warehouse just to the south, the roofs appeared mostly intact, but there were large openings where roof-top ducts or vent-heads had blown off.

Fire Damage - According to the site demolition contractor, the heat from the fire buckled the building columns and the roof collapsed. At the time of our site visit the debris had been cleared from the building footprint.

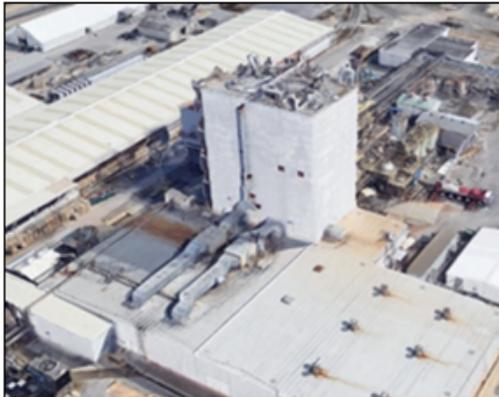
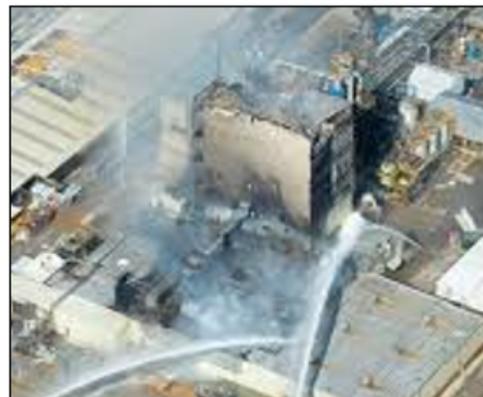
Views of High Bay tower, looking northeast

Pre-event (GoogleEarth)

Firefighting (late August, A/P News)

Wind Damage – At the south exterior wall, most of the outer layer of corrugated steel wall paneling had been torn away, as well as the insulation. The inner layer of paneling remained largely intact. Both layers of the wall paneling remained generally intact at the other three sides of the tower. Possible wind damage to the roof and upper wall panels could not be ascertained, as these parts had been destroyed by fire.

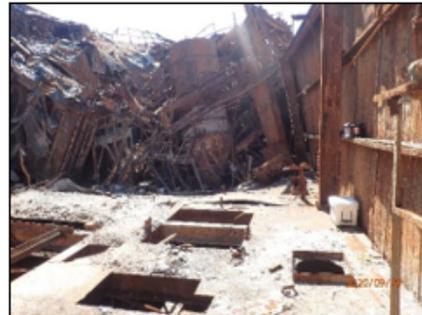
Fire Damage – The fire had severely damaged the tower’s structural framing. The fire’s heat softened the steel, leading to deformation and collapse of the building columns above the Level 4. These columns folded inward, funneling the roof-top blowers, their concrete roof slabs, and the mezzanine equipment toward the center of the building and dropping this debris onto the Level 4 floor. The middle of the Level 4 floor system failed and some of this equipment dropped below onto Level 3. Part of the Level 3 floor system also failed. We found heat-deformed out-of-line columns, beams, and bracing at every floor level. The fire destroyed all the internal process equipment. Many machines fell loose from their moorings, and tons of debris fell to floor areas not designed for concentrated loading.

4th floor level, from north stair (Atlas 9/29/2020)

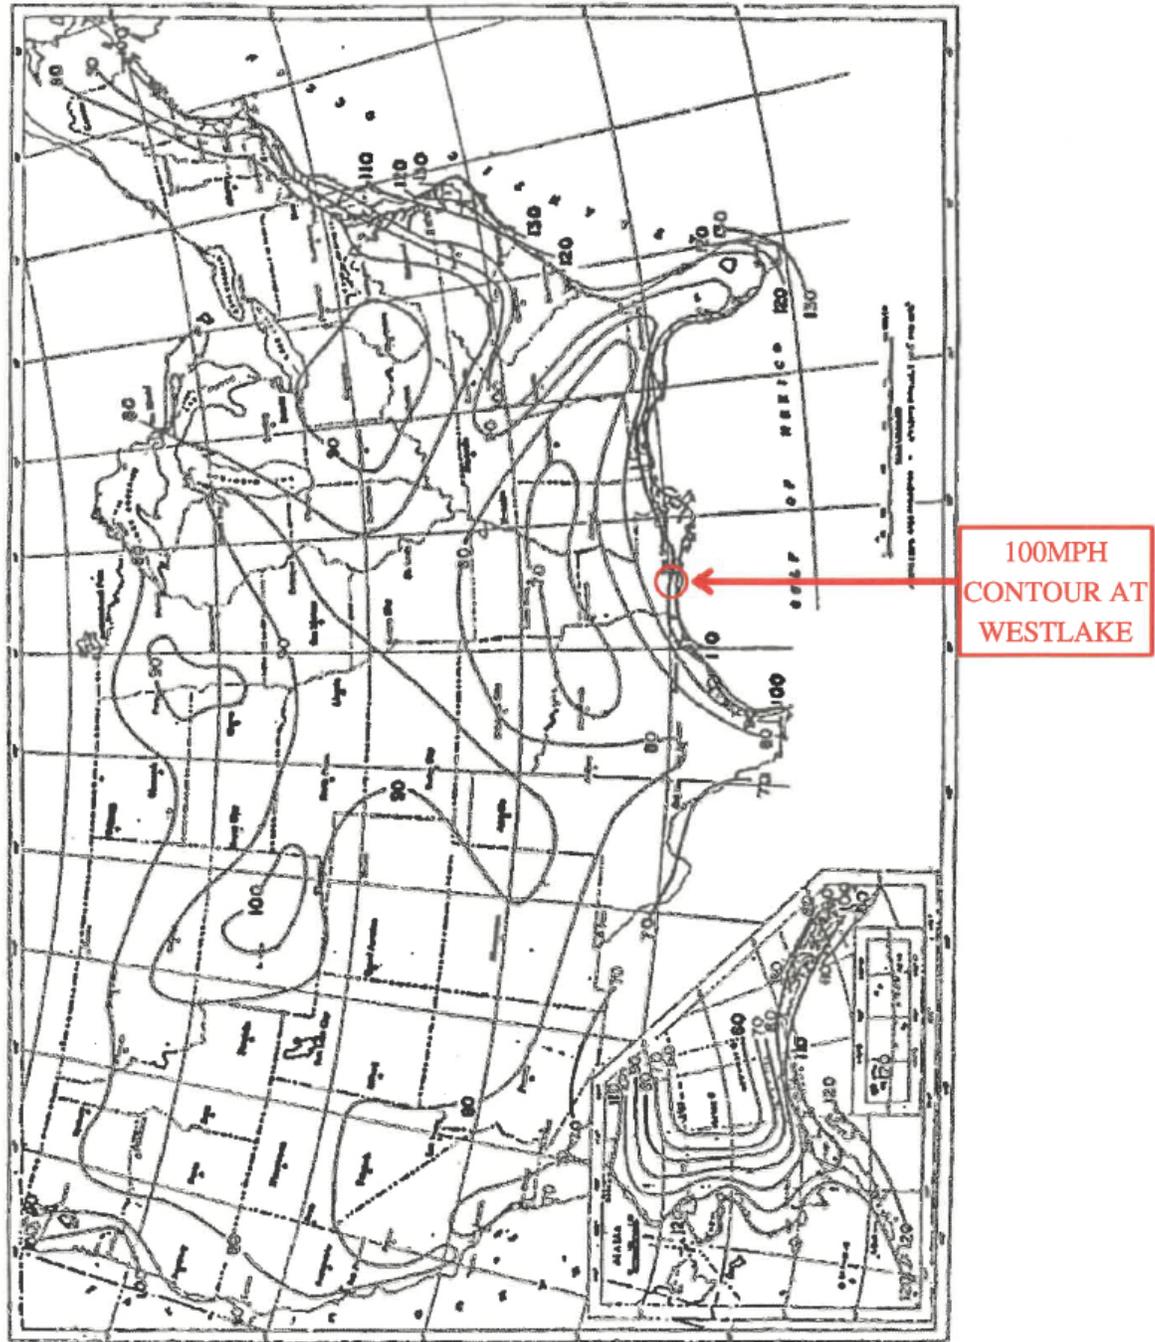
Attachment 2: Wind map, 1974 Standard Building Code (SBC)

The SBC in use in 1978 was the 1974 revision of the 1973 edition. Basic design wind speeds are shown in Chapter 12, on figure 1205.1, with the Westlake area falling close to the 100 mph wind speed contour (see Attachment 2).

FIGURE 1205.1 - BASIC WIND SPEEDS IN MILES PER HOUR

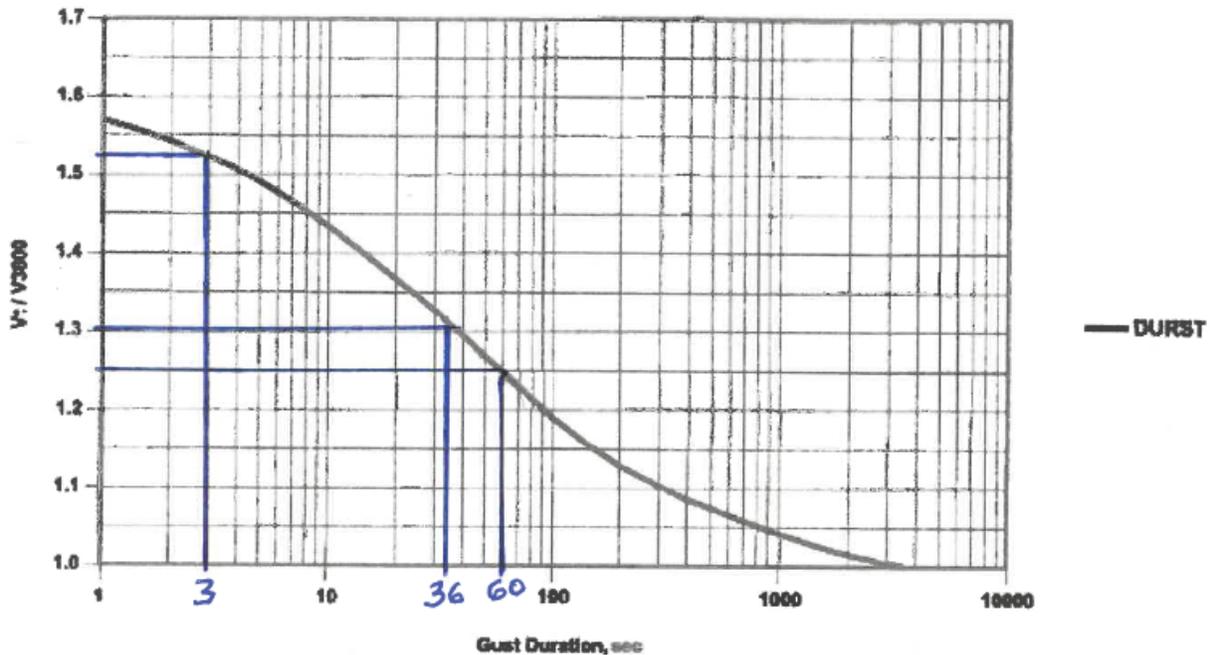
Attachment 3: Wind Speed Adjustments for Duration of Measurement

FIGURE C26.5-1 Maximum Speed Averaged over t s to Hourly Mean Speed.

100 mph, 60-second speed *compares to a* 122 mph, 3-second speed

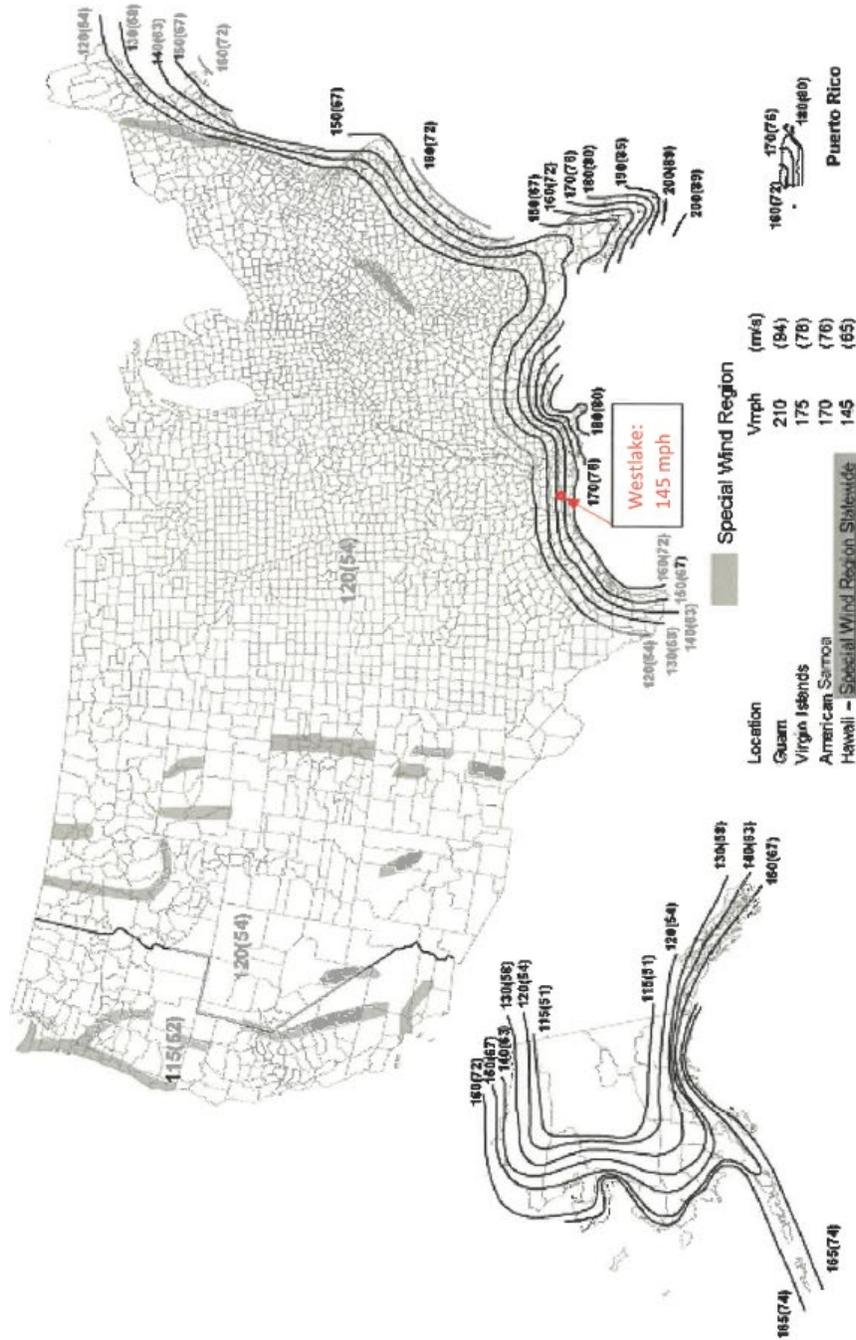
Attachment 4: Wind map, 2015 International Building Code Fig 1609.3(2)

For Risk Category IV buildings like those at the Bio-Lab site, the 2015 IBC design windspeed is 145 mph, in accordance with IBC Figure 1609.3(2) (see attachment 4).

FIGURE 1609.3(2) ULTIMATE DESIGN WIND SPEEDS, v_{ult} , FOR RISK CATEGORY III AND IV BUILDINGS AND OTHER STRUCTURES: 2015 IBC

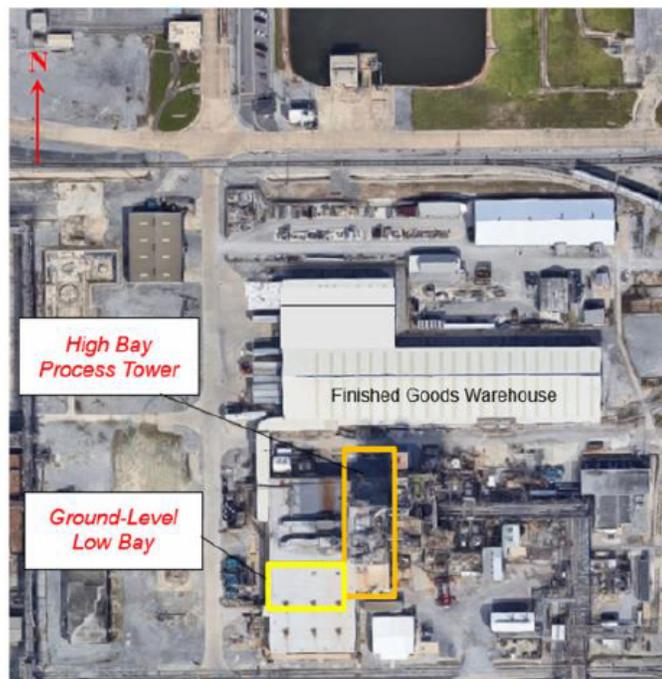
Figure 1: Plant 4 and Finished Goods Warehouse

The Plant 4 building is a five-story process tower with steel framing and a concrete floor. The building was originally designed and built in the late 1970s. The tower consisted of a high-bay tower and a single-story low-bay enclosed structure. The high-bay process tower was 110' tall with a footprint of 80' by 50'. The low-bay was approximately 20' tall with a 20' by 20' footprint.

Each level of the high-bay, including the ground floor, was provided with two manually operated fire hose stations. The low-bay was also provided with fire hose reels. As of 2020, neither Plant 4 nor the FGW were provided with automatic fire sprinklers.
