Factual Update

Published: October 30, 2019

U.S. Chemical Safety and Hazard Investigation Board

On Sunday, March 17, 2019, at approximately 10:00 am, a large fire erupted at the Intercontinental Terminals Company, LLC (ITC) bulk liquid storage terminal located in Deer Park, Texas (**Figure 1**). The fire originated in the vicinity of Tank 80-8, an 80,000-barrel aboveground atmospheric storage tank that held naphtha, a flammable liquid, typically used as a feedstock or blend stock for production of gasoline. ITC was unable to isolate or stop the release of naphtha product from the tank, and the fire continued to burn, intensify, and progressively involved additional tanks in the tank farm. The fire was extinguished on the morning of March 20, 2019.

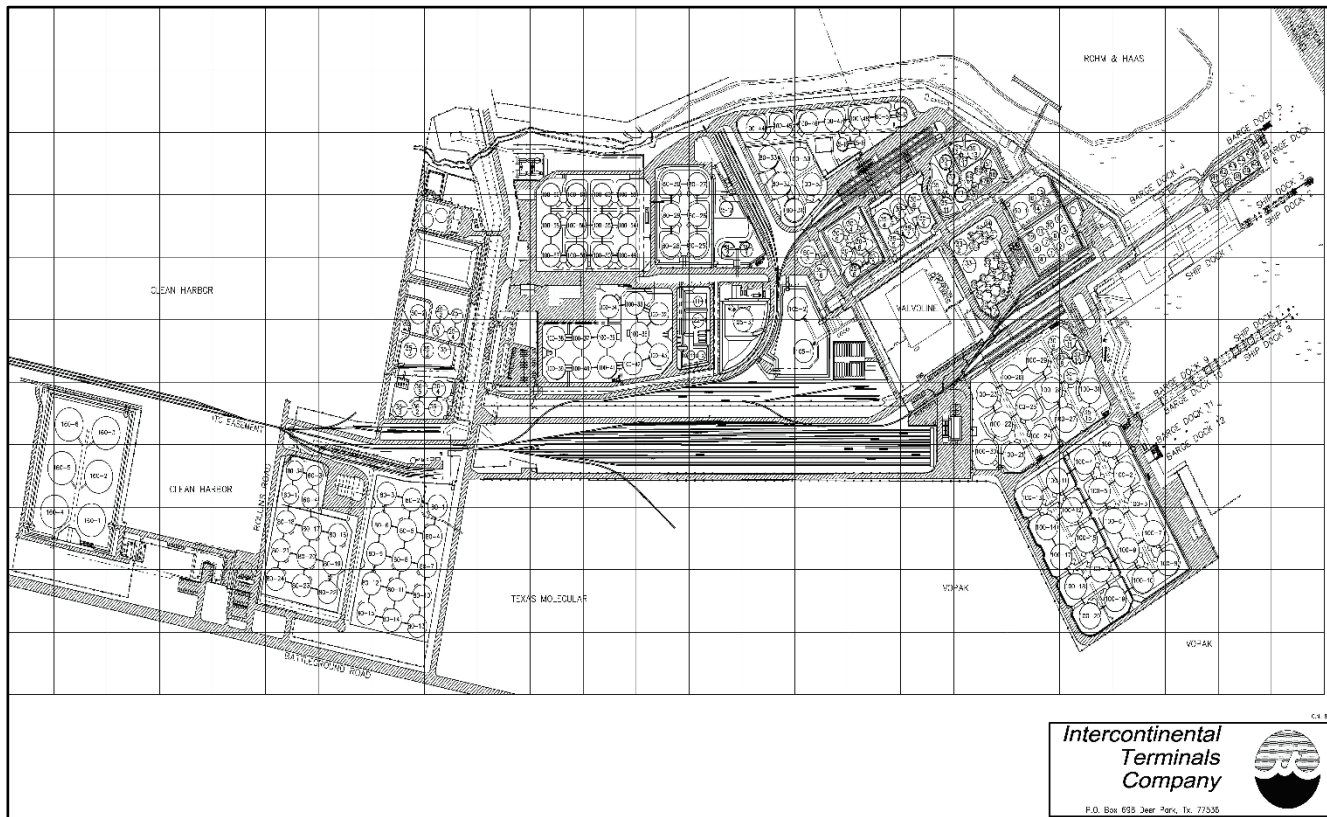
Figure 2. ITC Deer Park Terminal Overall Plot Plan. (Source: ITC).

The ITC Deer Park Terminal, where the incident occurred, is a bulk liquid storage terminal that has been servicing customers in and around Houston, Texas since 1972 (**Figure 2**) [1]. The terminal is equipped with both rail and truck access, five ship docks, ten barge docks, and multiple pipeline connections [1]. At the time of the incident the ITC Deer Park terminal contained 242 storage tanks, which equated to an overall capacity of 13.1 million barrels [1]. These storage tanks, which ranged in size from 8,000 to 160,000 barrels, were reportedly used to store petrochemical liquids and gases, fuel oil, bunker oil and distillates [1]. According to statistics provided on the company’s website, the ITC Deer Park Terminal handles approximately 770 ships, 3,700 barges, 12,000 rail tank cars, and 33,600 cargo tank trucks annually, with a total throughput of roughly 144-million barrels annually [1].
