U.S. CHEMICAL SAFETY AND HAZARD INVESTIGATION BOARD

# INVESTIGATION REPORT

## T2 LABORATORIES, INC.

## RUNAWAY REACTION

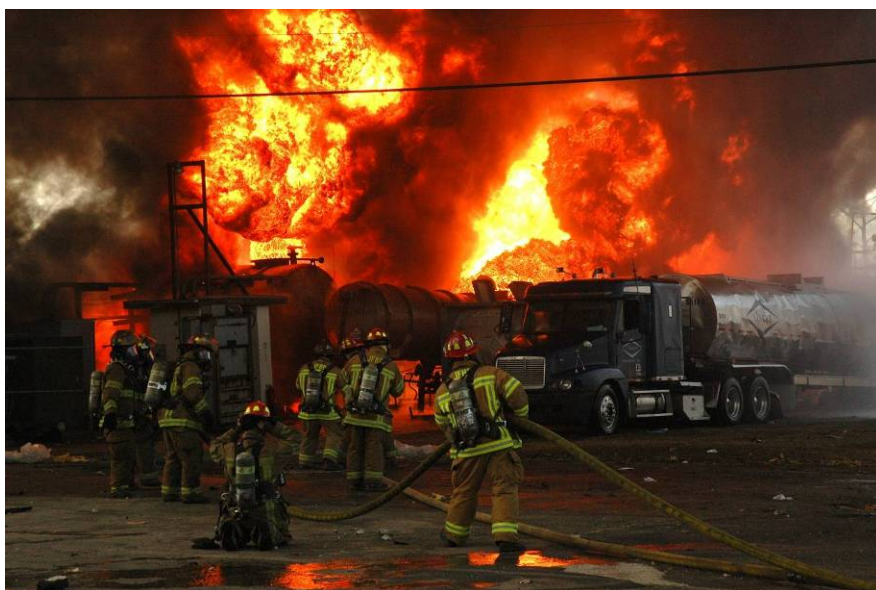
Photo JFRD

Figure 3. JFRD responders in SCBA battle fire.

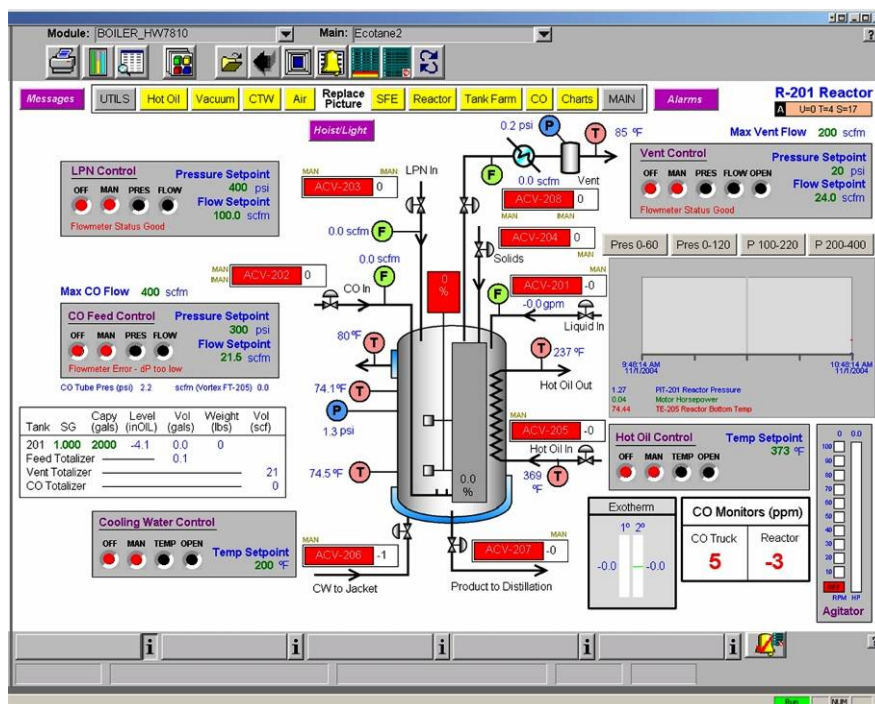
T2 screen capture

Each MCMT production step required the process operator to add raw materials and adjust heating, cooling, and pressure using a computerized process control system (Figure 9). On December 19, 2007, the incident occurred during the first (metalation) step of the reaction. The second and third steps of the reaction, which did not occur on December 19, 2007, were also conducted within the reactor. Appendix A discusses the complete reaction chemistry.

Figure 9. Process control system screen.

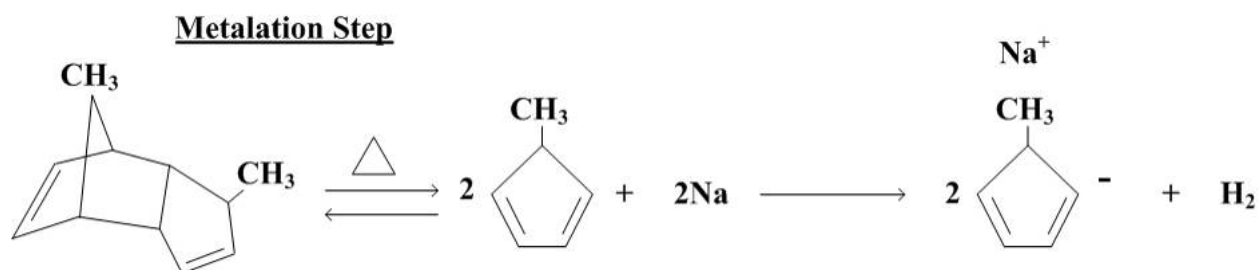
In the first step (called metalation), molten metallic sodium was reacted with methylcyclopentadiene (MCPD) in the presence of a diethylene glycol dimethyl ether (diglyme) to form sodium methylcyclopentadiene and hydrogen gas. This was accomplished by adding metallic sodium to a mixture of MCPD dimer<sup>37</sup> and diglyme, then heating the mixture. Heating melted the sodium and split the MCPD dimer molecules into two MCPD molecules that reacted with the sodium. T2 vented the hydrogen gas produced by this step to the atmosphere.

Figure 10. MCMT metalation reaction.

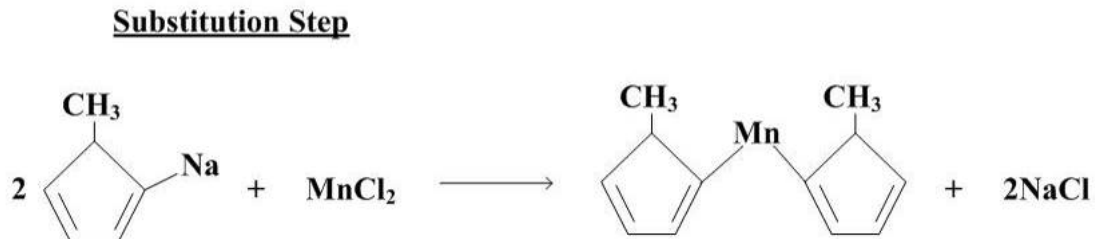
In the second step (called substitution), T2 added manganese chloride (dry powder) to the reactor. The manganese chloride reacted with the sodium methylcyclopentadiene in the reactor to form manganese dimethylcyclopentadiene and sodium chloride.

Figure 11. MCMT substitution reaction.

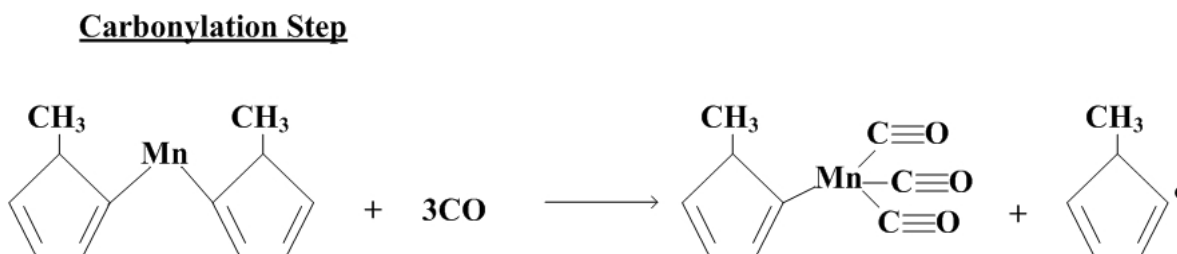
In the final step (called carbonylation), T2 added carbon monoxide gas to the bottom of the reactor, bubbling the gas through the manganese dimethylcyclopentadiene under pressure. In this step, one of the methylcyclopentadiene molecules on each manganese dimethylcyclopentadiene molecule was replaced with three carbon monoxide molecules, forming the MCMT.

Figure 12. MCMT carbonylation reaction.

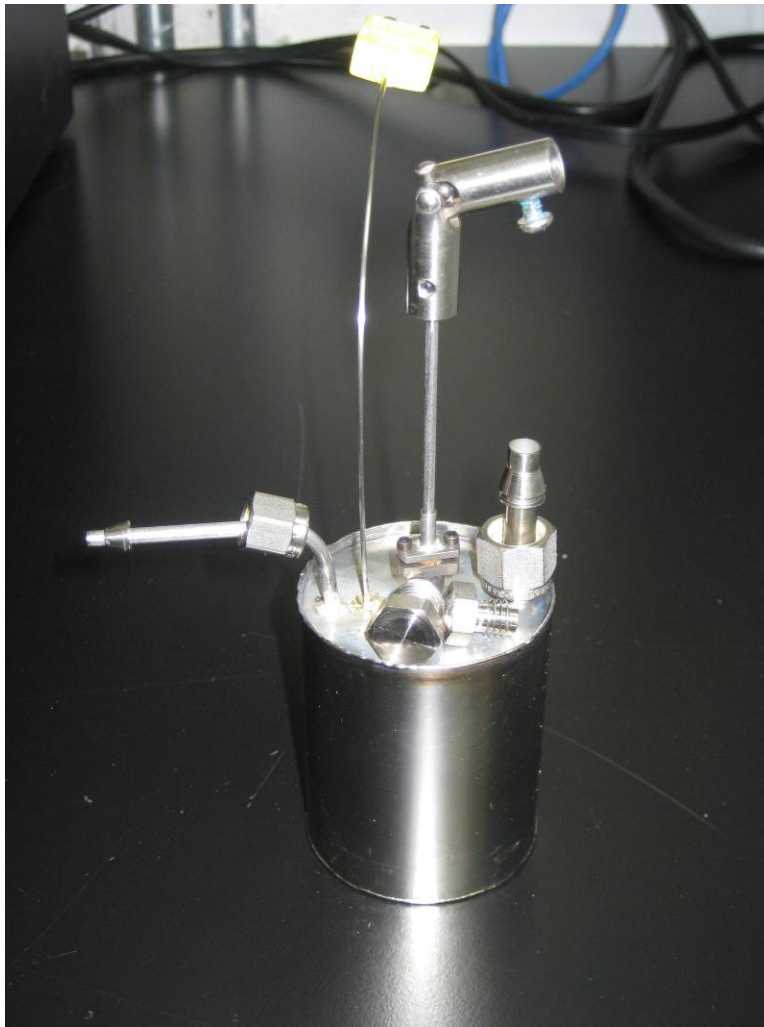
Figure 15. New VSP2 Test Cell.

The VSP2 mimics the T2 facility's physical arrangement more closely and can accommodate more intense stirring to improve mixing of the chemical components. The VSP2 also incorporates baffles in the test cell which provide turbulence and shear in the liquid. These features reduced the molten sodium droplet size and increased contact between the molten sodium and the MCPD, similar to the mixer in the T2 reactor.

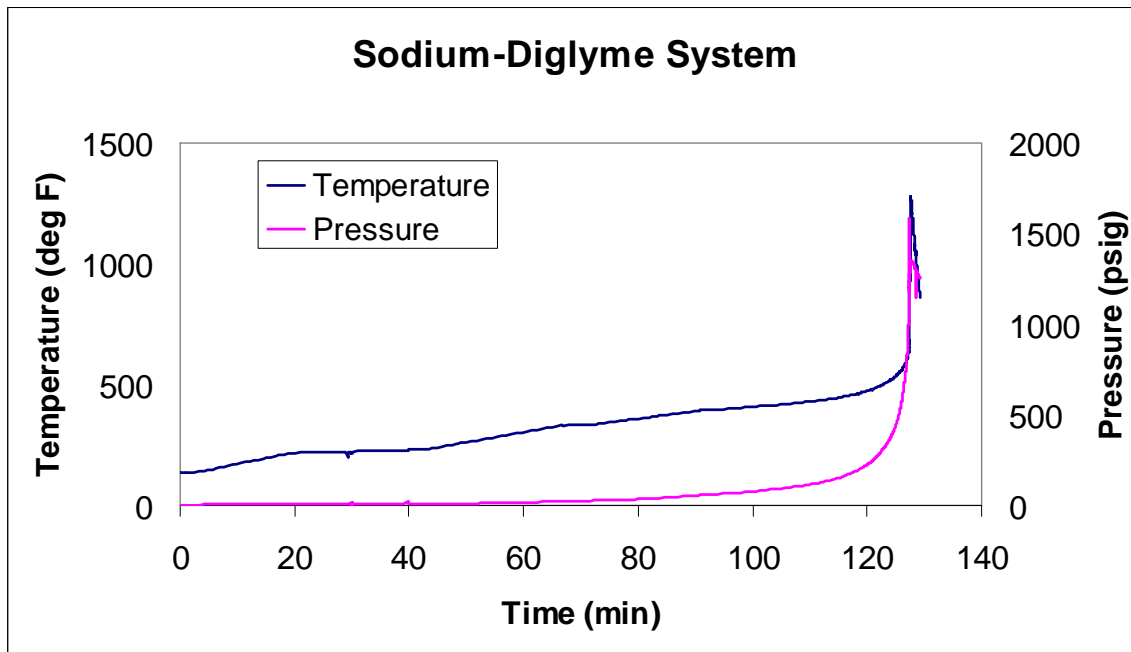
Figure 17. Sodium Diglyme Test Results.
