FINAL INVESTIGATION REPORT

CARIBBEAN PETROLEUM TANK TERMINAL EXPLOSION AND MULTIPLE TANK FIRES

CARIBBEAN PETROLEUM CORPORATION (CAPECO)

OCTOBER 23, 2009

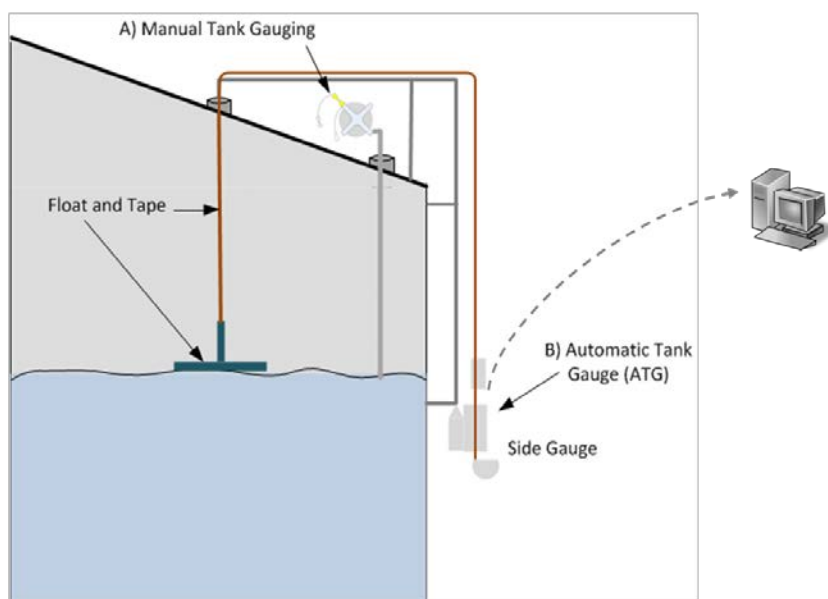
Figure 3: Manual and Automatic Tank Gauging. (A) Manual Gauging requires an operator to use a tape and measure to determine the liquid levels inside the tank. (B) Automatic Tank Gauging (ATG) requires an operator to read a level measurement from a tank gauge mounted to the side of the tank.

Prior to the start and end of filling operations, the independent inspector manually measured the fuel tank levels by lowering a gauging tape¹² into the tank. (Figure 3.) A CAPECO operator verified the measurements by comparing the tank liquid level to the strapping table¹³ for that tank. The independent inspector and the operator placed car seals on various block valves of receiving tanks to prevent flow into or out of the tank before measuring the level in the tank and

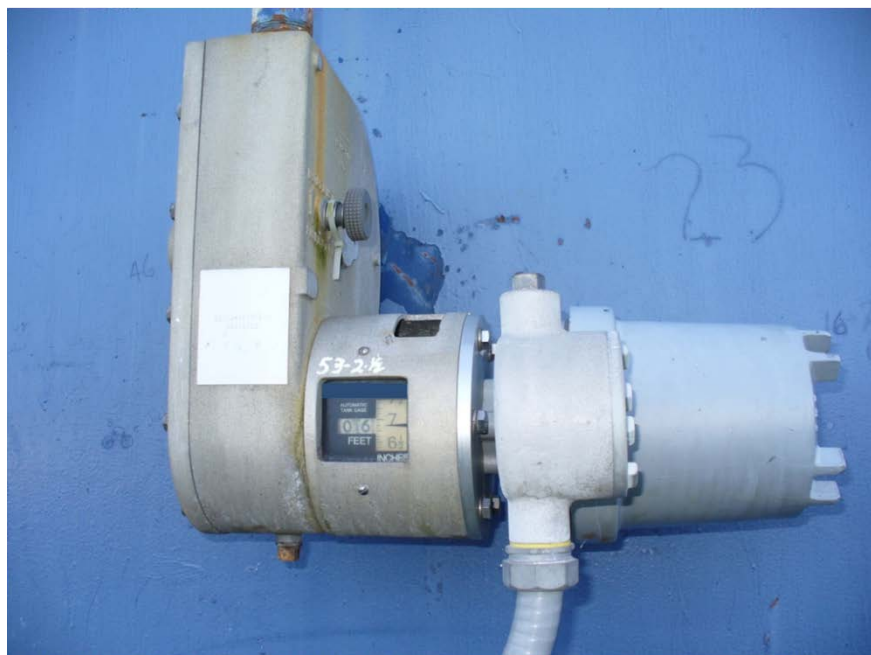
A typical float and tape gauge consists of depth-indicating dials, a motor, a long metal tape, and a sealed hollow cylinder called a float, which floats on the surface of the liquid in the tank. One end of the long metal tape attaches to the float, while at the other end, a motor winds the tape into a coil to maintain constant tension on the tape. As the liquid level in the tank falls, the weight of the float pulls the tape, and the motor allows the tape to extend farther into the tank. As the liquid level in the tank rises, the motor senses looseness in the tape and winds the tape into a coil to maintain the required tension. As the tape winds and unwinds, the mechanical dial rotates to indicate the total depth of liquid in the tank and displays the value on the side gauge (Figure 4).¹⁷ Section 6.5 analyzes the failure of the ATG system in the incident.

Figure 4: Side gauge: mounted on the side on a tank and displaying the amount of liquid in the tank

The CSB found that CAPECO purchased the least effective level-measurement system and employed an inadequate maintenance program to care for that system. These shortfalls in safety critical equipment in the level control and monitoring system, including the transmitters on the side gauge and the float and tape device in the tank, prevented operators from determining tank levels during filling operations. Figure 10 illustrates the issues with the level control system at CAPECO.

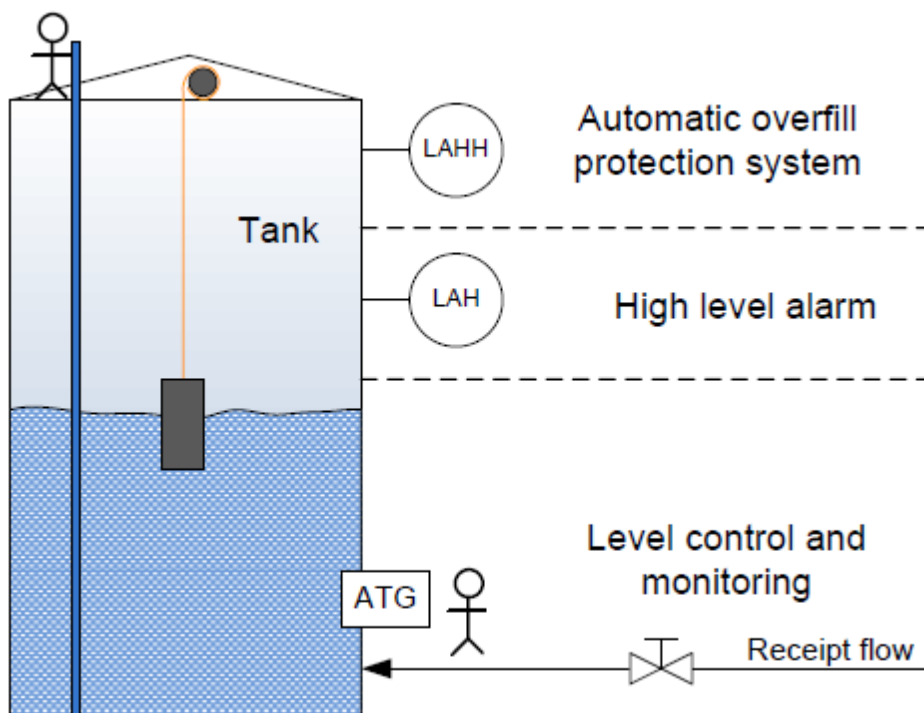
Figure 13: A comprehensive overfill prevention system includes the ATG, high level alarm (LAH), and automatic overfill prevention system (LAHH), in addition to the operator and facility procedures that govern, monitor, and control the flow of fuel into a tank.

CAPECO lacked a reliable automatic level control and monitoring system for measuring tank levels. (See Figure 12 and Figure 13.) The automatic gauging system at CAPECO, described in Section 3.6.3, had a history of repeated failures and prolonged out-of-service periods. On the night of the incident, the float and tape device inside Tank 504 became stuck and the transmitters for Tanks 107 and 409 were not receiving data from the side gauge on Tank 409; therefore, data on the tank liquid level and a calculated fill rate into 409 were not available in real time on the

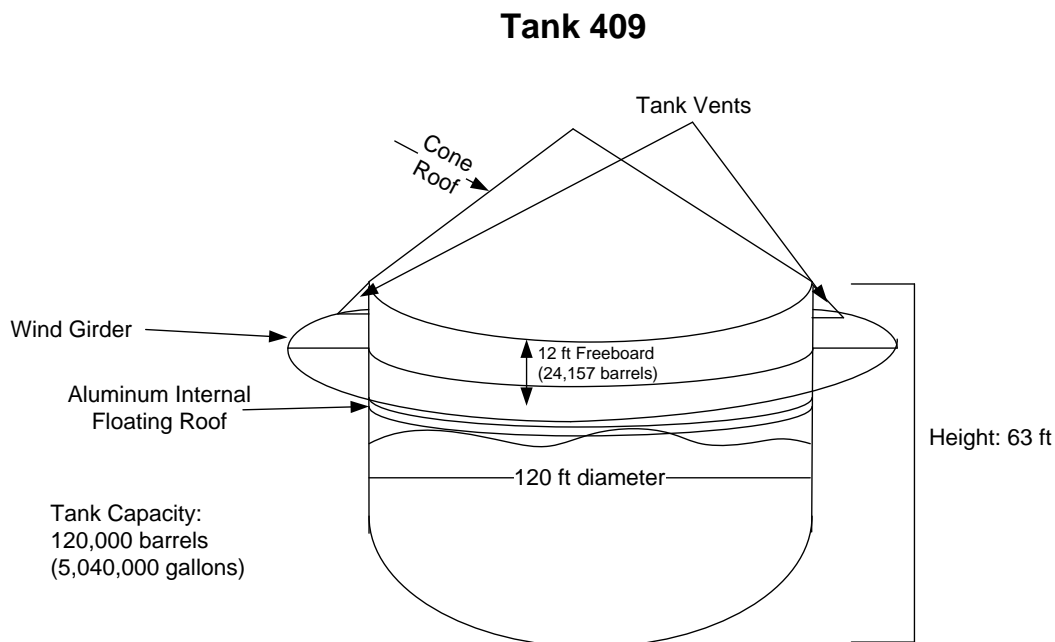
Figure 14: Tank 409 Specifications

Tanks 409 and 410 were located within the same secondary containment dike.²² Similar to the Buncefield incident,²³ during the overflow, gasoline sprayed from the tank vents, hitting the Tank 409 wind girder and aerosolized,²⁴ forming a vapor cloud.²⁵ A CSB topographic survey of the site shows that Tanks 409 and 411 were located at the highest point within the tank farm area, allowing the vapor cloud to spread to lower lying areas in the direction of the WWT (Figure 7). See Figure 14, Tank 409 Specifications.

floating roof (IFR), and a freeboard⁷¹ of 12 feet (24,157 bbls). (See Figure 14 for Tank 409 specifications.) Aluminum IFRs are prone to corrosion when exposed to caustic liquids but sufficient for petroleum and organic materials. An internal floating roof can fail by means of turbulence,⁷² roof submersion,⁷³ seal issues, and fatigue.⁷⁴
