U.S. CHEMICAL SAFETY AND HAZARD INVESTIGATION BOARD

## CHLORINE RELEASE

**DPC ENTERPRISES, L.P.**

REPORT NO. 2004-02-I-AZ

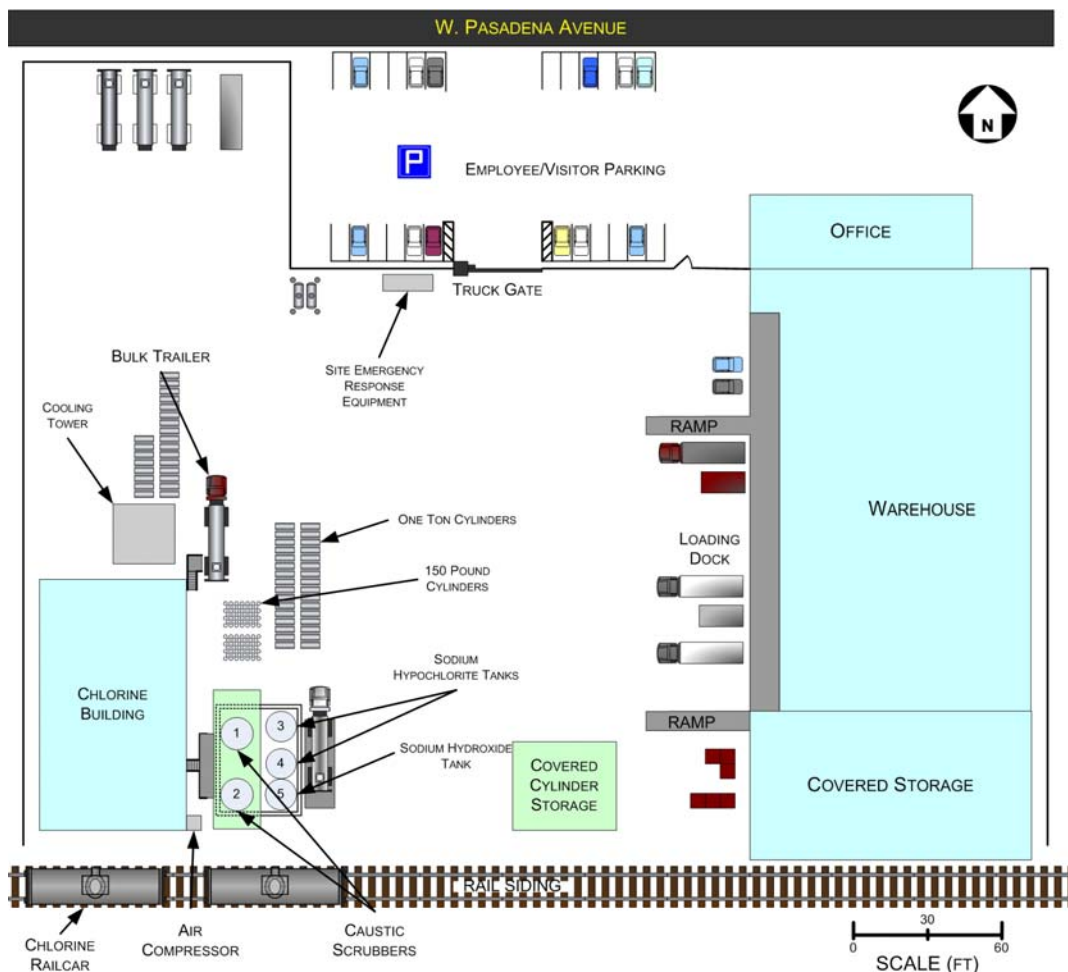
Figure 2. DPC-Glendale plot plan

At the site, DPC receives liquid chlorine in railcars and repackages it into smaller containers to distribute to local customers, and also manufactures sodium hypochlorite (or bleach). Figure 2 is a plot plan of the site, and shows the location of the major equipment involved in the November 17, 2003, incident. The caustic scrubbers used to control chlorine emissions are located in the southwest section, adjacent to the chlorine railcar unloading and bulk road trailer loading area. The chlorine building contains cylinder loading and bleach manufacturing facilities.
