| BETA LAB No.M10198, TESORO LS2 AND LS2/CS2 TEE FINDINGS | TESORO REFINING AND MARKETING COMPANY ANACORTES REFINERY 10200 W. MARCH POINT ROAD T91WA4428 ANACORTES, WA 98221 | CUSTOMER P.O. No.: 4501667904 |
| PART: 6600-E HEAT EXCHANGER, LS2 22 IN, 36.5 IN MOUNTS, LS2 T2L SEM FRACTOGRAPHY AND PART 22 LS2-CS2 TEE FINDINGS PARTS 16-1 AND 22 | | DATE: OCTOBER 13, 2010 |

LABORATORY REPORT

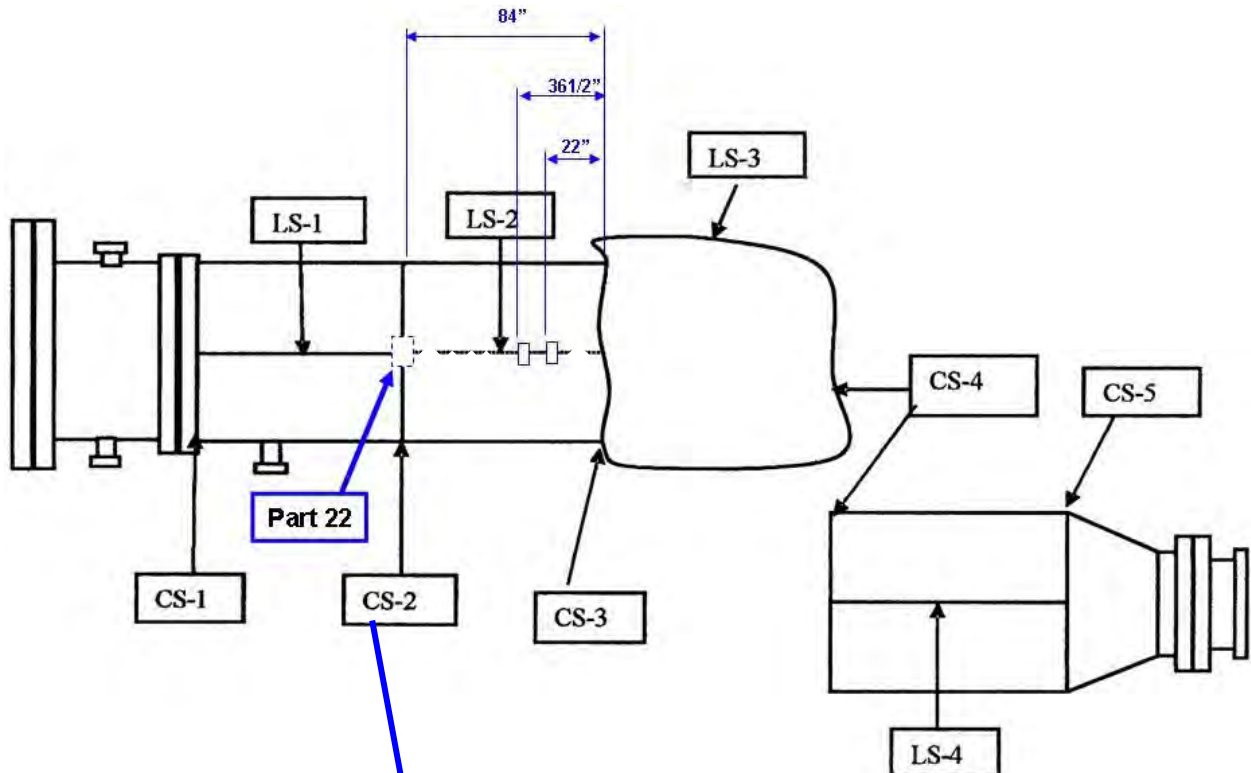
Sketch of main heat exchanger Cans 1-3 and separated back head can 4. Marked samples at 22", 36 1/2", and Part 22 from which two samples were cut (see Figures 22 and 23)

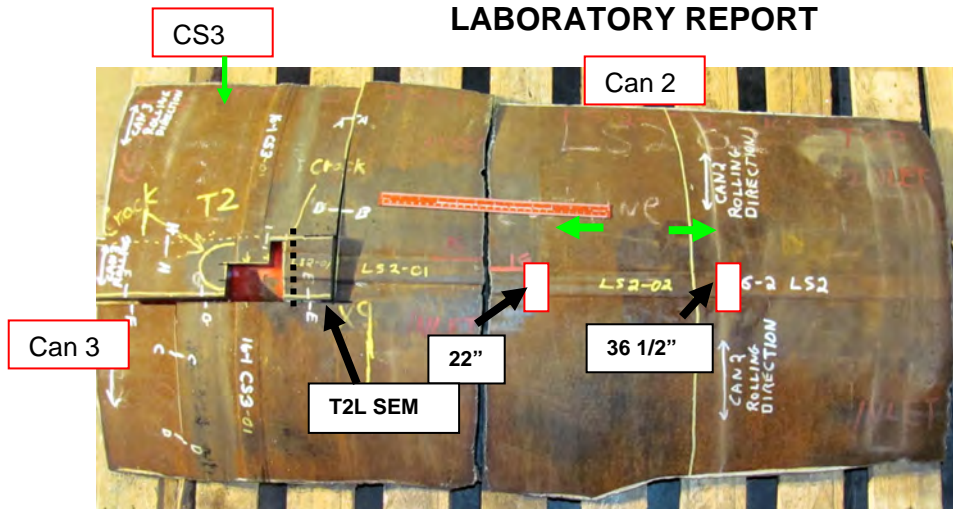
Part 16-1 with locations for the 22 inch, 36.5 inch mounts, and the part
the T2L SEM was cut out (black dotted line).

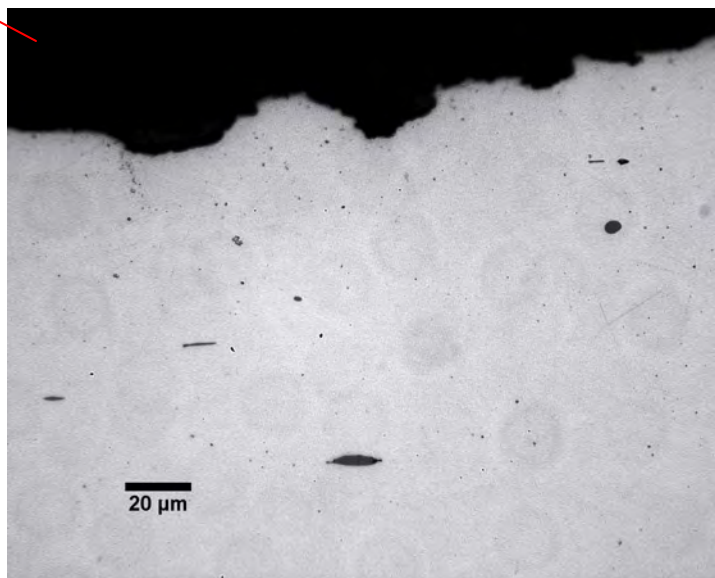
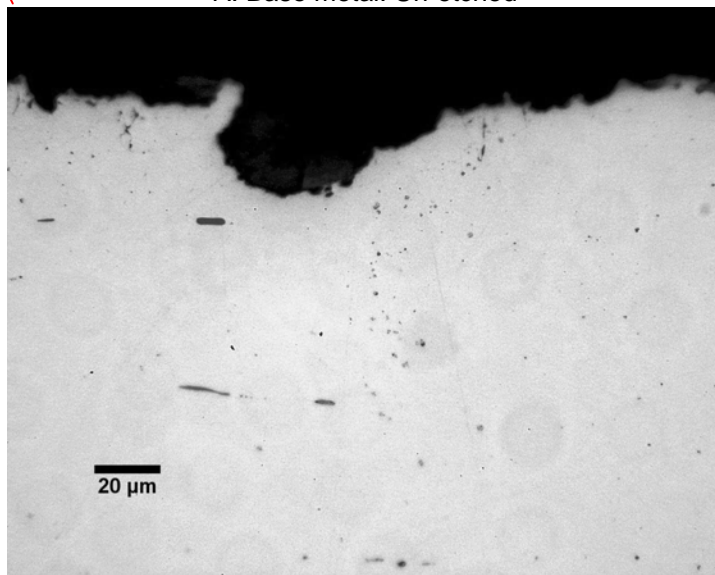
Figure 5

A. Base metal. Un-etched

B. Base metal. Un-etched

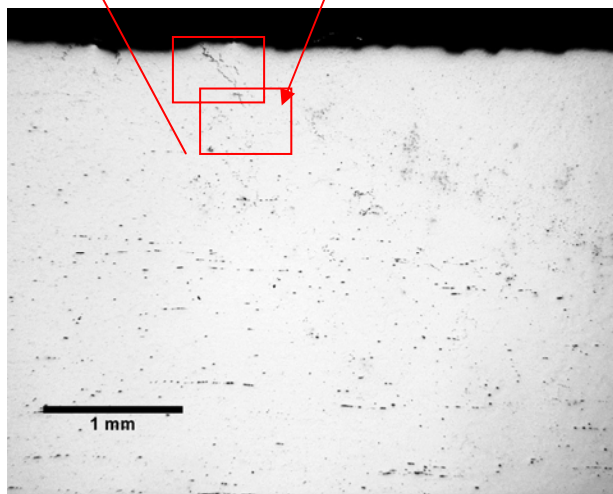
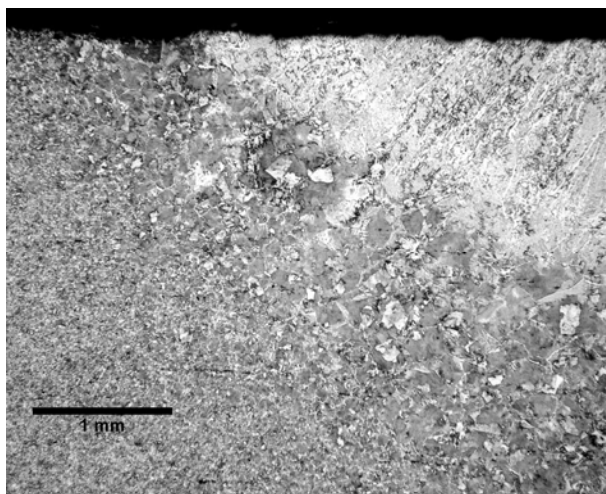
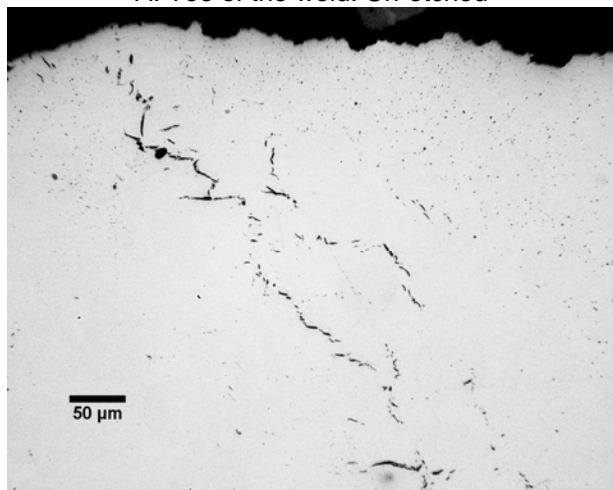
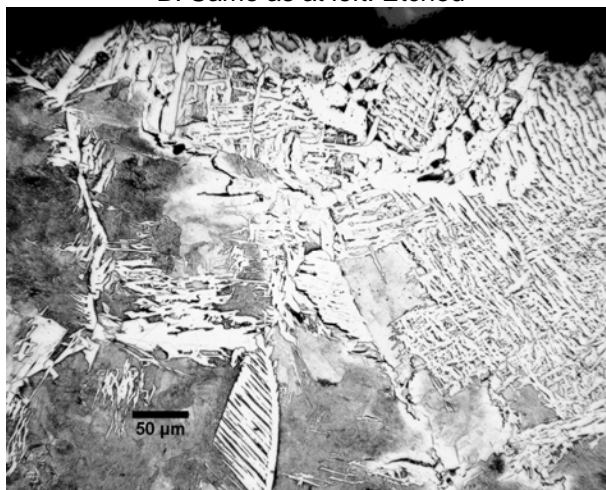
Figure 6

A. Toe of the weld. Un-etched

B. Same as at left. Etched

C. Enlarged area from [A] above. Un-etched

D. Same as at left. Etched

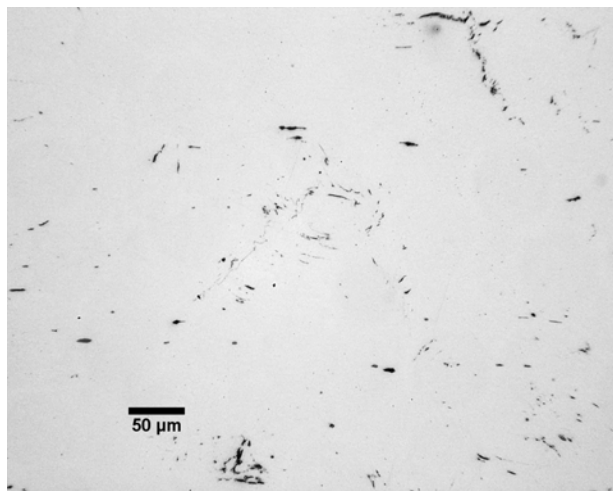
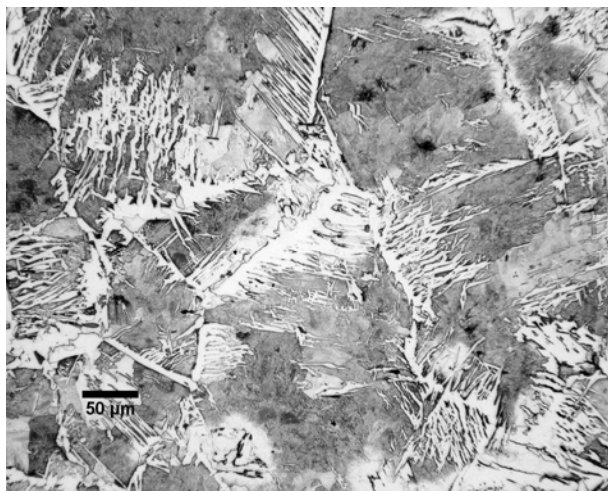
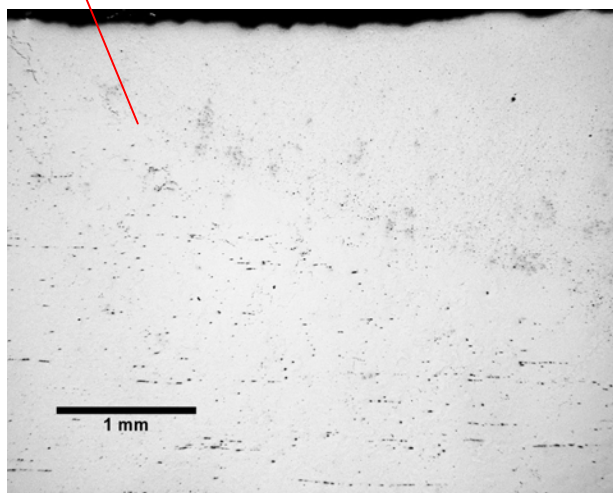
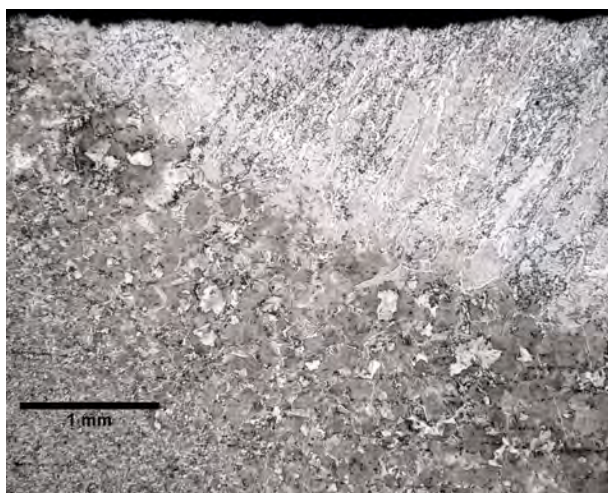
Figure 7

A. Area from Fig. 6A. Un-etched

B. Same as at left. Etched

C. Area at the weld toe. Un-etched

D. Same as at left. Etched

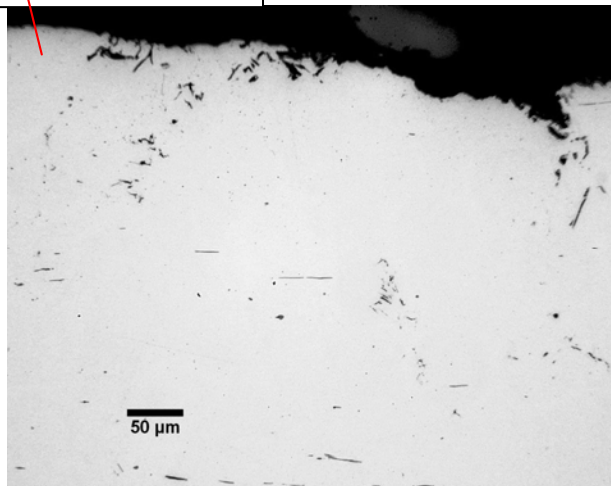
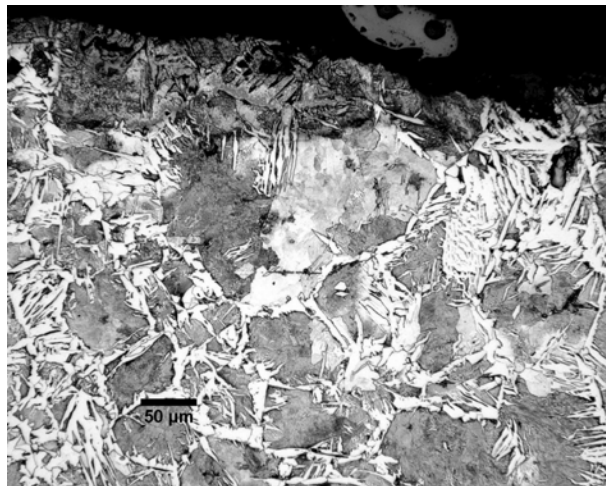
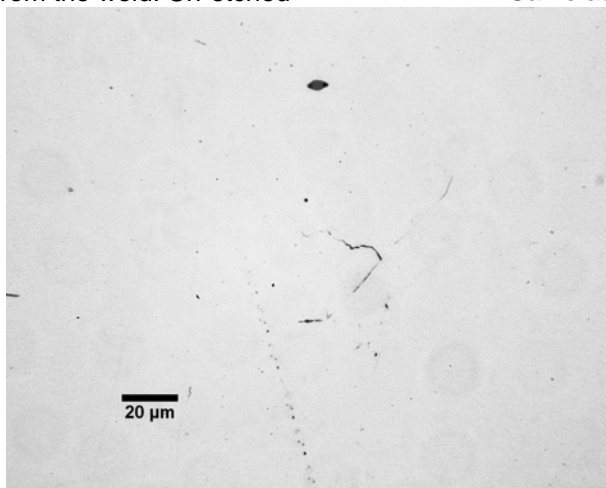
Figure 8

A. Area at the toe farther from the weld. Un-etched

B. Same as at left. Etched

C. Area at the toe farther from the weld one field down from the ID. Un-etched

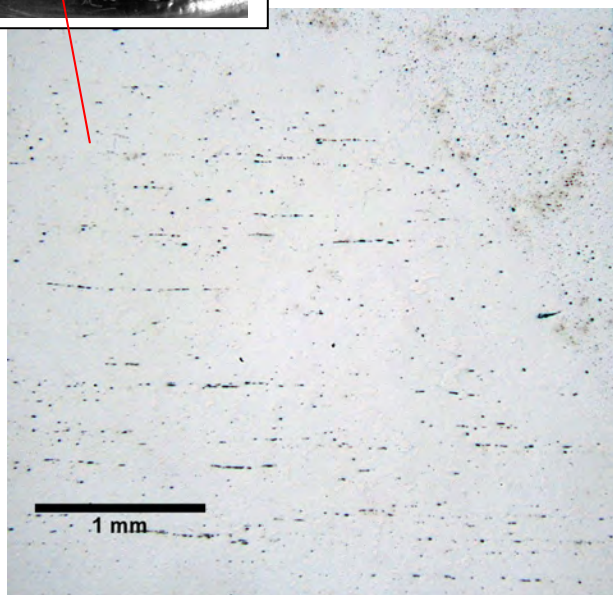
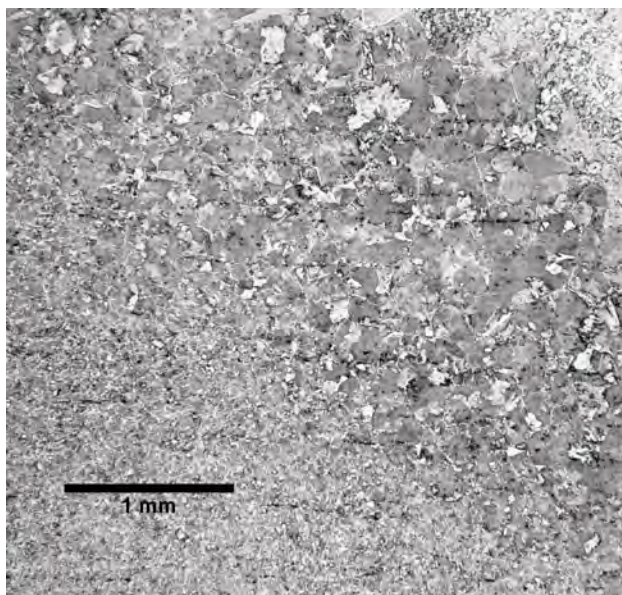
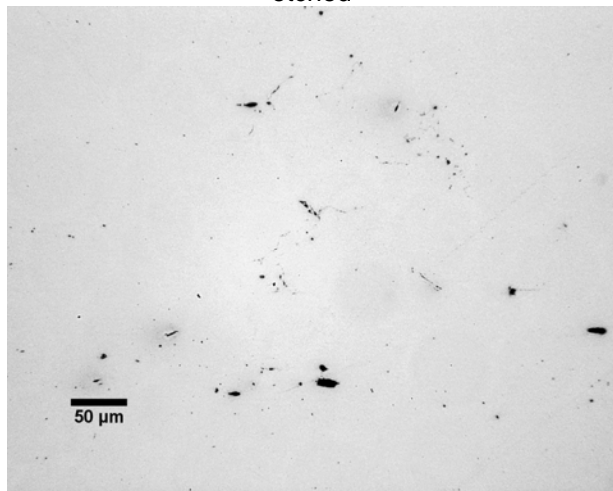
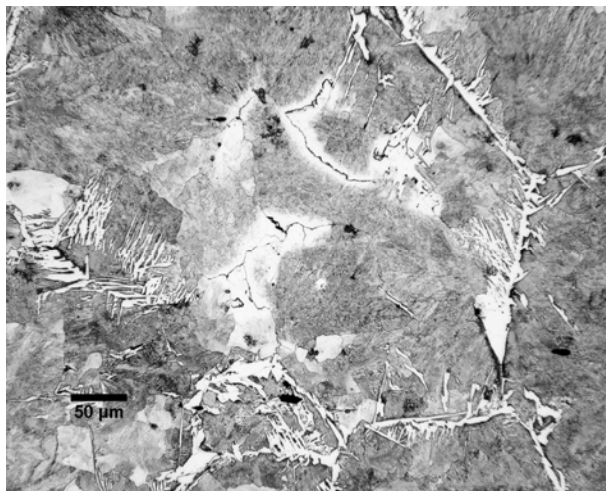
Figure 9

A. Area along the fusion line down from the ID. Un-etched

B. Same as at left. Etched

C. Enlarged area from the [A] above. Un-etched

D. Same as at left. Etched

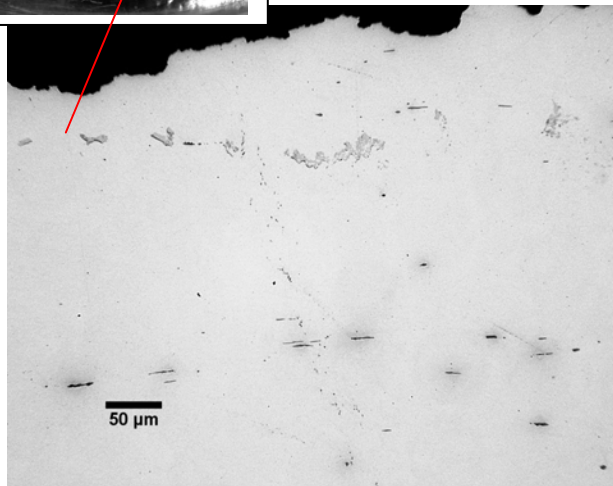
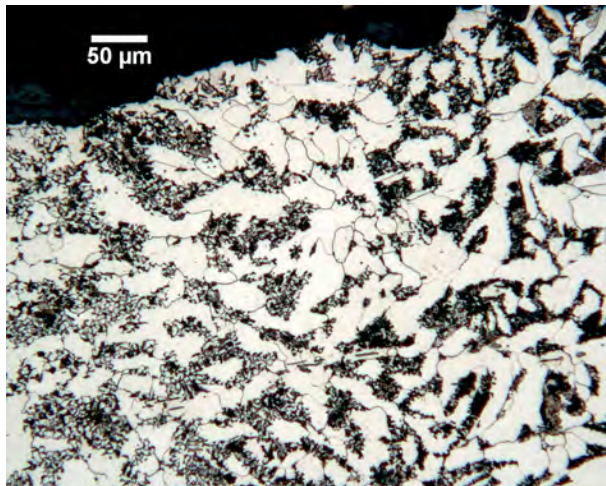
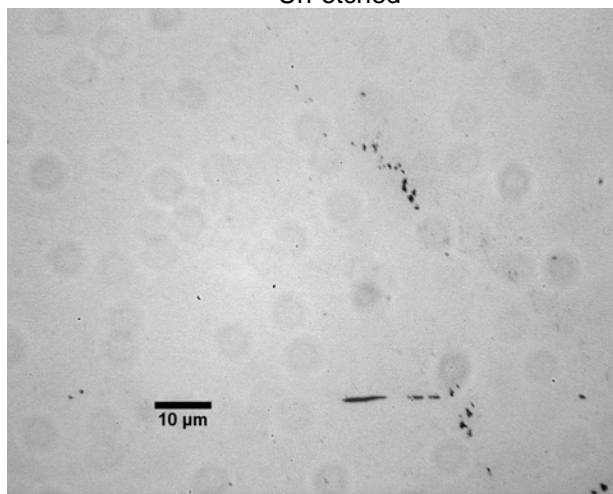
Figure 10

A. HAZ - Base metal, right of the weld near the ID.

B. Same as at left. Etched

C. Enlarged area of the base metal from the [A] above. Un-etched

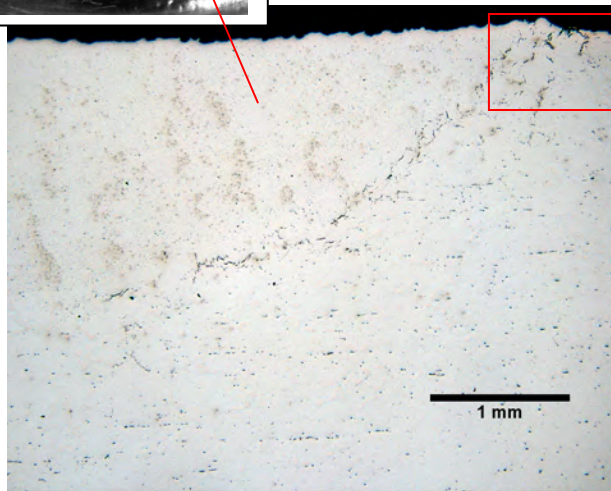
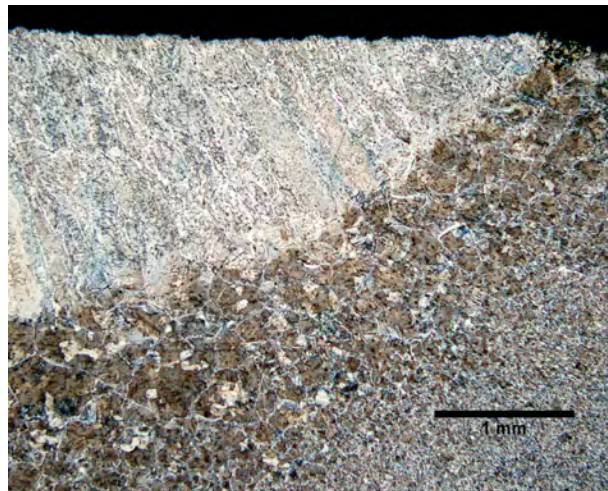
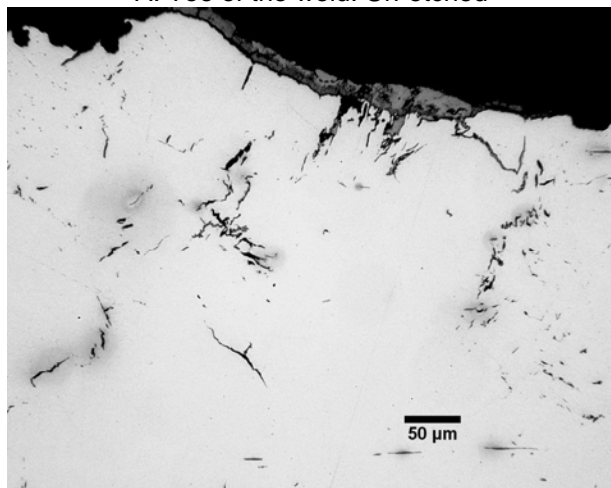
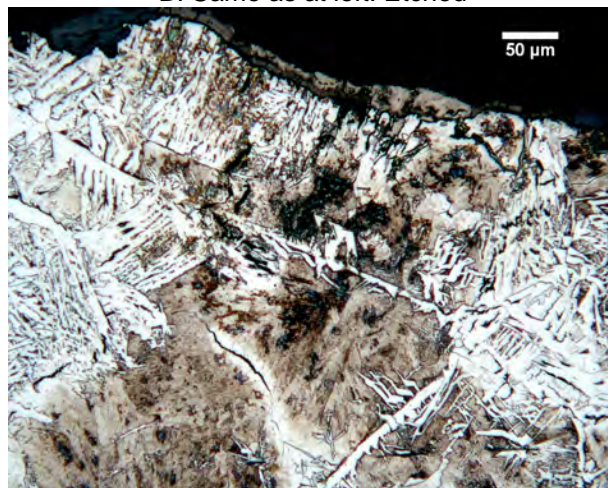
Figure 11

A. Toe of the weld. Un-etched

B. Same as at left. Etched

C. Enlarged area marked in [A] above Un-etched

D. Same as at left. Etched

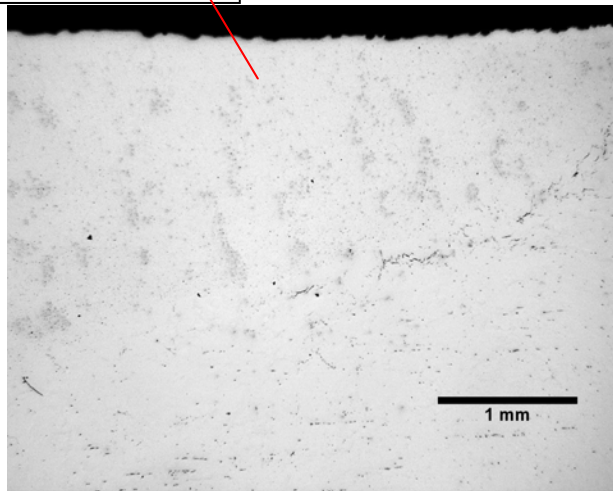
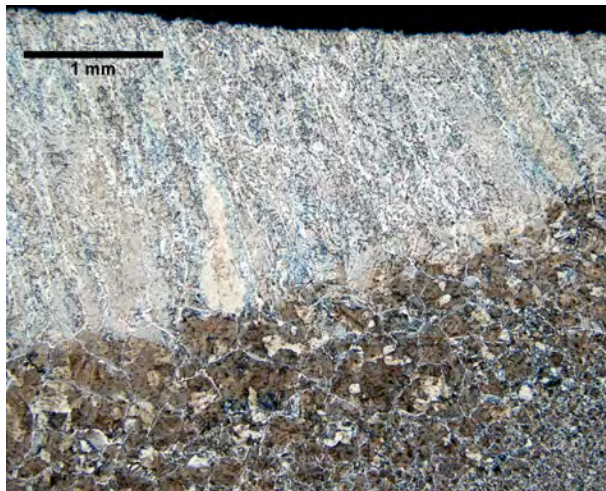
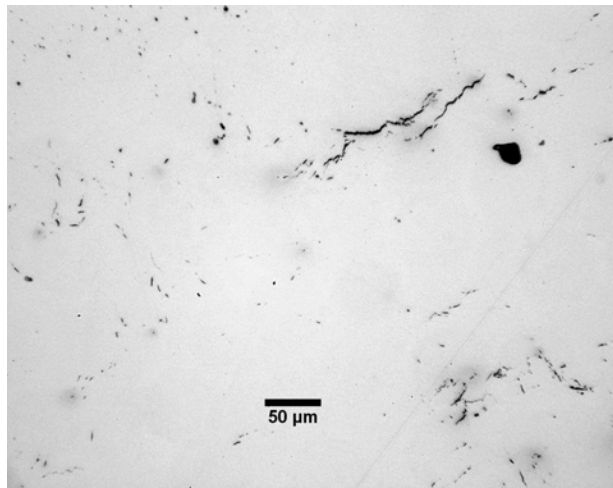
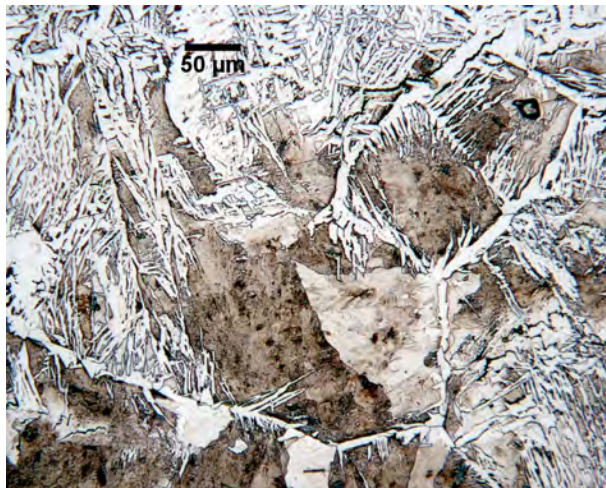
Figure 12

A. Area at the toe toward the weld. Un-etched

B. Same as at left. Etched

C. Enlarged area at the fusion line. Un-etched

D. Same as at left. Etched

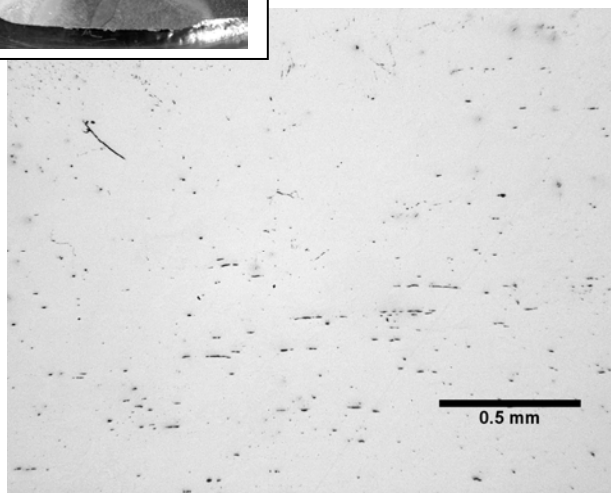
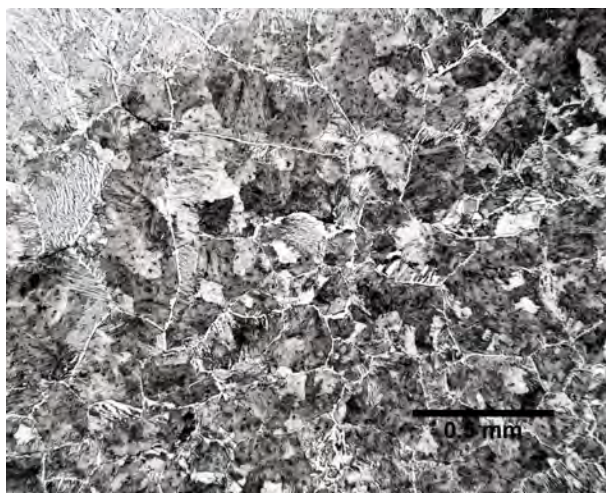
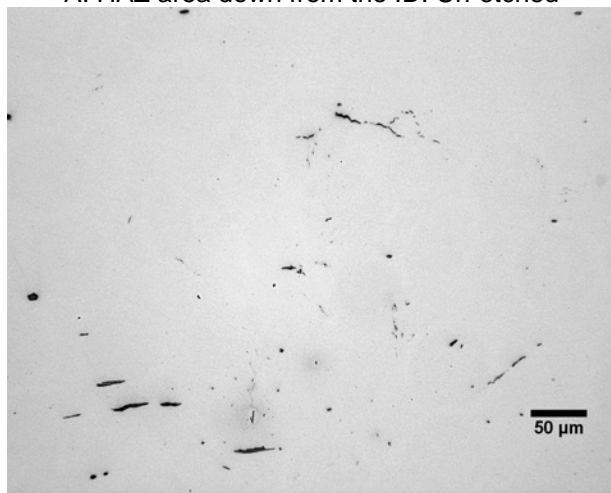
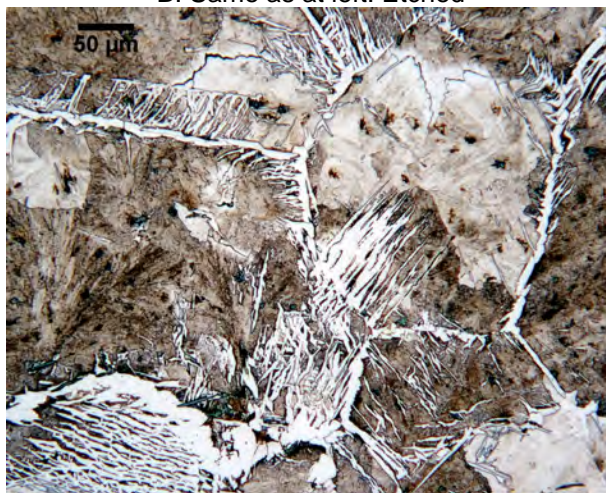
Figure 13

A. HAZ area down from the ID. Un-etched

B. Same as at left. Etched

C. Enlarged area from [A] above. Un-etched

D. Same as at left. Etched

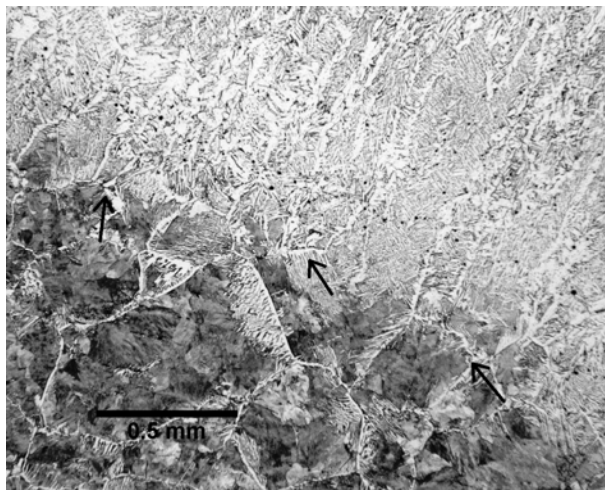
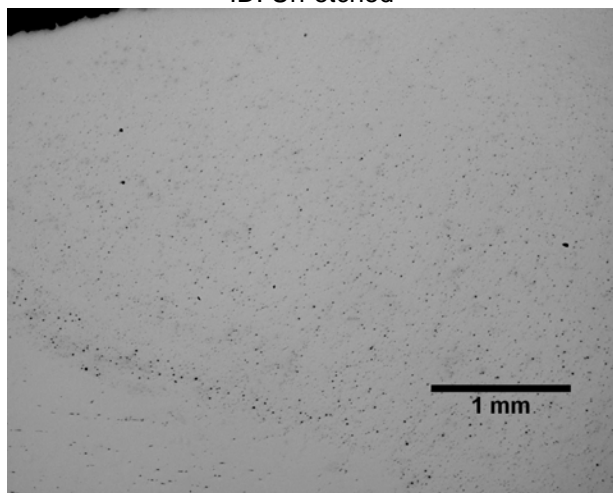
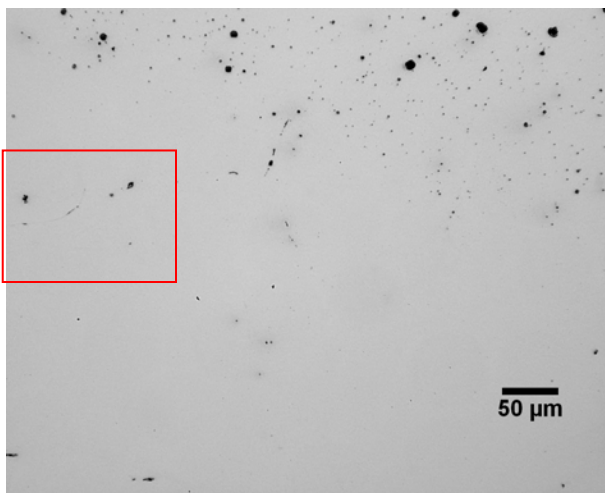
Figure 14

A. HAZ-Weld metal interface 3.28 mm down from ID. Un-etched

B. Same as at left. Etched

C. Same 3.28 mm level, different area. Un-etched

D. Same area as at left, enlarged. See marked area on Figure 15A below. Un-etched

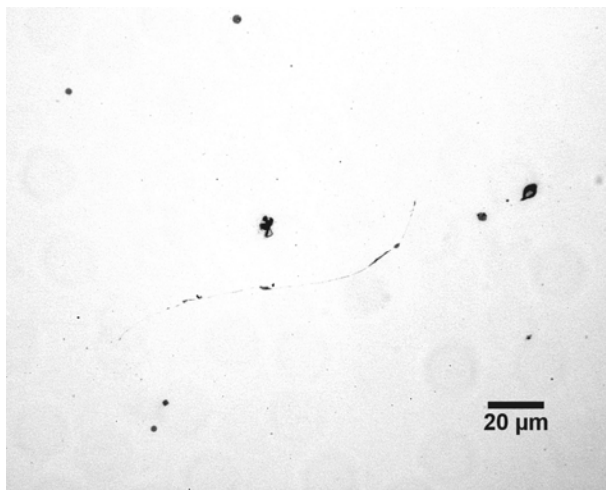
Figure 15

A. Enlarged area from Figure 14D above. Un-etched

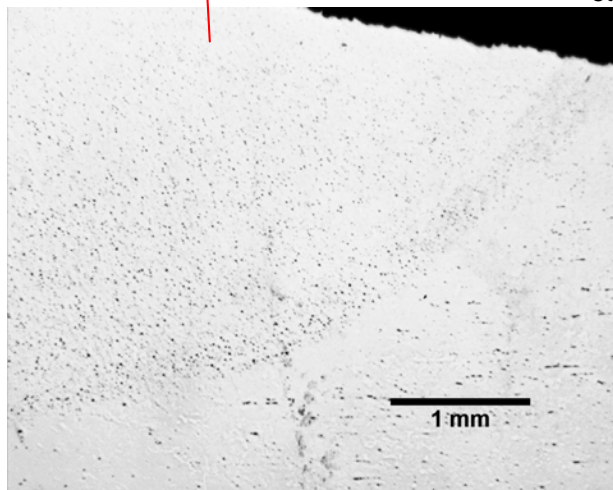
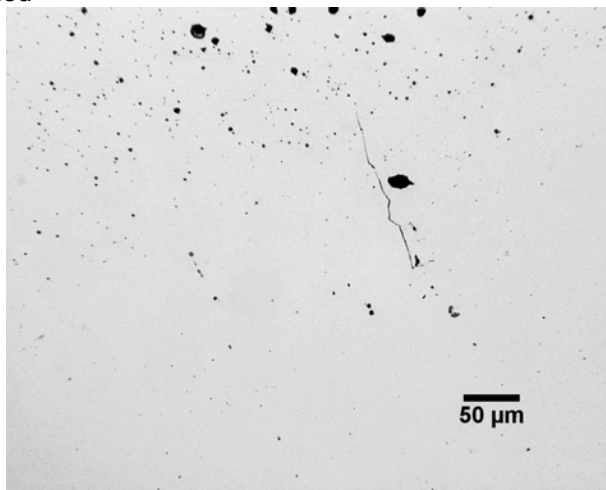
B. Weld metal-HAZ at ID. Un-etched

C. Same as at left, enlarged. Un-etched

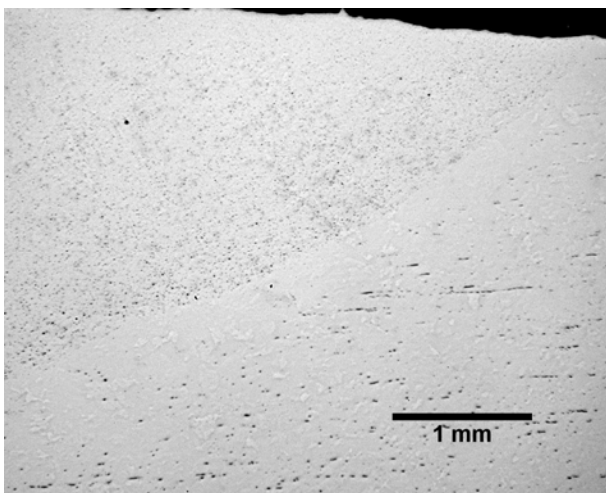
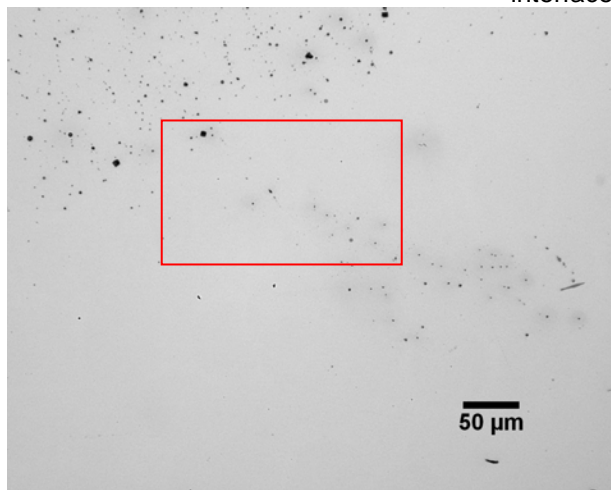
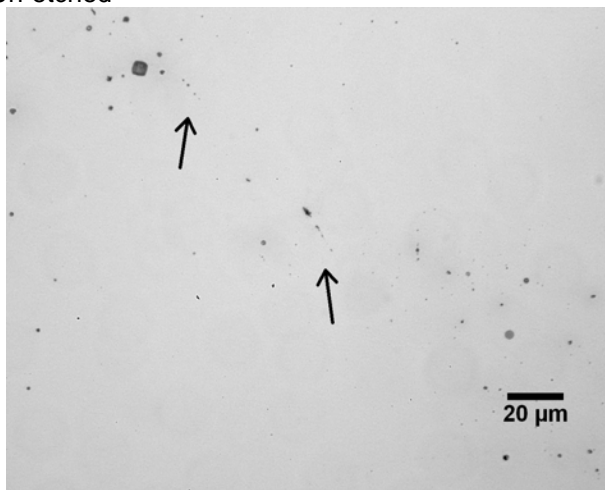
Figure 16

LS2 36 1/2" SAMPLE

A. Area 1.97 mm down from ID at the Weld-HAZ interface. Un-etched

B. Same as in [A] above, enlarged. Un-etched

C. Enlarged area marked on [B] at left. Un-etched

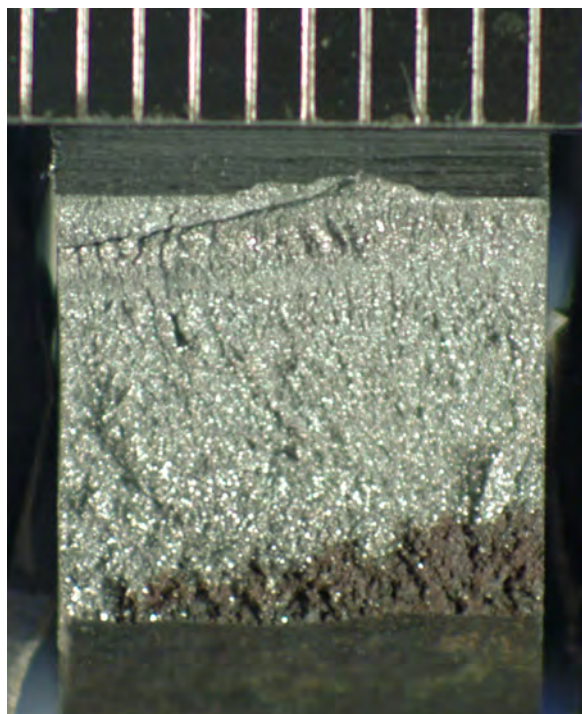
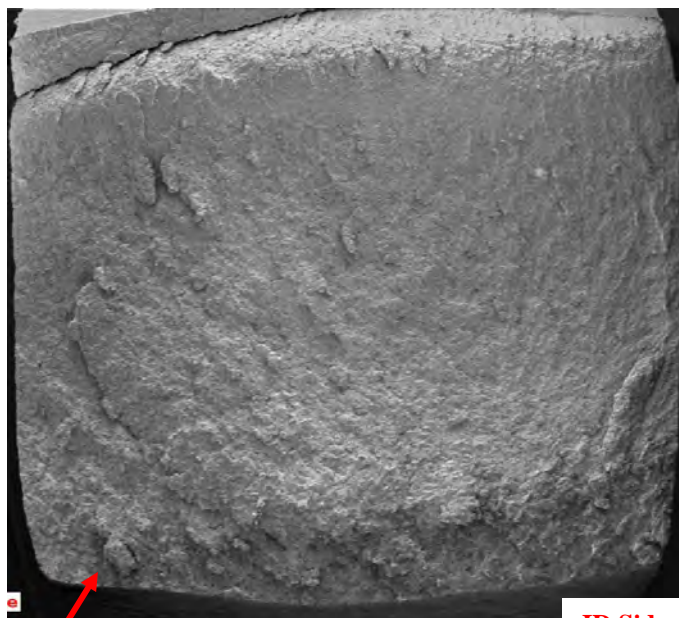
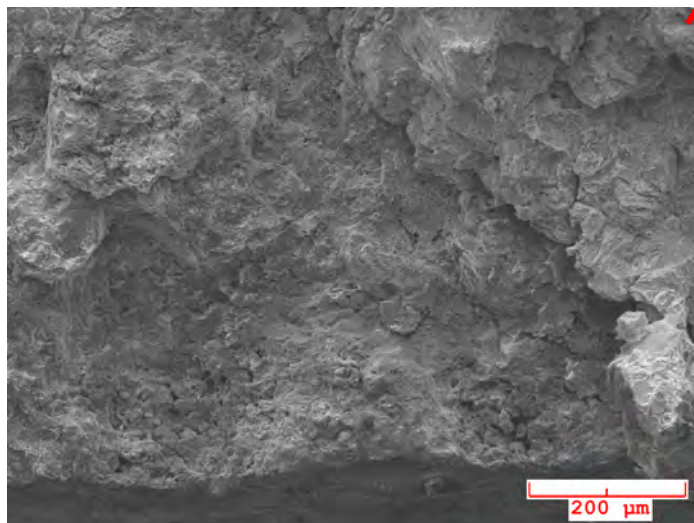
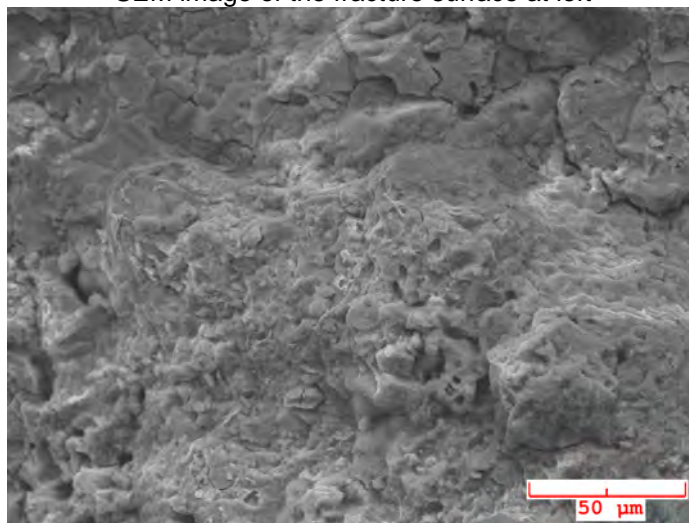
Figure 19

T2L SEM Fracture surface

SEM image of the fracture surface at left

SEM fracture at ID

Same as at left at higher magnification

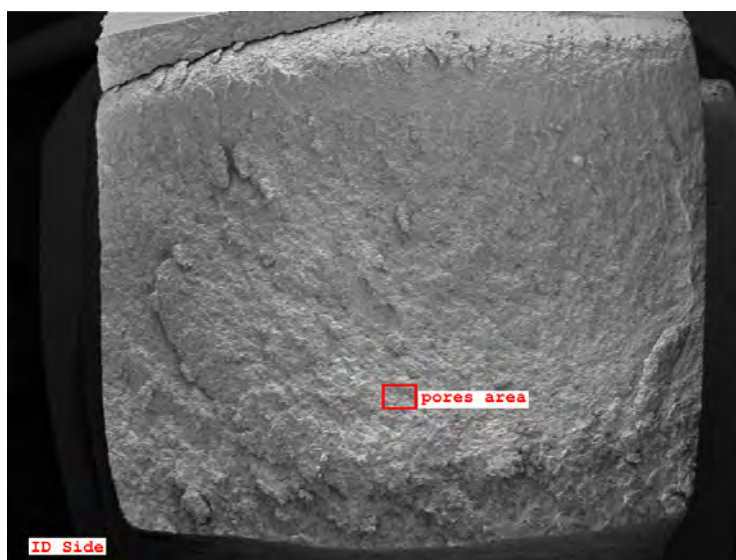
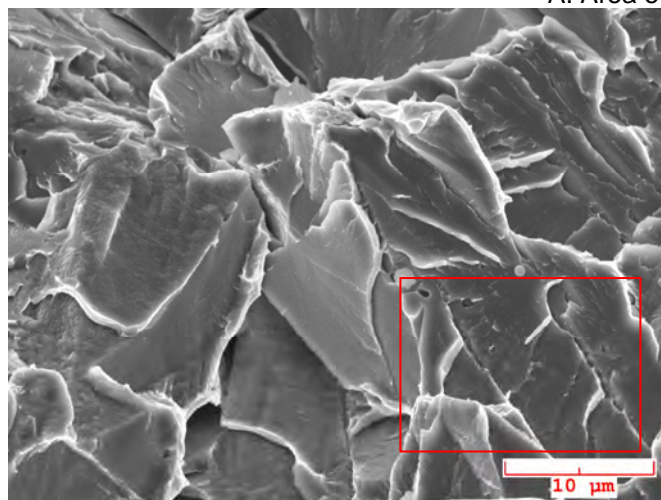
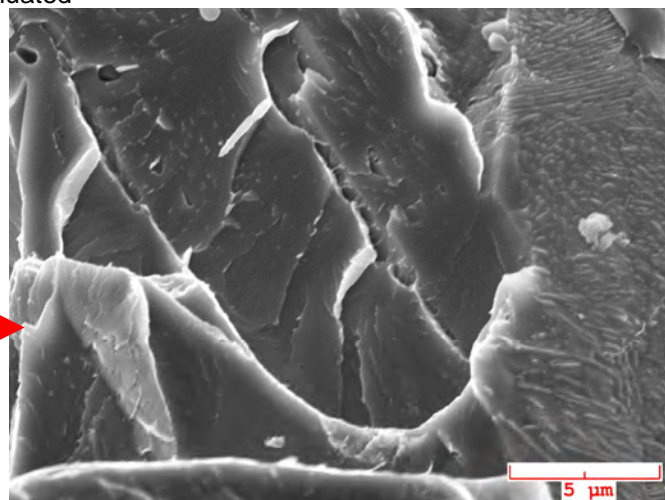
Figure 21

A. Area evaluated

B. Area marked in [A] at higher magnification

C. The same area as at left at higher magnification

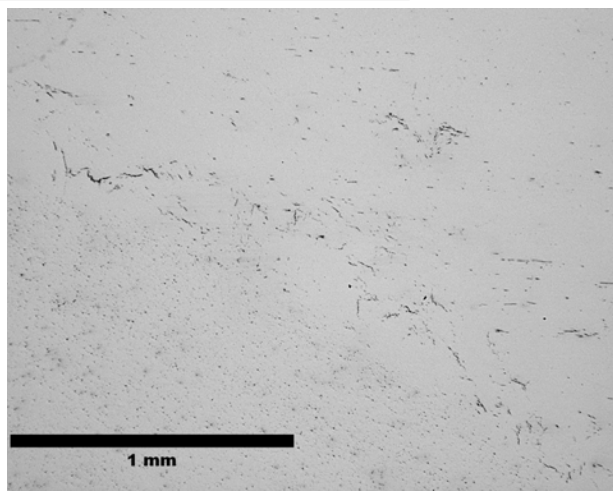
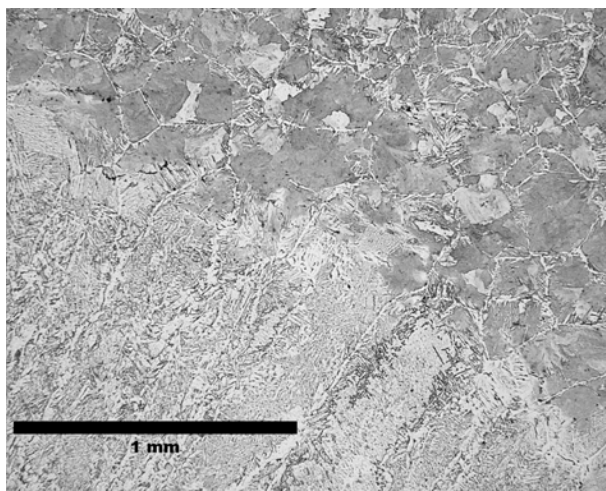
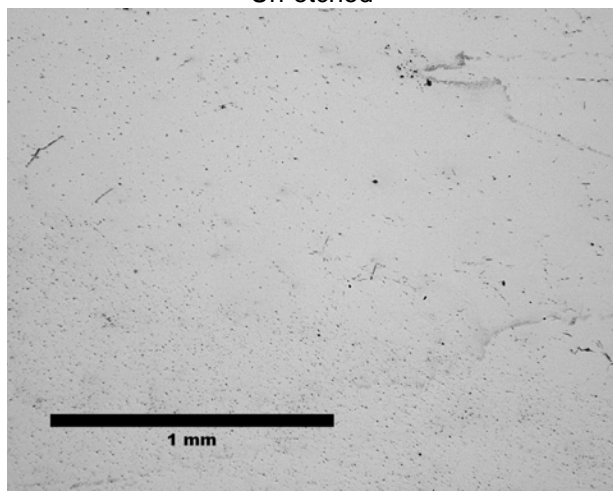
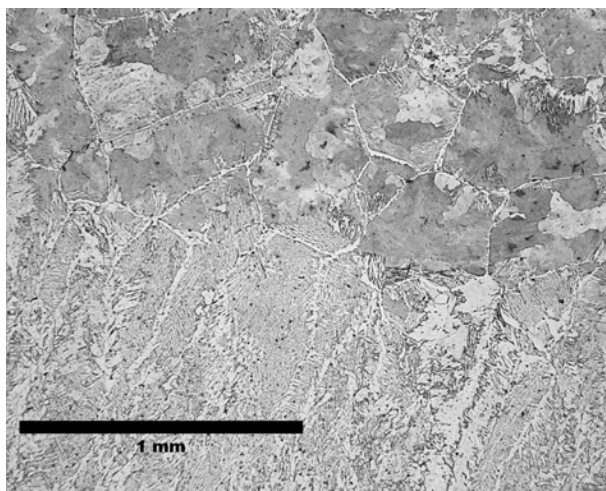
Figure 26

A. Area along the fusion line (see Fig. 25, area B).
Un-etched

B. Same as at left, etched

C. Area along the fusion line (see Fig. 25, area C).
Un-etched

D. Same as at left, etched

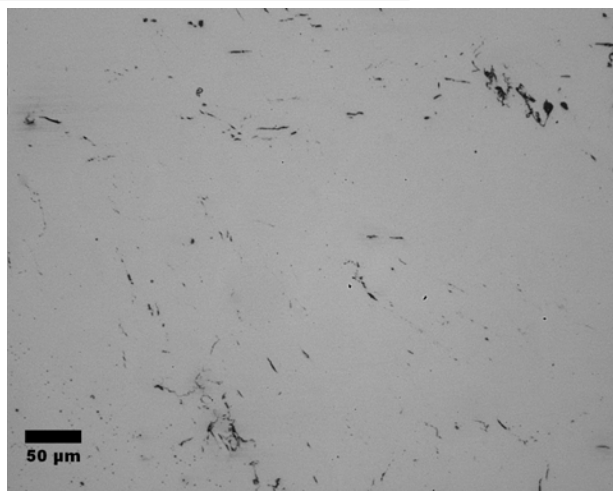
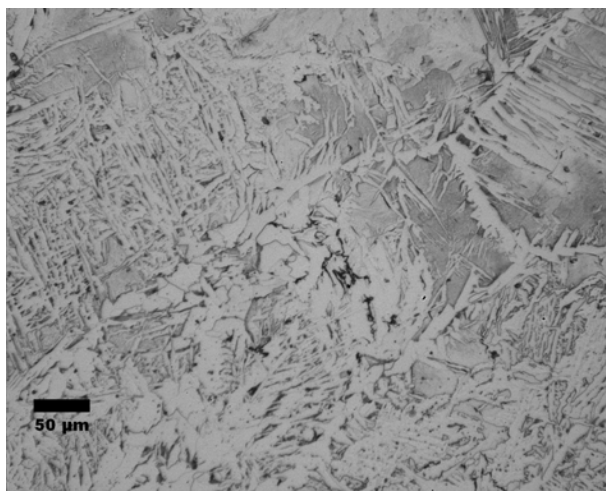
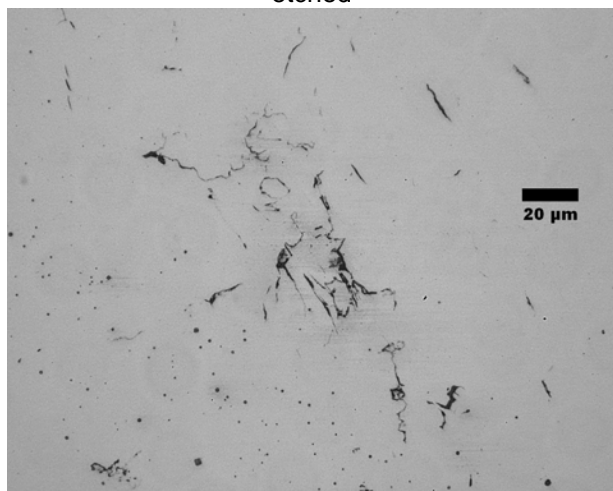
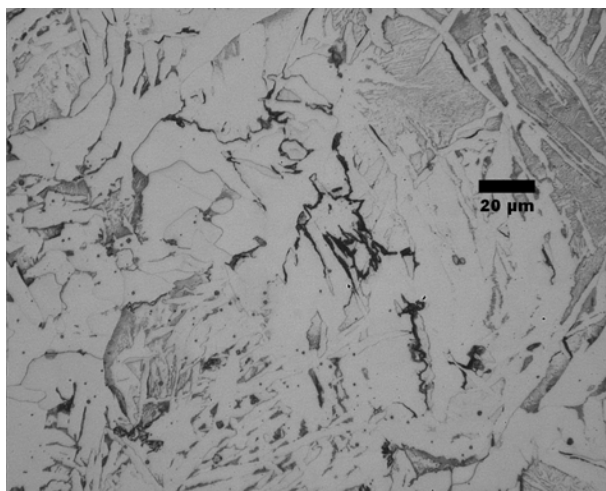
Figure 27

A. Enlarged area near the toe of the weld. Un-etched

B. Same as at left, etched

C. Enlarged area near the toe of the weld. Un-etched

D. Same as at left, etched

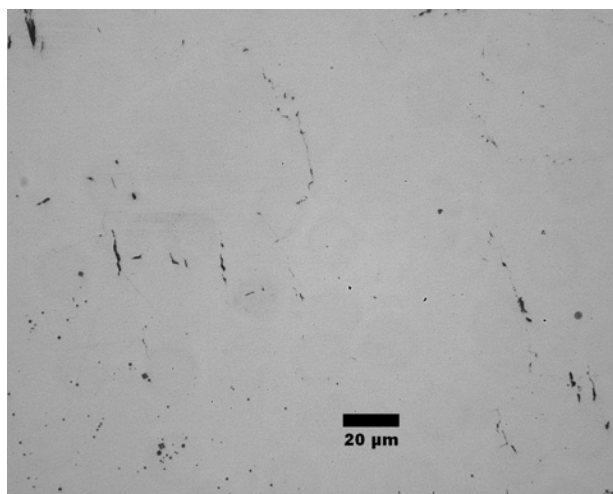
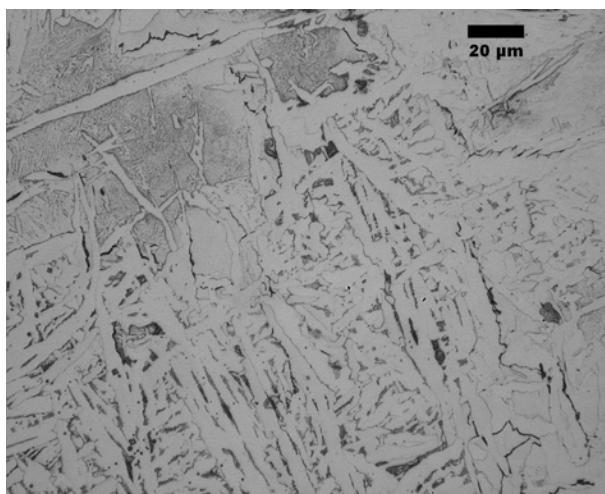
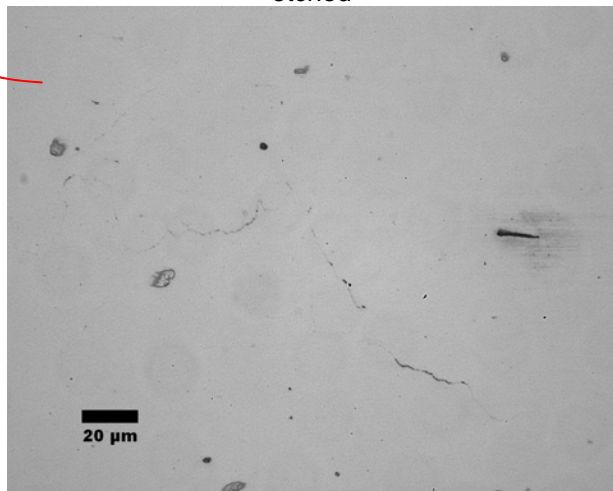
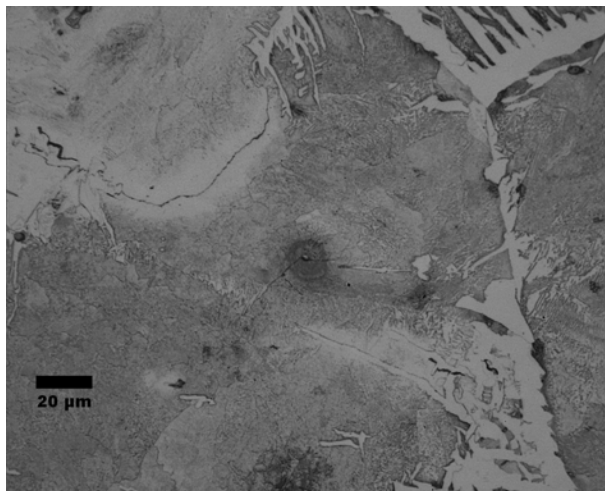
Figure 28

A. Enlarged area near the toe of the weld. Un-etched

B. Same as at left, etched

C. Area approximately at midpoint between ID and the cusp. Un-etched

D. Same as at left, etched

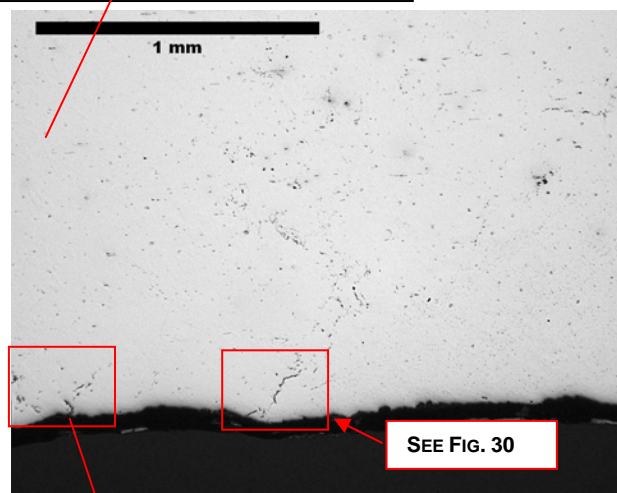
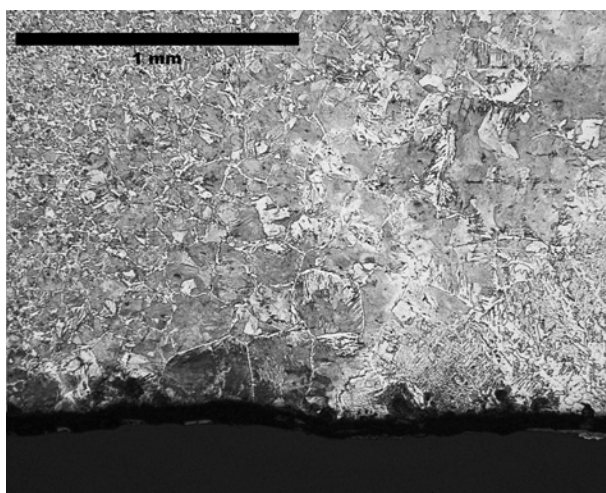
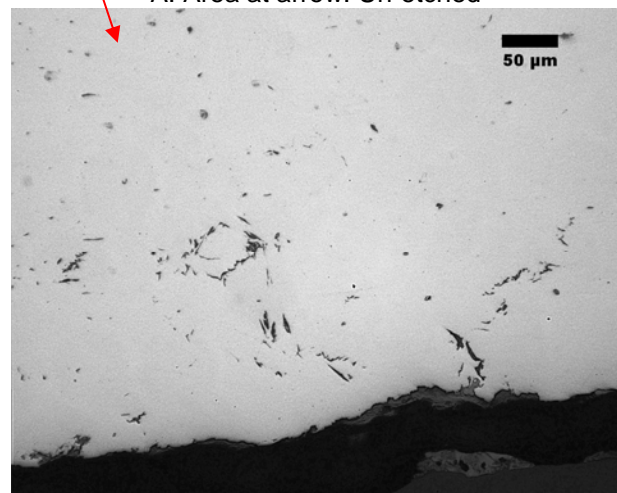
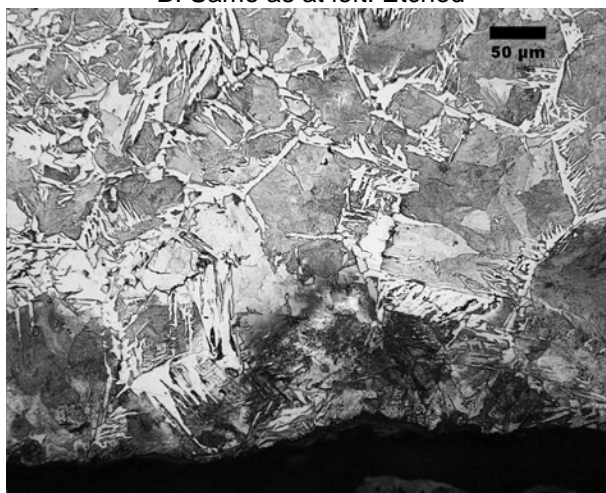
Figure 29

A. Area at arrow. Un-etched

B. Same as at left. Etched

C. Enlarged area from [A] above. Un-etched

D. Same as at left. Etched

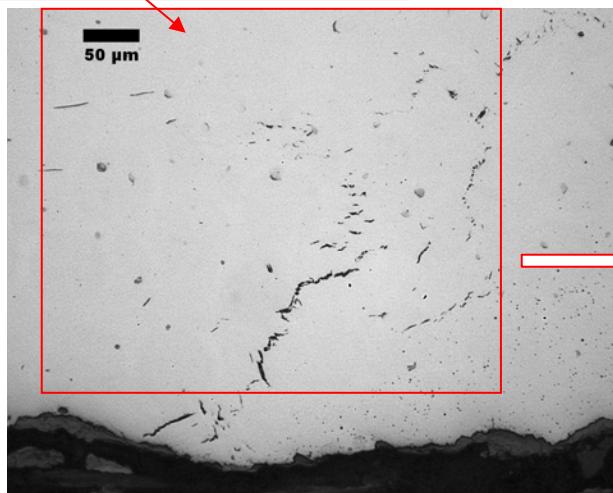
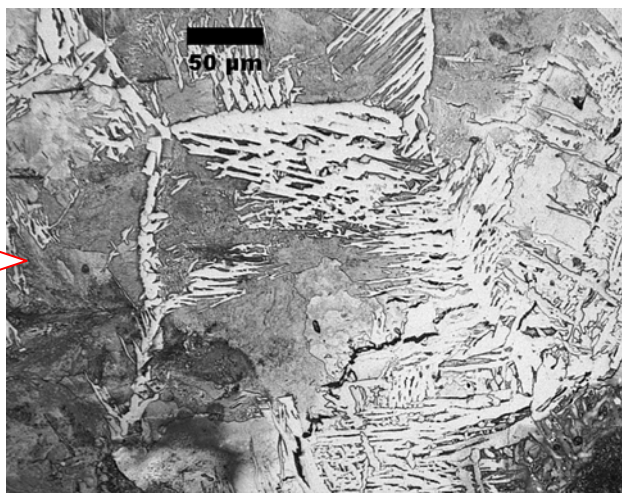
A. Enlarged area from Figure 29 above. Un-etched

B. Same as at left, slightly enlarged. Etched
