| BETA LAB No.M10198, TESORO LS2 AND LS2/CS2 TEE FINDINGS | TESORO REFINING AND MARKETING COMPANY ANACORTES REFINERY 10200 W. MARCH POINT ROAD T91WA4428 ANACORTES, WA 98221 | CUSTOMER P.O. No.: 4501667904 |
| PART: 6600-E HEAT EXCHANGER, LS2 22 IN, 36.5 IN MOUNTS, LS2 T2L SEM FRACTOGRAPHY AND PART 22 LS2-CS2 TEE FINDINGS PARTS 16-1 AND 22 | | DATE: OCTOBER 13, 2010 |

LABORATORY REPORT

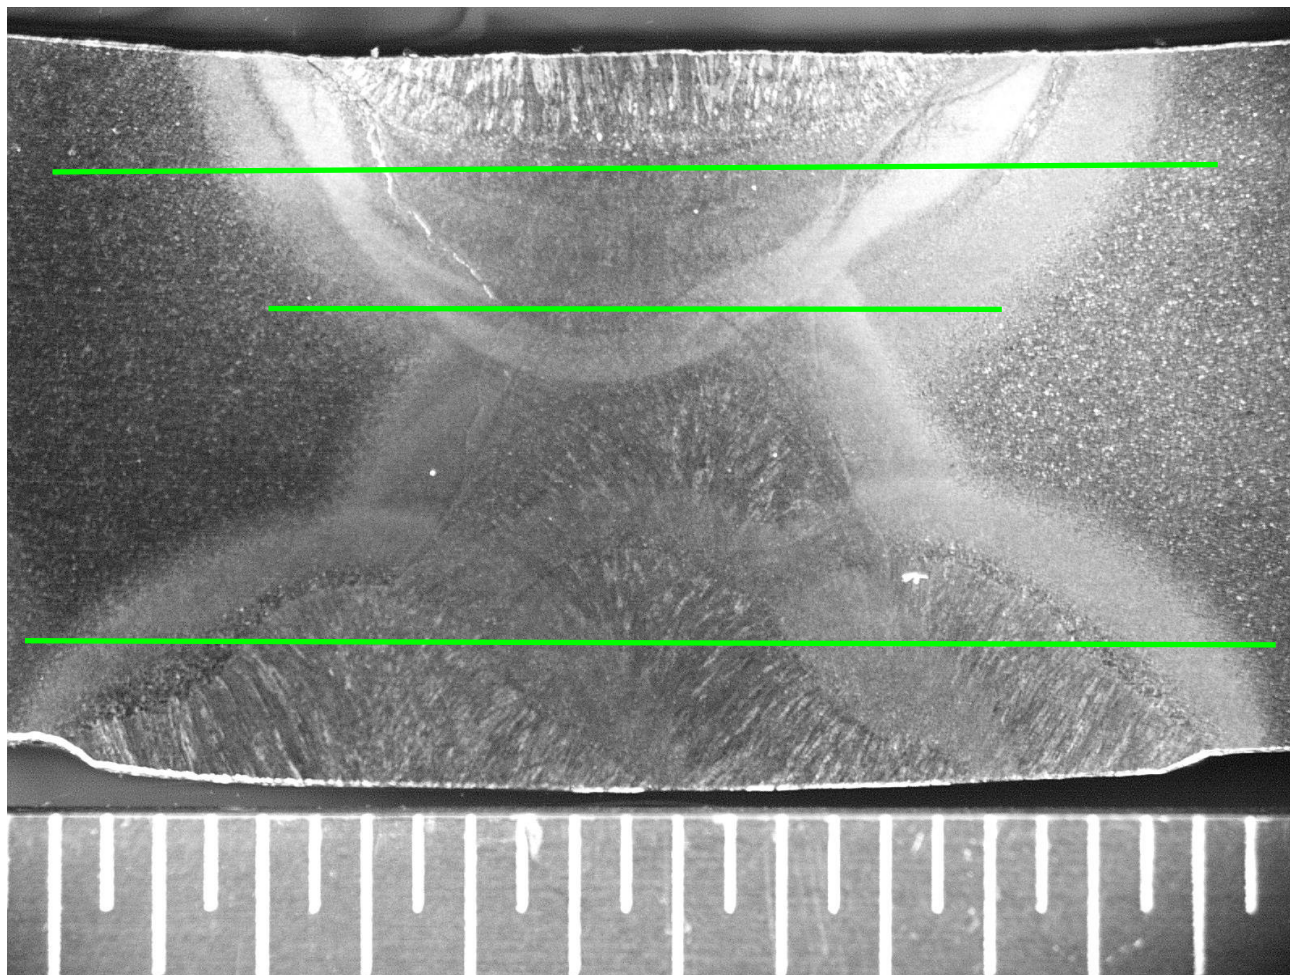
Mount T2L transverse through

Photo macrographs with green lines where the micro-hardness traverses were made. Hardness values are given in Table 3 & 5. The scale marks are 1/16inch. (Data are from Report M10198 Tesoro LS2-CS3 Tee Indications Findings, August 13, 2010). ID is on the top.

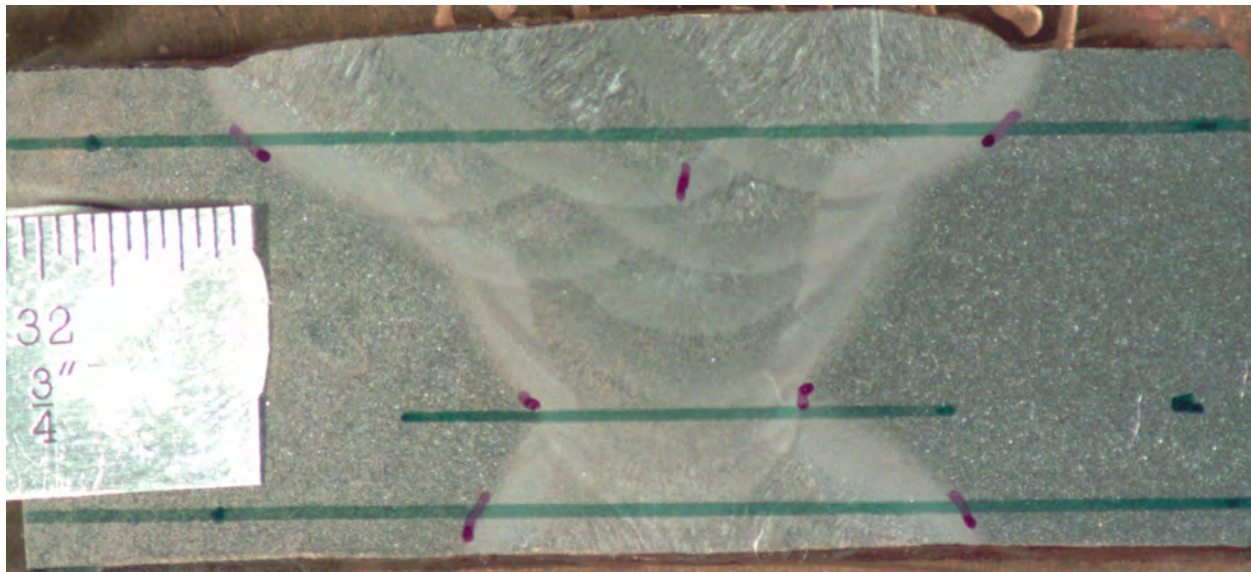
Figure 33

Photo macrograph with green lines where the micro-hardness traverses were made. Hardness values are given in Table 4 & 5, Graphs on Figure 31. . ID is on the bottom.
