Investigation Report

Published: July 6, 2023

On Sunday, March 17, 2019, a large fire erupted at the Intercontinental Terminals Company, LLC (ITC) bulk liquid storage terminal located in Deer Park, Texas. The fire originated in the vicinity of Tank 80-8, an 80,000-barrel aboveground atmospheric storage tank that held a blend of naphtha and butane product, a flammable liquid. Once the fire erupted, ITC was unable to isolate or stop the release. As a result, the fire burned, intensified, and spread to the other 14 tanks located in the same containment area. The fire burned for three days, until it finally was extinguished on Wednesday, March 20, 2019. The fire caused substantial property damage at the ITC Deer Park terminal, including the destruction of fifteen (15) 80,000-barrel aboveground atmospheric storage tanks and their contents.

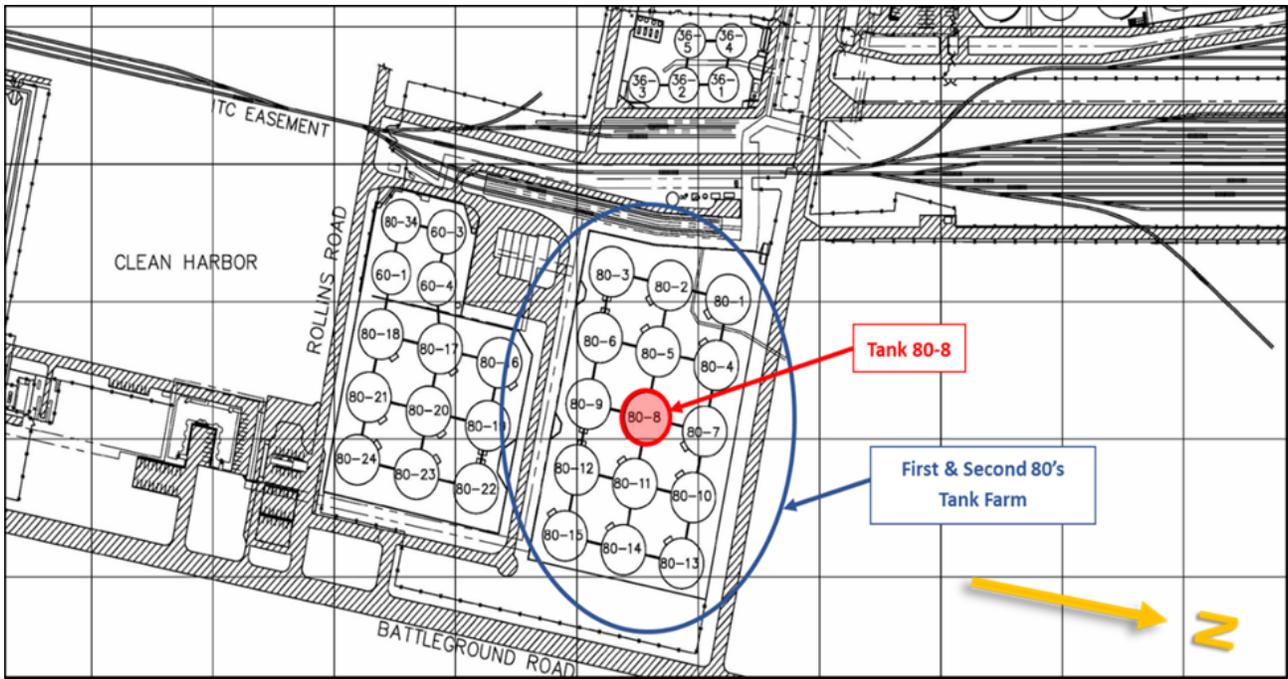
Figure 3. Plot plan of tank farm. Excerpt from overall plot plan for the ITC Deer Park terminal showing the location of the First & Second 80's Tank Farm. (Credit: ITC, annotations by CSB)

The incident occurred in what was commonly referred to as the First & Second 80’s tank farm at the ITC Deer Park terminal (**Figure 3**). The First & Second 80’s tank farm consisted of fifteen (15) 80,000-barrel (3,360,000-gallon) capacity aboveground atmospheric storage tanks situated within a common containment area that measured approximately 732 feet in length by 449 feet in width. The storage tanks measured 110 feet in diameter and 48 feet in height and were arranged in a 3 x 5 grid pattern, oriented in the east-west direction lengthwise. The aboveground atmospheric storage tank involved in the initial fire, Tank 80-8, was positioned in the center of the First & Second 80’s tank farm (**Figure 4**).

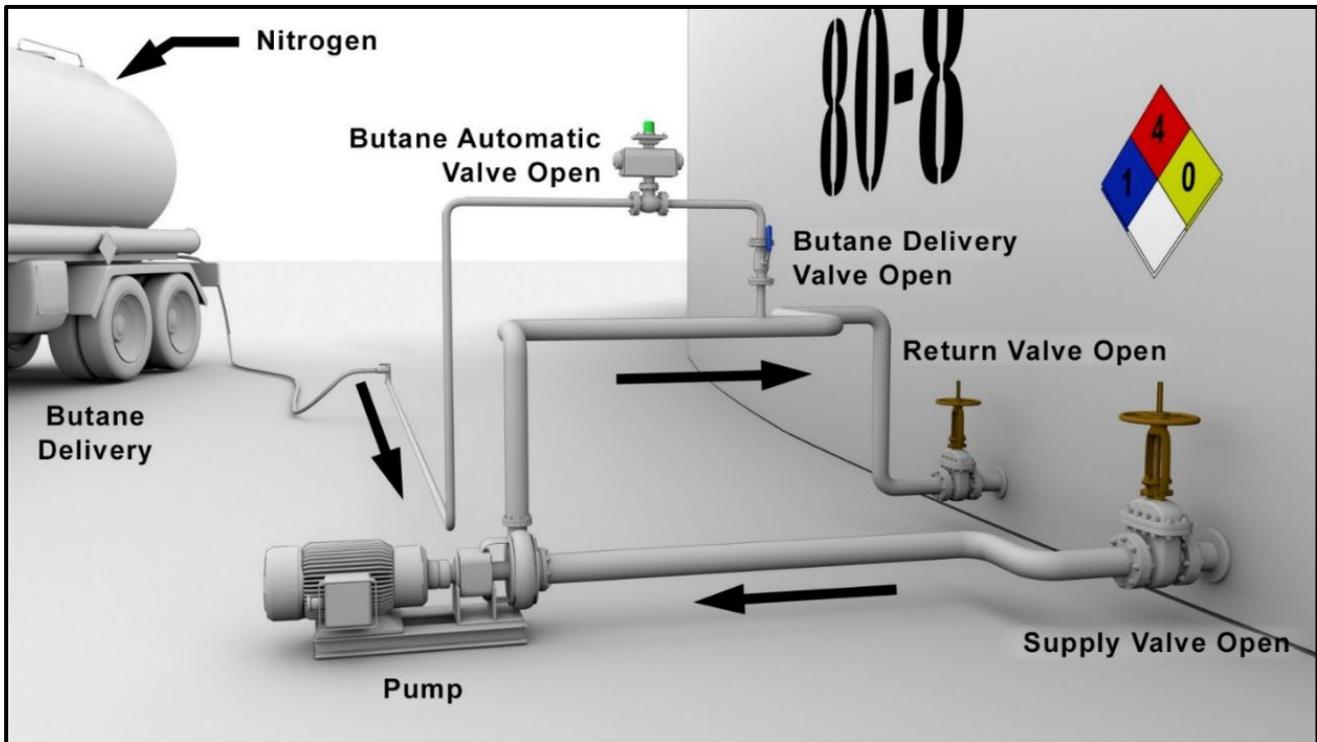
Figure 6. Simplified schematic showing ITC's butane injection system prior to 2016. The arrows in the figure show the butane flow direction and the naphtha product circulation path through the piping. Note: schematic not to scale. (Credit: CSB)

The Tank 80-8 Truck Butane Injection System originated at the 80's truck rack, located southwest of the tank farm (**Figure 5**), and terminated at an injection point in Tank 80-8's circulation line (**Figure 6**). The system was

designed so that the butane unloading operation could not begin unless the Tank 80-8 circulation pump was turned on, to ensure that butane-enriched naphtha product was circulating in the line. Once this condition was met, an ITC operator positioned at the 80's truck rack could then open the butane injection control valve to commence butane unloading operations. Nitrogen was used to unload the butane from the truck, and through two-inch piping to the Tank 80-8 circulation line, at which point the butane combined with the existing butane-enriched naphtha product in the tank. The Tank 80-8 circulation pump remained on throughout the unloading activity, and for several hours afterward, in order to facilitate the mixing of the naphtha and butane.

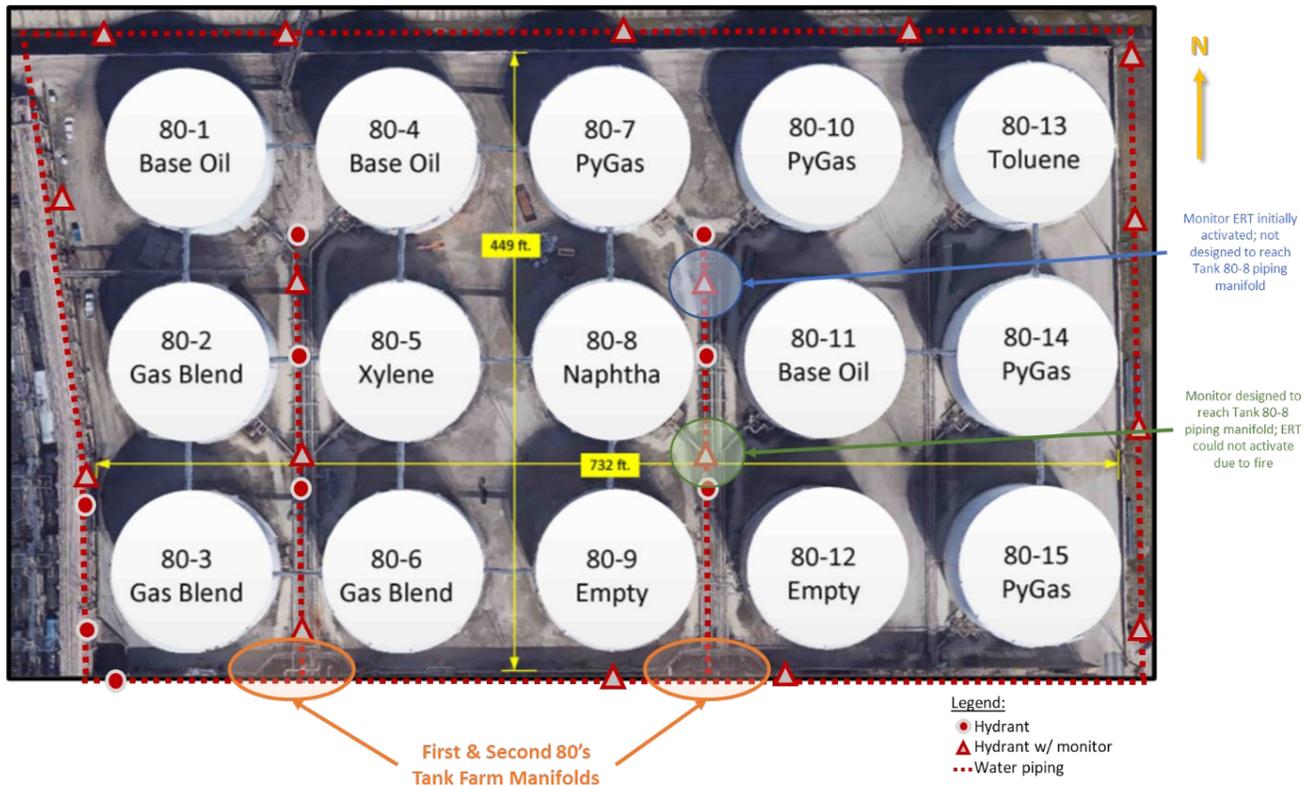
Figure 10. First & Second 80's tank farm layout, including products contained in the tanks at the time of the incident and positions of fire water equipment. (Credit: ITC, annotations by CSB)

^f These five additional tanks included Tanks 80-2, 80-3, 80-6, 80-9, and 80-11, which contained gasoline blendstock and base oil. Flammable vapors ignited along the rooflines of Tanks 80-2, 80-3, 80-6, and 80-9, causing fire to expel from the vents located near the top of the tanks. At this time, the fire involving Tank 80-11 burned at ground level in the area of the piping manifold. Sometime before 5:30 a.m., an additional tank containing toluene, Tank 80-13, became involved in the fire at ground level but was quickly extinguished (Figure 10).

^g For example, Tanks 80-14 and 80-15, which caught fire in the early hours of March 19, were located in the southeast corner of the tank farm (Figure 10) and contained Pygas, a highly flammable liquid.

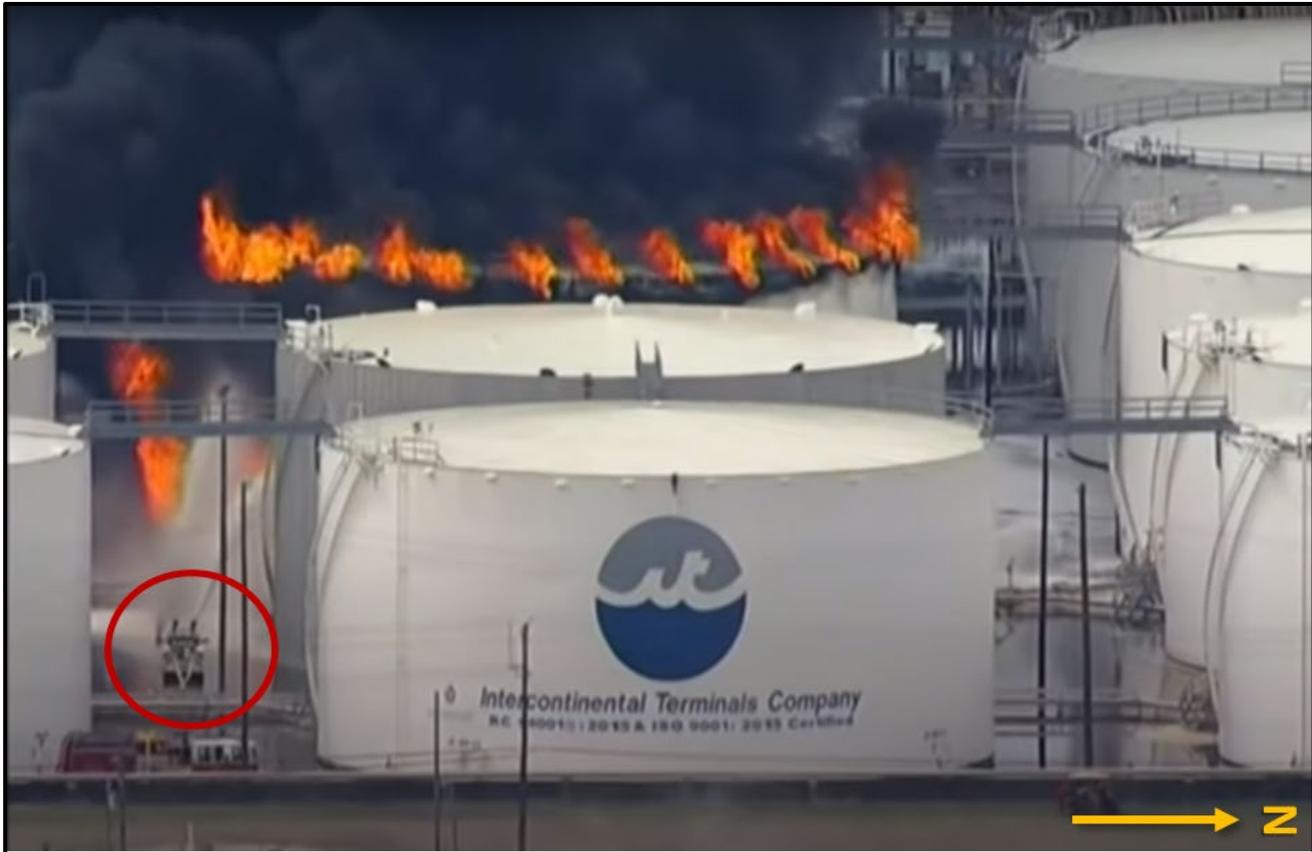
Figure 13. The quick attack truck (circled in red) staged between Tanks 80-11 and 80-12 on March 17, 2019. (Credit: Associated Press, annotations by CSB.)

Early response efforts focused on life safety^a and directing water sources at Tank 80-8 and the ground-level fire that engulfed its piping manifold (**Figure 13**). As the fire grew, additional water supply was needed; so, efforts were also underway to establish water supply from neighboring facilities and the Houston Ship Channel via fire boats. Emergency responders continued to work to control the fire; however, it was “growing faster than [they] could do anything.”

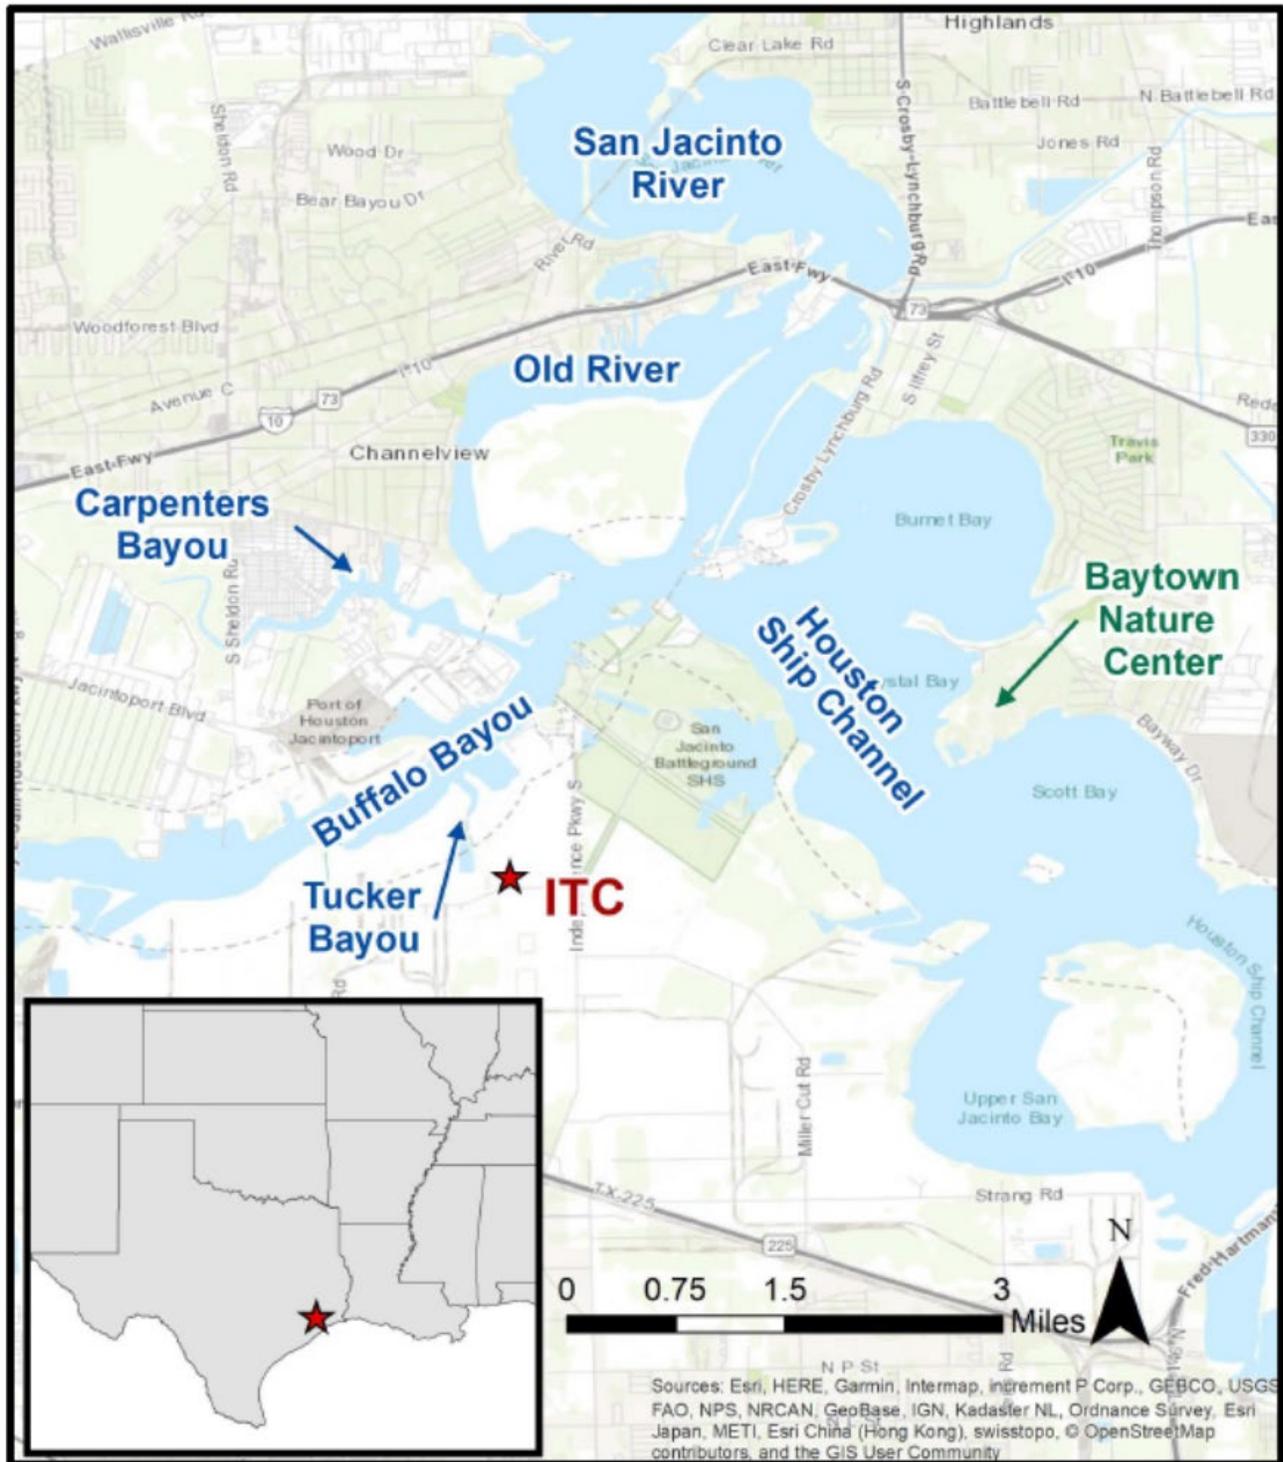
Figure 18. Houston Ship Channel closure. This map shows the general area where response activities associated with product recovery occurred, with the red star indicating the location of the ITC Deer Park terminal. (Credit: DOI) [15]

The released contaminants eventually entered the Houston Ship Channel via Tucker Bayou. As a result of the breach and subsequent release of materials, the USCG closed a seven-mile stretch of the Houston Ship Channel adjacent to the ITC Deer Park terminal extending from Tucker Bayou and the San Jacinto Monument to Crystal Bay (**Figure 18**) [13]. Additionally, Harris County Precinct 2 temporarily closed eight of the county's waterfront parks [14] The City of La Porte closed all its waterfront parks as well.^a By 4:00 a.m. the next day, the containment area was secured.

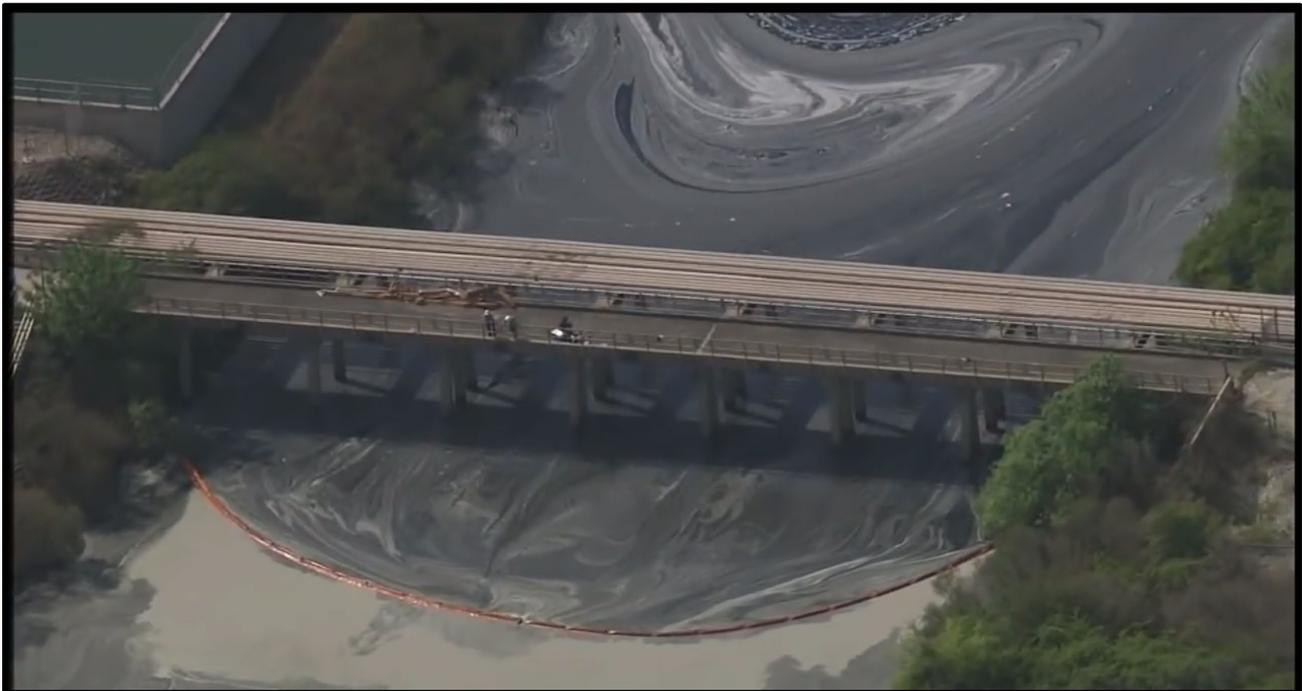
Figure 19. Booming operations conducted in the area of the Houston Ship Channel (Credit: ABC13).

Spill containment and cleanup operations to remove the released products from Tucker Bayou and the Houston Ship Channel also commenced on Saturday, March 23, 2019. Tucker Bayou and the adjacent ITC docks were determined to be the primary impacted locations.^a Crews deployed boom^b and response vessels to contain the materials and conduct clean-up operations in these areas, in addition to Patrick Bayou, Old River, Carpenter Bayou, Battleship Texas, Santa Ana Bayou, and the San Jacinto River (**Figure 19**).^{c,d} As of Monday, April 1, 2019, ITC reported that crews had deployed more than 130,000 feet of boom and recovered over 61,000 barrels of oily water mix from area waterways to date.

^d Skimmers – boats and other devices that can remove oil from the sea surface before it reaches sensitive areas along a coastline. In **Figure 19**, oil is being skimmed from the sea surface by a “vessel of opportunity.” Sometimes, two boats will tow a collection boom, allowing oil to concentrate within the boom, where it is then picked up by a skimmer [72].

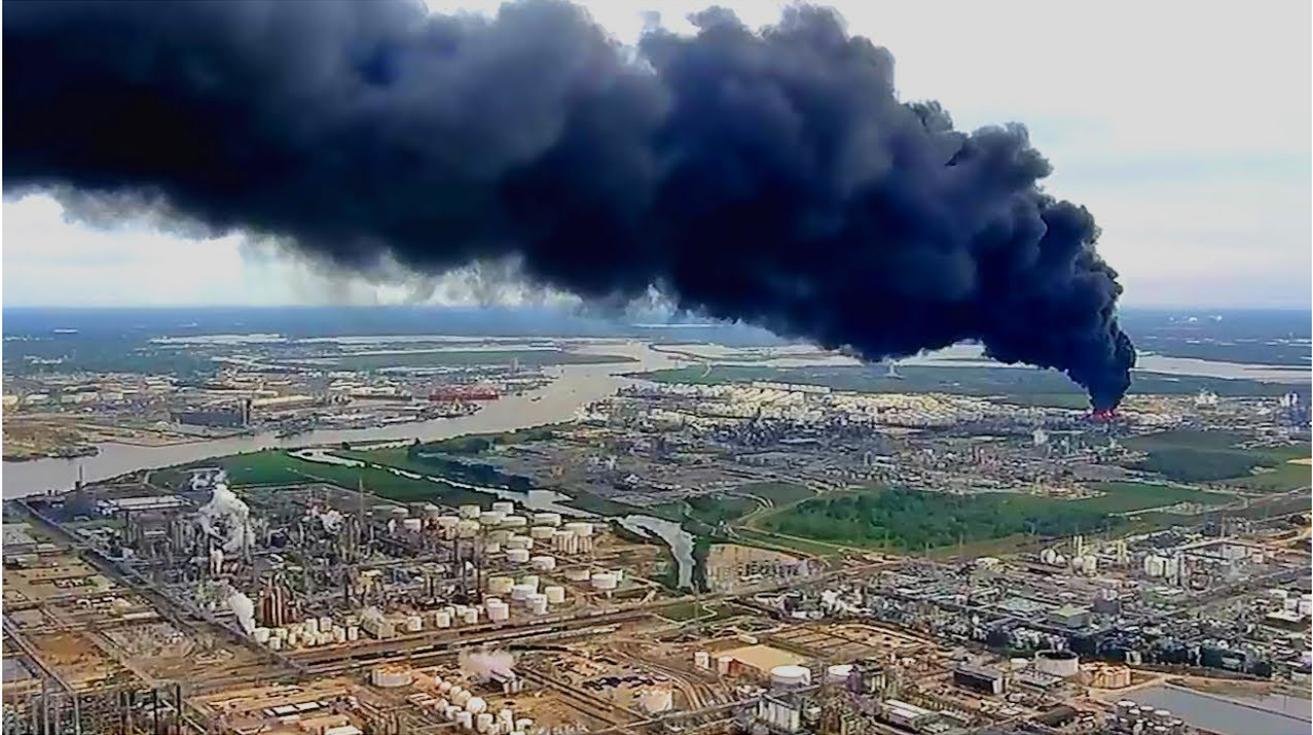
Figure 20. Photo showing plume of black smoke from First & Second 80's tank farm fire. (Credit: The Texas Tribune [18])

The ITC Deer Park incident had a direct impact on the surrounding community, including multiple shelter-in-place orders and closures due to benzene-related air quality concerns (**Figure 20**) [17]. Beginning on the morning of Sunday, March 17, 2019, the City of Deer Park issued a precautionary shelter-in-place order for a portion of the community and neighboring industrial facilities.^a That shelter-in-place order was later expanded to include the entire City of Deer Park, at which time a portion of State Highway 225 was also closed to all traffic. Working under a Unified Command with the EPA, TCEQ, Harris County, USCG, and other agencies, ITC was directed to conduct air monitoring.^b TCEQ, the EPA, and Harris County staff also deployed air monitoring resources beginning on March 17, 2019. The shelter-in-place order was lifted early the next morning after ITC publicly released an environmental report issued by CTEH that showed all air quality detections recorded were below levels that would represent a public health concern. The City of Deer Park also reopened State Highway 225.

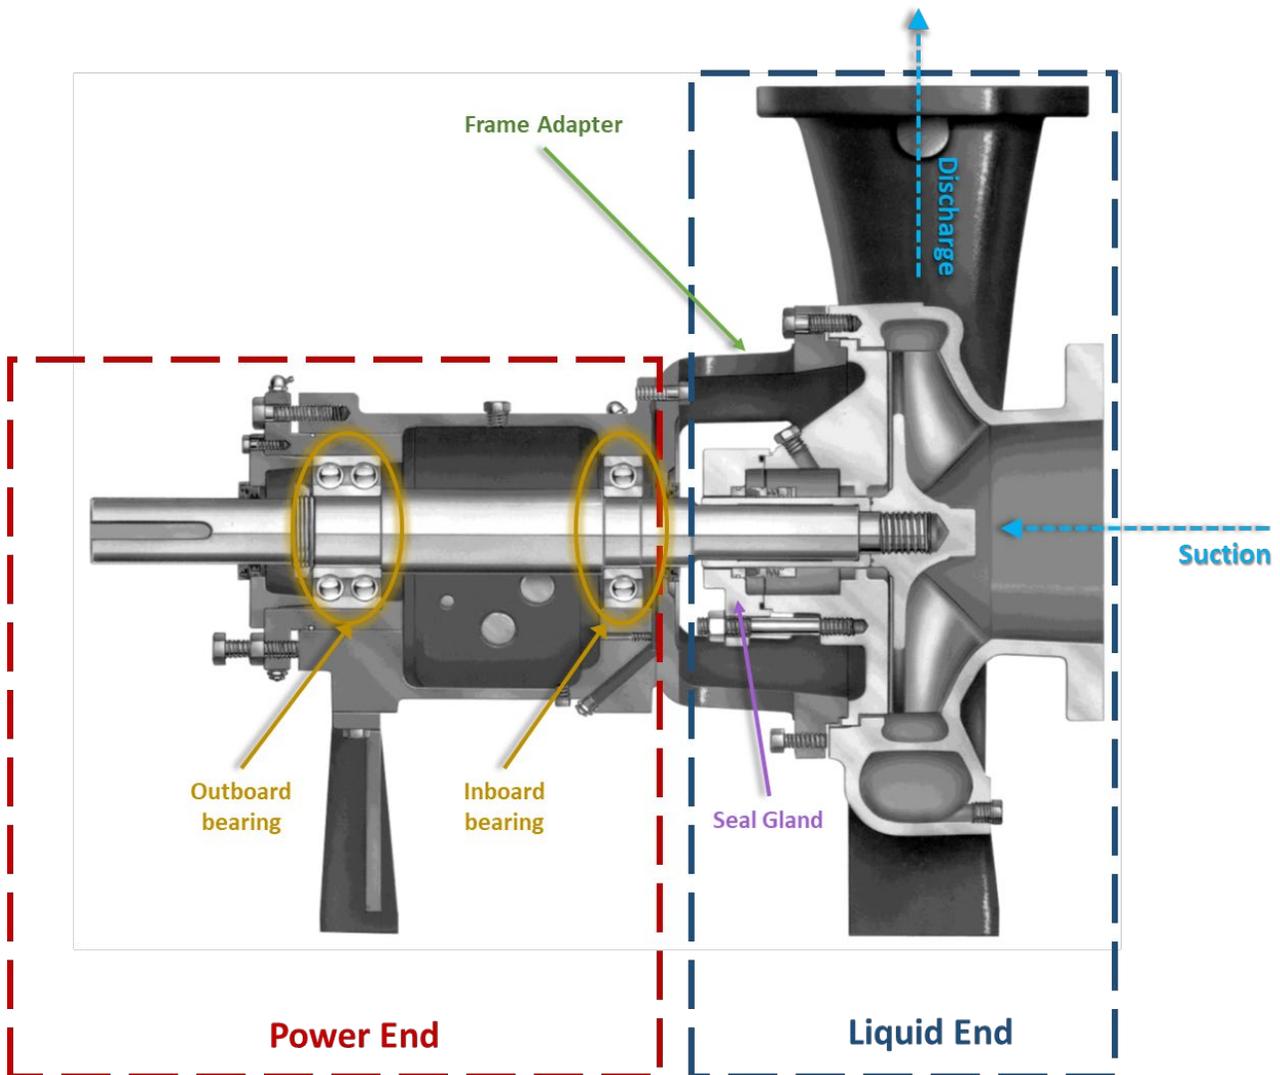
Figure 21. Sectional view of *Goulds Model 3196 XLT-X* chemical process pump. This view identifies the pump's liquid end, power end, and rigid frame adapter. (Credit: *Goulds*, annotations by CSB)

(Figure 21). The liquid end was comprised of the casing, impeller, seal chamber, and mechanical seal gland.^a The mechanical seal was designed to contain the butane-enriched naphtha product inside the seal chamber as it flowed through the pump. The seal gland mounted flush to the seal chamber cover and was secured by four gland nuts threaded onto the seal chamber studs that extended through designated slots on the seal gland. The power end was comprised of the bearing frame, pump shaft, two sets of ball bearings, and oil seals. The purpose of the two sets of ball bearings was to support the pump shaft. The inboard bearing was responsible for carrying radial loads,^b and the outboard bearing was responsible for carrying both radial and thrust (axial) loads. The pump shaft extended from the impeller through the seal chamber and bearing frame to the motor coupling.

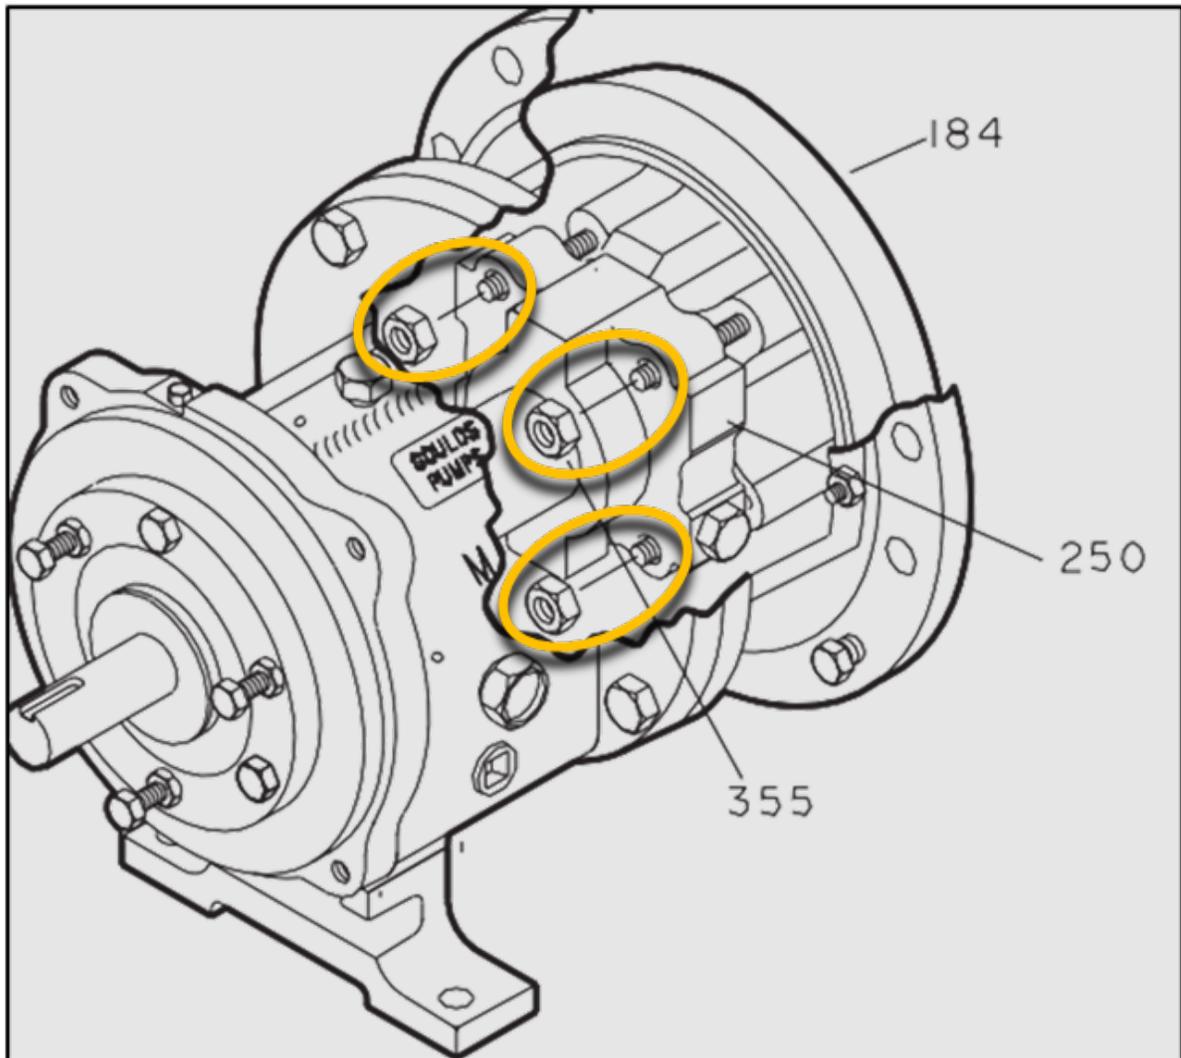
Figure 25. Cutaway drawing of *Goulds* chemical process pump showing the locations of three of the four gland nuts that held the seal gland in place against the seal chamber cover. *Note: fourth gland nut is not visible in drawing.* [Credit: *Goulds*, annotations by CSB]

Four gland nuts secured the seal gland to the seal chamber cover to prevent the butane-enriched naphtha product from leaking from the pump, as shown in **Figure 25**. Post-incident inspection of the Tank 80-8 circulation pump revealed that none of the four gland nuts remained in place and that the seal gland was completely separated from the seal chamber cover (**Figure 26**). Additionally, the barrier fluid steel tubing used to provide lubrication

to the mechanical seal via the seal gland was found severed from the nearby external seal pot and wrapped around the pump shaft.

Develop and implement a condition monitoring program for all pumps in highly hazardous chemical service at the ITC Deer Park terminal. Ensure that condition monitoring equipment is programmed with control limits, including but not limited to vibration, consistent with ANSI/ISO 9.6.9.-2018, that trigger alarms when control limits are exceeded, and that operating procedures and training reflect the appropriate actions to take when an alarm is triggered.

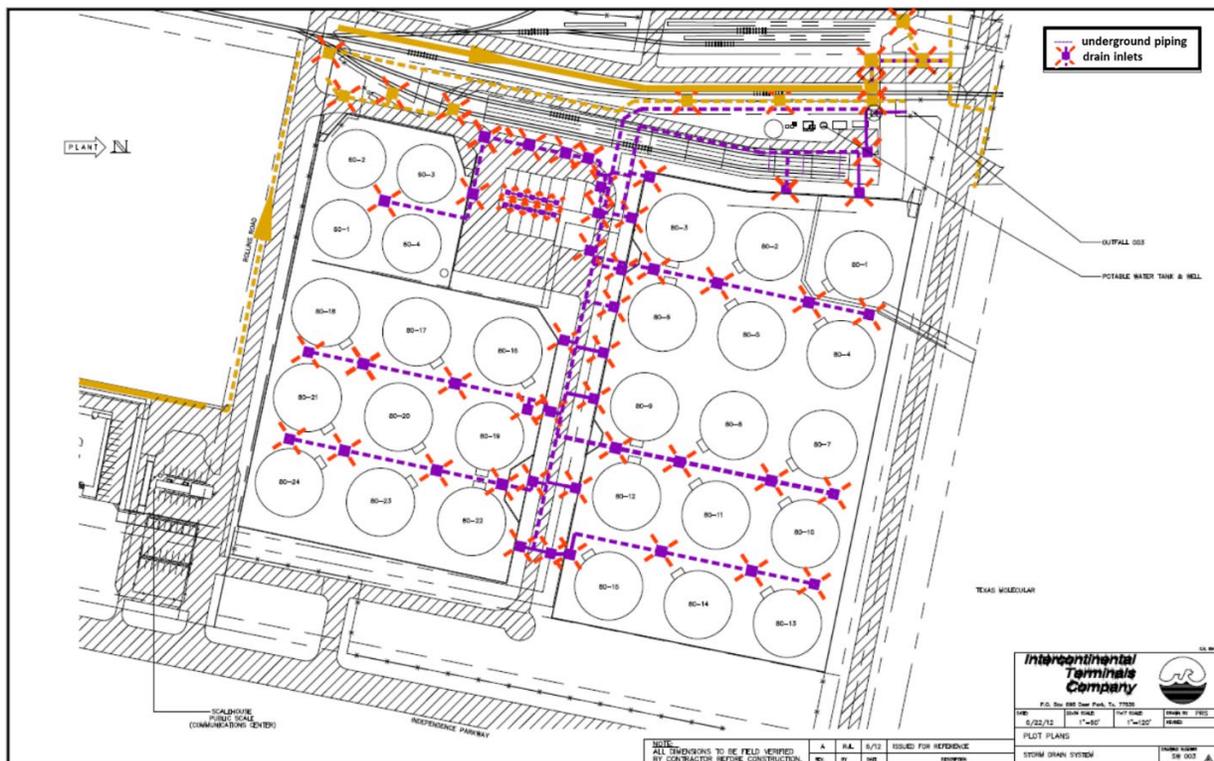
Figure 31. Plot plan of First & Second 80's tank farm stormwater drain system. (Credit: ITC)

There were two drainage systems in place within the First & Second 80's tank farm: a chemical drain system and stormwater drain system. Materials collected in the chemical drain system were routed via underground piping to the terminal's wastewater treatment system. The stormwater drainage system was responsible for collecting stormwater from the First & Second 80's tank farm and directing it through pipes and control structures to an adjacent drainage ditch through a discharge location near the northwest corner of the tank farm (**Figure 31**). A Harris County drainage ditch was located just outside of the containment wall and inside of Tidal Road on the north side of the First & Second 80's tank farm.

Although the First & Second 80's tank farm was designed largely in accordance with NFPA 30 (1973 edition), a convergence of several issues related to liquid accumulation resulted in complications during the emergency response, including:
