# Fatal Propylene Release and Explosion at Watson Grinding

Houston, Texas | Incident Date: January 24, 2020 | No. 2020-03-I-TX

## Investigation Report

Published: June 29, 2023

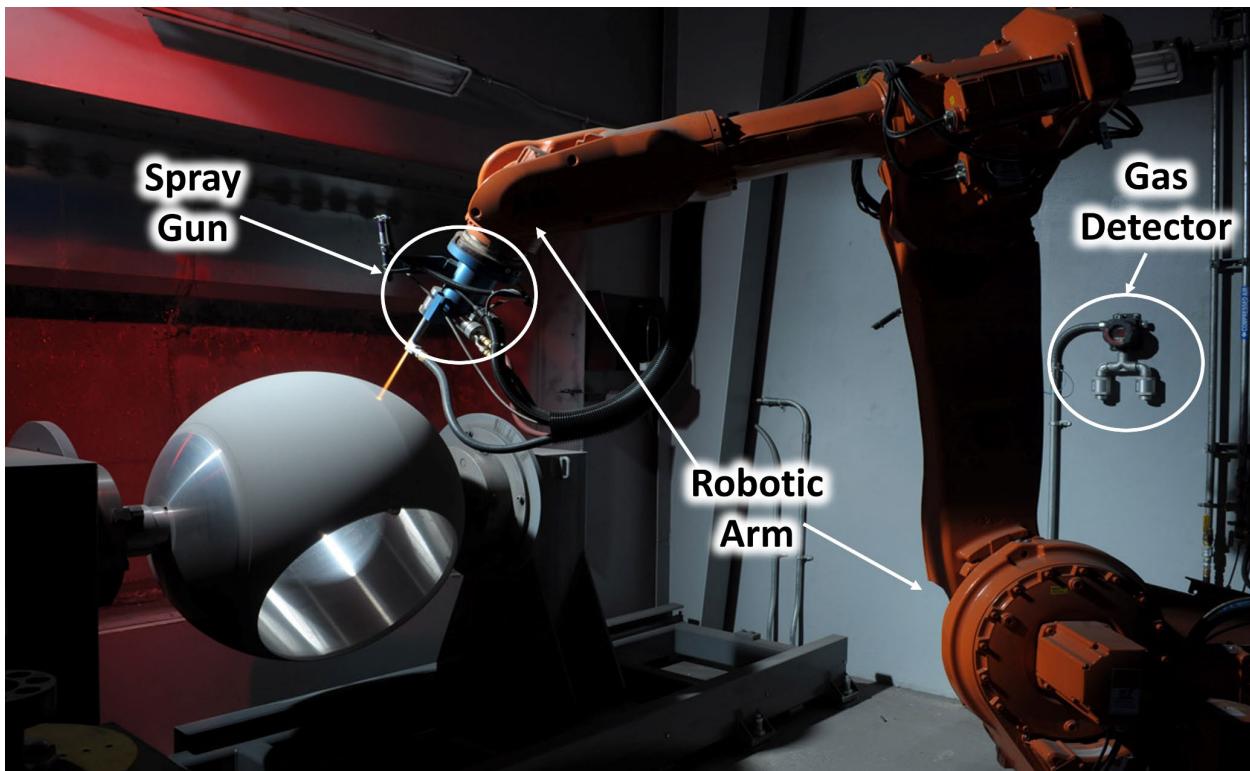
**Figure 3.** HVOF Booth. (Source: Watson Grinding, annotations by CSB)

Watson Grinding conducted thermal spray coating operations in separate coating booths, each staffed with a coating booth operator who reported to the Coating Department Supervisor. Watson Grinding coating booth operators performed the HVOF coating both manually and by using industrial robotic arms. **Figure 3**, a photo taken before the incident, shows the interior of an HVOF coating booth (Booth 8) during the spray coating of a ball valve component. The spray gun was attached to the robotic arm. Six of the booths (including Booth 4) were equipped with a gas detector, similar to what is shown on the right side of the figure. The purpose of the gas detection system was to continually monitor the propylene and oxygen concentration inside the coating booths and, in instances of dangerous concentrations, provide local alarms when the prescribed parameters were exceeded, start up the booth's exhaust fan (if not already operating), and stop the flow of these gases (both locally in the booth and remotely at the propylene and oxygen storage tanks located north of the coating building).

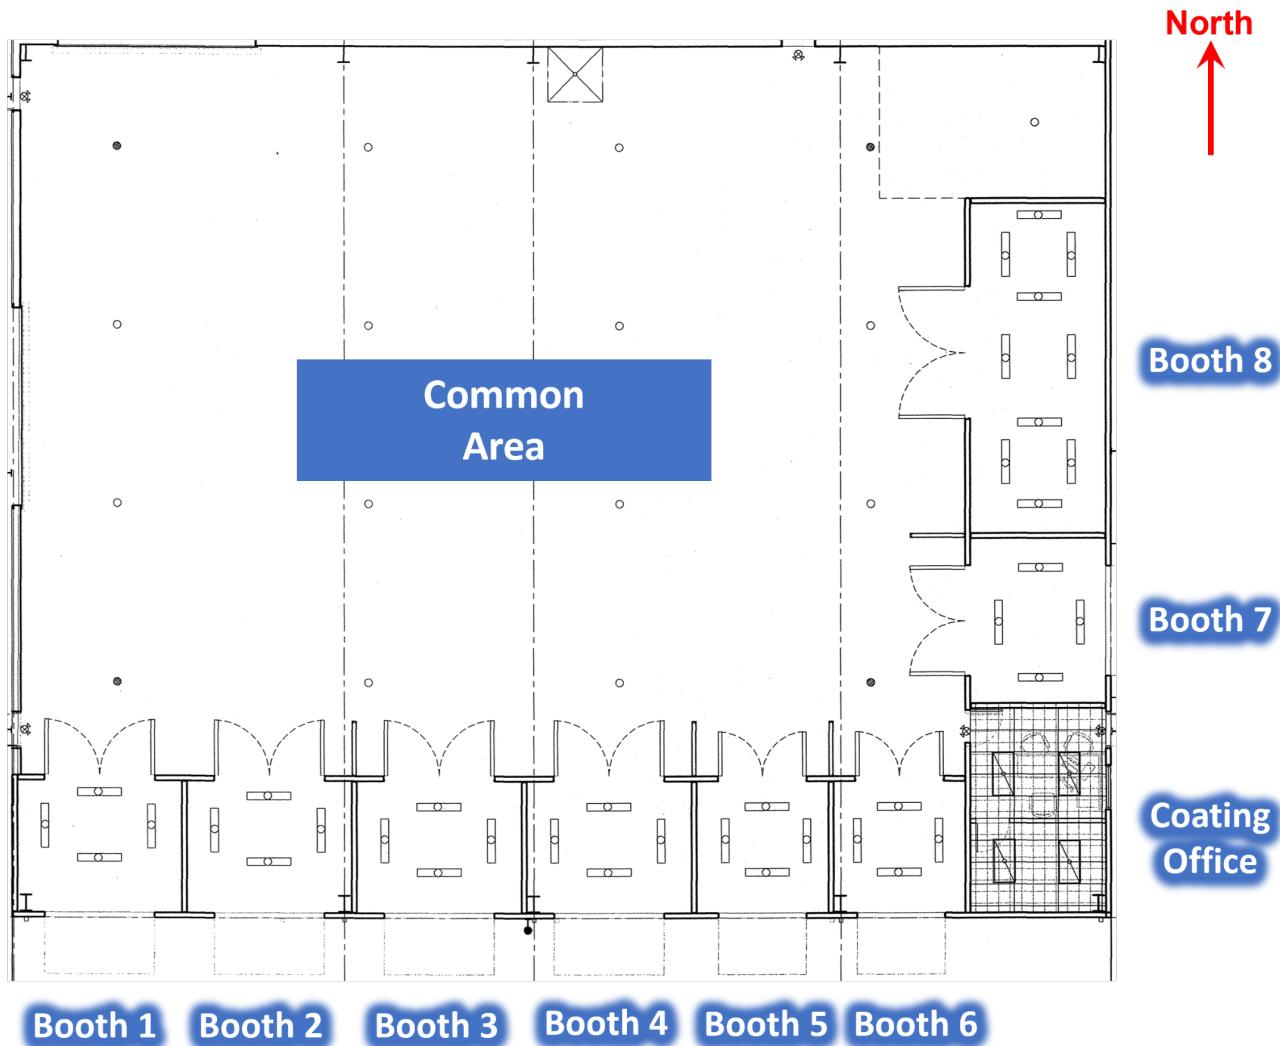
Figure 4. Coating Building Diagram. (Source: Watson Grinding; annotations by CSB)

Eight of Watson Grinding's ten coating booths (Booths 1 through 8) were located inside the coating building, as shown in **Figure 4**. Booths 1 and 2 were not equipped for HVOF spray coating; instead, these booths contained equipment for plasma spray coating. The other six coating booths in the coating building (Booths 3 through 8) were equipped for HVOF spray coating. **Figure 5** shows a photo of the interior of the coating building, taken soon after construction was completed (circa 2010). In addition to the eight coating booths, the large open space of the coating building, referred to as the common area, was used to conduct other metal shop work activities.

All eight coating booths inside the coating building were equipped with blue double access doors located at the front of the booth. These booths had concrete walls that were four to six inches thick.<sup>a</sup>

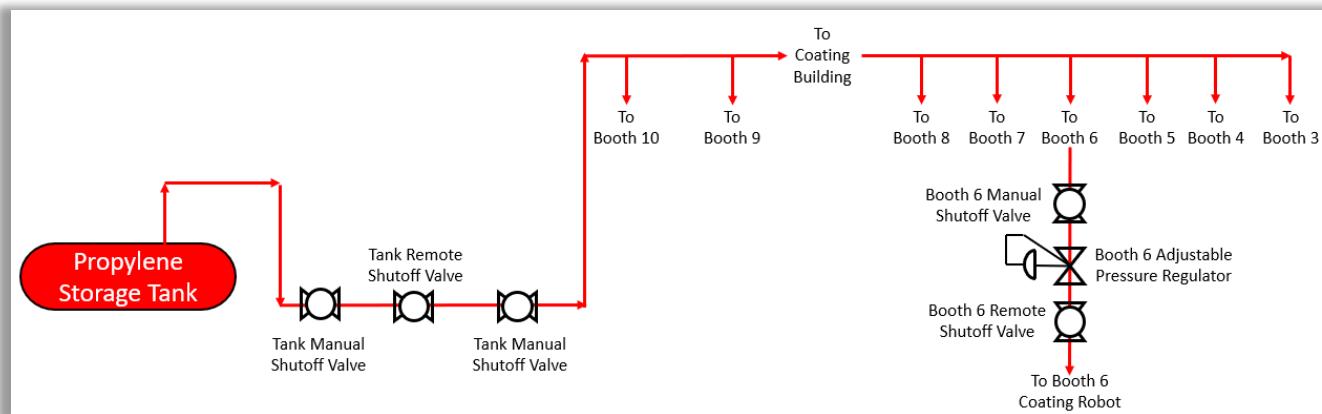
**Figure 6.** Simplified Propylene Flow Diagram. (Credit: CSB)

A simplified flow diagram showing the main equipment from the propylene storage tank to the exemplar Booth 6 is shown in **Figure 6**.<sup>a</sup>

propylene supply piping to the coating booths (Booths 3 through 10). When these valves in **Figure 6** are open, the propylene vapor flows through the piping to supply propylene fuel to the coating booths.

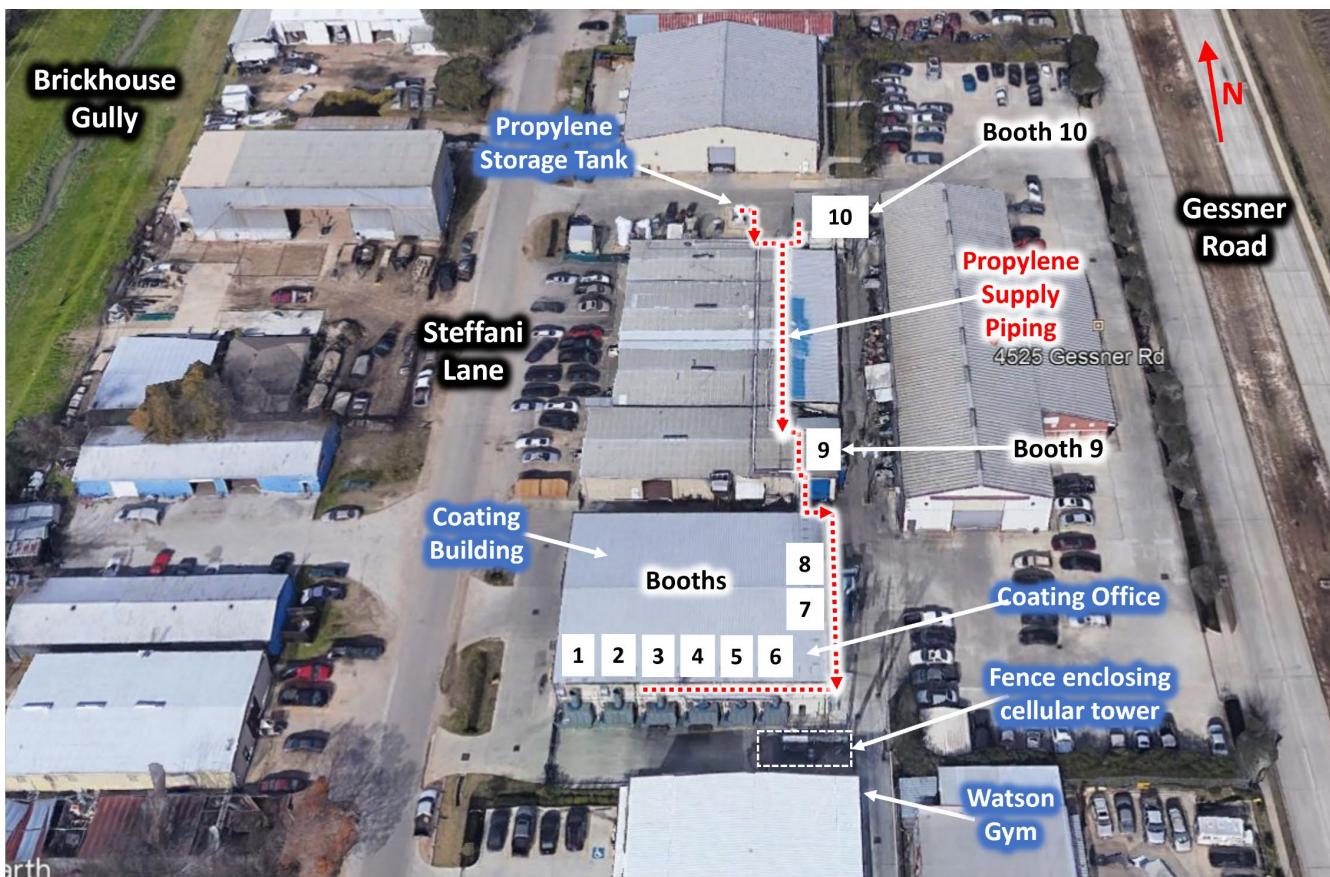
**Figure 8.** Propylene Supply Piping. (Source: Photo Google Earth Pro, annotations by CSB)

After the second manual shutoff valve, propylene vapor was routed through the propylene supply piping (see the red dashed line in **Figure 8**, which was mounted along the buildings' exterior, where it ran to the eight propylene-fueled HVOF coating booths (Booths 3 through 10). The propylene supply piping was located approximately 15 feet above the ground. At each coating booth, the propylene supply piping branched off and entered near the top of each coating booth. The piping was then routed down towards ground level, through pressure and controlling equipment, and connected to the robotic arm. Each robotic arm was equipped with a spray gun to apply the HVOF spray coating (as shown in **Figure 3**).

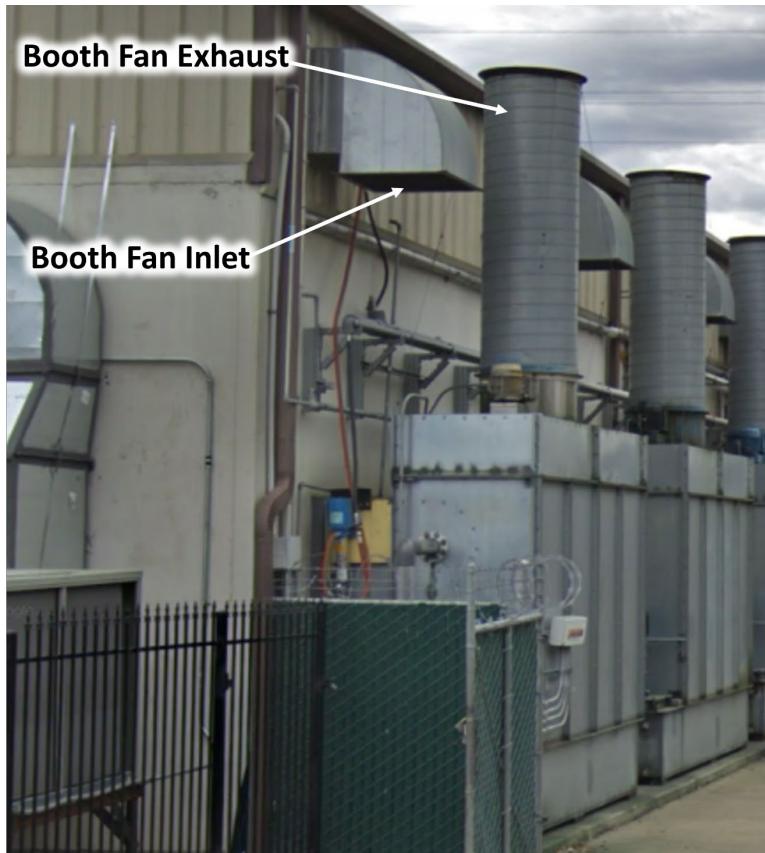
**Figure 11.** Booth Ventilation Exhaust System. (Source: Google Street View, annotations by CSB)

A large exhaust fan continually operated during coating booth operations to remove process gases and provide ventilation for the spray operations in each booth. See **Figure 11**.

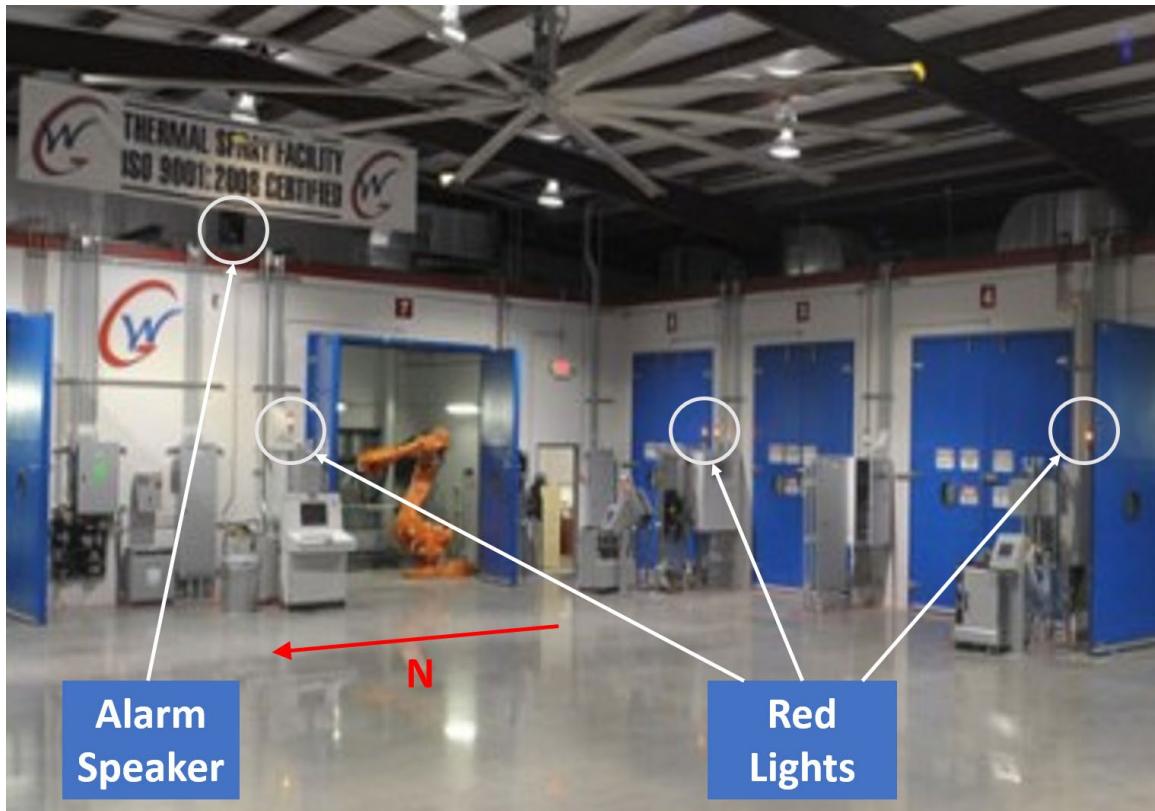
Figure 13. Alarm Locations Inside the Coating Building. (Source: Watson Grinding, annotations by CSB)

The alarms were both audible and visual (see **Figure 13**). The audible alert consisted of a verbal message alerting employees of the hazard and directing employees to evacuate, alternating with a siren. Meanwhile, the visual alarm consisted of a flashing red beacon located outside of alternating coating booths. At the time of the incident, the automated gas detection alarm, exhaust fan startup, and gas shutoff system was not functional.

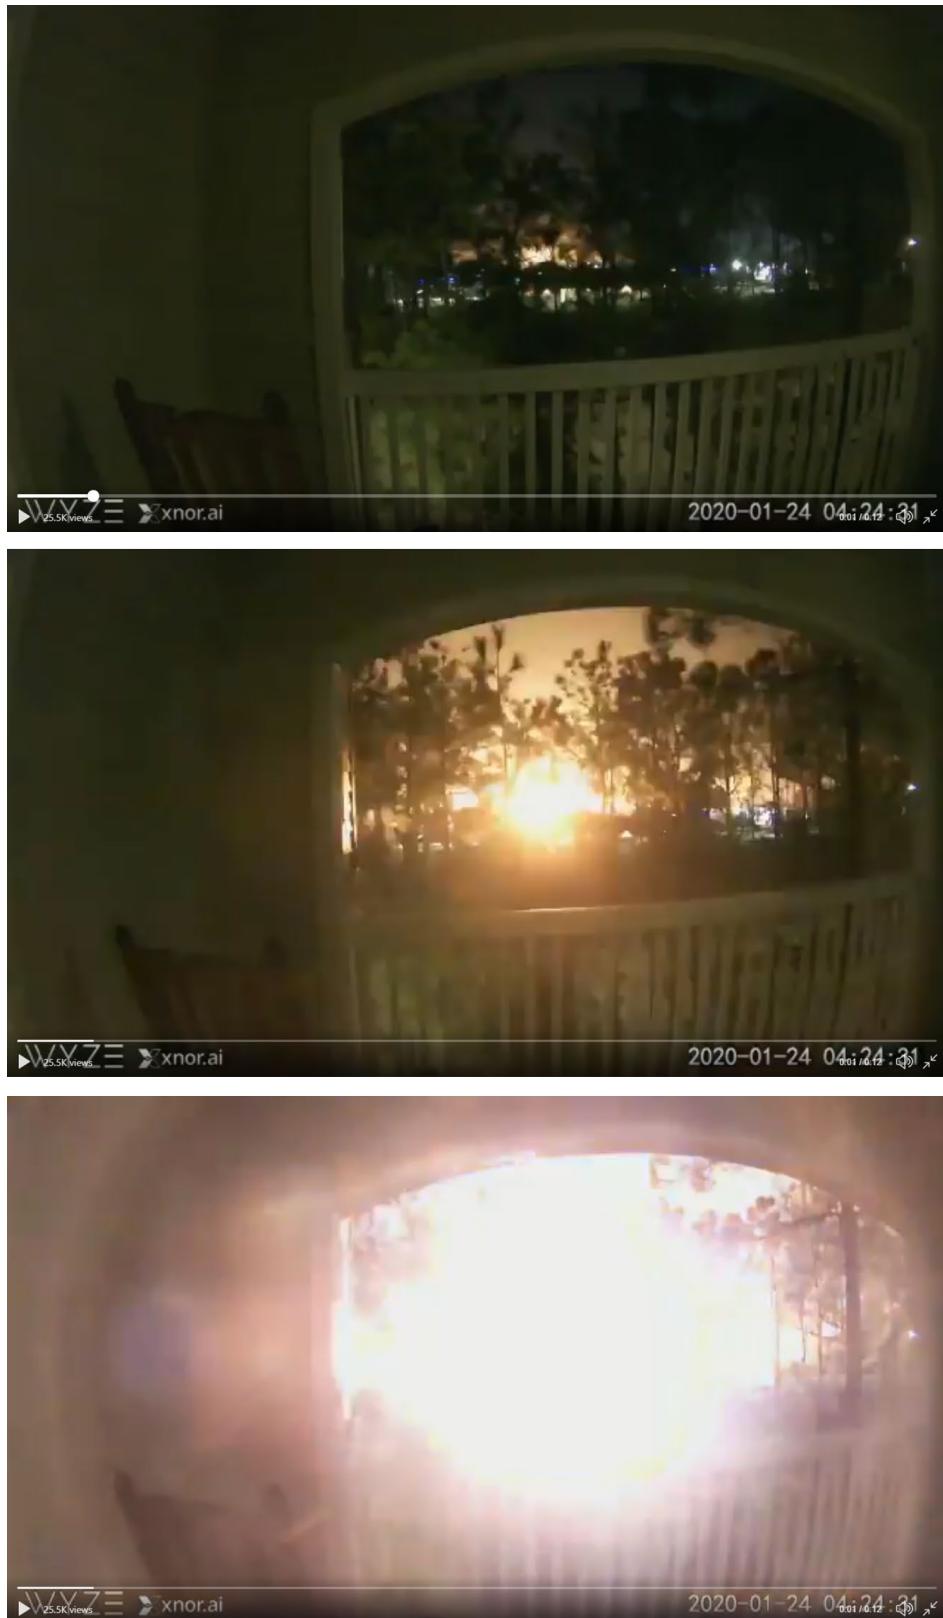
**Figure 15.** Explosion. (Source: Residential Camera [11])

At around 4:24 a.m., another Watson Grinding coating booth operator (Employee Four) arrived. As he stopped and prepared to park his truck, he noticed Employee Three's car parked just outside the coating building and saw him enter the coating building through the open west door. As Employee Four backed his truck into a parking space, the flammable propylene vapor ignited, and the coating building exploded. The explosion was captured by a nearby residential camera (**Figure 15**). The explosion fatally injured Employees Two and Three and injured Employees One and Four.

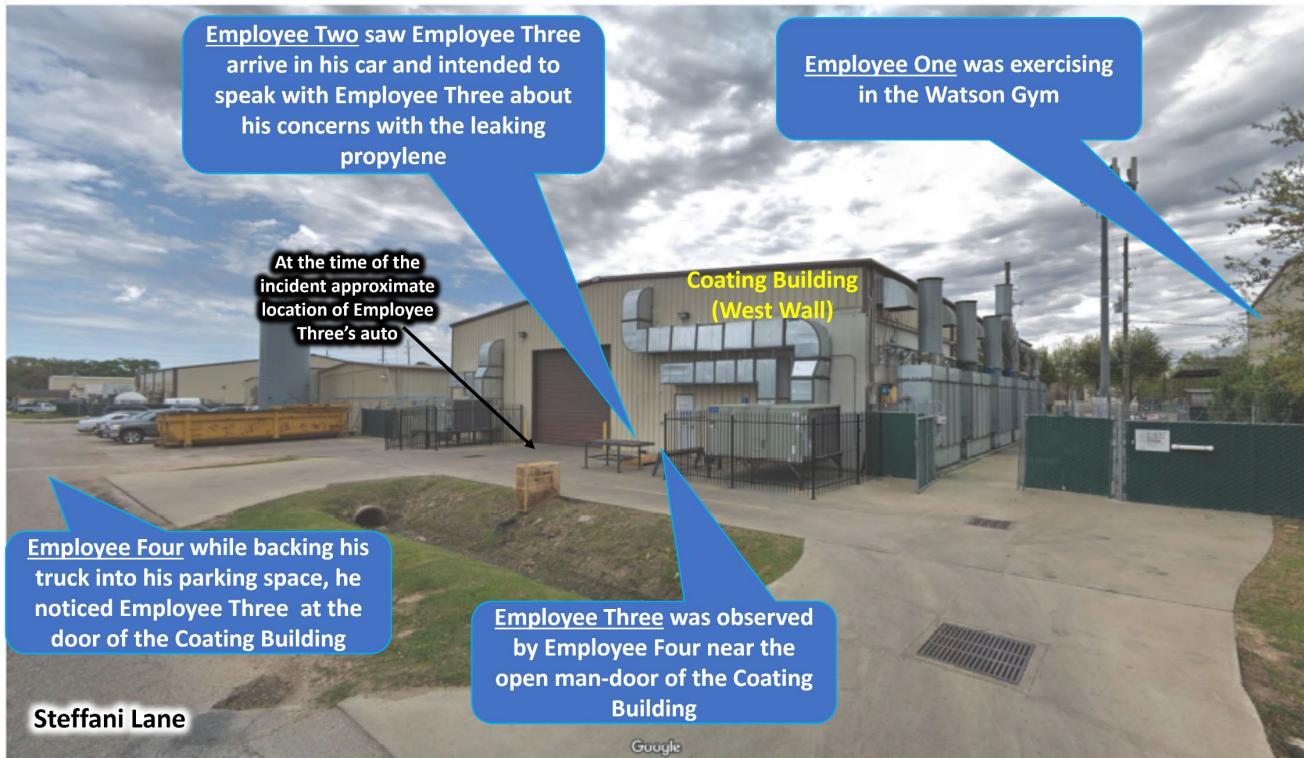
Figure 16. Employee Locations at the Time of the Incident. (Source: Google Street View, annotations by CSB)

**Figure 16** shows a pre-incident photo of the coating building and identifies the approximate locations of the four employees at the time of the incident.
