U.S. Chemical Safety and
Hazard Investigation Board

Trichloroisocyanuric Acid Reaction, Decomposition, and Toxic Gas Release at Bio-Lab, Inc.

Westlake, LA | Incident Date: August 27, 2020 | No. 2020-05-I-LA

Investigation Report

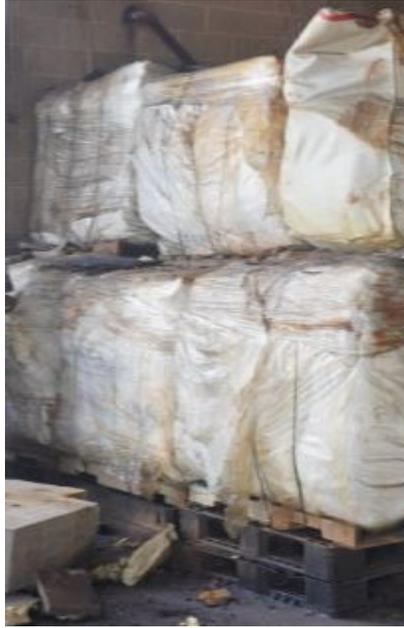
Nine employees assigned to the Bio-Lab Hurricane Crew^b reported to the facility on August 25, 2020, around 5:00 p.m. Each crew member had specific job assignments, including securing loose items that could become hazardous during the hurricane (e.g., by being propelled by wind), placing sandbags at entrances to prevent floodwater entry, and other tasks defined in the hurricane plan. To protect the remaining TCCA and other products from potential floodwater, the Hurricane Crew raised the materials above floor level by placing the material on triple-stacked pallets (**Figure 5**).^c

Figure 5. TCCA product stacked as a precaution from floodwater. (Credit: CSB)

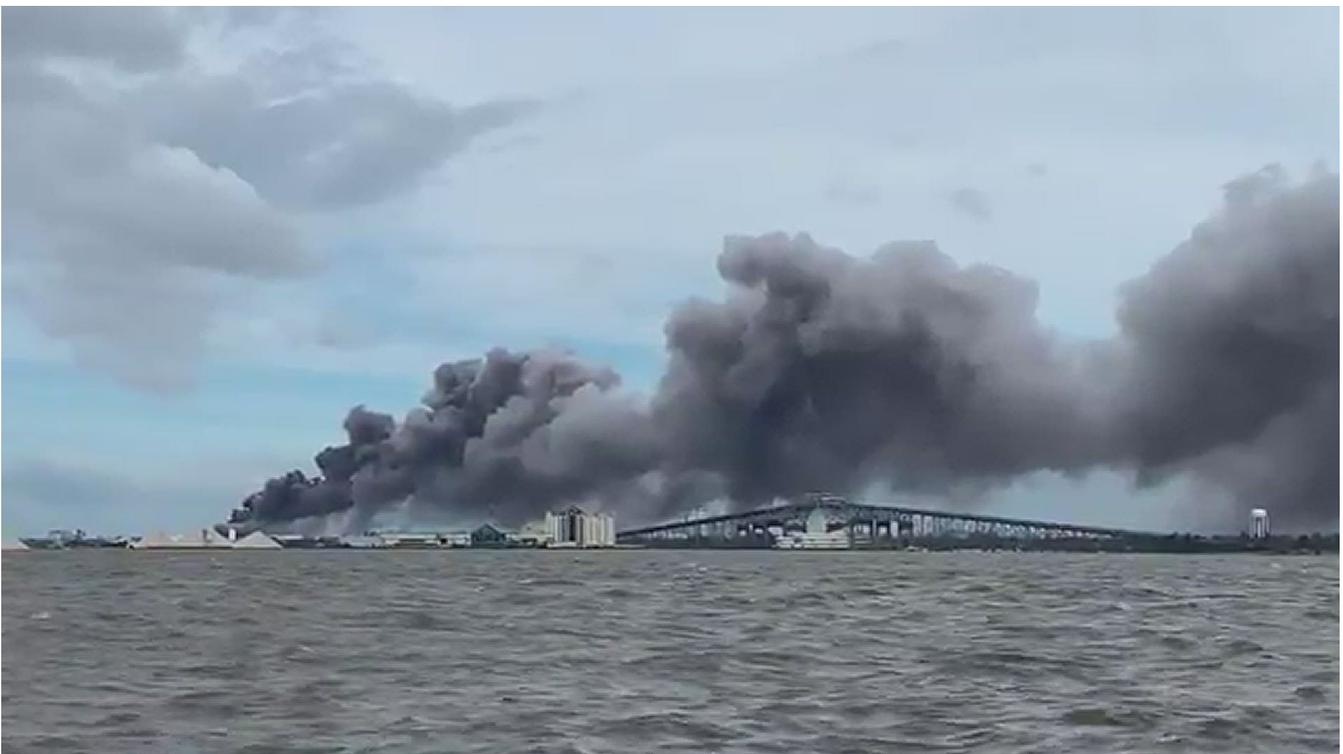
Figure 8. Photo of plume from TCCA decomposition in Bio-Lab Plant 4 approaching the Calcasieu River Bridge near the facility. (Credit: CBS 4WWL [22])

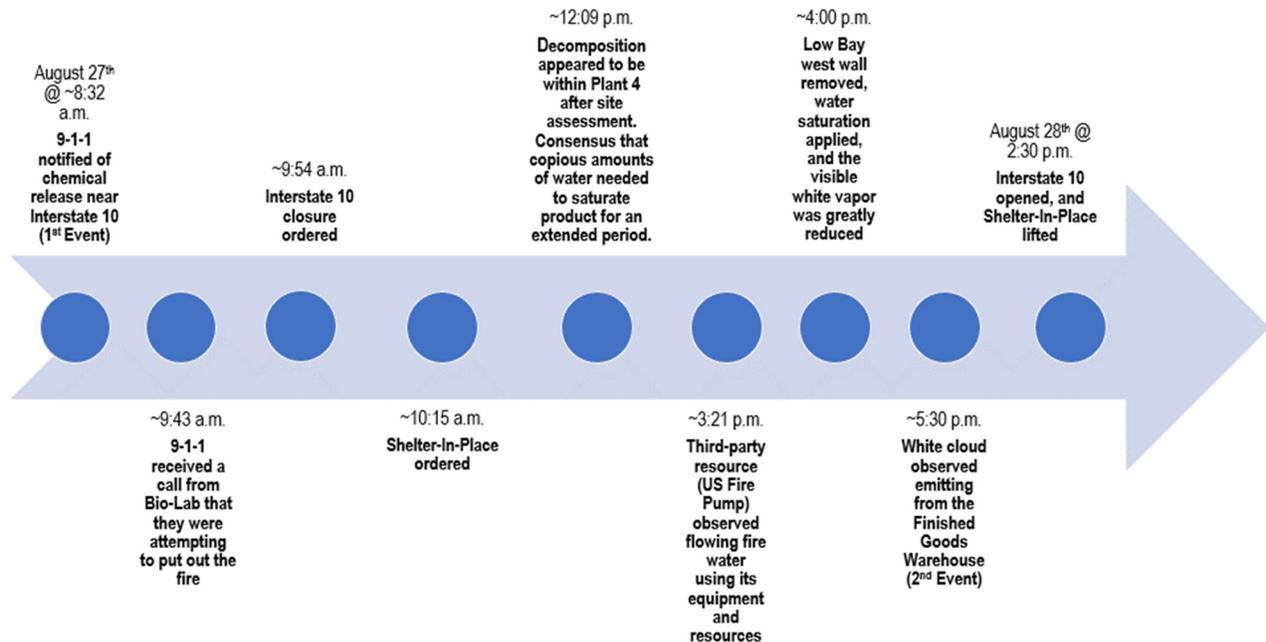
Figure 10. Timeline of events associated with the decomposition reactions. (Credit: CSB)

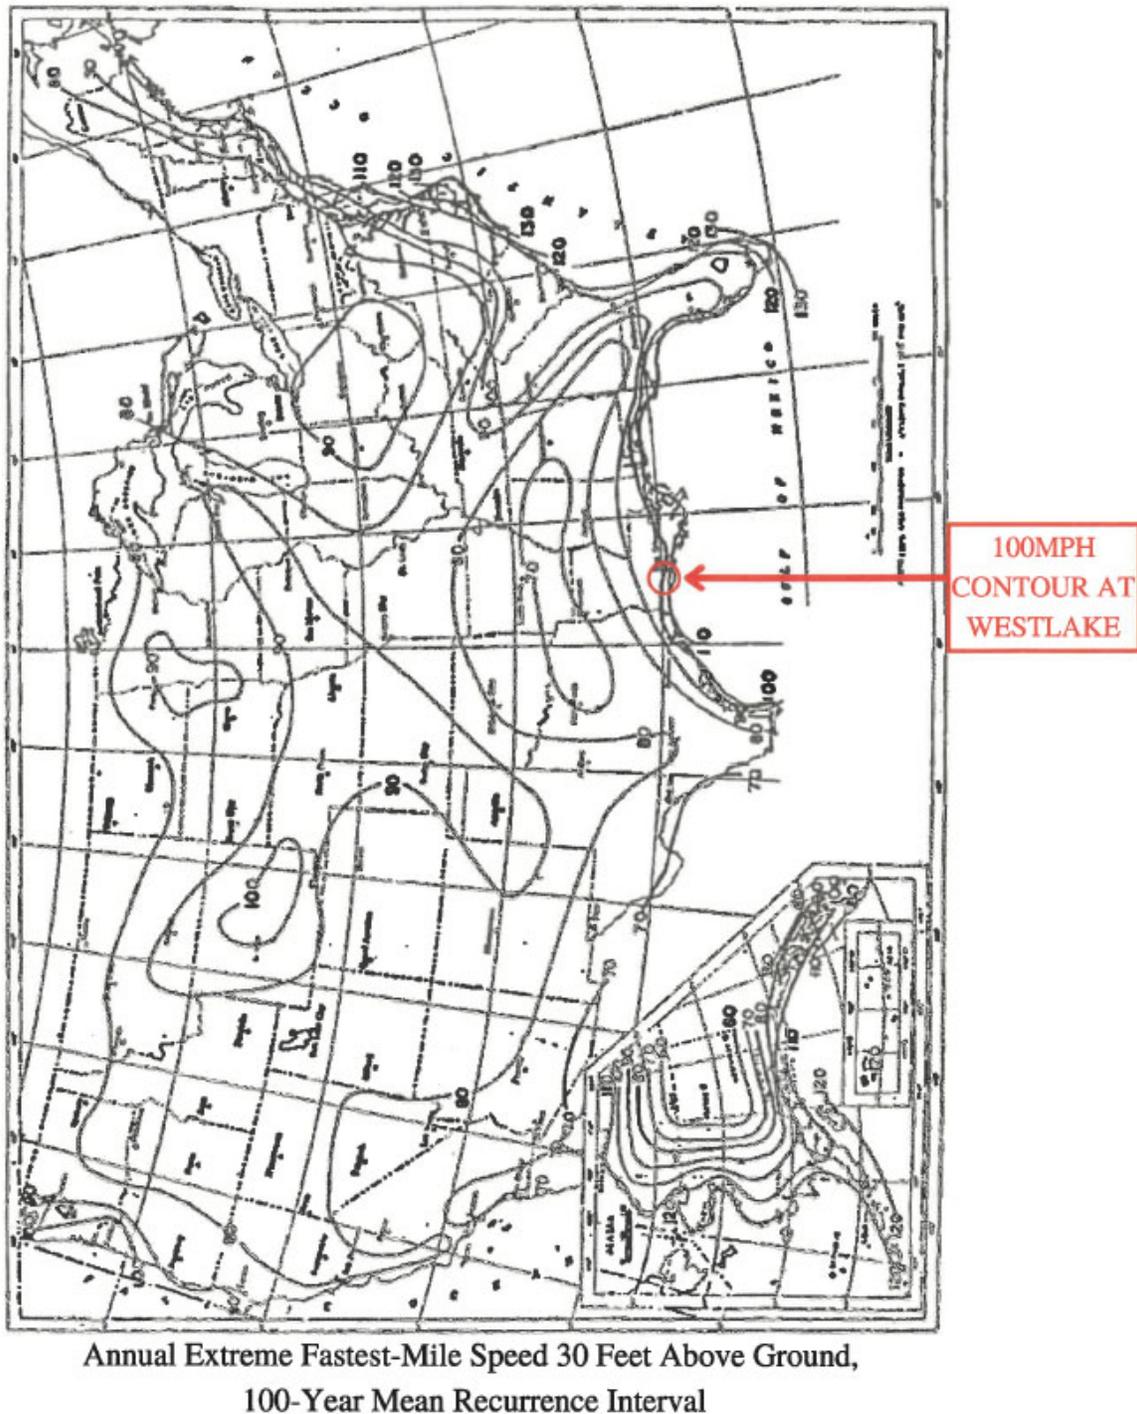
The CSB's discussions with building officials in the Calcasieu Parish and the Cities of Westlake and Lake Charles, Louisiana, suggest that general design standards in the area during the 1970s were largely deferred to the architects and engineers involved. Representatives from the Calcasieu Parish told the CSB that licensed designers in the Parish would potentially look to standard engineering practices, including the prevailing Standard Building Code, for design guidance in the absence of official state adoption of the code. The Standard Building Code in use in 1979 was the 1974 revision of the 1973 edition. Basic design wind speeds are shown in Chapter 12 of that Code, with the Westlake / Lake Charles area falling close to the 100-mph wind speed contour for building design (see **Figure 15** and **Appendix D**).

Figure 15. Basic design wind speeds in the prevailing Standard Building Code in 1979, the year the Bio-Lab facility was constructed. (Credit: 1974 Standard Building Code, annotations by CSB)

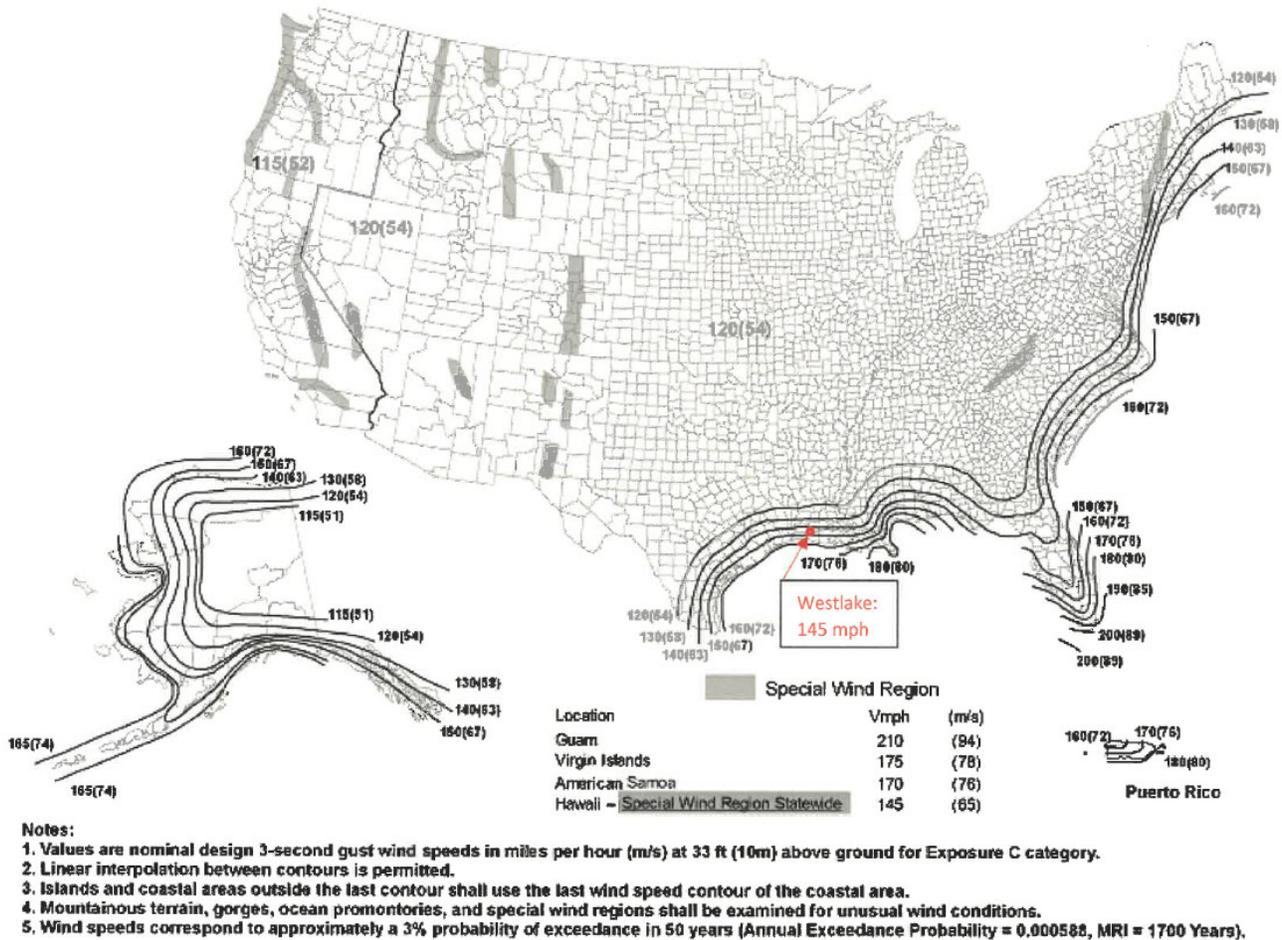
buildings and other structures in the state consistent with the public health, safety, and welfare of its citizens [27].” At the time of the incident (and at present), the LSUCCC adopted the 2015 version of the International Building Code, with amendments,^a as the Louisiana State Uniform Construction Code [28]. Under the 2015 International Building Code requirements for Risk Category IV buildings, the Bio-Lab facility would be required to withstand 145 mph winds (see **Figure 16** and **Appendix D**).

Figure 16. 2015 International Building Code Fig 1609.3(2), Design Wind Speeds for Risk Category III and IV Buildings. (Credit: 2015 International Building Code, annotations by CSB)

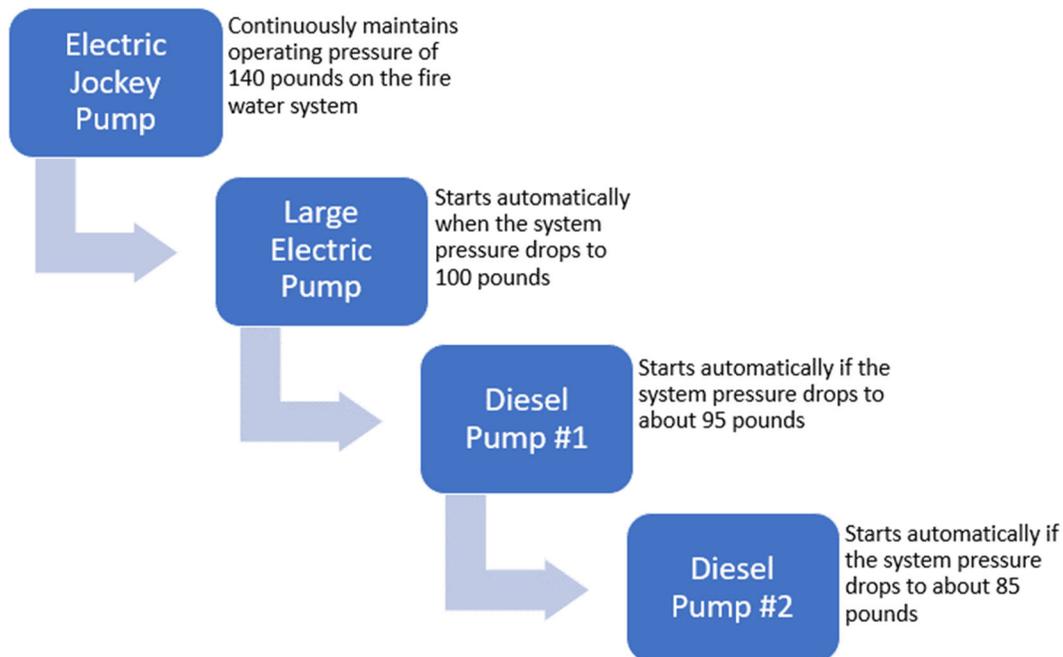
Figure 18. Bio-Lab's fire water pumps automatic start-up sequence. (Credit: Bio-Lab, illustration by CSB)

Hurricane Laura damaged a power grid, causing the Bio-Lab facility and the surrounding area to lose electrical power. Bio-Lab personnel attempted to turn on the rental backup generator to operate the fire protection system. Initially, they could not activate the rental generator, and as a result, neither the electric jockey pump nor the large electric pump could be operated. Later, another employee successfully turned on the generator, but it still could not supply power to the electric pumps. The employees did not have a manual or operating procedure to reference for the rental generator. In addition, one of the diesel pumps was nonfunctional before the hurricane made landfall, resulting in only one fire water pump—a diesel pump—available for use to respond to the decomposition and fire. Once the Fire Department arrived, they also experienced difficulties priming their pump, as discussed in Section 2.3.2. With only one fire water pump, the facility could not achieve adequate pressure to apply water to the decomposing TCCA. The incident could not be controlled until the contracted third-party emergency responders arrived, set up their equipment, and successfully flowed sufficient water to the decomposing TCCA. The problems with the Bio-Lab fire protection system resulted in a lengthy delay of around five and a half hours before productive emergency response operations began. During this delay, the TCCA continued to decompose, releasing large clouds of decomposition products, including chlorine.

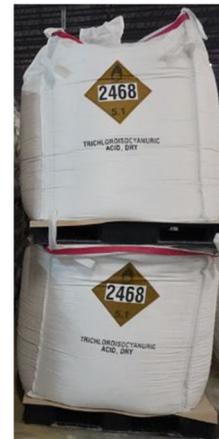
Figure 22. TCCA super sacks storage method inside the Bio-Lab Conyers Plant 6. (Credit: CSB)

^a Bio-Lab stores the TCCA product on wood or plastic pallets inside Plant 6. Worker #1 told the CSB that the TCCA stored in the area was sitting on wood pallets, similar to exemplar stacked bags shown in **Figure 22** where the reaction and decomposition occurred. The CSB confirmed the height of two wood pallets. One measured approximately seven inches high, and the other was about five inches.

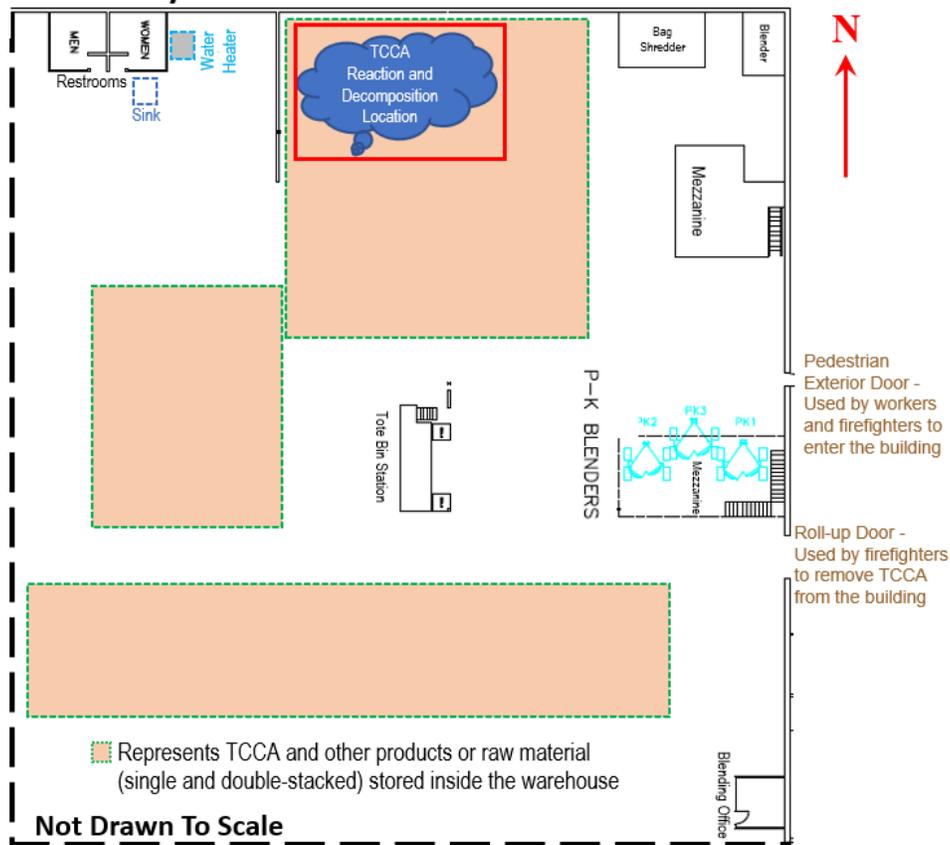
Figure 23. The configuration of a section of Plant 6 and the incident location (red box). (Credit: Bio-Lab Conyers, annotations by CSB)

Between the close of business on Saturday, September 12, 2020, and the normal arrival of employees on Monday, September 14, 2020, a 3/8-inch polyethylene water line leaked in the Bio-Lab Conyers Plant 6, flooding a portion of the building. At approximately 4:50 a.m. on Monday, September 14, 2020, while Worker #1, a production lead, was in the building office preparing for the shift, Worker #2, a blending operator, entered the office and reported seeing water on the building floor. Worker #1 proceeded to the area to assess the situation and saw that water covered approximately 75% of the floor. Worker #1 estimated that the floodwater was about two or three inches deep in some areas but lower than the top of the wood pallets used to store TCCA near the building's north wall (**Figure 23**).^a He then walked near the employee restrooms (**Figure 23**) and saw water releasing from a polyethylene line connected to the water heater (**Figure 24**). Worker #1 immediately closed the water heater's hot water outlet valve, which stopped the water leak. After stopping the water leak, Worker #1 contacted the Maintenance Department to report the damaged line and notified management of the flooded warehouse.

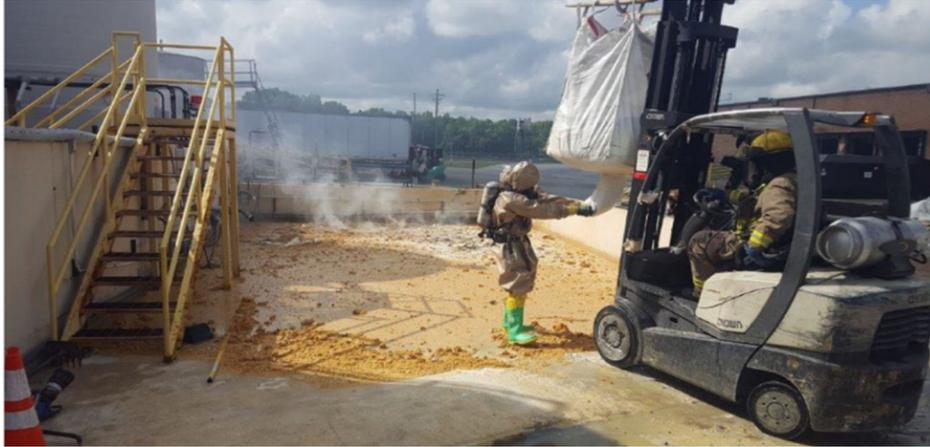
According to the Rockdale County Fire Department, “access to the decomposing pallets was hindered by other surrounding poorly stacked pallets of materials.” The Fire Department also established an external decontamination area (**Figure 26**) and moved decomposing materials to this area using forklifts and skid steers^a to stop the chemical reactions inside the building.^b

Figure 26. External decontamination area outside the Bio-Lab Conyers Plant 6. (Credit: Bio-Lab Conyers)

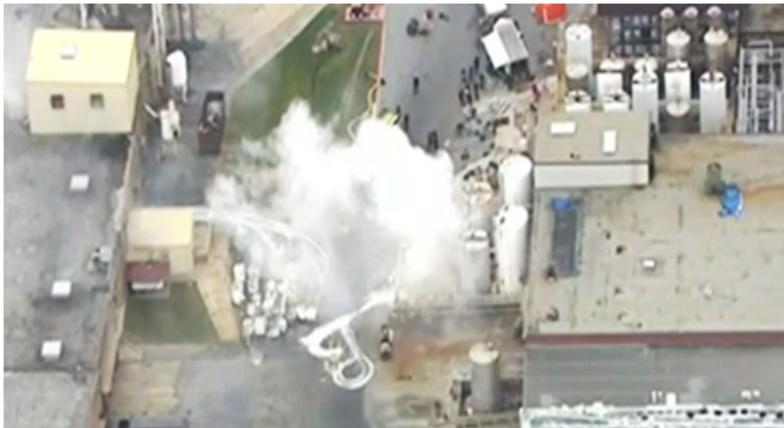
The Fire Department temporarily closed a portion of Georgia Interstate 20 (I-20) from approximately 7:00 a.m. to 1:00 p.m. while chemical plumes were emitting from the Bio-Lab Conyers facility (**Figure 27**). Post-incident, nine firefighters were taken to the hospital for evaluation after inhaling hazardous vapors, and were subsequently released.

Figure 27. TCCA decomposition products, including chlorine, releasing from the Bio-Lab Conyers facility on September 14. (Credit: WSB-TV Channel 2 Atlanta)

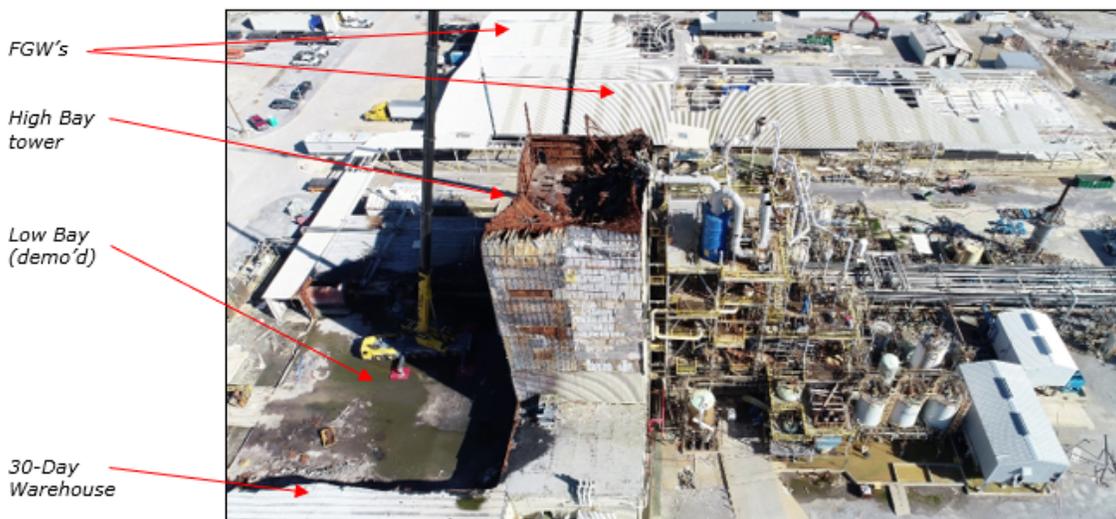
We observed conditions at five damaged buildings at the facility soon after the event. The A-Z Building and the two FGW structures suffered substantial wind damage but were repairable. The Plant 4 Low Bay was destroyed by fire and had been demolished at the time of our site visit. The Plant 4 High Bay tower had severe structural damage. The High Bay was not safe to enter, and was not repairable.

Overview, looking north (Atlas UAV, 9/30/2020)

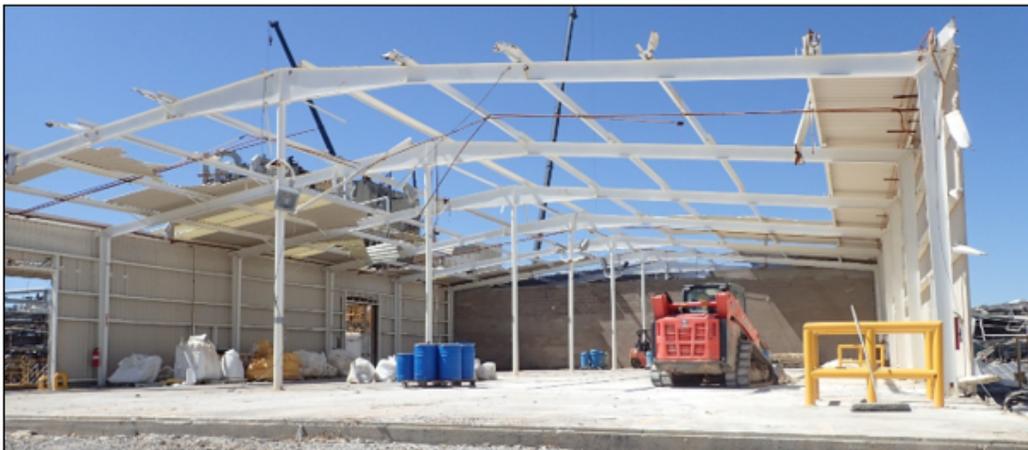
Eastern bay of south FGW, looking SW. Wrecked framing has been removed (Atlas, 9/29/2020)

Wind Damage – At both FGW’s, the columns at the eastern end-walls collapsed to the west, falling into the eastern building bay and buckling roof purlins and wall girts as they fell. We examined the column bases at these end-walls and found severe corrosion at the anchor bolts. Several anchor bolts had corroded in two, leaving the end-wall columns unattached to the slab, and less able to resist wind loads.

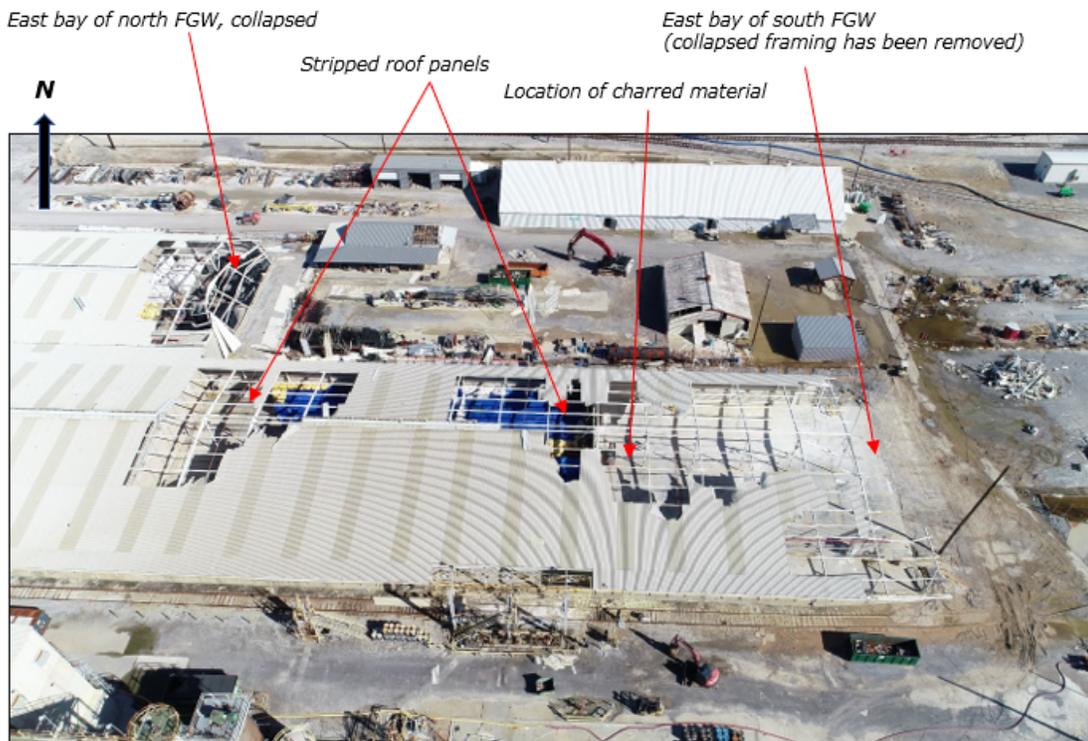
Finished Goods Warehouses (Atlas UAV, 9/30/2020)

Post-Incident Condition – The buildings were damaged but the structures were relatively stable. Hazards included loose overhead panel debris, damaged framing at the eastern bays, and hanging wires. It was feasible to repair these buildings.

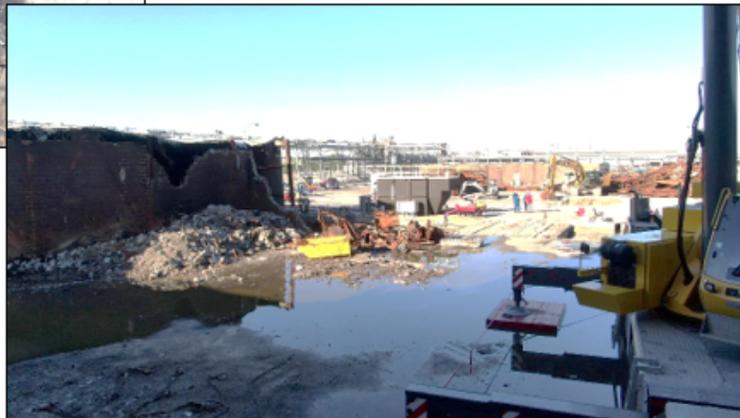
View looking west (Atlas UAV, 9/30/2020)

Fire Damage - According to the site demolition contractor, the heat from the fire buckled the building columns and the roof collapsed. At the time of our site visit the debris had been cleared from the building footprint.

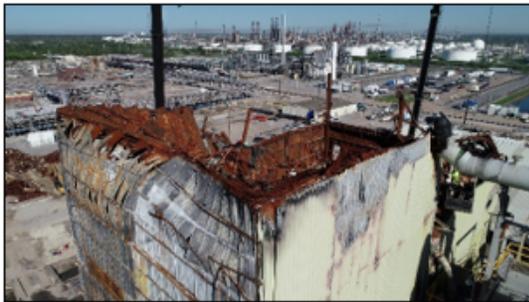
Fire Damage – The fire had severely damaged the tower’s structural framing. The fire’s heat softened the steel, leading to deformation and collapse of the building columns above the Level 4. These columns folded inward, funneling the roof-top blowers, their concrete roof slabs, and the mezzanine equipment toward the center of the building and dropping this debris onto the Level 4 floor. The middle of the Level 4 floor system failed and some of this equipment dropped below onto Level 3. Part of the Level 3 floor system also failed. We found heat-deformed out-of-line columns, beams, and bracing at every floor level. The fire destroyed all the internal process equipment. Many machines fell loose from their moorings, and tons of debris fell to floor areas not designed for concentrated loading.

Upper 35’ of tower looking NW, after fire & demo work (Atlas UAV, 9/30/2020)

Post-Incident Condition – The High Bay tower was standing but had been severely damaged by fire. The floor levels were damaged, overloaded, and liable to collapse at any time. While at the site, we advised the CSB, the Bio-Lab Plant Manager, and the site contractor not to enter the tower or allow anyone to do so. The High Bay tower was damaged beyond repair. We recommended that demolition be accomplished using stand-off methods.

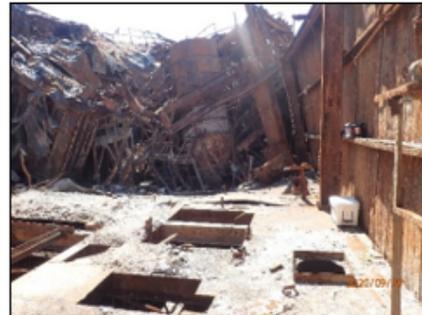
4th floor level, from north stair (Atlas 9/29/2020)

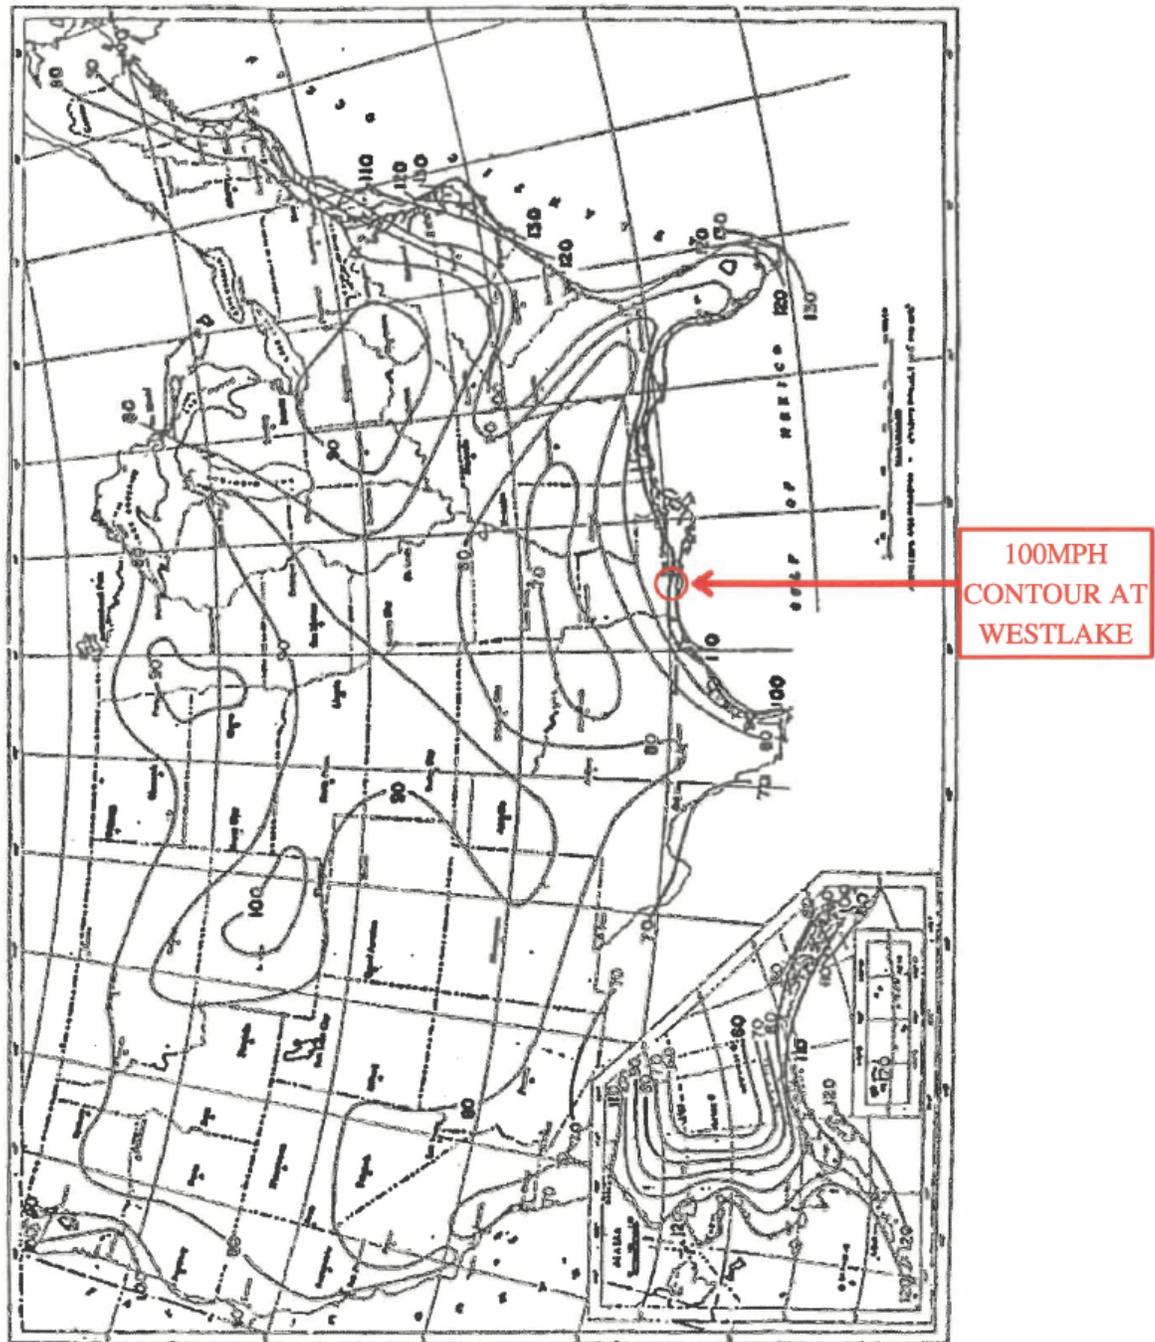
Attachment 2: Wind map, 1974 Standard Building Code (SBC)

The SBC in use in 1978 was the 1974 revision of the 1973 edition. Basic design wind speeds are shown in Chapter 12, on figure 1205.1, with the Westlake area falling close to the 100 mph wind speed contour (see Attachment 2).

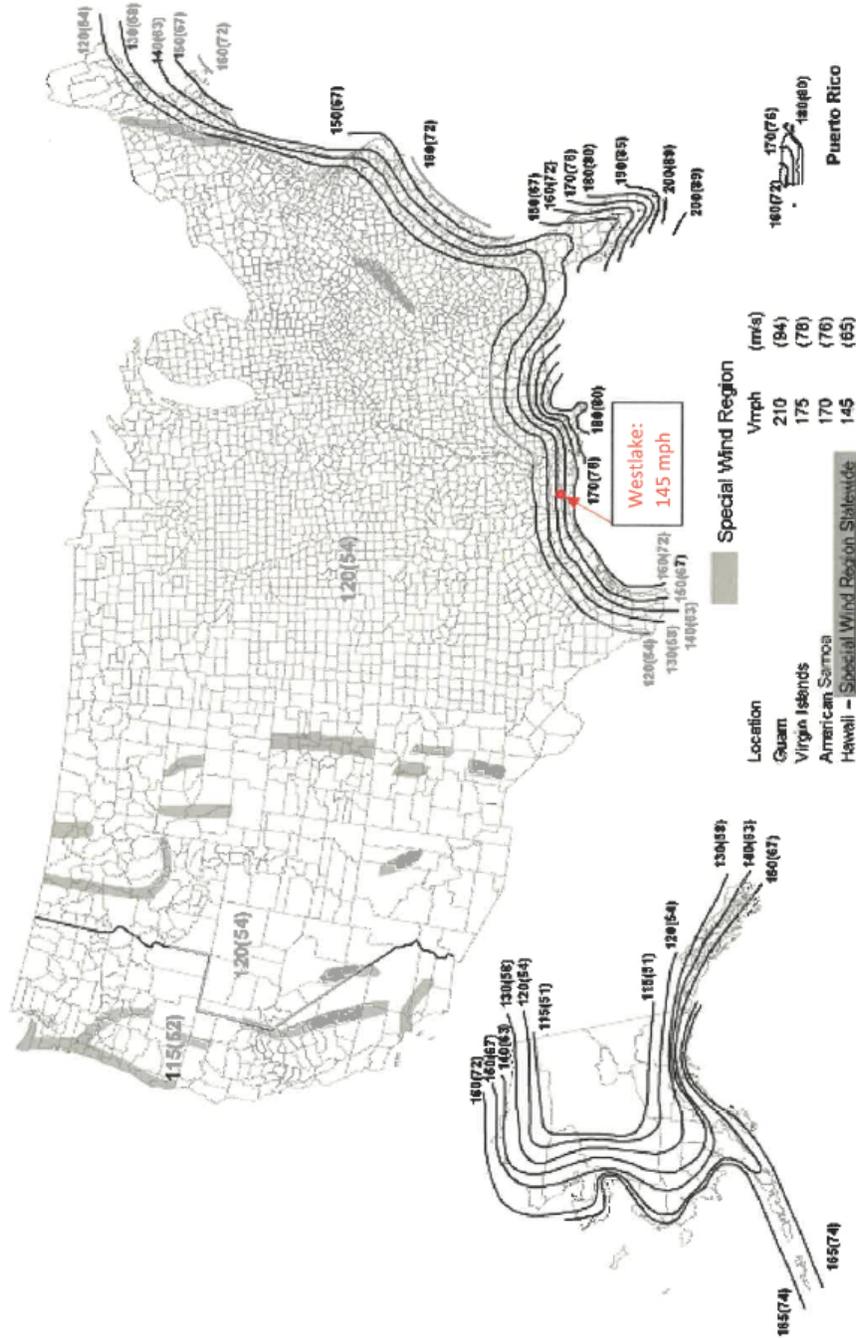
Attachment 4: Wind map, 2015 International Building Code Fig 1609.3(2)

For Risk Category IV buildings like those at the Bio-Lab site, the 2015 IBC design windspeed is 145 mph, in accordance with IBC Figure 1609.3(2) (see attachment 4).
