### Introduction

**A**t approximately 11:00 PM on May 31, 2017, explosion(s)<sup>1</sup> at the Didion Milling (Didion) facility in Cambria, Wisconsin, resulted in 5 worker deaths and an additional 14 workers injured. Because the event occurred at night, only 19 employees were working within the facility at the time of the incident.<sup>2</sup>

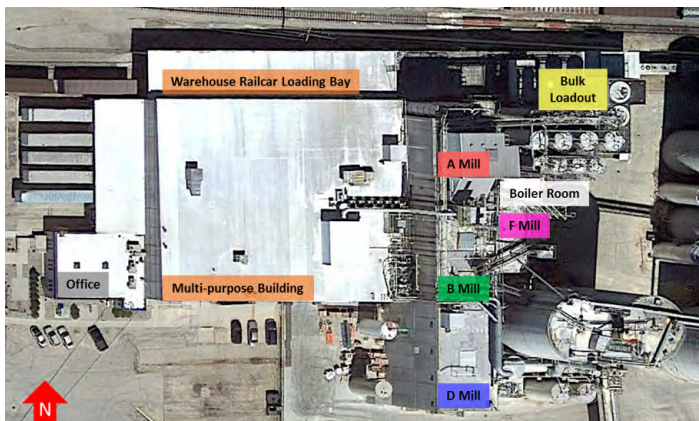
**Figure 1.** Pre-incident overhead view of the Didion corn mill facility.<sup>12</sup> Each building has been highlighted with its own color.

The explosion(s) caused the complete collapse of the multi-purpose building, the Warehouse Railcar Loading Bay F Mill, and the boiler room, and severely damaged the remaining three mill buildings (A Mill, B Mill and D Mill), bulk loadout, and the front office. Figure 3 depicts the severity of the post-incident damage that various buildings sustained and the approximate locations of workers inside the Didion facility at the time of the incident. Figures 4 and 5 provide pre- and post-incident comparisons of the Didion facility from different locations.

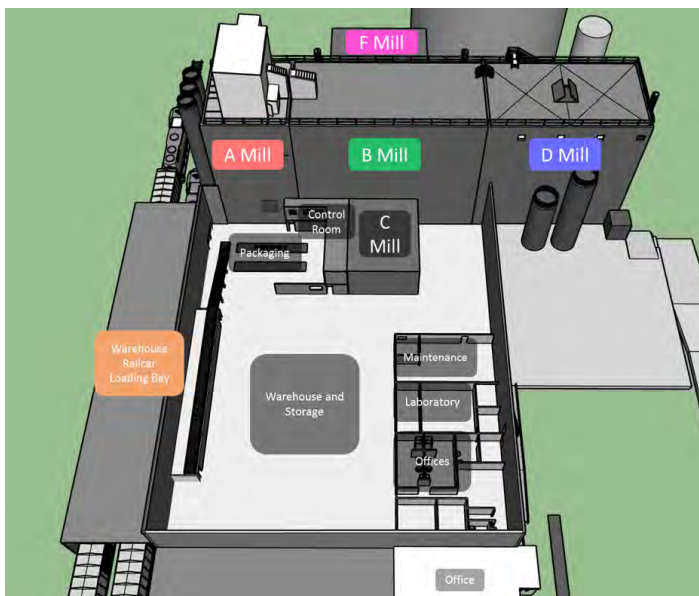
**Figure 2.** The multi-purpose building housed C Mill, packaging equipment, offices, a laboratory, a maintenance shop, and the mill control room.

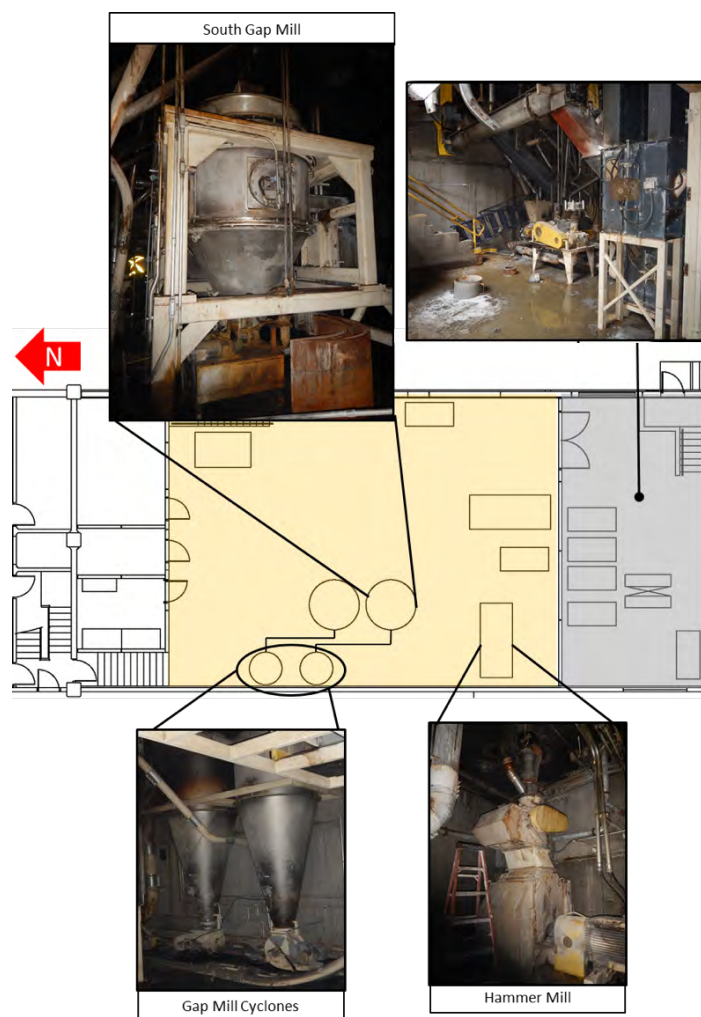
**Figure 8.** Partial equipment layout and photos in 1B identifying and denoting the locations of the south gap mill and a cyclone connected to gap mill’s product output stream (see Figure 10 and footnote 29 for further explanation), a hammer mill and a room (grey) containing various pieces of equipment that Miller B inspected for burned belts or other problems.

Miller B was returning to the second floor when he noticed a small amount of smoke in another room in 1B (yellow room, Figure 8), but he could not tell where it was coming from. He and another co-worker who had come to look for the smoke source checked a hammer mill and they assessed it to be running well (Figure 8). They also visually confirmed that product was flowing well through a nearby gap mill (Figure 8) by inspecting a sight glass on a cyclone connected to the mill's product output stream (Figure 9).<sup>29</sup>

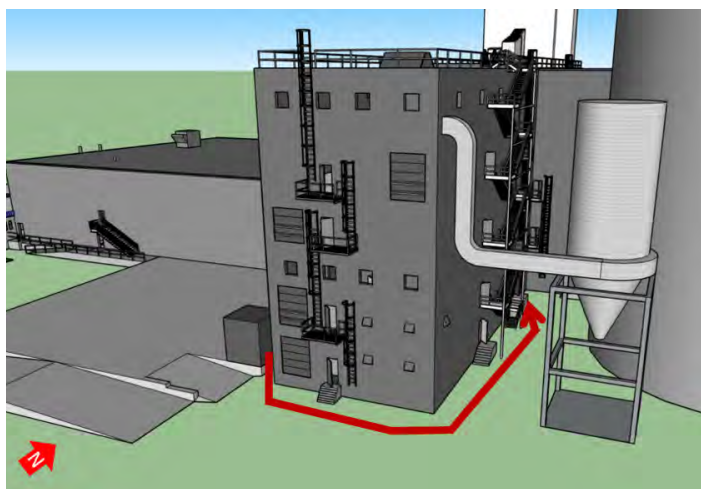
There were two access doors to the control room, one through the mill and the other through the warehouse. To check for smoke outside, the Superintendent walked through the warehouse and around the south end of D Mill toward the east side of B Mill, where he entered 1B from the stairs next to a metal garage door (Figure 11). He did not find any smoke outside, but as soon as he opened the door to 1B, he saw thin smoke lingering on the ceiling. The smell was unfamiliar to him, so he started to worry.

**Figure 11.** The Superintendent walked (red arrows) the south side of D Mill and entered 1B from a door the east side.
