U.S. Chemical Safety and
Hazard Investigation Board

Fatal Combustible Dust Explosions at Didion Milling Inc.

Cambria, Wisconsin | Incident Date: May 31, 2017 | No. 2017-07-I-WI

Investigation Report

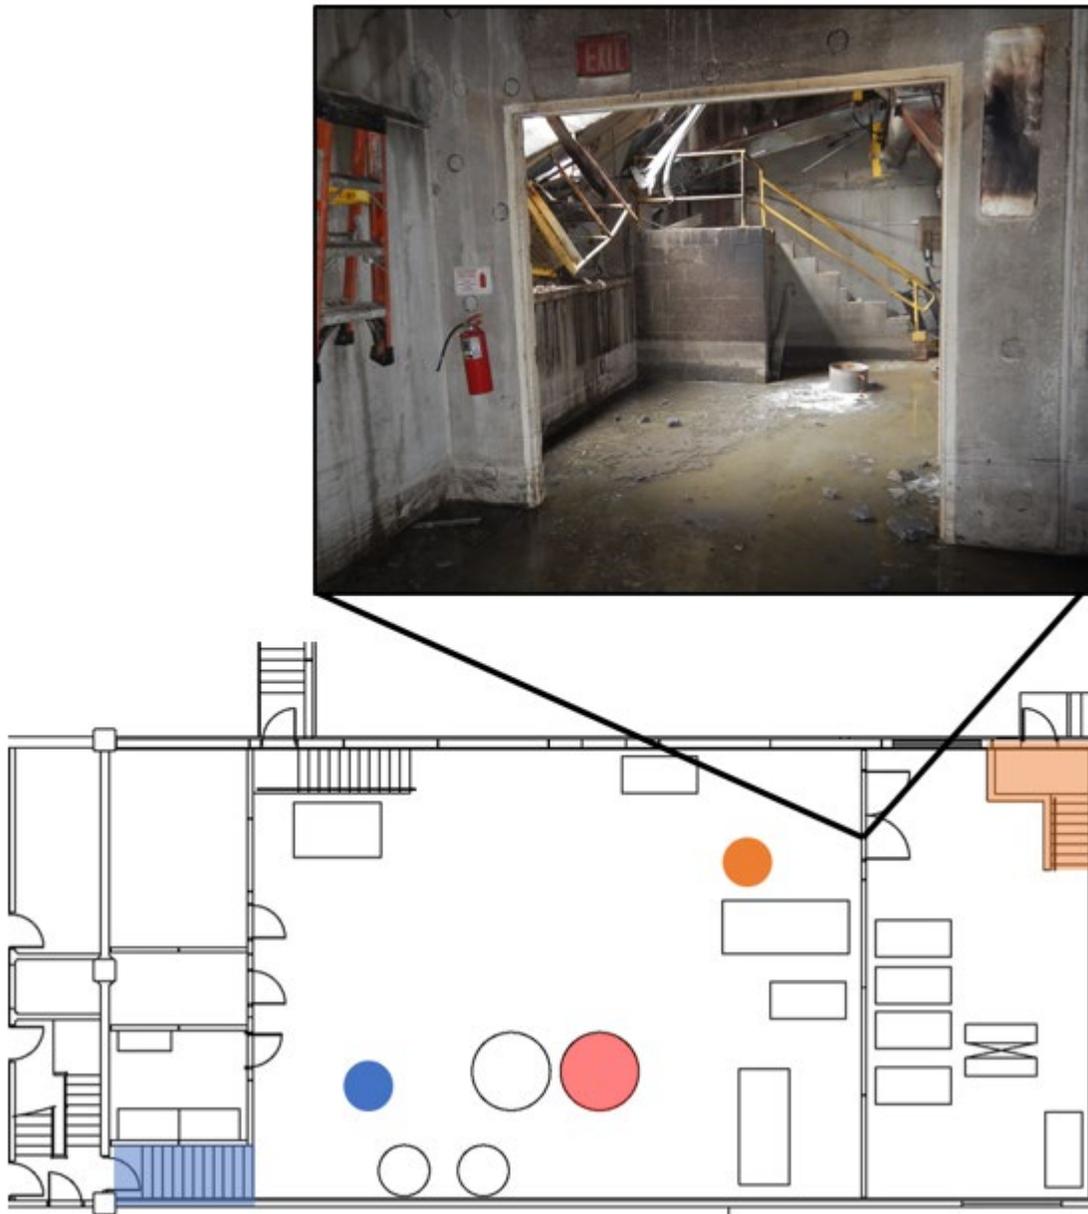
Seeing the flame and dust in the air and recognizing that the dust cloud was likely to ignite and explode, Employees A and B decided to leave 1B immediately. They ran out in opposite directions, each leaving the same way they had entered, as shown in **Figure 18**. As Employee B left 1B, he could still hear radio traffic, but he could not interject on the Miller radio channel to tell people to evacuate due to the amount of radio traffic.^a Just as Employee B stepped outside, the radio channel cleared. He attempted to make an evacuation announcement, but at that moment, a significant explosion occurred (Explosion 2).

Figure 18: 1B floor plan showing escape routes. Employee A escape route shown in blue and Employee B escape route shown in orange. South BM shown in red. Inset photo: stairwell post-incident that Employee B escaped through. (Credit: CSB)

Employee B also described, as he escaped from the building via the southeast door of 1B, that multiple explosions continued to occur. He estimated that he was 15 to 20 steps outside the southeast door of 1B (see **Figure 18**) when Explosion 2 happened. He was having difficulty seeing his escape route through dust and smoke.

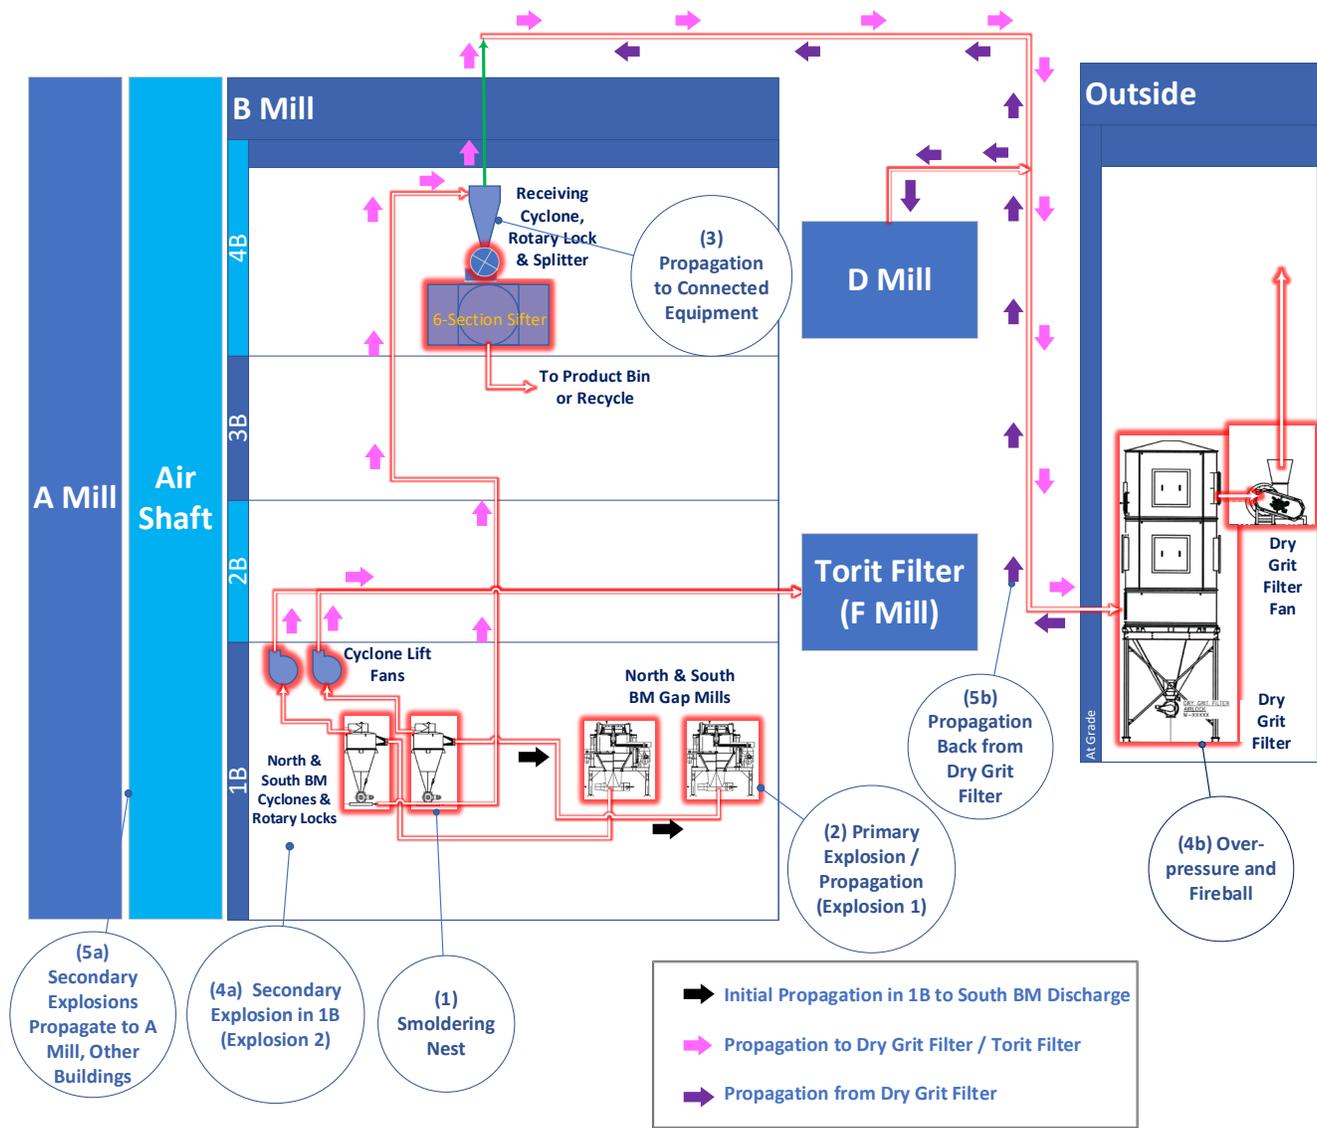
1. A smoldering nest developed in the Bran process, likely downstream of the South BM.
2. A primary explosion (Explosion 1) occurred inside Bran process equipment, likely located in 1B.
3. The primary explosion propagated inside the interconnected process equipment.
- 4a. The first secondary explosion (Explosion 2) occurred on 1B.
- 4b. Within a few seconds of Explosion 2, the Dry Grit Filter overpressured and released a fireball.
- 5a. A series of secondary explosions begins throughout the mill buildings, resulting in significant building damage and collapse.
- 5b. At approximately the same time, a deflagration propagated from the Dry Grit Filter back toward other process equipment through piping and ductwork.

Figure 24: Summary of sequence of events during Didion incident, numbered in order. (Credit: CSB)

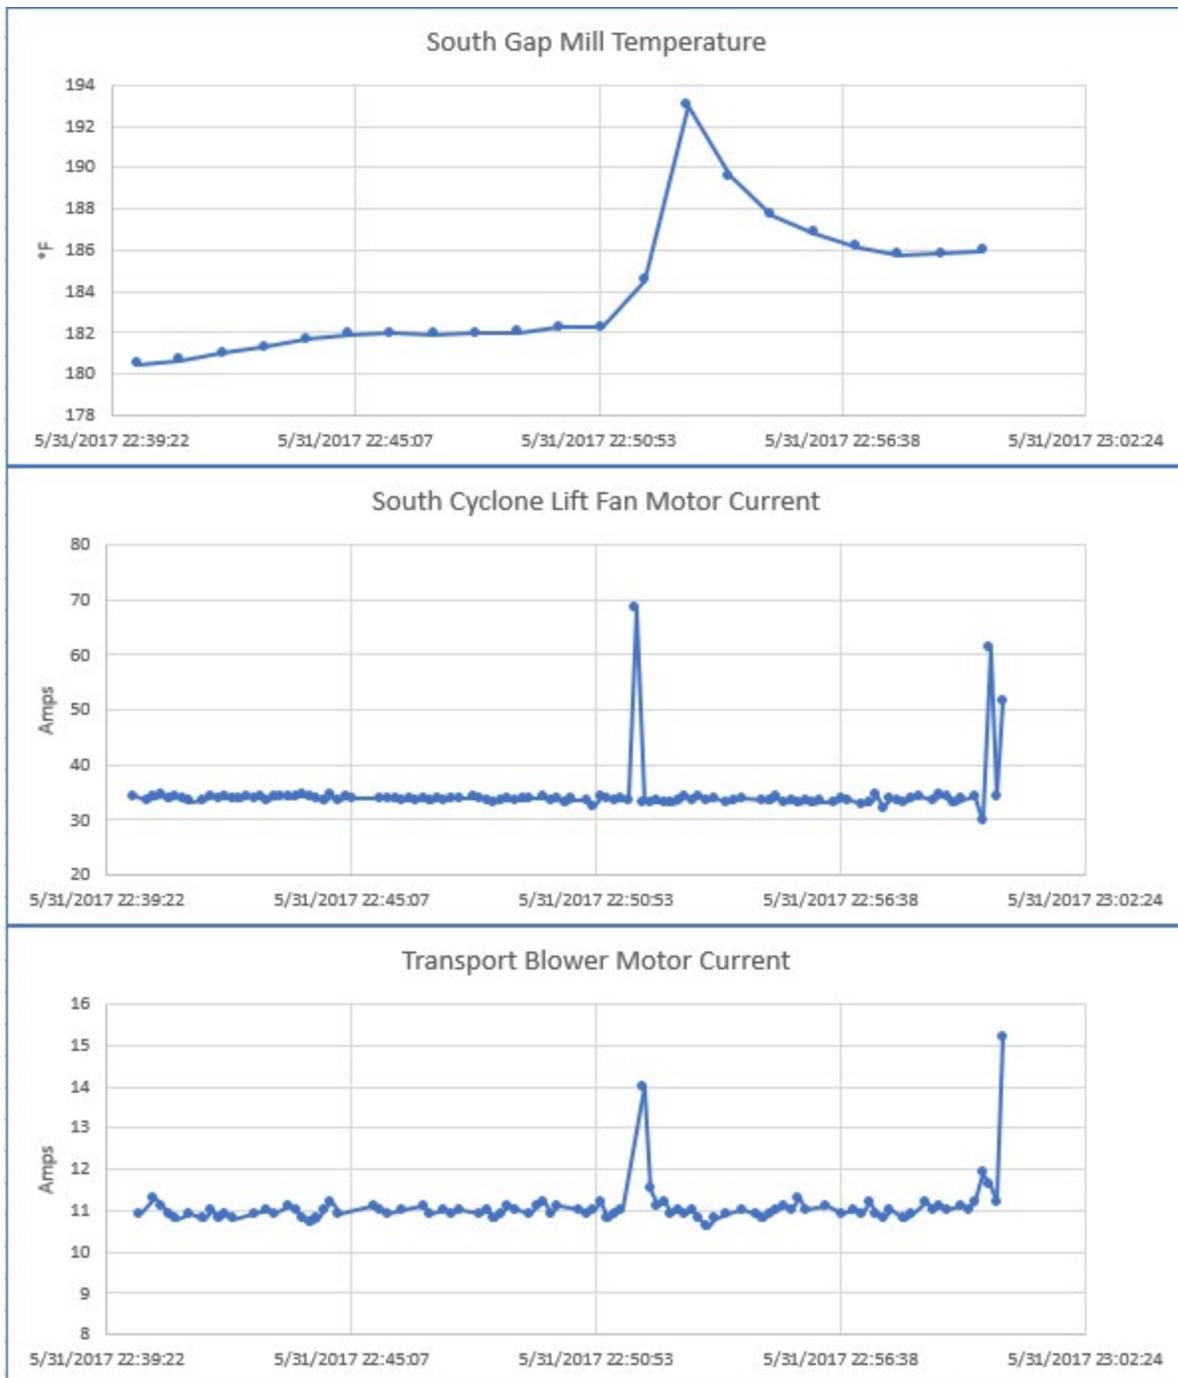
From 10:12 p.m. until 10:52 p.m., eight minutes before the explosion occurred at 11:00 p.m., the South BM temperature gradually increased. At approximately 10:52 p.m., the South BM temperature spiked, and the current draw for the transport blower (to 4B) and South BM Cyclone Lift Fan spiked at nearly the same time, as shown in **Figure 25** (center trend). These spikes are consistent with a hot slug of material traveling through the process, briefly plugging the South BM Cyclone Lift Fan and Transport Blower discharge line and clearing out when the spike returned to previous values.

Figure 25: South BM temperature, cyclone fan amps, and transport blower amps in the 20 minutes leading up to the explosion. (Credit: Didion, adapted by CSB)

It should be noted that the temperature indicators for the South BM are near the top of the unit, and hot material below or downstream of the South BM may not be fully detected by temperature sensors near the top of the South BM. Thus, the actual temperatures inside the downstream process could have been higher than indicated inside the South BM.

In the last 30 seconds before the process data historian lost power, the South BM Cyclone Lift Fan motor current oscillated significantly. This was a departure from its behavior at any other time (center trend in **Figure 25**

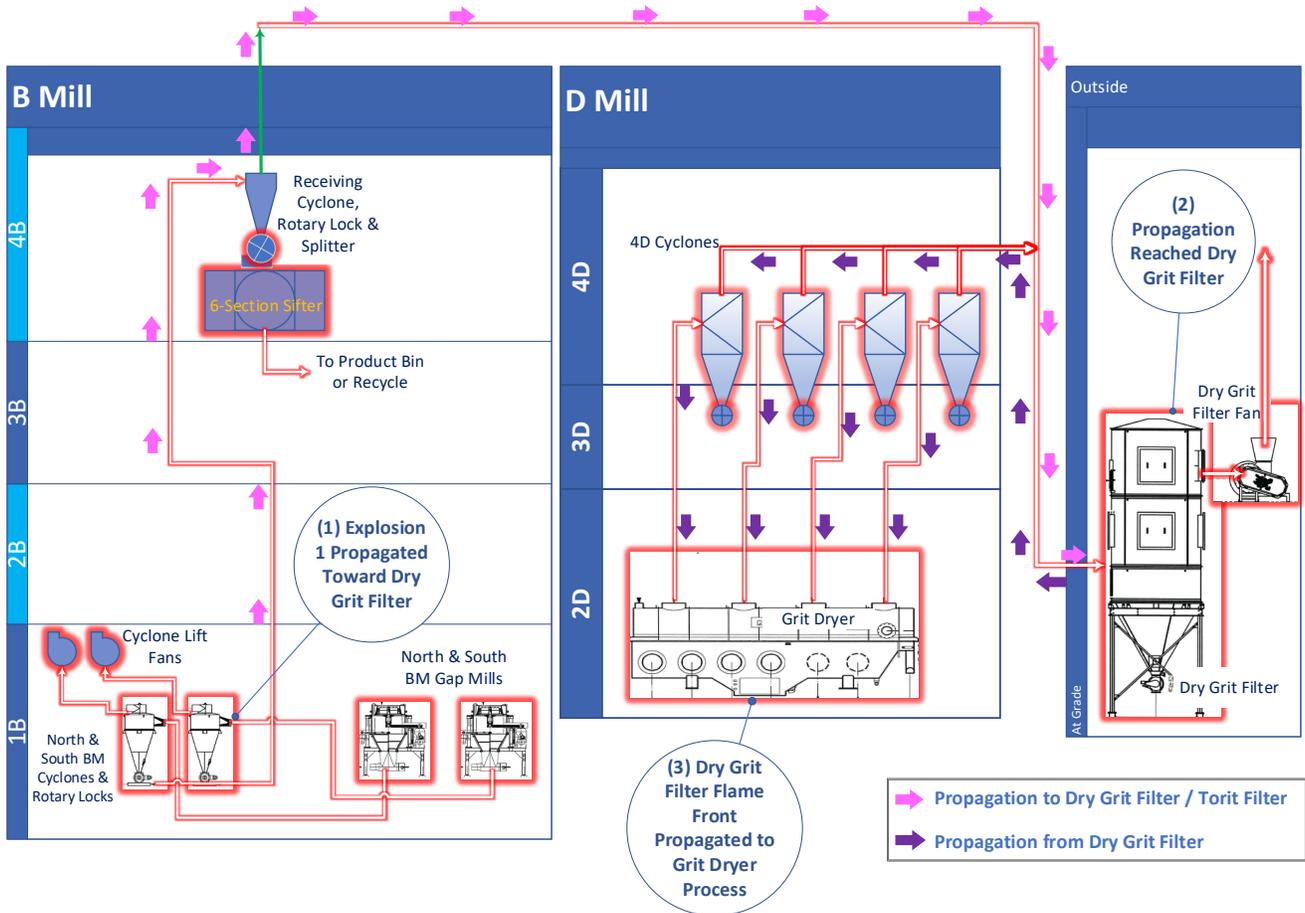
The Grit Dryer system was not directly connected to the Bran process on 1B where the first explosion occurred. The only connection between the two processes was through the Dry Grit Filter. **Figure 33** shows one likely path from the initial explosion on 1B, to the Dry Grit Filter, and then back out to the Grit Dryer system. As discussed above, there were several potential paths from 1B to the Dry Grit Filter, but the path from Dry Grit Filter to Grit Dryer system is clear, as shown in **Figure 34**. **Figure 35** shows an example of fire damage to the Grit Dryer exhaust ductwork that led to the Dry Grit Filter.

Figure 34: Potential path for propagation from 1B to Dry Grit Filter (pink arrows) to (simplified) Grit Dryer system (purple arrows). Known internal fire damage is highlighted red. (Credit: CSB)

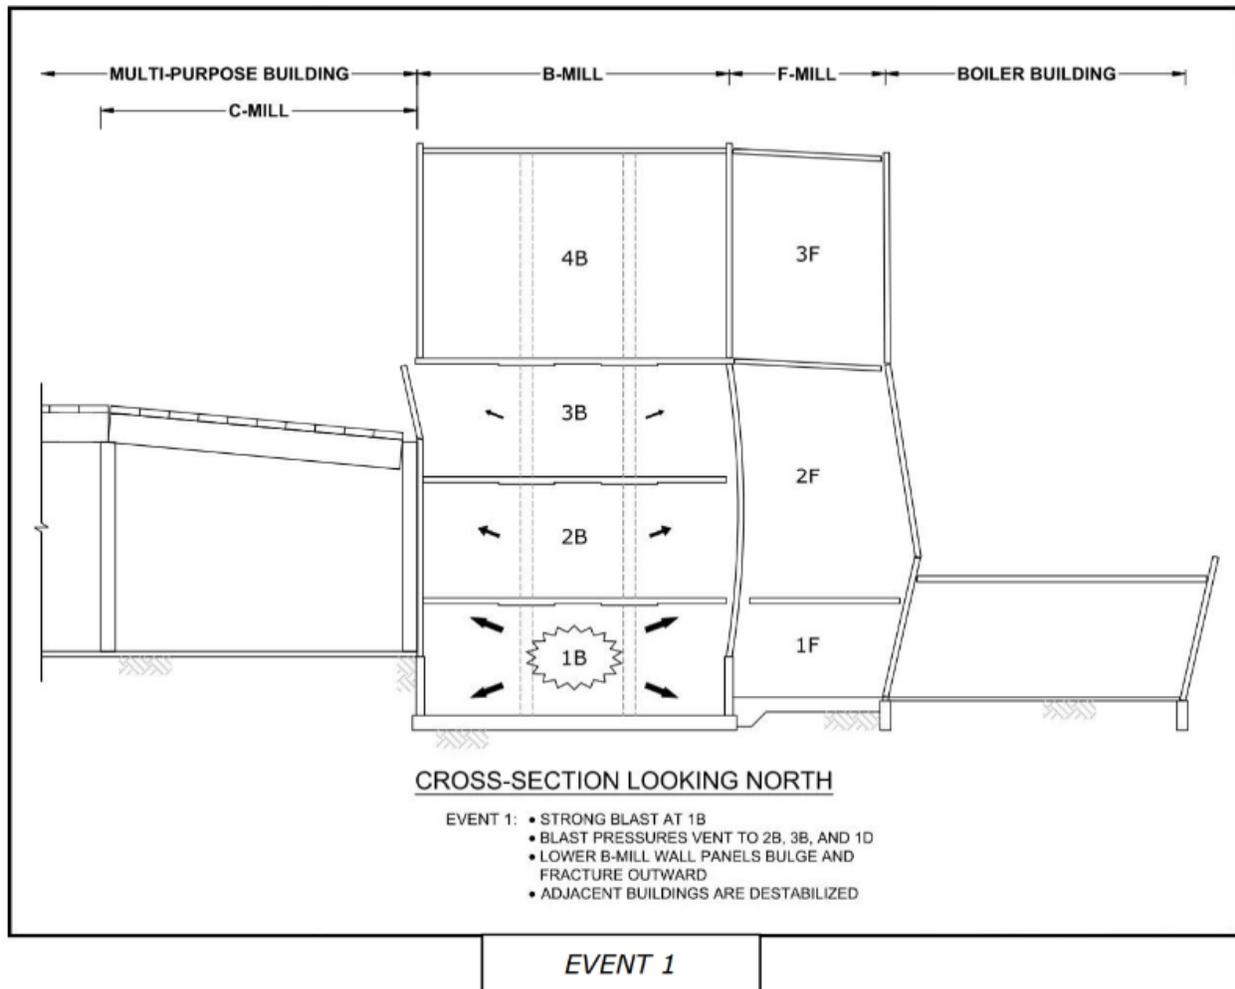
Because the initial building pressurization was centrally located in 1B, and because of the add-on construction using shared walls, the first explosion on 1B had a destabilizing effect on many mill facility structures almost simultaneously, leaving employees without enough time to escape the collapsing buildings once the initial blast began. **Figure 42** illustrates the destabilizing effect that a 1B blast wave could cause. This structural design is discussed further in **Section 4.4**. The full structural analysis report is in **Appendix D**.

Figure 42: Destabilizing results of an initial blast in 1B. (Credit: CSB)

According to the structural analysis, it took only three to five seconds for connections and structural members to break apart and for the broken pieces to fall to the ground in C Mill, the Multipurpose Building, F Mill, and the Boiler Room. After the incident, the 4B wall panels were found resting on top of F Mill and the Boiler Room rubble on the east side and C Mill and Multipurpose Building rubble on the west side. This indicates that the 4B wall panels likely separated from the building and fell at least several seconds after the other buildings collapsed.

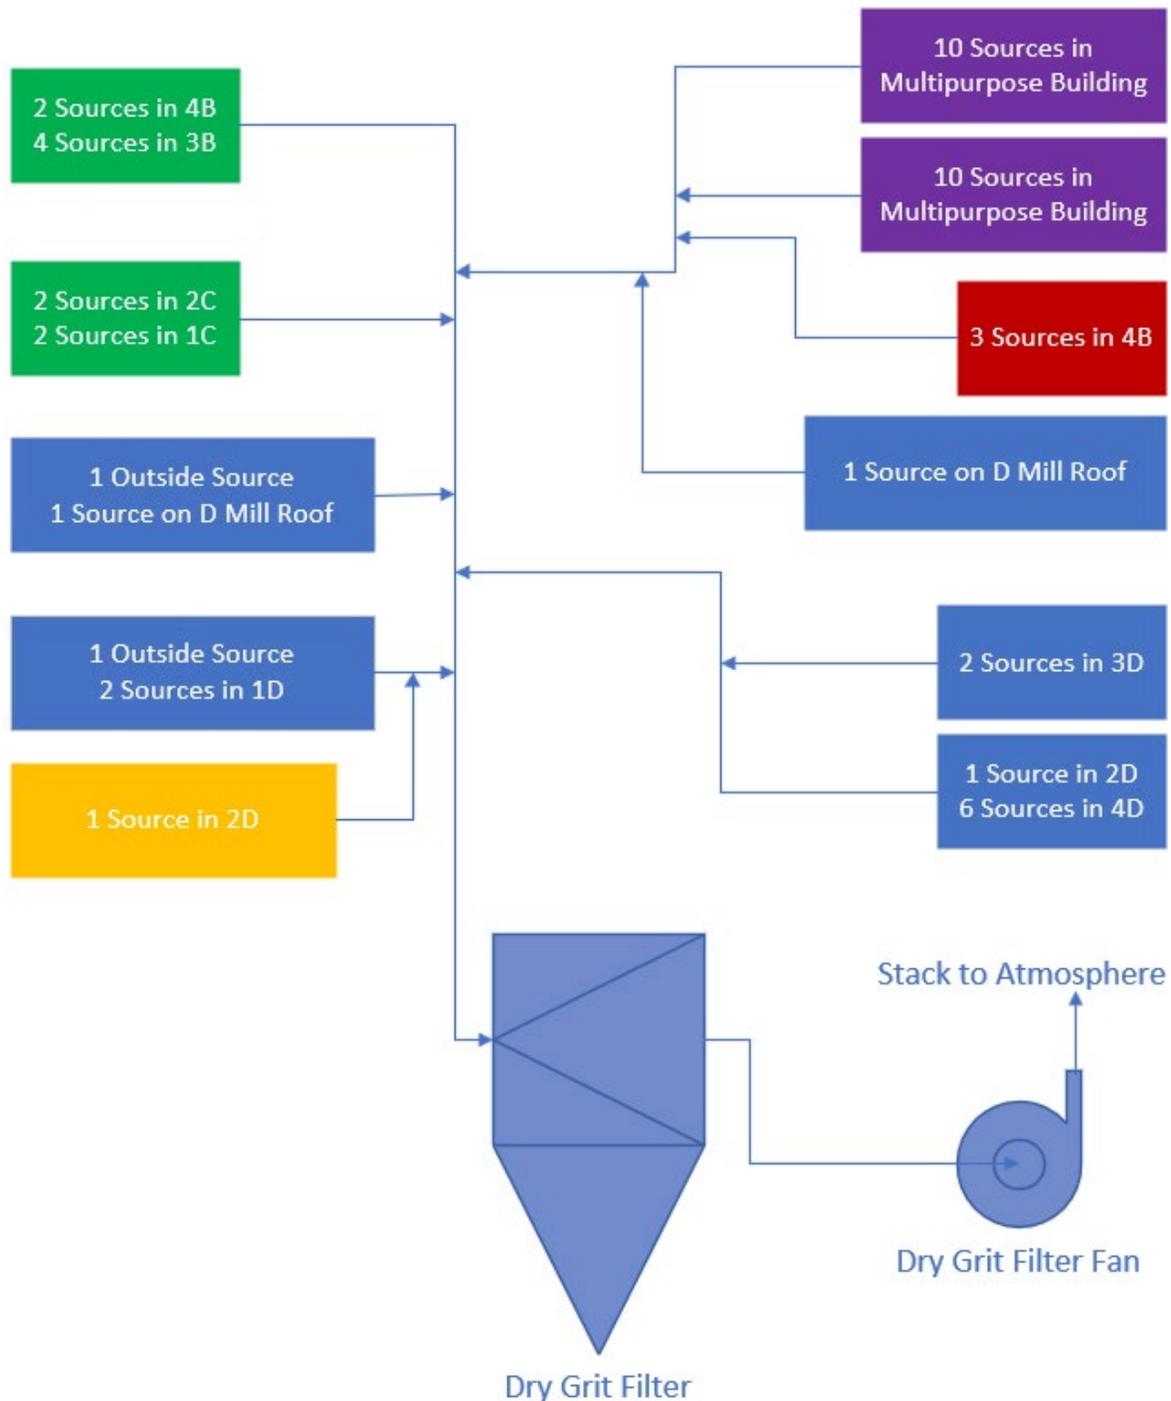
Didion connected numerous pieces of equipment together, including mills of various types, as shown in **Figure 45** below. For example, the CSB estimated that the Dry Grit Filter connected at least 46 pieces of equipment across at least four different processes and three buildings. This heavily manifolded system design, without any form of isolation controls present to mitigate or stop a propagation event, increased the propagation risk at Didion. As shown in **Figure 45**, once a propagation began in this system, it could continue to spread through multiple buildings and processes (represented by different-colored boxes) quickly given the interconnectivity the Dry Grit Filter provided. As discussed below in **Section 4.9**, OSHA alerted Didion to this hazard more than three years before the incident. The engineering controls for propagation risk mitigation are further discussed in **Section 4.3**.

Figure 45: Diagram of sources for the Dry Grit Filter. Each mill facility process is represented by a different-colored box. (Credit: CSB, adapted from Didion)

The CSB concludes that Didion did not recognize the propagation hazard that interconnecting numerous pieces of equipment presented and did not take sufficient action to prevent flame front propagation through its dust collection systems. This lack of recognition increased the likelihood that a propagation

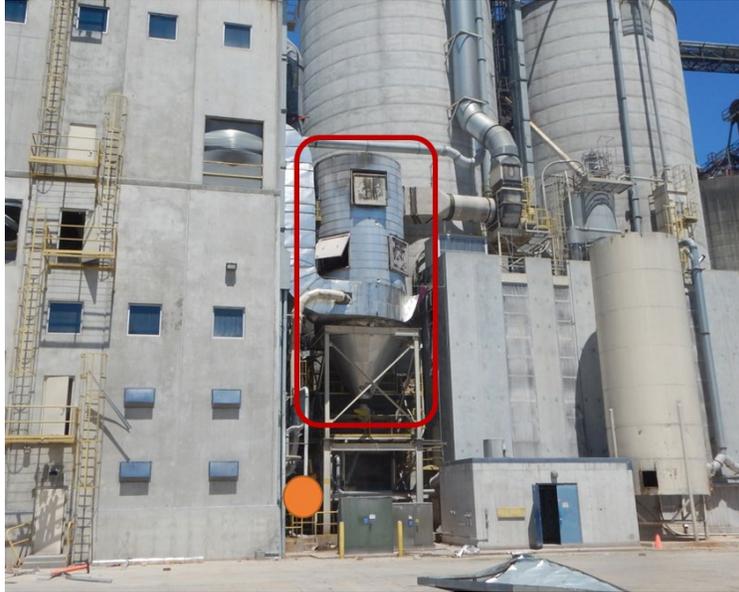
While the Dry Grit Filter was located outside of the mill buildings, the deflagration venting from the filter housing presented a hazard to the facility structure and the employees. The pressure relief vents installed on the Dry Grit Filter discharged into an occupied area. During the incident, the deflagration vent doors opened and exposed an employee to the flame front and the pressure wave that was relieved from the equipment, injuring the employee. **Figure 54** shows the location of the Didion employee when the deflagration vents on the Dry Grit Filter opened. The employee suffered burns when he was enveloped by the relieving flame front.

Figure 54: Approximate location of employee at the time of the Dry Grit Filter vent opening. (Credit: CSB)
