Deepwater Horizon RBS 8D BOP MUX Control System Report
To the U. S. Chemical Safety and Hazard Investigation Board
CSB-FINAL REPORT-MUX(06-02-2014)

MUX Control System Investigation Index

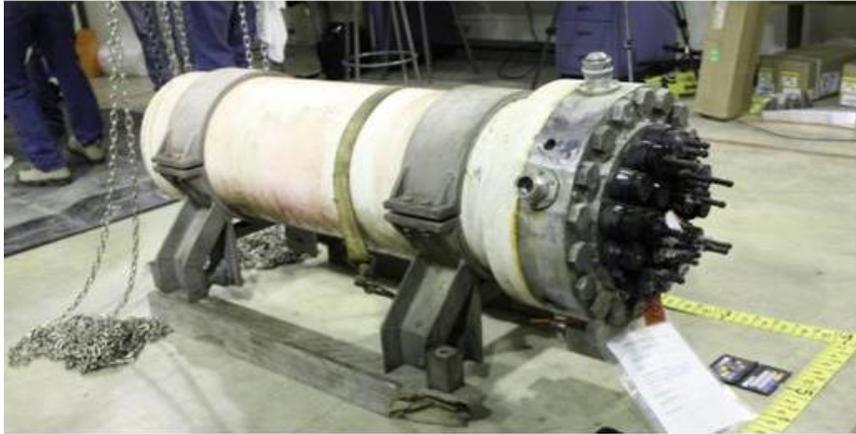
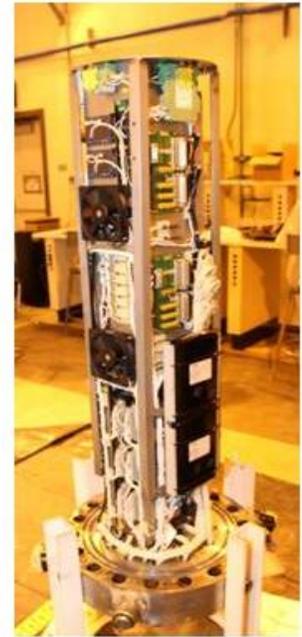
Each pod contains two redundant subsea electronic modules (SEM A and SEM B) located in a SEM housing. See Figure 4. Each SEM includes a programmable logic controller (PLC), an AMF/deadman controller card, and a 9 volt battery pack for booting and operating the AMF/deadman card. There is one 27 volt battery pack per SEM housing, providing power for sensors and solenoids needed by both SEMs only during an emergency event.

Figure 4. SEM from the Deepwater Horizon (left) with its protective housing removed (right) as observed during Phase 1 testing.

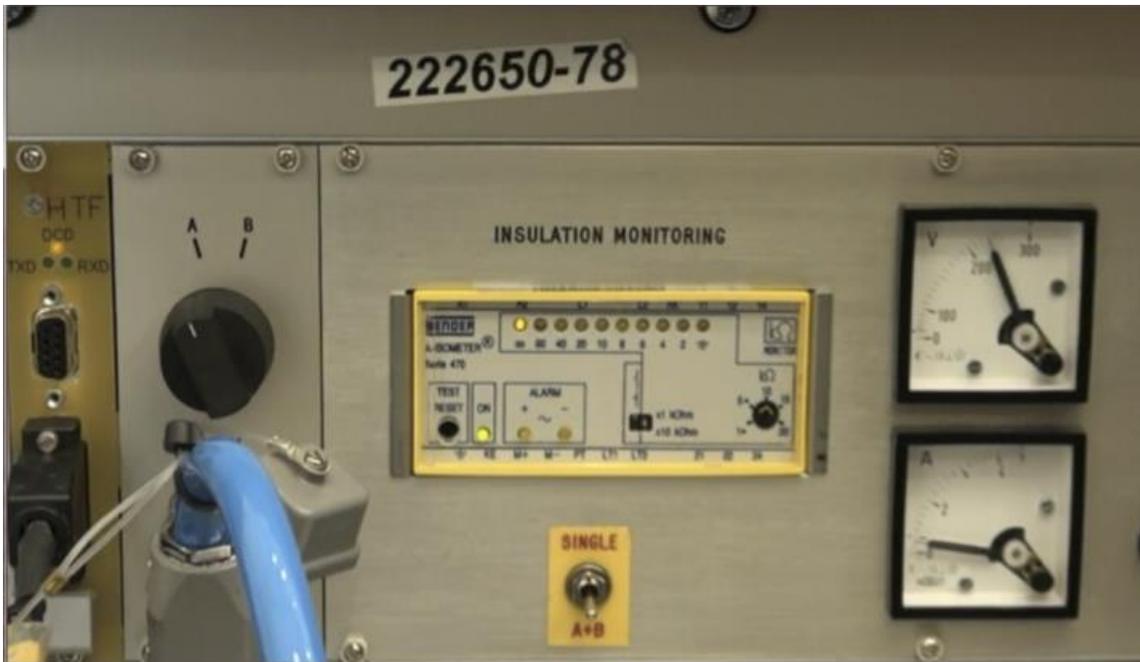
Technicians used four different PETUs during testing at various times on the Q4000 and during Phase 1 and 2 of the BOP testing. Visual inspection of the PETUs revealed they all had a switch that could be toggled between “A” or “B”. Some of the PETUs had another switch that could toggle between “Single” and “A+B”. This switch is apparent on the PETU shown in Figure 8, but missing from the PETU shown in Figure 9.

Figure 8. PETU: Note the A/B switch and the Single/A+B switch - Photo Phase 2 testing

When testing of the pods was first conducted on the Q4000, serial numbers of the PETUs used were not recorded, but a technician conducting the test recalled that a PETU without the “A+B/single” (Figure 8) was used;⁷² test results from the miswired SV 103Y support this recollection.⁷³ To fail during deck testing, both coils in SV 103Y would have to be energized simultaneously. If only one coil were energized, SV 103Y should have opened (See Section 4.7 for details).

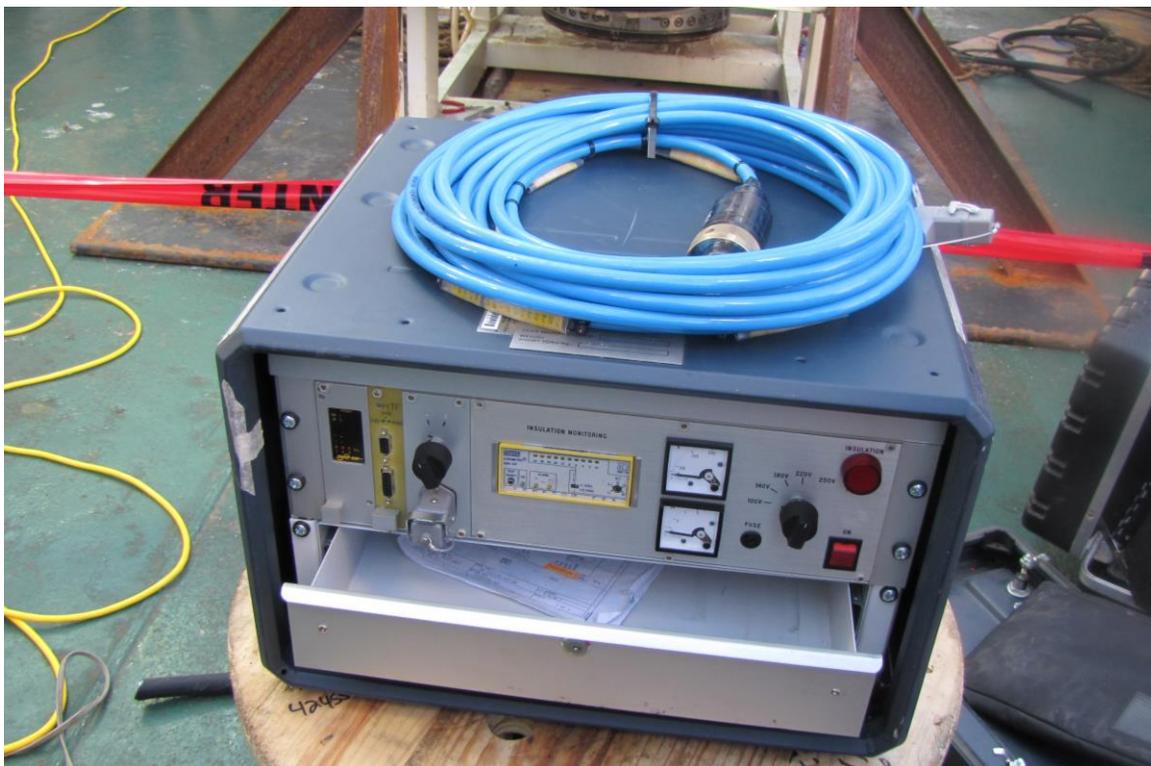
Figure 9. PETU: This one has no Single/A+B switch - Photo from Q4000 Intervention”

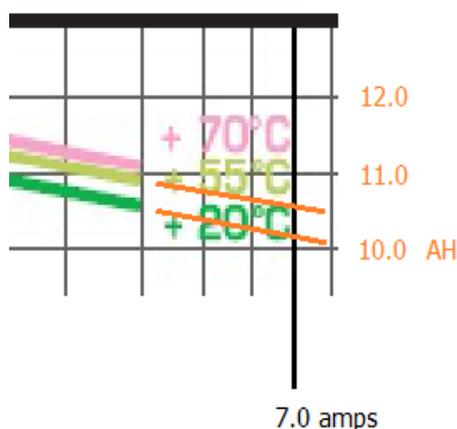
Figure A3-8: Zoomed View of SAFT Capacity chart vs. current and temperature – modified by Engineering Services

From this chart we cannot interpolate the capacity difference (increase) based on an increase in temperature from 15.5 to 34.5°C at 7.0 amps. We can however, get some indication that an increase of 0.1 to 0.2 AH capacity might be entirely possible. This would amount to 1 to 2% recovered capacity based on temperature rise from subsea to Michoud.

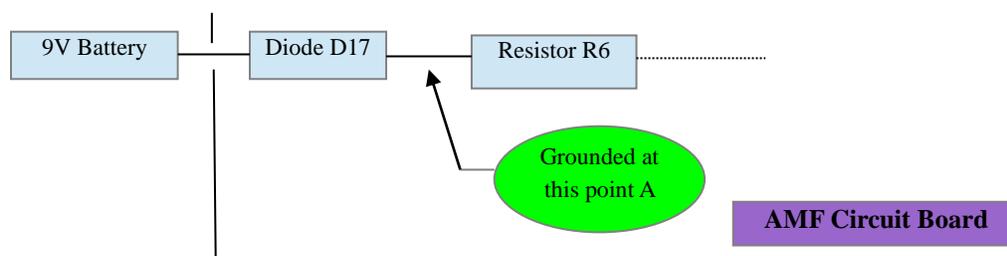
Figure B-3. Circuit configuration from the 9 volt battery to resistor R6.

It is obvious that one of the technician's measurements pierced the conformal coating in order to get such a low reading of 0.2 ohm to ground. If diode D17 were grounded at point A and the diode was still working, then the SEM B 9 volt battery would have been completely drained over a short period of time due to the short to ground. Since the Blue SEM B 9 volt battery passed all load tests imposed on it late in the Phase 2 testing, we conclude that the diode was not conducting forward current to the AMF card.

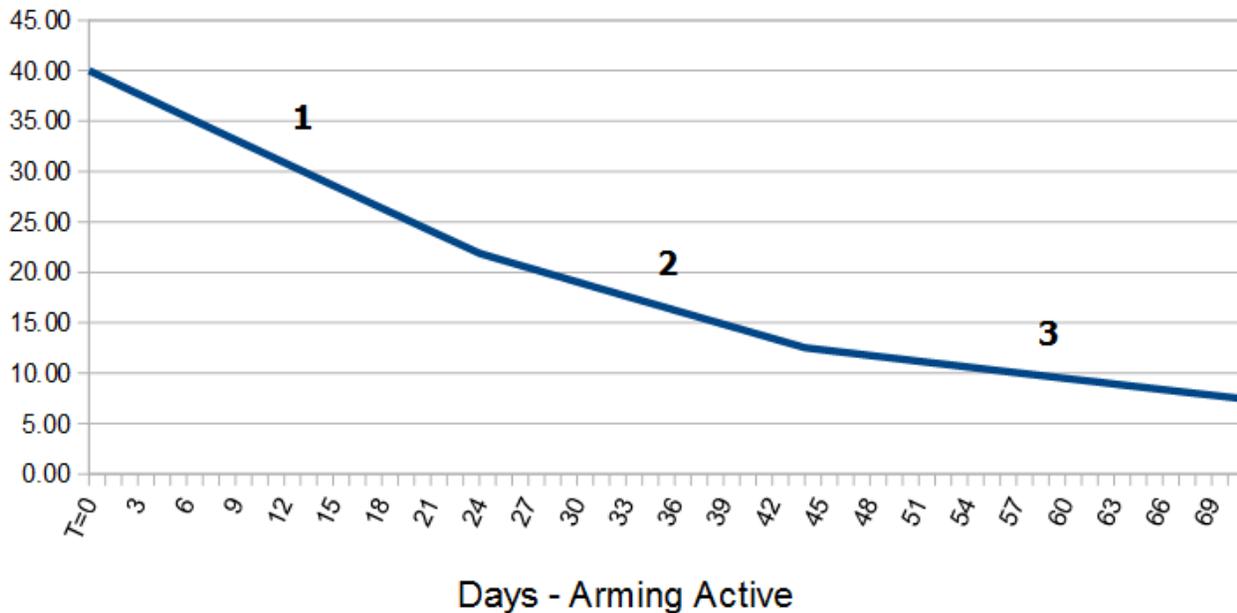
Figure D-2: Blue Pod 27 volt Battery Loading Time Segments (Source: Engineering Services)

Figure D-2 contains three distinct blue pod 27 volt battery loading time segments:

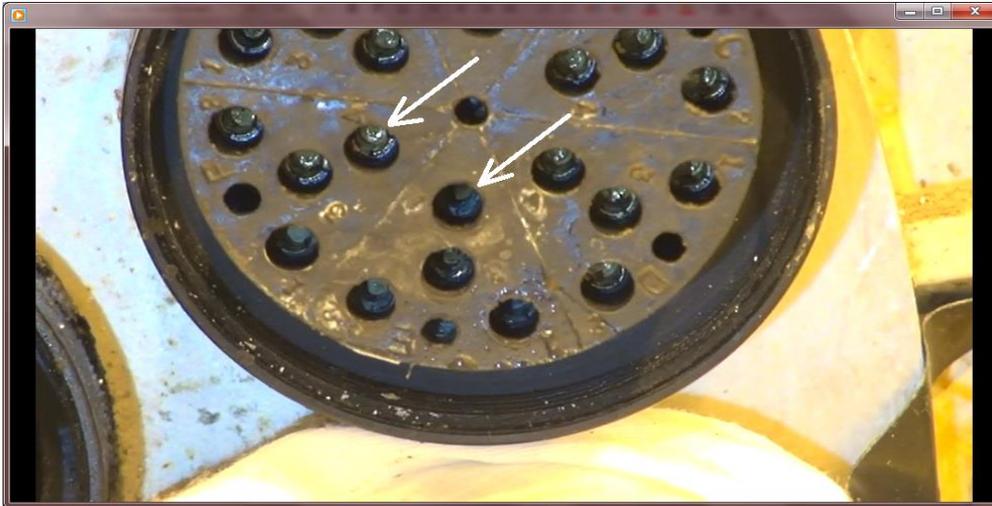
Figure C7-3: Oxide Cleaning Process

Pie Connector 3 appears to be the only connection which has severe oxide exposure. In particular, pie connection 3E is the only connection that exhibits these corrosion products. (function 3E = Blue Pod Hotline Supply)

Technician uses swab and compressed air to clean oxide out of connection. After cleaning, 3E pie connection interior contacts are not bright and shiny like other connections.
