U.S. CHEMICAL SAFETY AND HAZARD INVESTIGATION BOARD

ALUMINUM DUST EXPLOSION

HAYES LEMMERZ INTERNATIONAL—HUNTINGTON, INC.

REPORT NO. 2004-01-I-IN

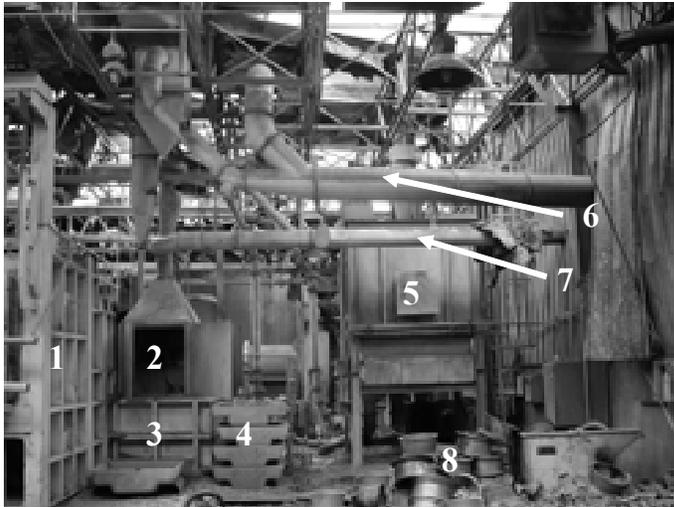
Figure 4. Photo of furnace 5 sidewell, showing fume hood, ingots, and dry chip hopper.

At about 2:30 pm on October 29, 2003, Hayes maintenance personnel shut down the chip feed system because of a smoldering fire located near furnace 5 in the duct from the fume hood to the fume separator (see Figure 4, item 7). The glowing red duct alerted employees to the fire. According to plant personnel interviewed by CSB, fires in this duct were not uncommon. On this particular day, employees followed the usual practice for dealing with these fires by shutting down the dry chip feed and the fume hood draft fan (but not the dust collector draft fan), and allowing the fire to burn itself out. Employees judged that the fire was out when the duct had cooled, and they found burnt material that had broken free in the fume separator solids drum. They then opened the fume duct and cleaned out the remaining residue within reach. The October 29 duct fire had been out for at least 2 hours before maintenance personnel restarted the dry chip feed.¹⁷

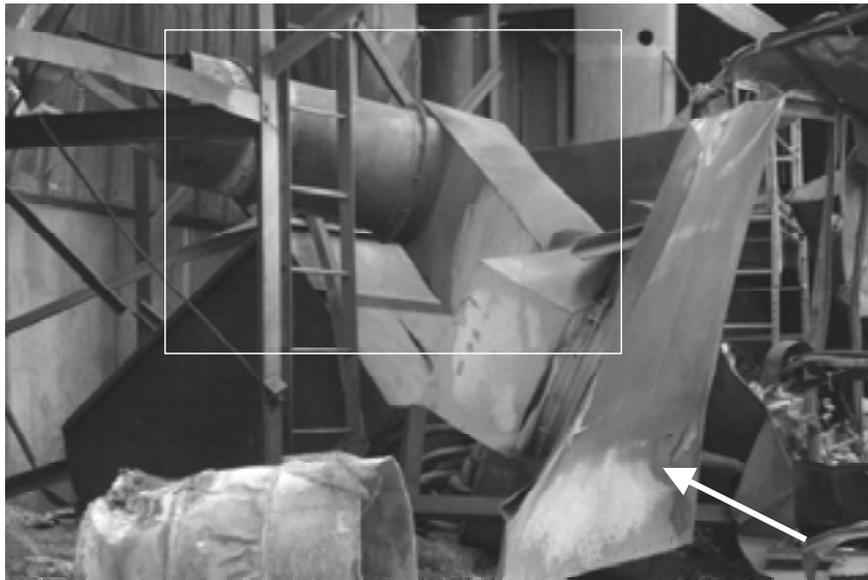
Figure 9. Drop box side panel (arrow) with outlet duct (box).

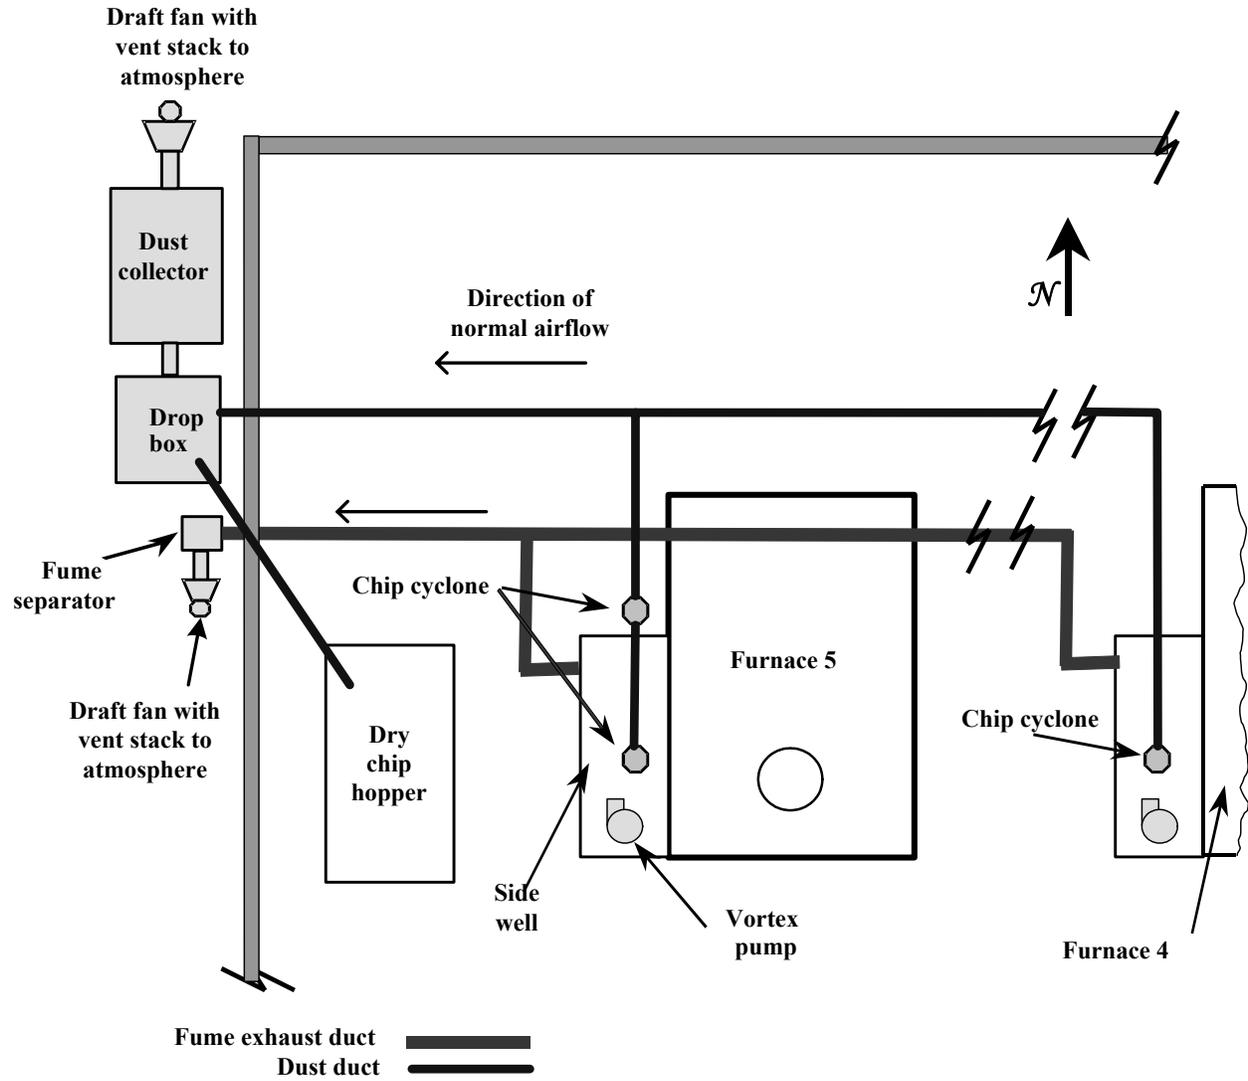
Figure 12. Layout (overhead or plan view) of dust collection, furnaces, and ducts. Some ducts and equipment omitted for clarity.

However, Hayes added a direct duct from the dry chip hopper to the drop box (see Figure 12) in an effort to vent what employees described as “positive pressure” within the dry chip hopper. In correspondence with CSB, Hayes opined that embers might migrate from the kiln dryer to the dry chip hopper. CSB believes that such an ember could have been pulled by the draft fan into the drop box.

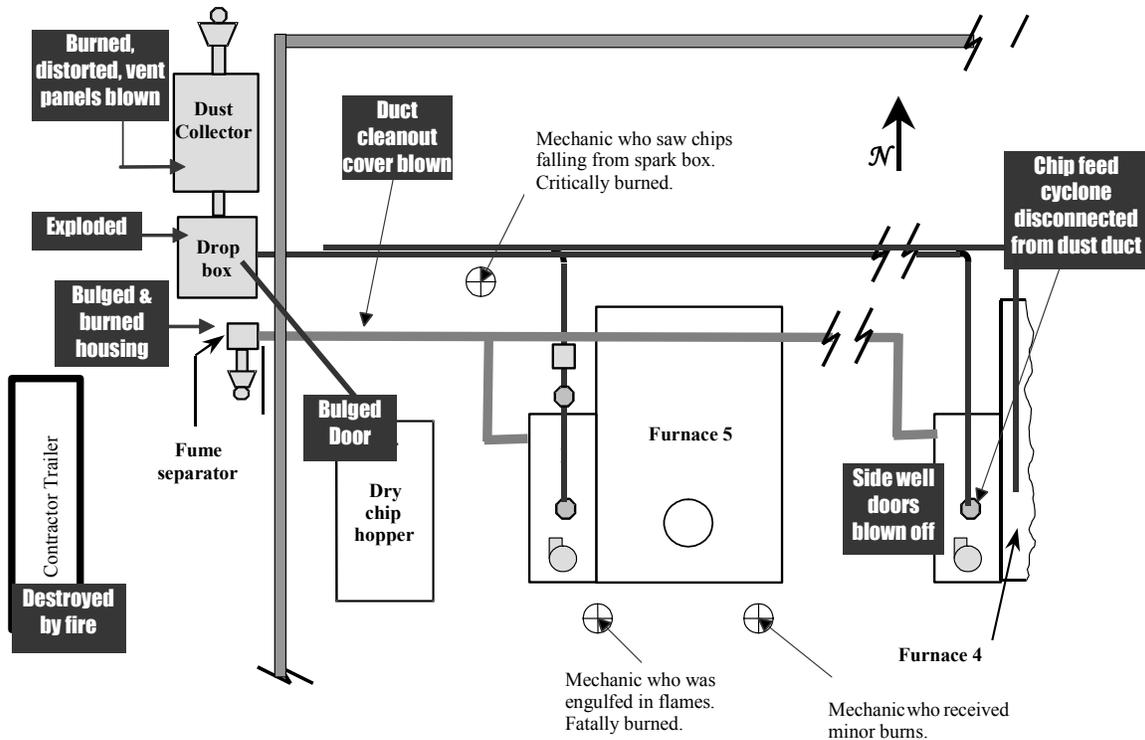
Figure 15 shows the location of most of the interior and exterior damage and the location of employees at the time of the explosion. One stack-testing contractor was on the roof above furnace 5; the other was in a trailer just southeast of the drop box. Not shown in the figure are damage to the wall south of the kiln dryer and the exterior wall southwest of the kiln, water damage inside the compressor room south of the kiln, and damage to the wet chip hopper.

Figure 15. Damage overview and location of employees (plan view). Roof over entire area was also damaged.

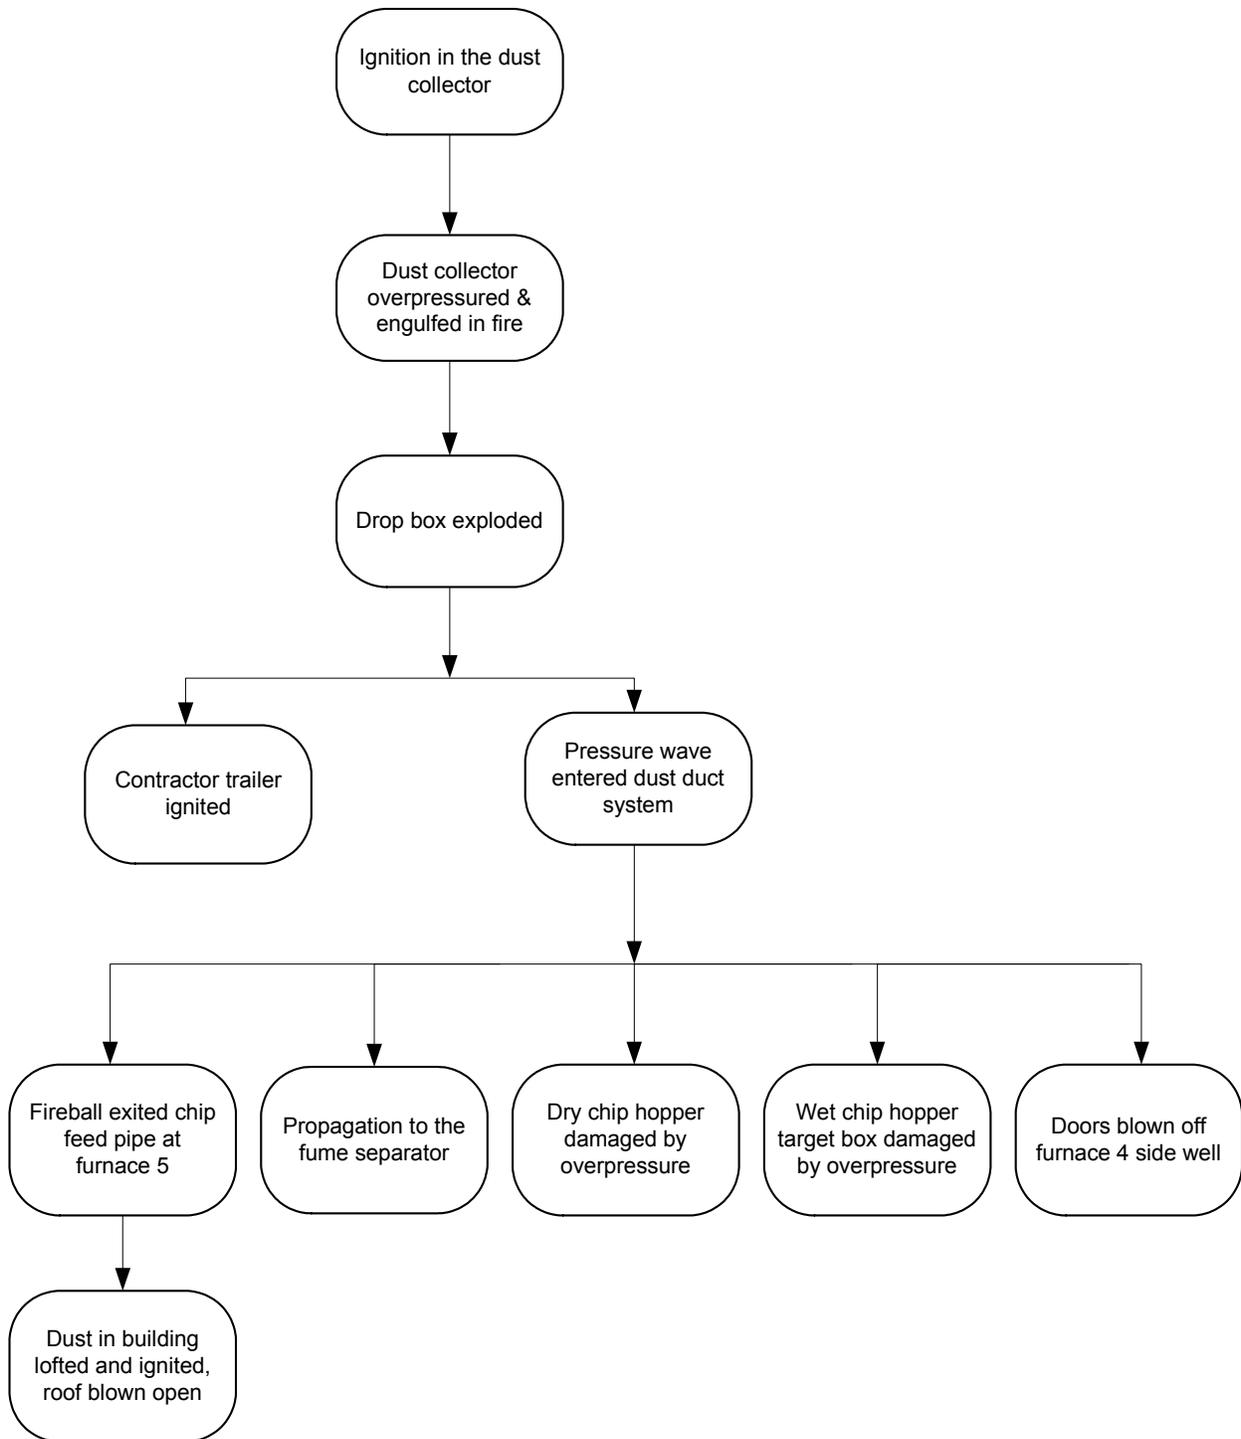
Figure 20. Sequence of events for CSB dust explosion scenario.

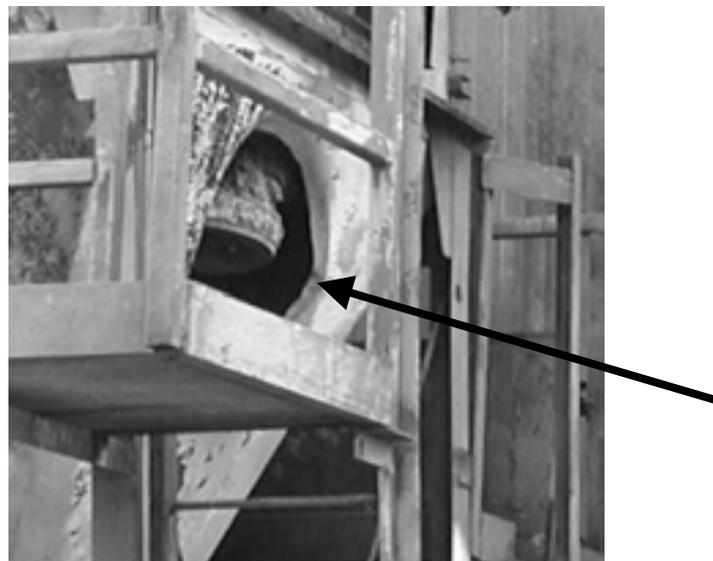
Figure 23. Air inlet on the south side of the dust collector.

The drop box may have experienced significantly higher pressure than the dust collector, since an explosion propagating between two containers can result in a phenomenon referred to in literature as pressure piling.³³ However, the drop box was a much weaker structure than the dust collector, lacking substantial framing and joined only by small corner welds, and it was relatively unprotected by explosion venting. The drop box failed mainly along the seams and fractured into several large pieces.³⁴ One of the larger fragments impacted the building wall and was found resting below the impact point (Figure 24). The impact slightly bent the vertical steel wall support beam inward (Figure 25).

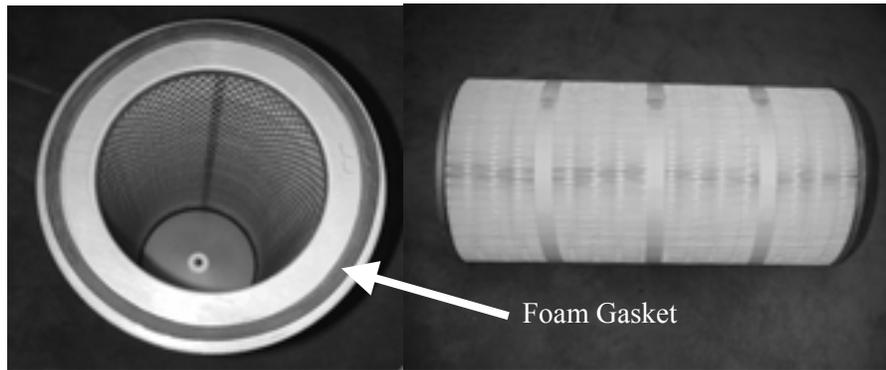
The filter medium used in the dust collector at Hayes was a pleated cellulose cartridge on a steel cage frame, with steel end pieces (Figure 32). Each cartridge was mounted in the dust collector housing on a threaded rod through its center. The pleated filter media was non-conductive material similar to paper. A thick foam gasket separated each cartridge from its steel support plate. Further, a washer used to help hold the cartridge in place had a non-conductive coating on one side. The features of the cartridges and

installation provided an opportunity for static charge accumulation. The conductive aluminum particles in and on the filter would tend to dissipate that charge to the ground via the central rod.

The dust collector pulse jets lofted aluminum dust into the air stream every 90 seconds, resulting in dust concentration within the explosive range. If a static discharge were to occur, the most likely location would be the across the hold-down washer, since this is the smallest insulated gap in the cartridge assembly. It is unlikely that such a static discharge with sufficient energy would occur within that dust cloud created by the pulse jets. CSB concluded that electrostatic discharge is unlikely to be a credible cause for igniting the explosion in the dust collector.

Figure 32. Dust Collector Filter Cartridge
