## Williams Geismar Olefins Plant

### Reboiler Rupture and Fire

### Geismar, Louisiana

No. 2013-03-I-LA

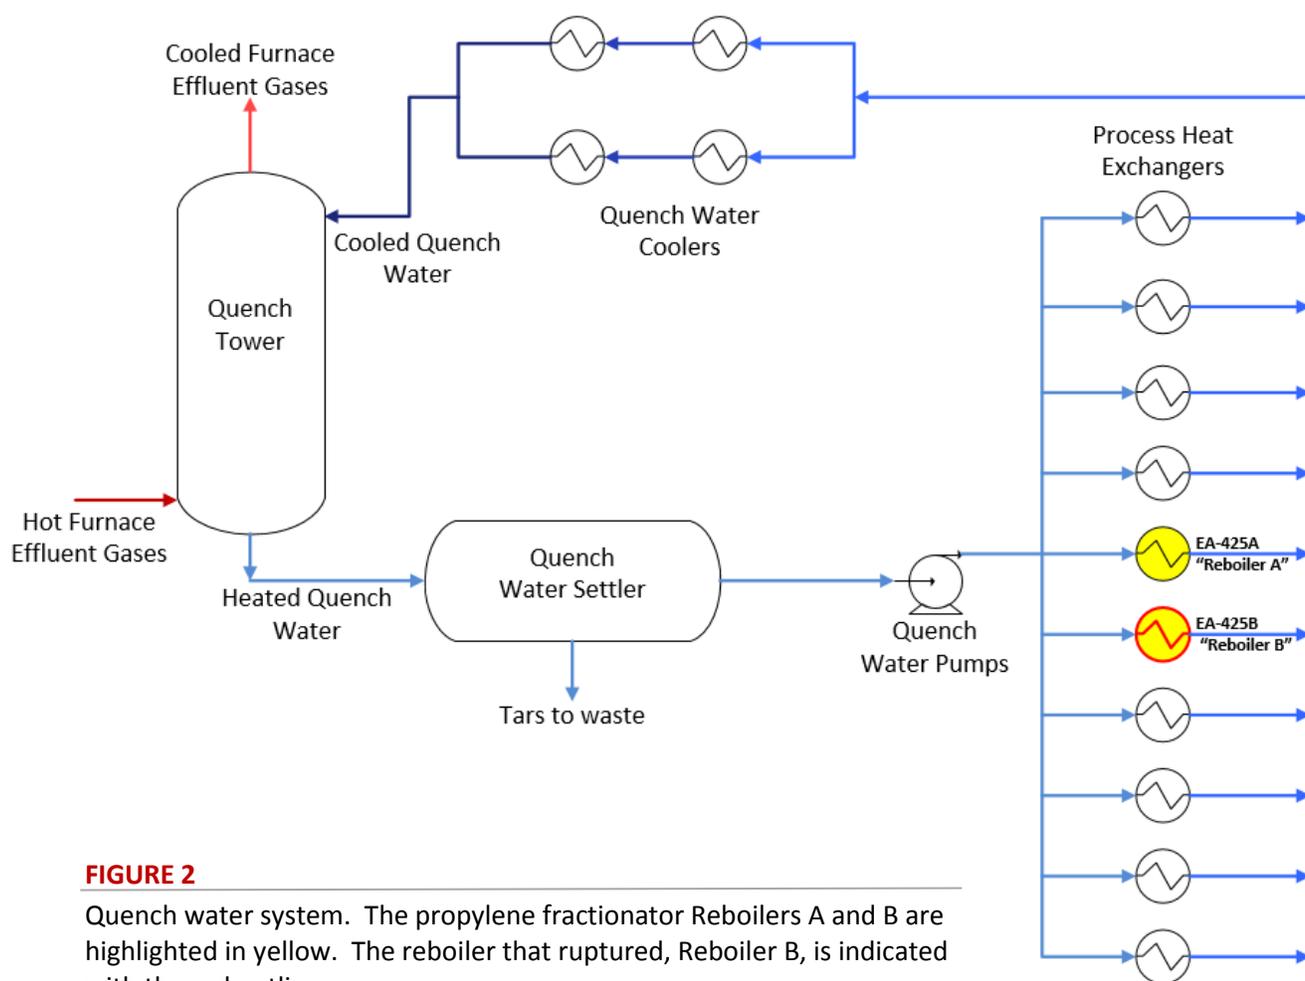
**FIGURE 2**

Quench water system. The propylene fractionator Reboilers A and B are highlighted in yellow. The reboiler that ruptured, Reboiler B, is indicated with the red outline.

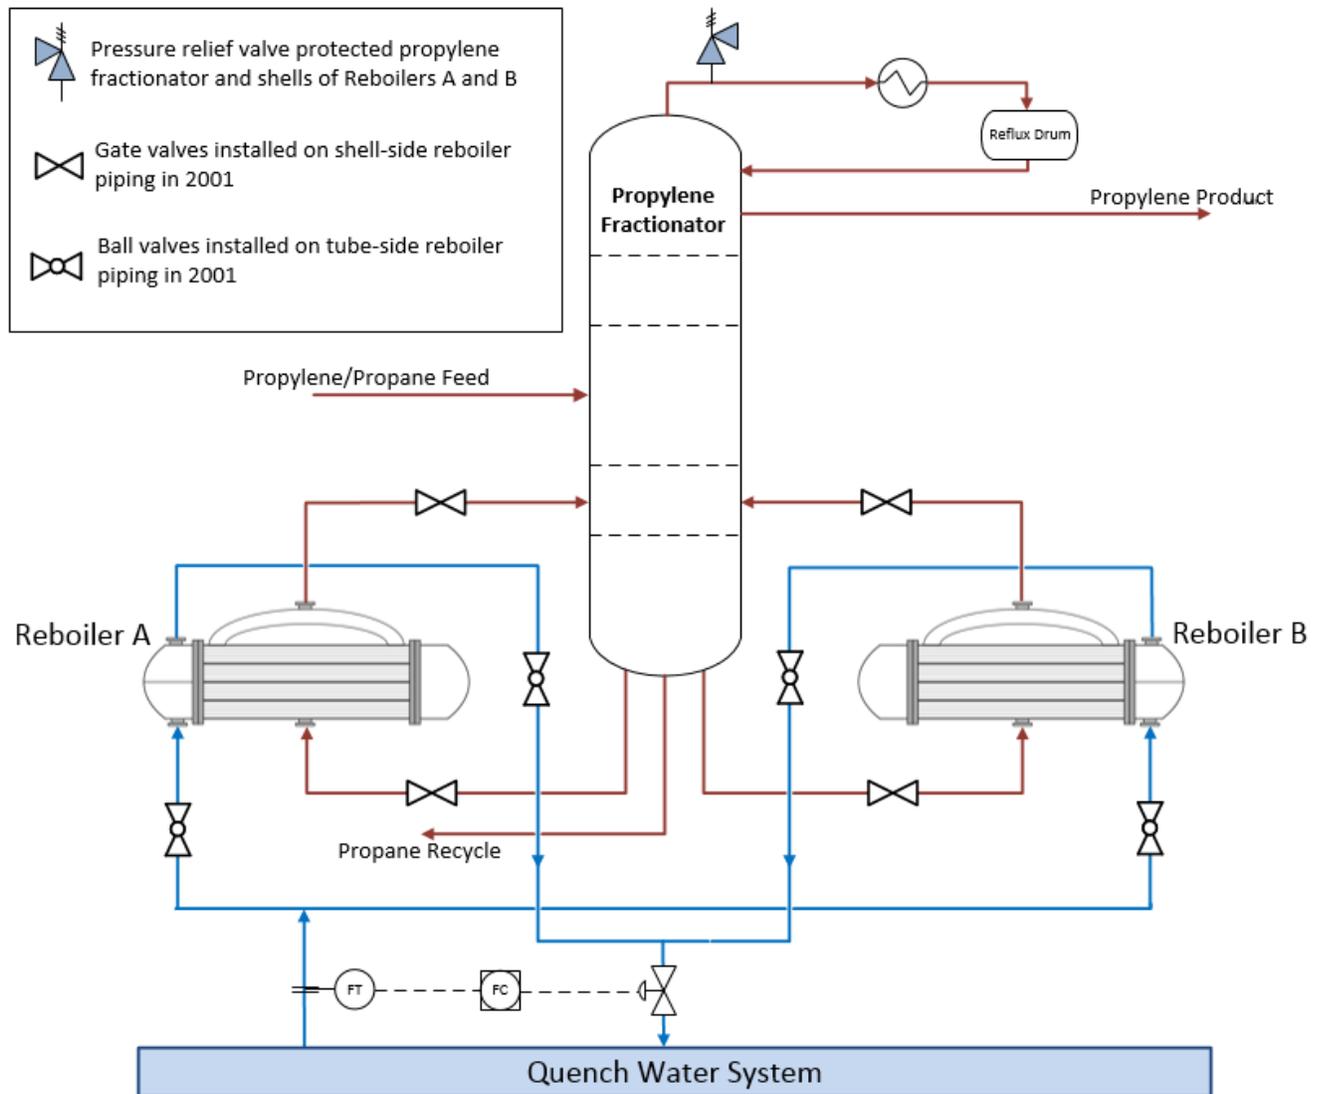
**FIGURE 4**

Propylene fractionator schematic. This schematic represents the equipment configuration at the time of the incident. The valves (gate valves) isolating the reboilers from the pressure relief valve at the top of the propylene fractionator were not part of the original design, and were installed in 2001. Section 5.1 provides additional information about these valves.

Post-incident field observations identified that the Reboiler B tube-side hot quench water valves were in the open position (Figure 10). The shell-side process valves were closed, which isolated the shell of Reboiler B from its protective pressure relief valve on the top of the propylene fractionator (Figure 4). This valve alignment shows that heat was introduced into a closed system (i.e., the blocked-in Reboiler B shell).

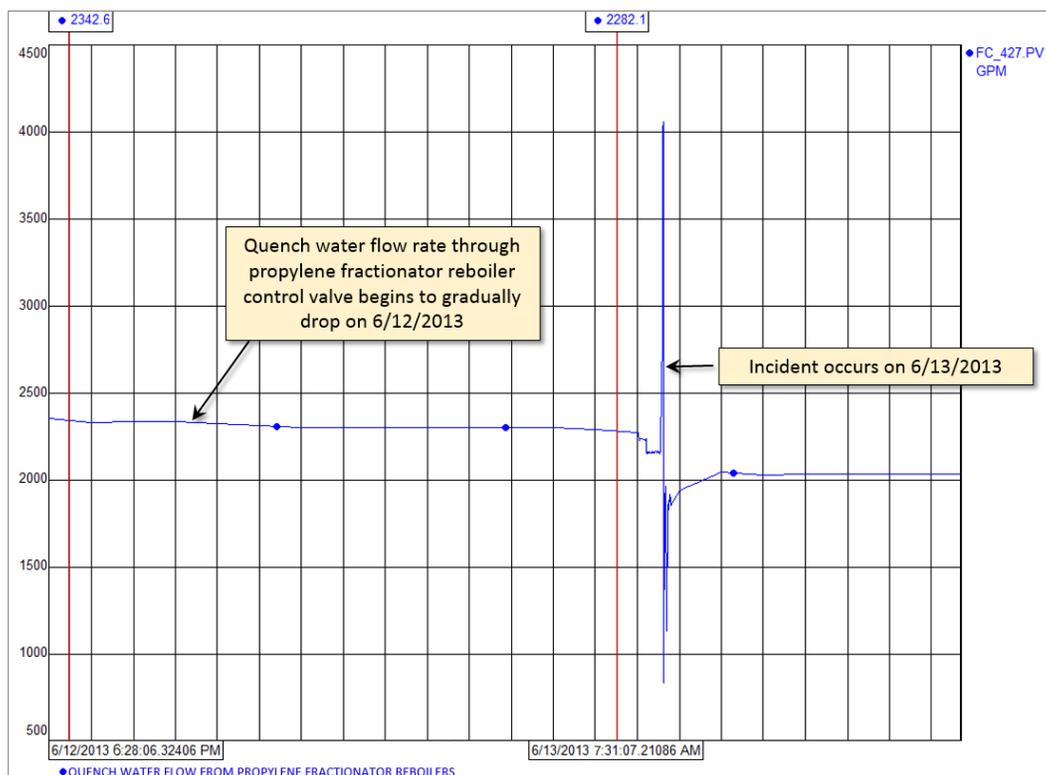
**FIGURE 5**

On June 13, 2013, during a daily morning meeting with operations and maintenance personnel, the plant manager noted that the quench water flow through the operating propylene fractionator reboiler (Reboiler A) had dropped gradually over the past day (Figure 5). The group then analyzed plant data and noticed the entire quench water circulation rate seemed to be impaired. An operations supervisor, who Williams often relied on to troubleshoot and mitigate operational problems, informed the group that he would try to determine what caused the drop in flow. After evaluating the quench water system in the field, the operations supervisor informed several other personnel that fouling within the operating reboiler (Reboiler A) could be the problem and they might need to switch the propylene fractionator reboilers to correct the quench water flow. The operations supervisor attempted to meet with the operations manager to discuss switching the reboilers—a typical chain of communication—so that they could begin getting the necessary maintenance and operations personnel involved who needed to perform the work. The operations manager was not available, however, and the operations supervisor decided to return to the field and continue evaluating the quench water system.

Graph of quench water flow rate through propylene fractionator Reboiler A prior to incident. Williams personnel identified that quench water flow rate had dropped.

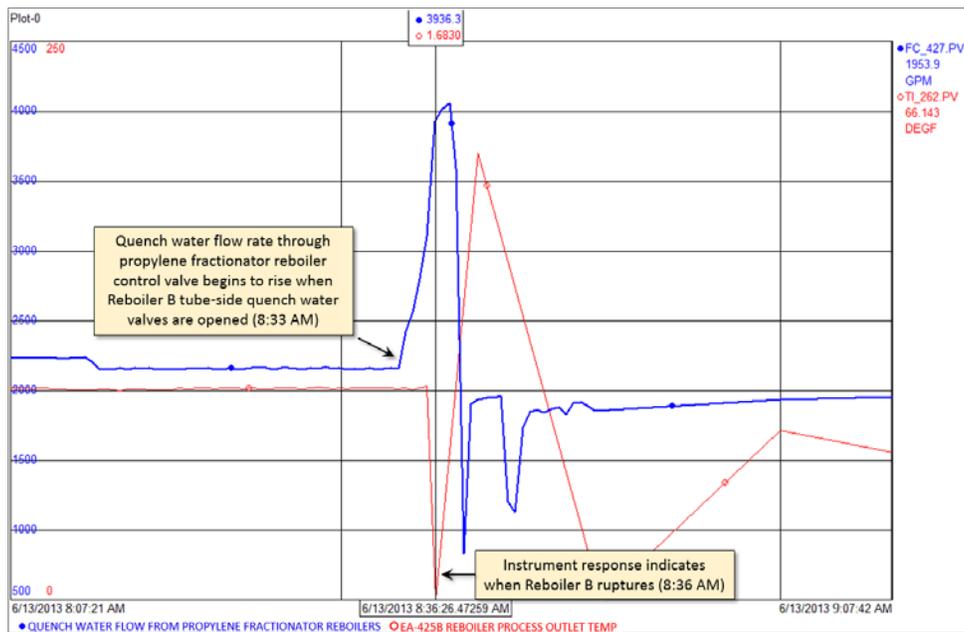
**FIGURE 6**

The CSB determined that at 8:33 am, the operations supervisor likely opened the quench water valves on the offline reboiler, Reboiler B, as indicated by the rapid increase in quench water flow rate shown in Figure 6. Approximately three minutes later, Reboiler B exploded (Figure 7). Propane and propylene process fluid erupted from the ruptured reboiler and from the propylene fractionator due to failed piping. The process vapor ignited, creating a massive fireball. The force of the explosion launched a portion of the propylene fractionator reboiler piping into a pipe rack approximately 30 feet overhead (Figure 8).

Graph of quench water flow rate immediately prior to incident. Quench water flow rate rises when Reboiler B tube-side quench water valves are opened. Reboiler B ruptures approximately three minutes later.

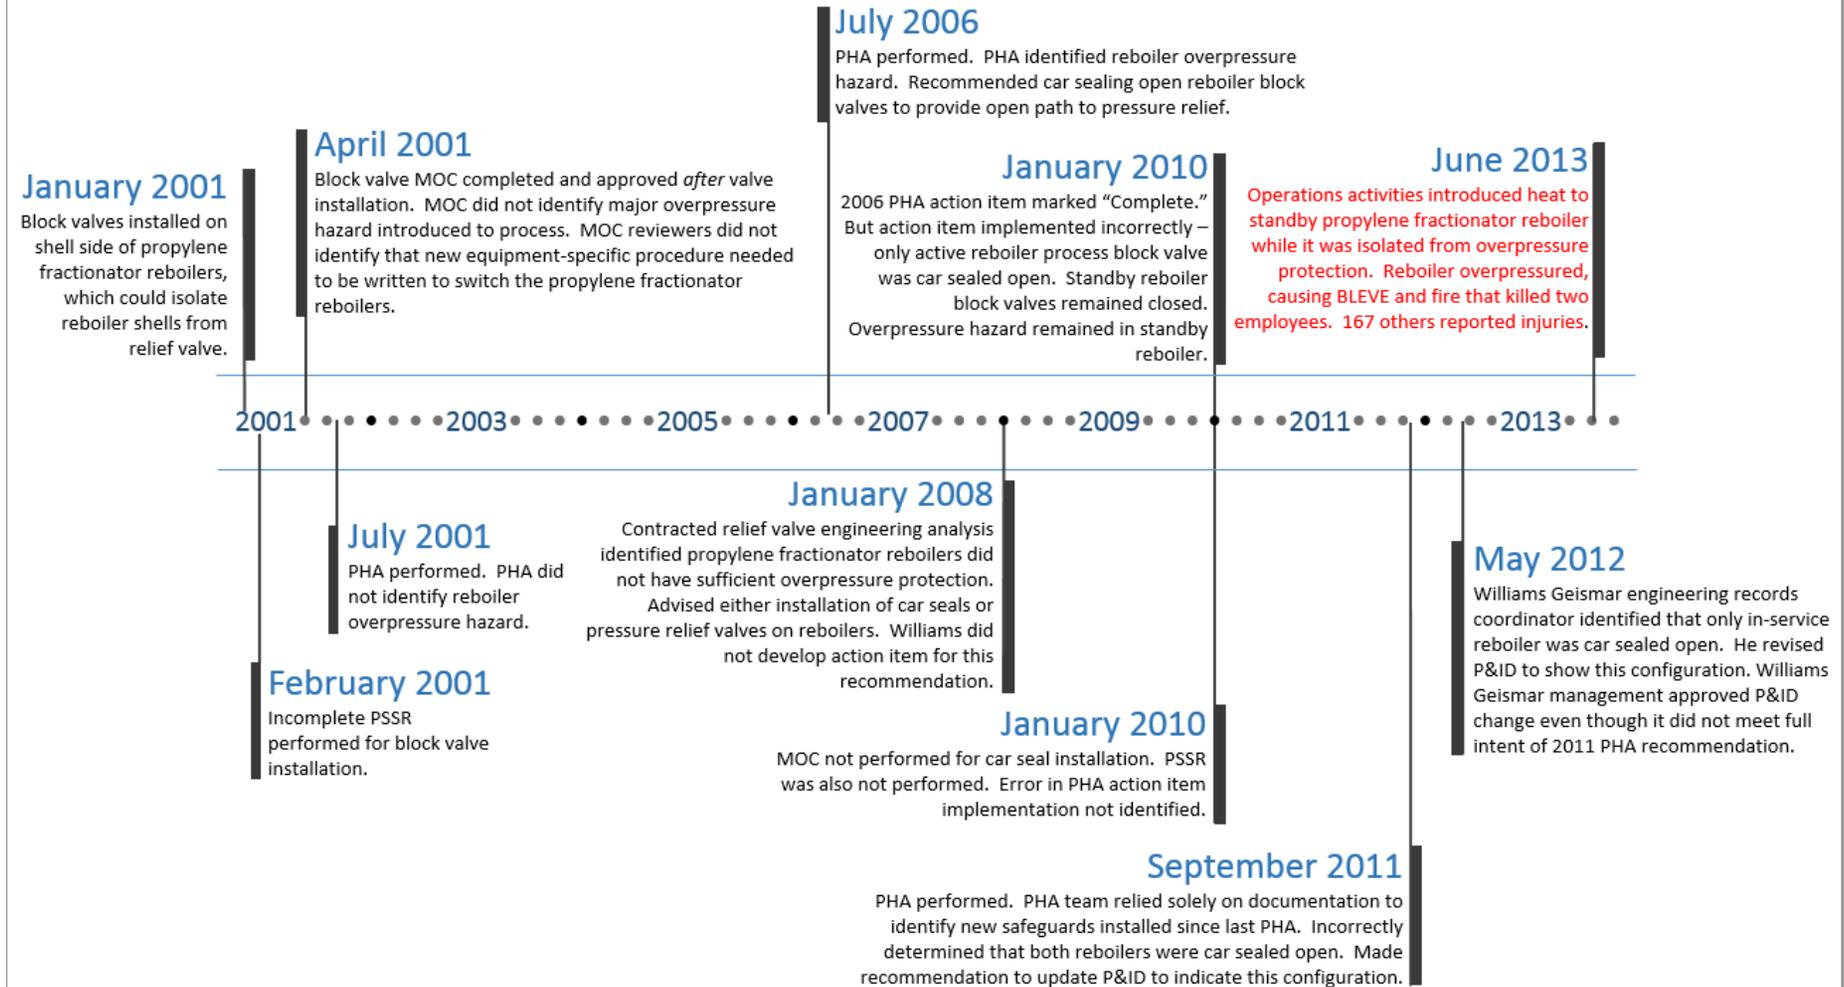
**FIGURE 13**

As will be explained in this section, the ineffective implementation of the Williams Geismar process safety management programs<sup>28</sup> (Figure 13 shows a timeline of the program deficiencies during the 12 years leading to the incident), as well as weaknesses in Williams’ written programs themselves, were causal to the incident.

Timeline of events leading to the June 2013 incident.

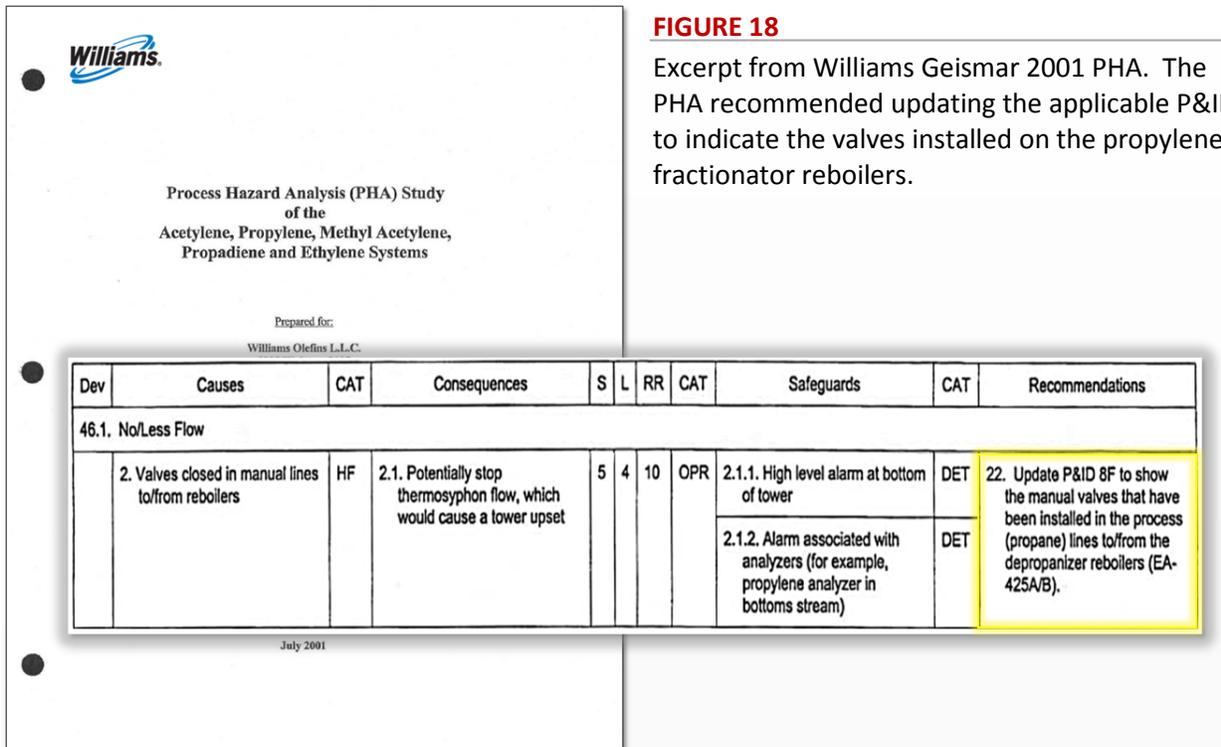
**FIGURE 18**

The PHA team correctly identified that the piping and instrumentation diagrams (P&IDs) did not show the new valves on the propylene fractionator reboilers. The PHA team recommended updating the relevant P&ID (Figure 18). The CSB notes that the P&ID update should have been required as part of the MOC process. In addition, the PSSR process should have reviewed a marked-up version of the P&ID showing the approved change. Such a review could have identified the significant error with the engineering drawing.

Excerpt from Williams Geismar 2001 PHA. The PHA recommended updating the applicable P&ID to indicate the valves installed on the propylene fractionator reboilers.

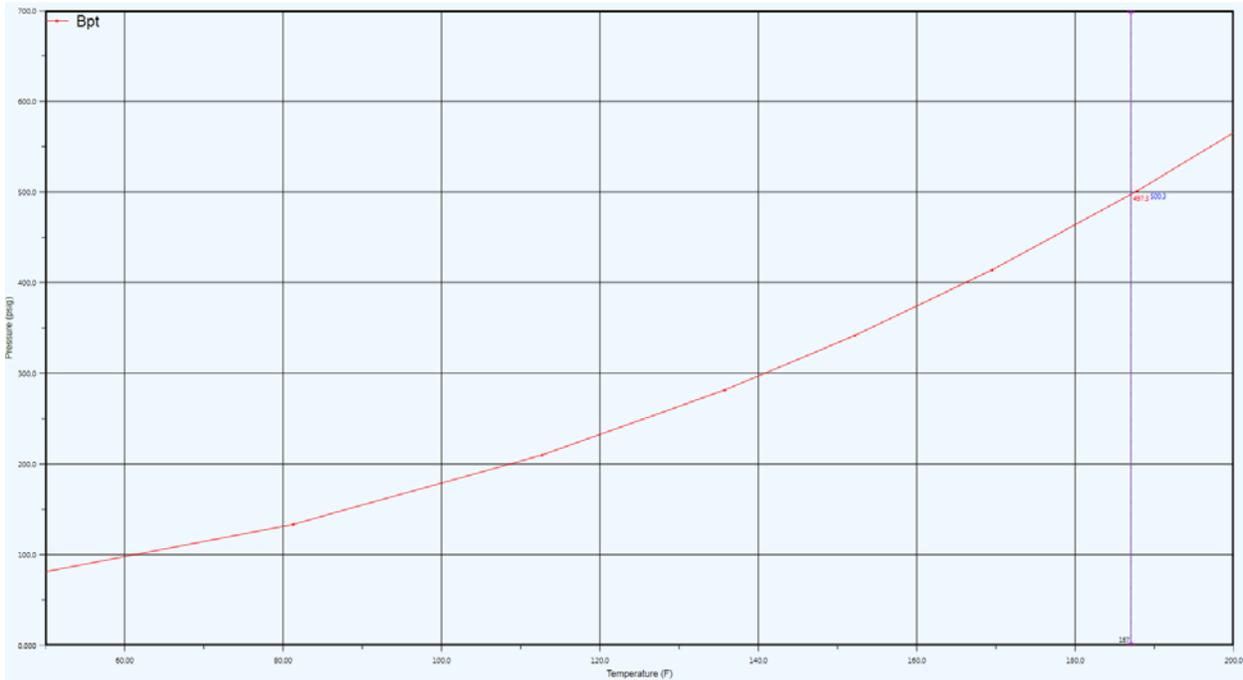
**FIGURE B-1**

Boiling Point Curve of Williams reboiler process fluid. Graph indicates process fluid could generate a vapor pressure of 496 psig at equilibrium conditions.

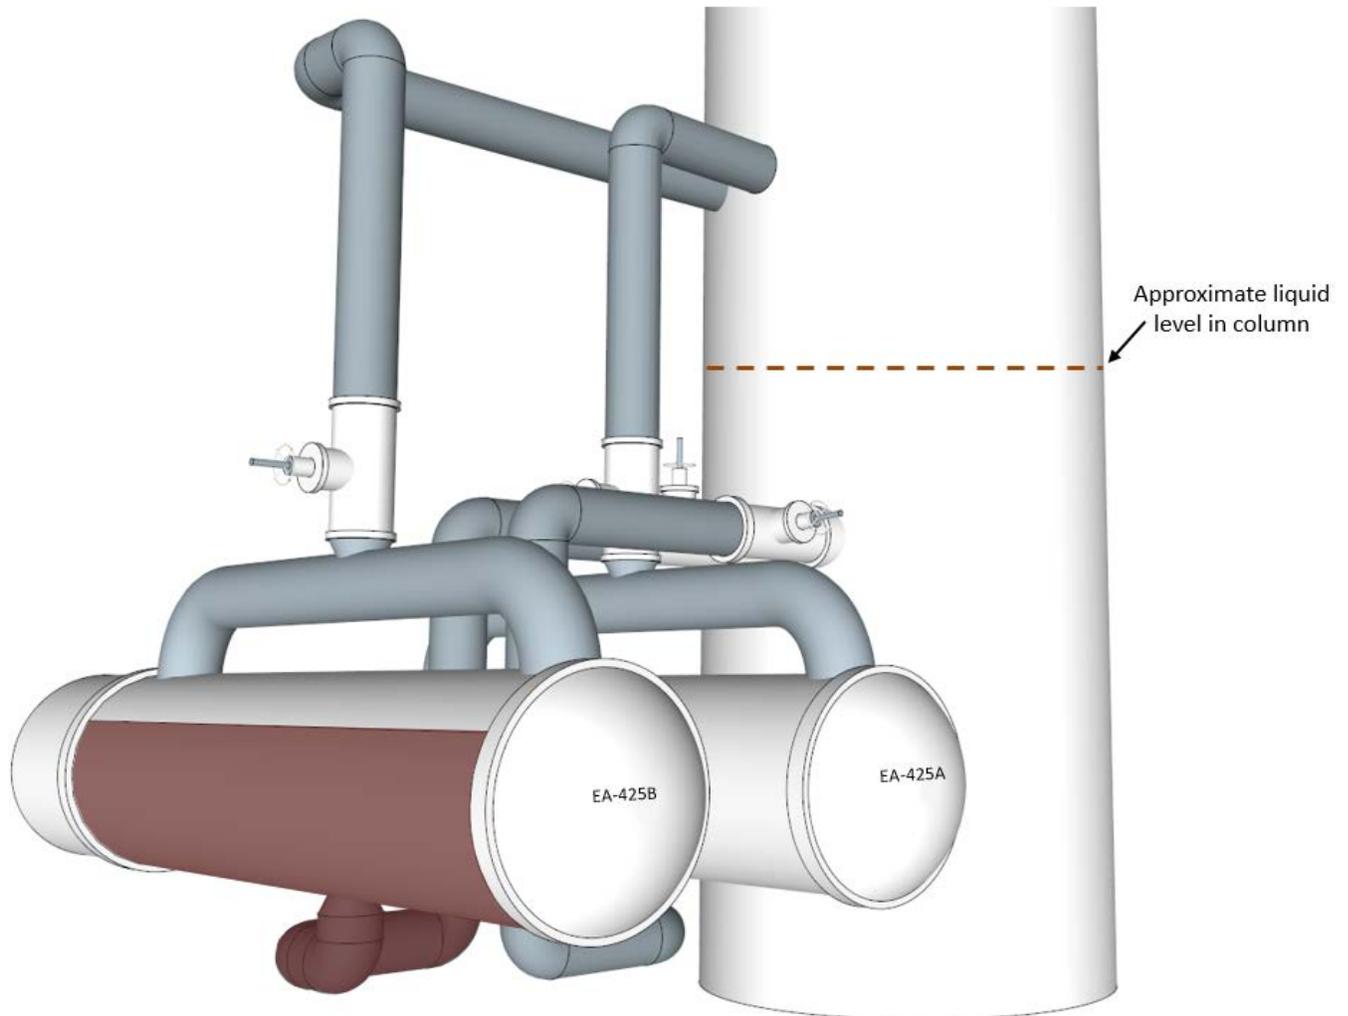
**FIGURE B-3**

minimum quantity of liquid is reasonable because (1) it would have resulted in a level in the reboiler below the liquid level in the propylene fractionator, and (2) this quantity of liquid would have had enough contact with the reboiler tubes to sufficiently heat and expand (Figure B-3). Reboiler B was likely between 65.5 vol% and 100 vol% full of the liquid propane mixture prior to the introduction of the 187 °F quench water.

Depiction of minimum required liquid level in reboiler EA-425B (Reboiler B) to result in possible liquid overpressurization of reboiler shell.

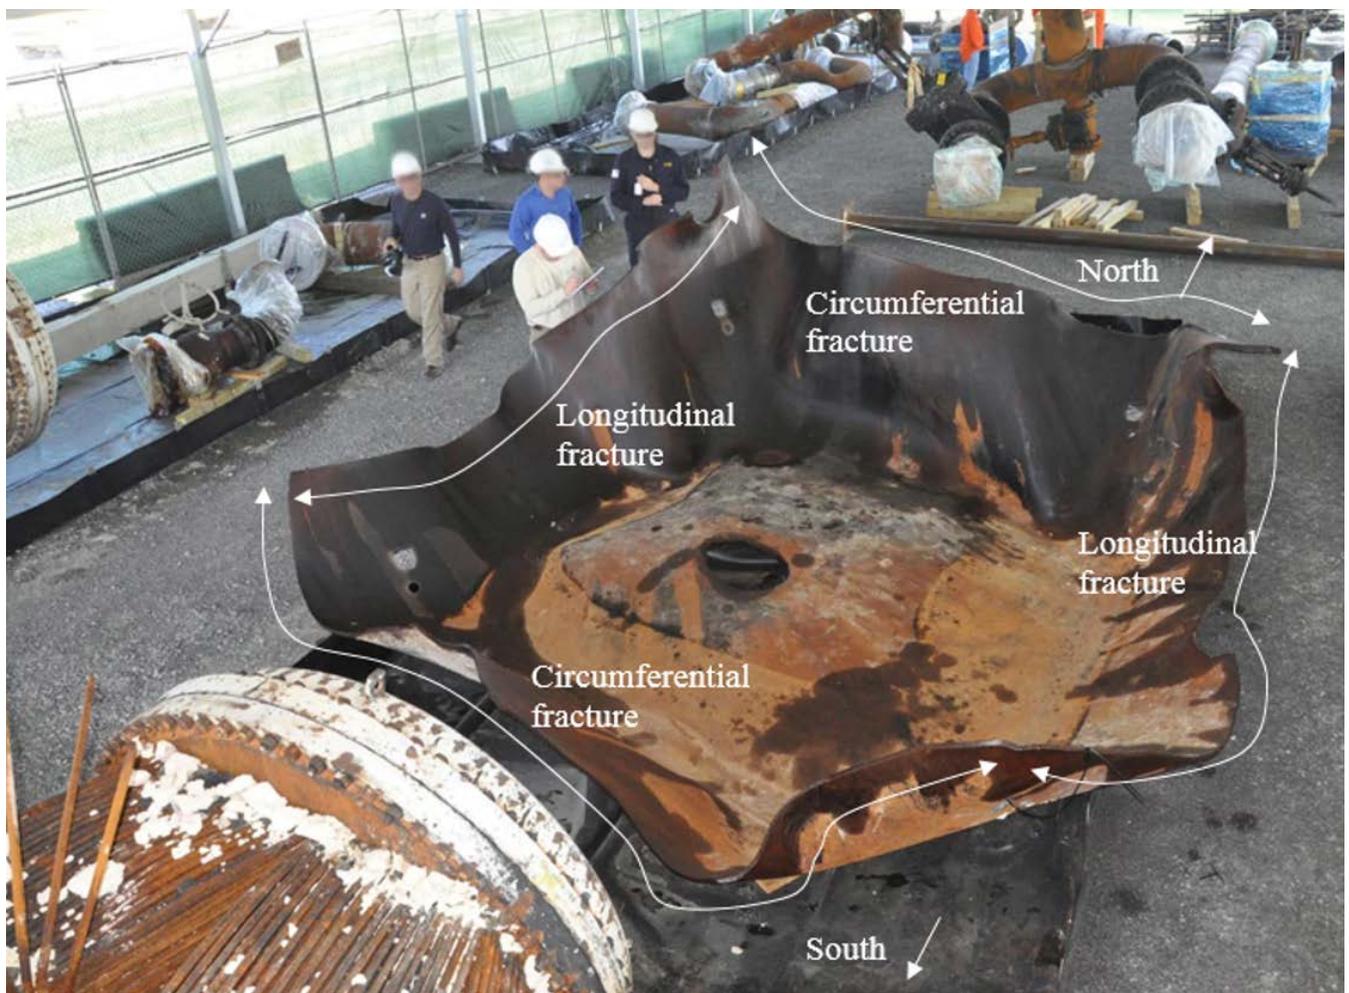
**FIGURE B-4**

When the reboiler shell failed locally (cracked) due to liquid thermal expansion of the shell contents, the shell contents began to flash near the failure opening and a two-phase (liquid and vapor) jet release would have accelerated out of the failure opening. The two-phase flow would have choked in the failure opening, maintaining the pressure in the vessel for a short period of time. The pressure loading on the open edges of the failure caused the crack to continue to grow along the vessel length and the failure opening rapidly increased in size. As this opening increased in size, the two-phase jet would have grown rapidly. At some point, the full opening of the vessel would have resulted in an explosive release of the remaining vessel contents. This explosive release is called a boiling liquid expanding vapor explosion (BLEVE).<sup>92</sup> The pressure forces during this process usually flatten the vessel cylinder on the ground (Figure B-4). The escaping propane mixture then found an ignition source and ignited.

Post-incident photo of Reboiler B shell. The originally cylindrical shell was flattened during the event.
