# Investigation Report

Published: July 29, 2022

- Pressure Vessel Corrosion
- Pressure Vessel Inspection and Regulation
- Pressure Vessel Repair
- Process Safety Management Systems

On April 3, 2017, an explosion occurred at the Loy-Lange Box Company (Loy-Lange) in St. Louis, Missouri. The incident occurred when the bottom head of a pressure vessel called a Semi-Closed Receiver, which was used in Loy-Lange's steam system, catastrophically failed. The pressure vessel failure caused a boiling liquid expanding vapor explosion (BLEVE) which fatally injured the Loy-Lange employee working nearby and launched the pressure vessel from the Loy-Lange building into the air. The vessel eventually crashed through the roof of a nearby business, fatally injuring three members of the public.

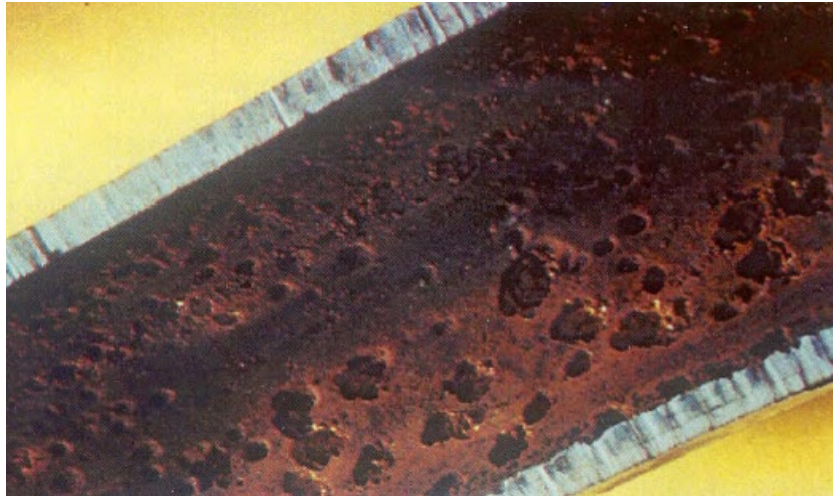
**Figure 5.** Pitting corrosion in a boiler tube. (Credit: U.S. Dept. of Defense [5, p. 38])

Oxygen pitting corrosion is a widely known damage mechanism that occurs in steam systems [4, p. 42]. Dissolved oxygen in steam system feedwater can cause corrosion in steel, typically appearing as pitting (**Figure 5**) [4, p. 42] [5, p. 54]. As shown in **Figure 6**, pitting corrosion damage can assume multiple different shapes [6].

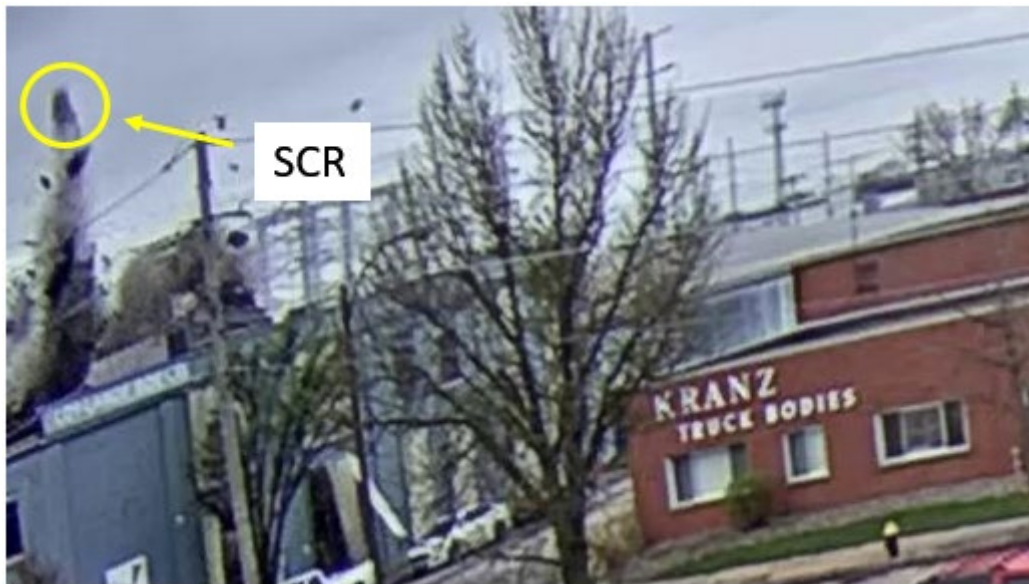
**Figure 9.** Surveillance video still capturing explosion. (Credit: Kranz Body Co., annotations by CSB)

On Friday, March 31, 2017, Loy-Lange stationary engineers observed a leak that appeared to be coming from underneath the SCR. One stationary engineer took photos of the underside of the vessel to confirm the leak. Another contacted a local welding company and requested that it assess the vessel and make a repair recommendation. The welding company was not available to visit the Loy-Lange facility until the following Monday, April 3, 2017. Loy-Lange continued operating the leaking pressure vessel throughout the remainder of the Friday production schedule and shut down the steam system as normal that evening. The following Monday a Loy-Lange stationary engineer began his normal start-up routine at about 6:00 a.m. At around 7:20 a.m. on April 3, 2017, the SCR bottom head catastrophically failed. The SCR was launched from the Loy-Lange building and into the air (**Figure 9, Figure 10**).

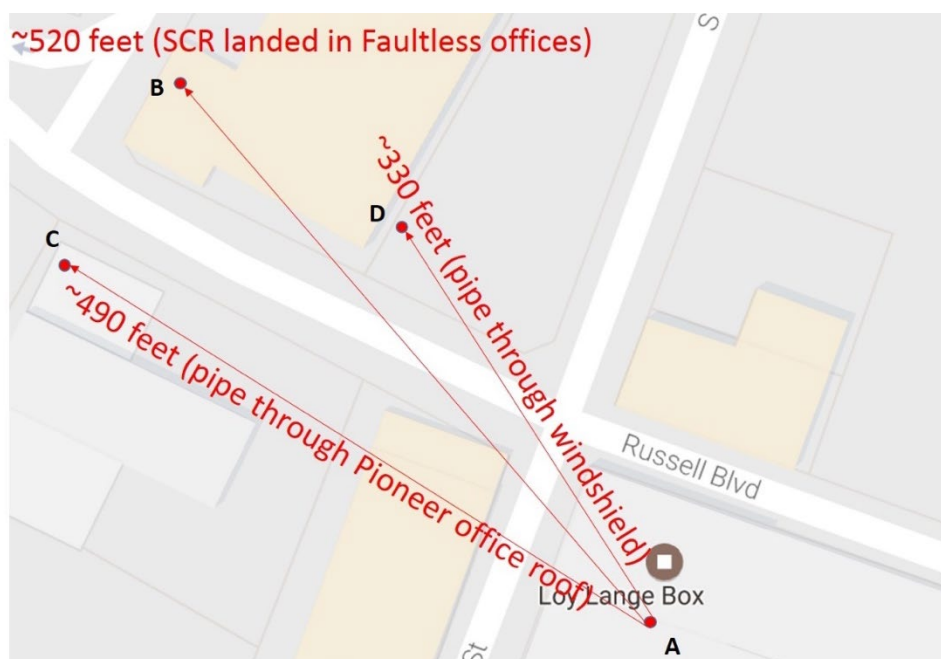
**Figure 12.** Debris map from incident. (Credit: Google, annotations by CSB)

The vessel remained airborne for approximately 10 seconds<sup>a</sup> and traveled laterally approximately 520 feet (**Figure 11A, Figure 12**). The SCR fell through the roof of the nearby Faultless Healthcare Linen company one block away, where it came to rest (**Figure 11B**). Various other pieces of debris from the explosion also fell into the surrounding area. A third building in the vicinity, owned by Pioneer Industrial Group, suffered damage when a large piece of pipe from the Loy-Lange explosion punctured the roof and ruptured its water sprinkler system

(**Figure 11C**). A section of 1.5-inch pipe approximately seven feet in length pierced the windshield and embedded in the dashboard and through the floorboard of an unoccupied pickup truck parked in the area (**Figure 11D**). A map of the debris field is shown in **Figure 12**. As a result of the incident, one stationary engineer at Loy-Lange was fatally injured. At Faultless Healthcare Linen, three employees were fatally injured when the SCR fell through the roof.

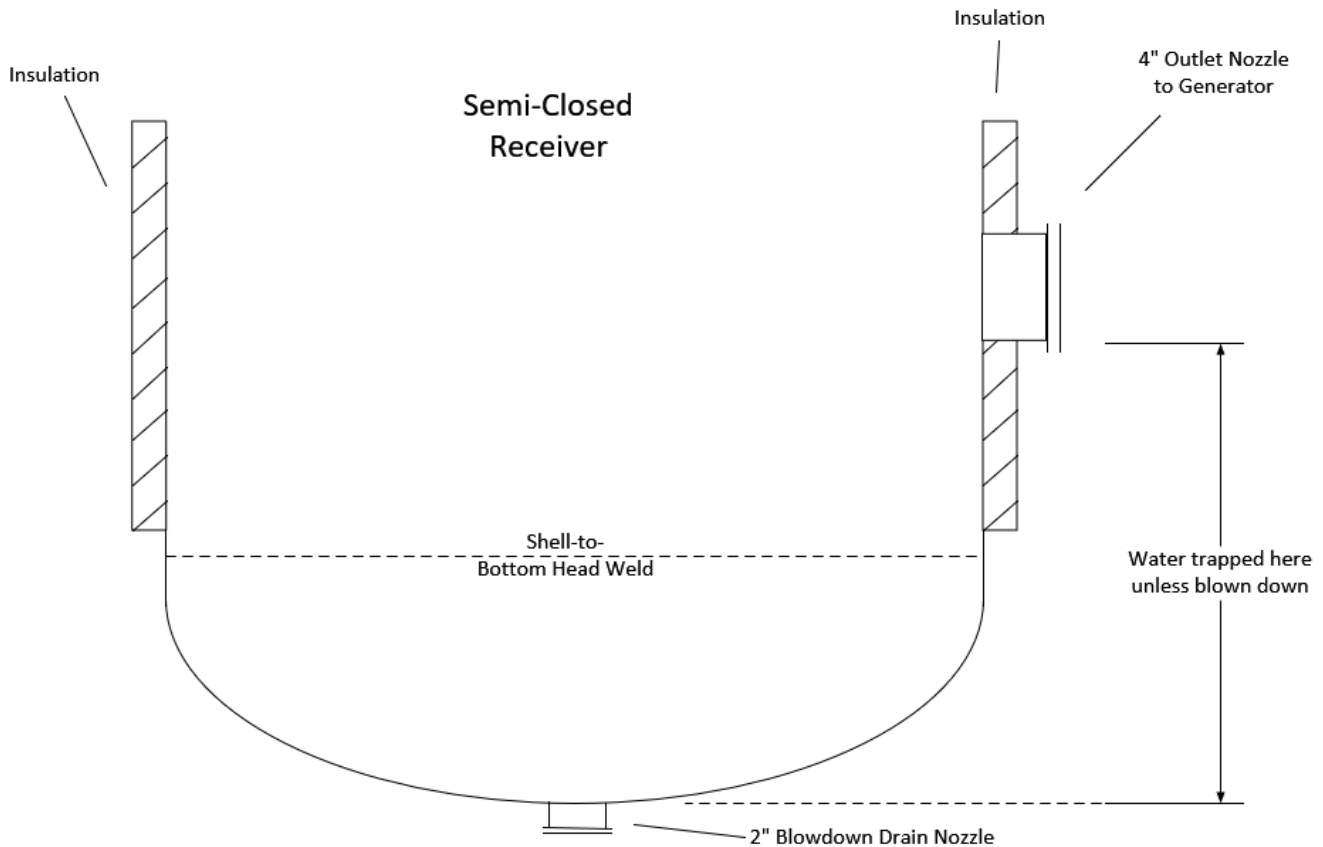
**Figure 27.** Conceptual diagram of the SCR bottom head. (Credit: CSB)

7. Eventually, operators routed the returning condensate back to the SCR instead of to drains (circled valves in **Figure 26**).
8. Unless operators performed a procedure called *blowdown* (see **Figure 27** and Section 1.7.3), a portion of water in the SCR below the outlet nozzle likely was trapped in the bottom head.

Water in the SCR bottom head remained stagnant during normal operation. To achieve flow in the bottom head of the SCR, operators had to manually open the drain line (blowdown) (**Figure 4, Figure 27**). Blowdown was intended by Clayton to drain precipitated solids produced by the water treatment chemicals. Clayton's 1995 operation manual recommended blowdown of the SCR weekly at minimum. In the absence of daily water tests, the manual requires a blowdown frequency of every 10-12 hours. Loy-Lange operators told the CSB that the vessel was rarely and irregularly blown down prior to 2012. In 2012, after the repair to the SCR bottom head (discussed in Section 1.3), they increased the blowdown frequency to weekly.

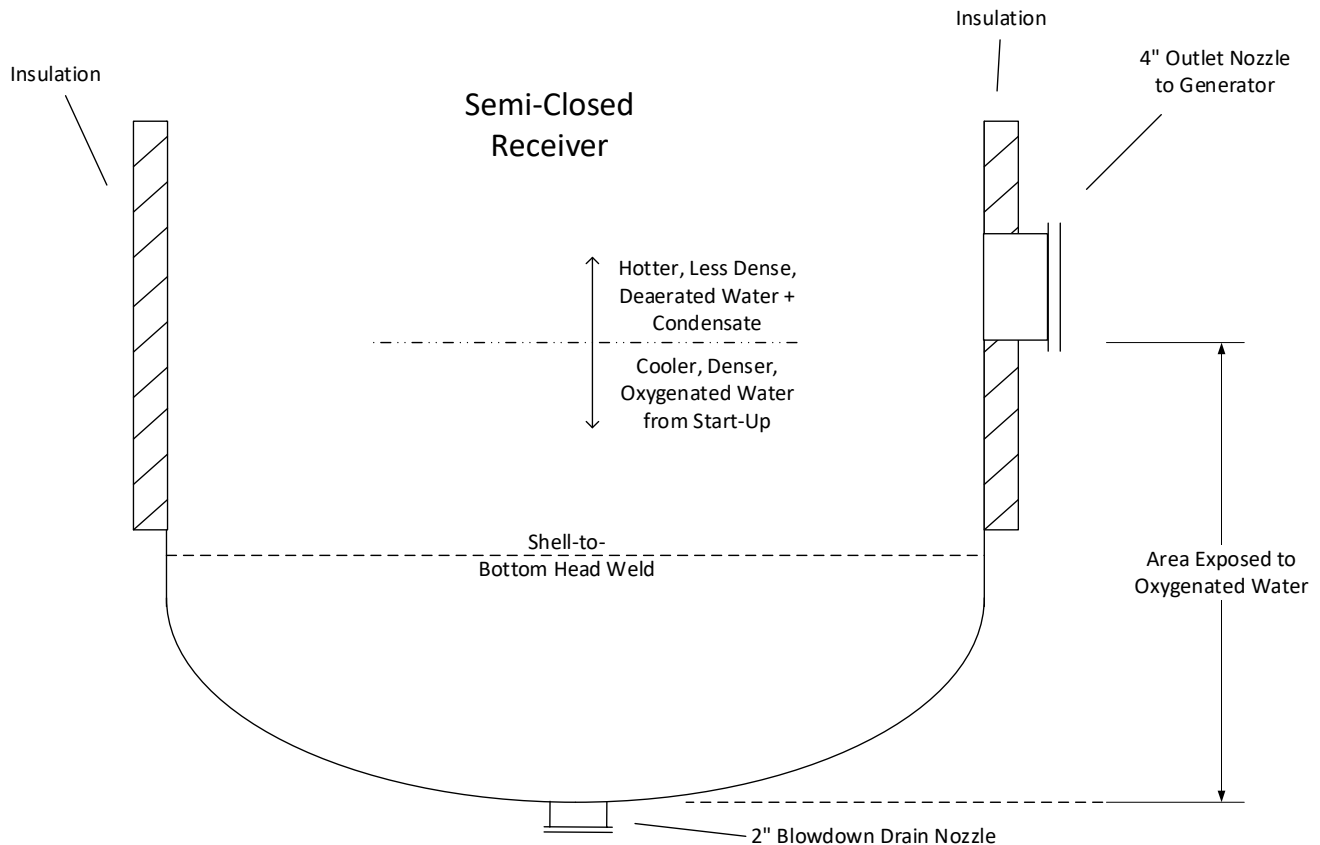
**Figure 32.** Conceptual diagram of the SCR bottom head. (Credit: CSB)

This oxygen, likely introduced into the SCR during daily startup operations, was the result of either insufficient mechanical deaeration, chemical deaeration, or both. Because the SCR bottom head trapped water below the SCR outlet nozzle (illustrated by **Figure 32**), some oxygenated water from startup would remain trapped at the bottom of the vessel until operators performed the weekly blowdown. Although blowdown was not expressly intended by Clayton to remove dissolved oxygen from the system (Section 1.7.3), given that oxygenated water likely remained trapped in the SCR bottom head, it is likely that blowing down the SCR daily after startup would have drained oxygenated water from the bottom head and filled it with treated water. The CSB concludes that Loy-Lange likely introduced oxygen into the SCR during its daily startup operation.

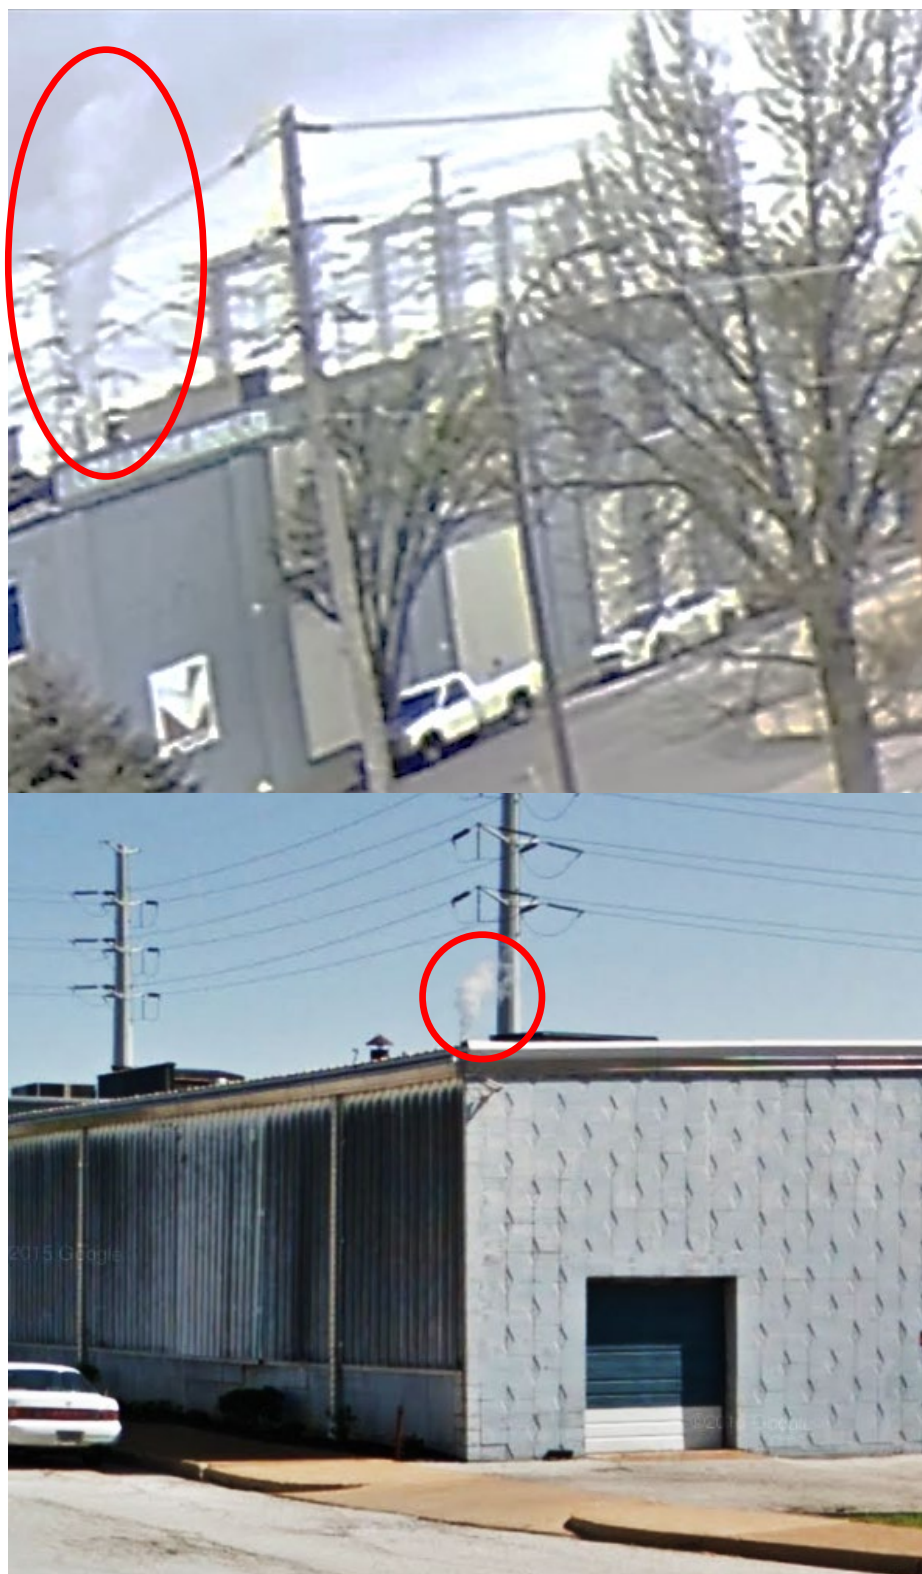
**Figure 36.** Steam plume comparison. (Credit: Top: Kranz; Bottom: Google, edited and annotated by CSB)

Evidence available to the CSB suggests that a steam system process upset may have occurred during the steam system startup on April 3, 2017. A surveillance video capturing the explosion shows a large plume of steam venting with high velocity from the roof of the building just before the incident (**Figure 36**, top). This steam plume appears substantially larger than the normal plume seen venting from the building historically.

For comparison, using Google Earth® and Google Street View®, the CSB evaluated historical images of the Loy-Lange facility. These images show a small white steam plume emanating from the roof of the facility, which may be from the normal venting of vapor during the deaeration process to remove dissolved gases [31]. One representative photo of the typical steam plume is shown in **Figure 36**.

One of the Loy-Lange stationary engineers confirmed to CSB investigators that the vapor venting from the roof of the facility immediately before the SCR rupture was abnormally large. After seeing the surveillance video, the stationary engineer said:
