## Investigation Report

Published: December 2023

## U.S. Chemical Safety and Hazard Investigation Board

The April 2, 2019, explosion and fire at the KMCO facility in Crosby, Texas, fatally injured James Mangum.

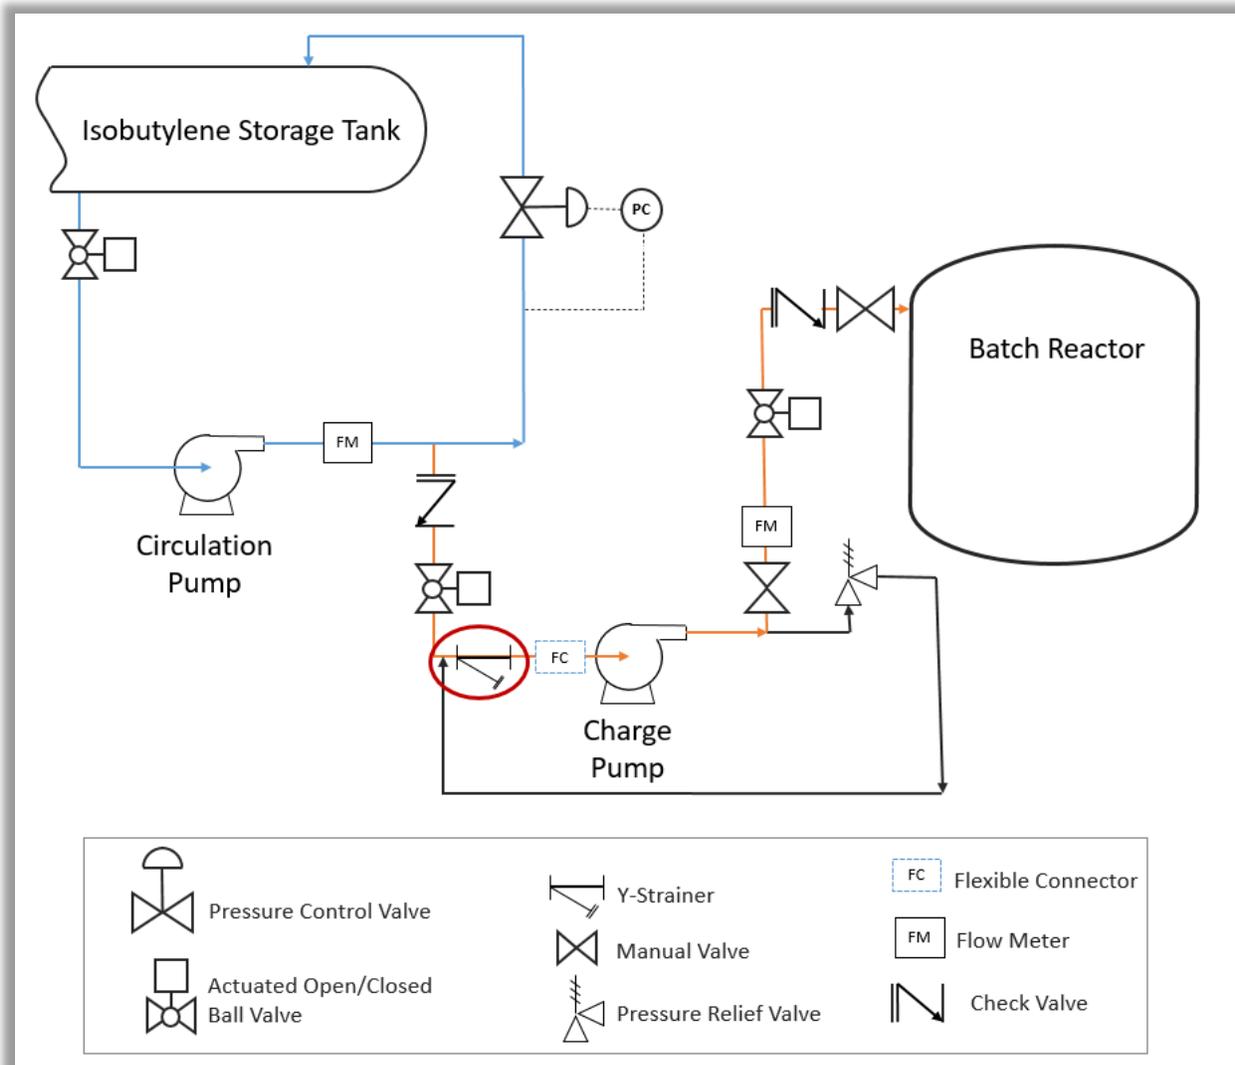
**Figure 3.** Isobutylene System. This simplified schematic shows the isobutylene system KMCO used to supply (charge) its batch reactor. The red circle shows the location of the y-strainer. (Credit: CSB)

<sup>d</sup> KMCO control system data for the flow meter on the isobutylene circulation pump (**Figure 3**) shows a significant increase in isobutylene flow shortly before 10:41 a.m., consistent with a hole developing in the y-strainer, releasing isobutylene to the atmosphere.

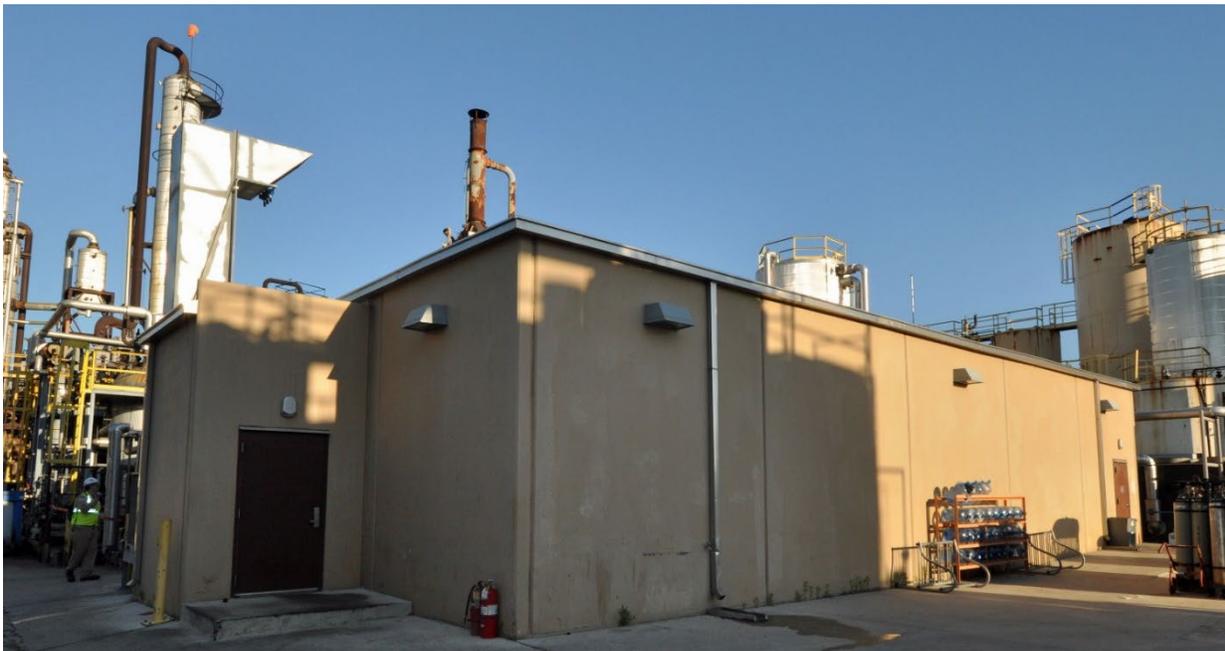
**Figure 5.** Reaction Control Room. KMCO’s blast-resistant control room. (Credit: CSB)

Following a facility siting study, KMCO built a blast-resistant control room in 2013 to improve safety.<sup>a</sup> After its completion, KMCO relocated the shift supervisor and plant operators from the two previous control rooms—the Reaction 1 Control Room and the Reaction 2 Control Room—to the new Reaction Control Room (**Figure 6**).

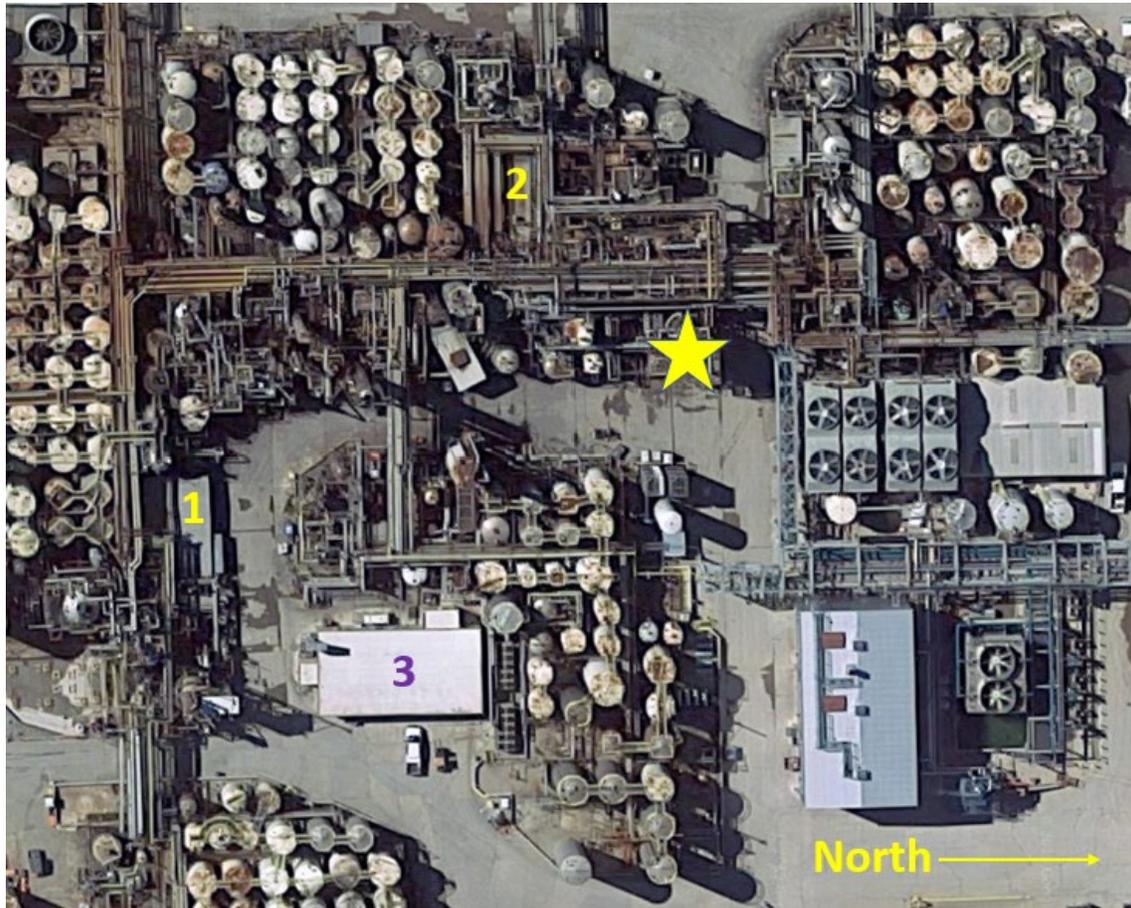
**Figure 6.** KMCO Control Rooms. This 2019 image of the KMCO facility shows the location of the Reaction 1 Control Room (yellow “1”), the Reaction 2 Control Room (yellow “2”), the new Reaction Control Room (purple “3”), and the location of the isobutylene release (yellow star). (Credit: Google, annotations by CSB)

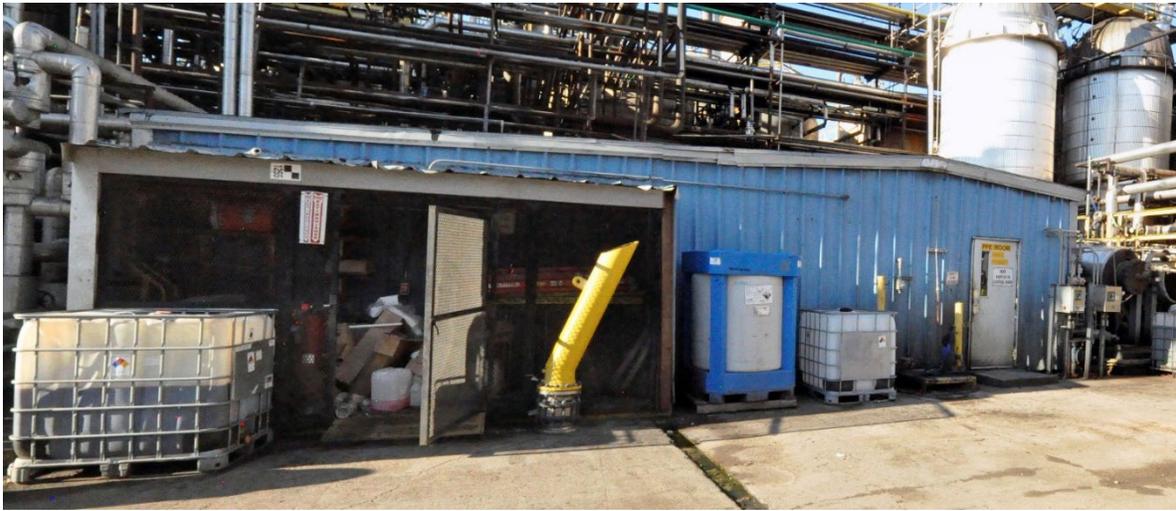
**Figure 7.** PPE Room. This photo shows the former Reaction 1 Control Room that KMCO converted to store PPE. The construction of the former Reaction 2 Control Room was similar to this building. (Credit: CSB)

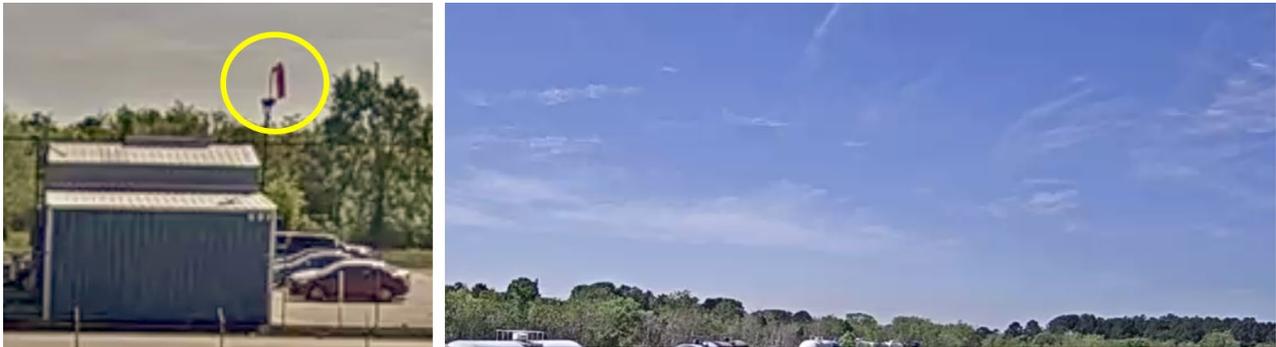
<sup>c</sup> KMCO did not have weather station equipment to monitor or record weather conditions. Weather conditions are available for the George Bush Intercontinental Airport, a straight-line distance of about 19 miles from KMCO. Five consecutive hourly weather records, from 5:53 a.m. through 9:53 a.m., show calm winds at the airport, with temperatures rising from 38 to 54 °F [72]. The 10:53 a.m. airport weather data shows a temperature of 59 °F, variable wind direction, and a wind speed of three miles per hour [72]. The National Weather Service defines variable wind the same way as variable wind direction. Variable wind means that the wind direction fluctuates by 60 degrees or more during the 2-minute evaluation period and the wind speed is greater than six knots (6.9 miles per hour), or the wind direction is variable, and the wind speed is less than six knots [71].

**Figure 9.** Surveillance Video Images Showing the Time of Incident Weather Conditions at KMCO. The yellow circle (left) shows a windsock under calm wind conditions. (Credit: KMCO, annotation by CSB)

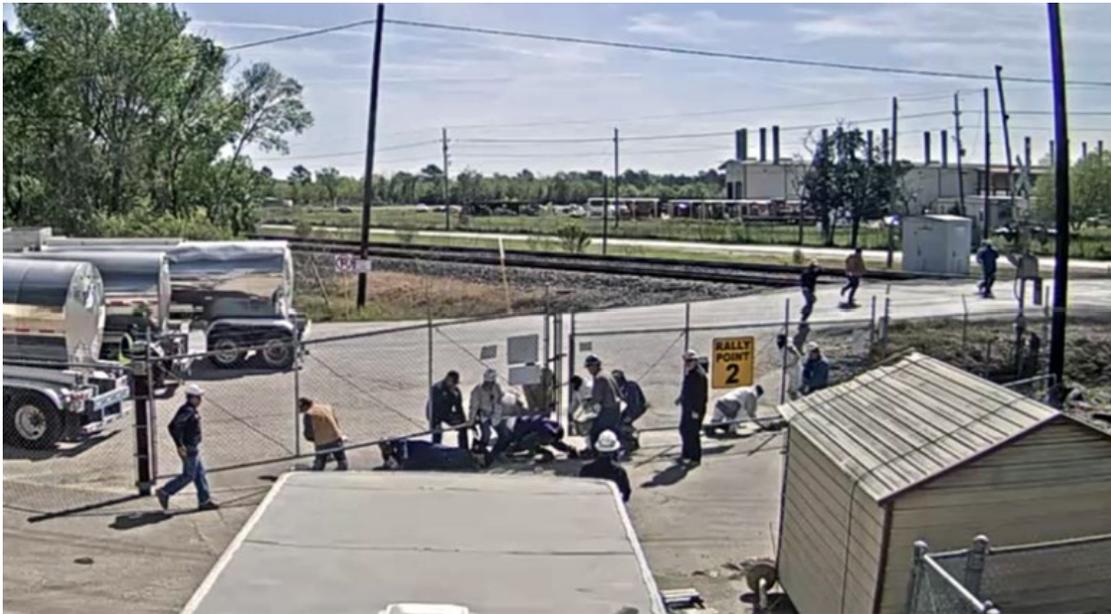
**Figure 10.** Evacuation Under Plant Fencing. This surveillance camera image shows workers helping other workers to exit under plant fencing about 36 seconds after the explosion.<sup>a</sup> (Credit: KMCO)

<sup>a</sup> According to KMCO's evacuation plan, this gate was not intended to be an entrance or exit for workers. KMCO periodically unlocked and opened this gate to allow heavy equipment to enter or exit. At the time of the incident, this gate was in its usual position, closed and locked for site security. Only one of KMCO's four rally points was outside the plant fence line.

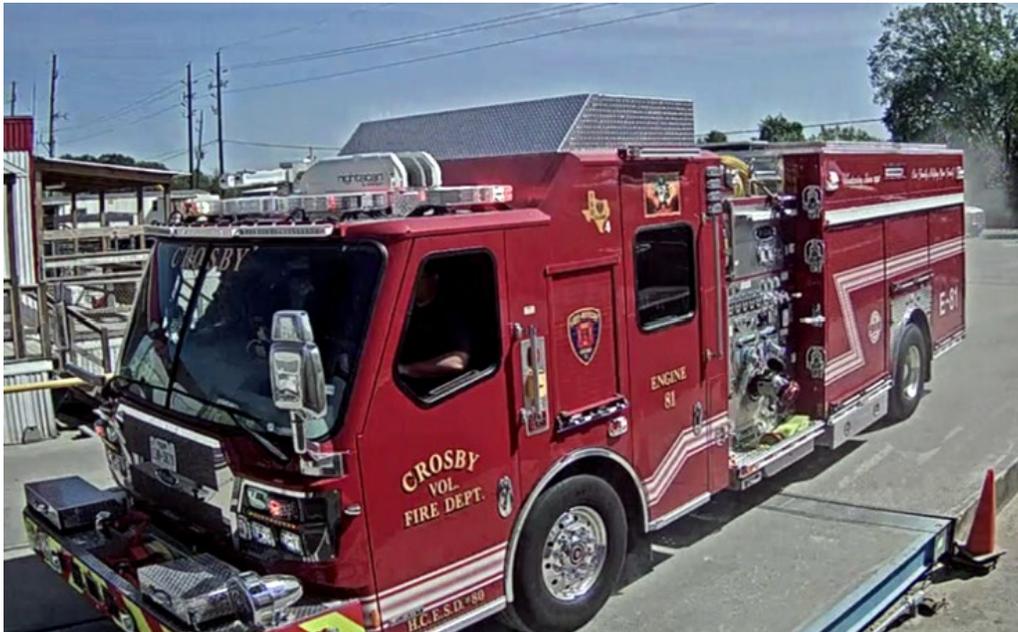
**Figure 11.** Emergency Response. This image from a KMCO surveillance camera shows a fire truck entering the facility at about 11:28 a.m. (Credit: KMCO)

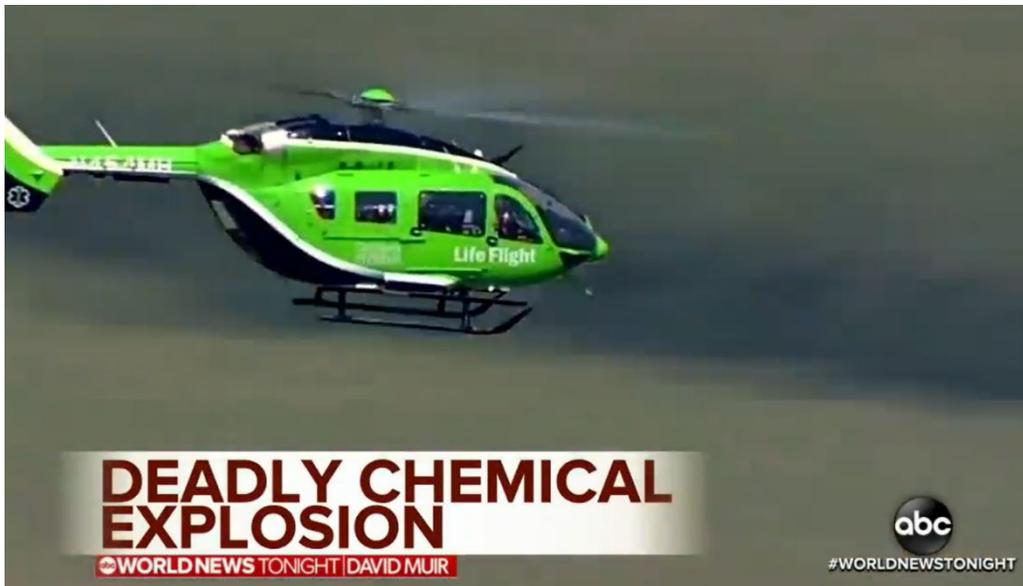
**Figure 12.** Life Flight Helicopter. One of the two helicopters that responded to the incident to transport injured workers. (Credit: ABC [9])

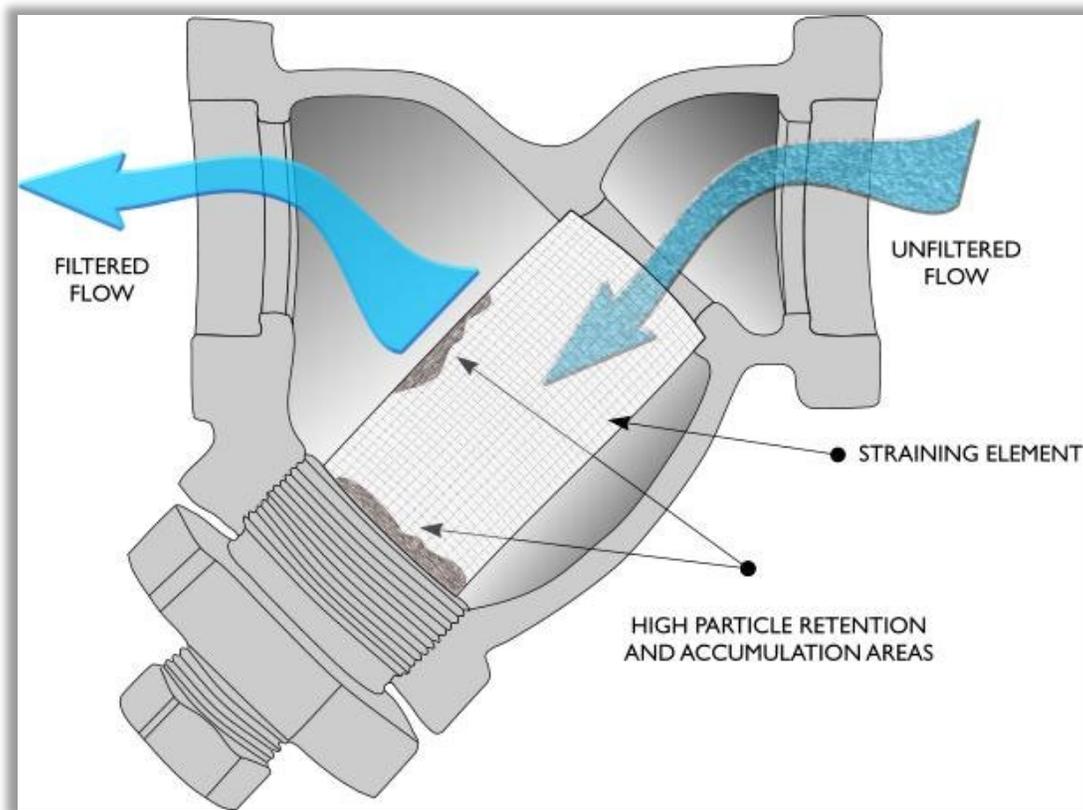
**Figure 16.** Generic Y-Strainer. This graphic shows a generic depiction of a typical y-strainer application—used to remove solid particles from a liquid stream. (Credit: Warden [16])

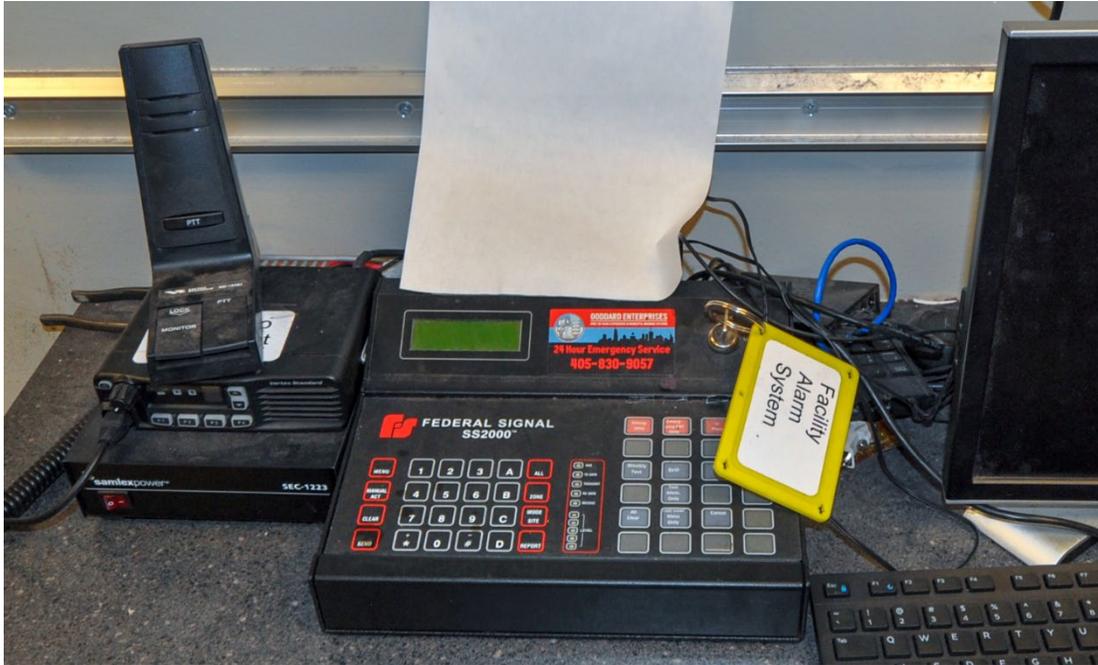
Figure 22. Base Station for Facility Alarm System. (Credit: CSB)

One operations supervisor stated that the old facility alarm system never worked—or at least, not during his 14 years at KMCO—and that he had never heard a facility alarm until the new system was up and running.
