U.S. Chemical Safety and Hazard Investigation Board

E.I. DuPont de Nemours & Co Inc.

Flammable Vapor Explosion

Welding on Tank Containing Vinyl Fluoride (1 Killed, 1 injured)

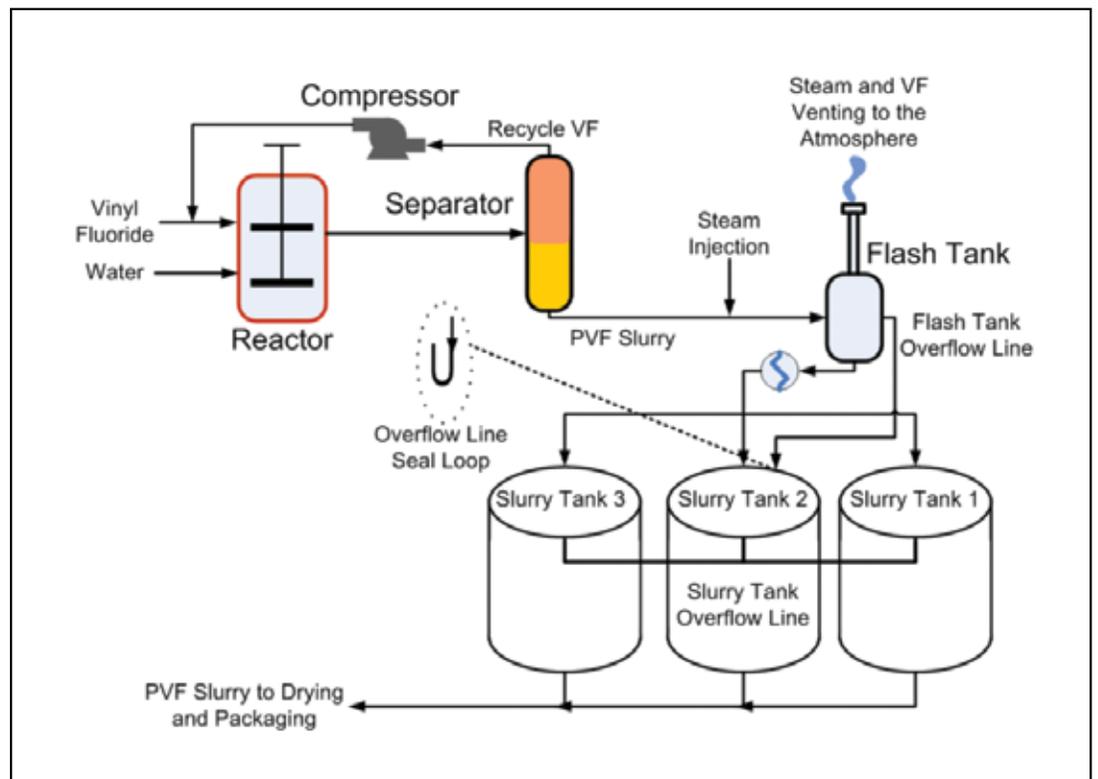
FIGURE 1

The non-combustible PVF slurry then passes to one of three insulated slurry holding tanks (numbered 1, 2, or 3) in the tank farm adjacent to the production building (Figure 1). Under normal operating conditions, slurry is pumped to slurry tank 3. Slurry tank 3 is newer than slurry tanks 2 and 1; it had been replaced in 2009 due to corrosion². Slurry tanks 2 and 1 were used as overflow storage space in the event slurry tank 3 was filled and slurry tank 1 was generally kept empty of slurry.

PVF process flow diagram

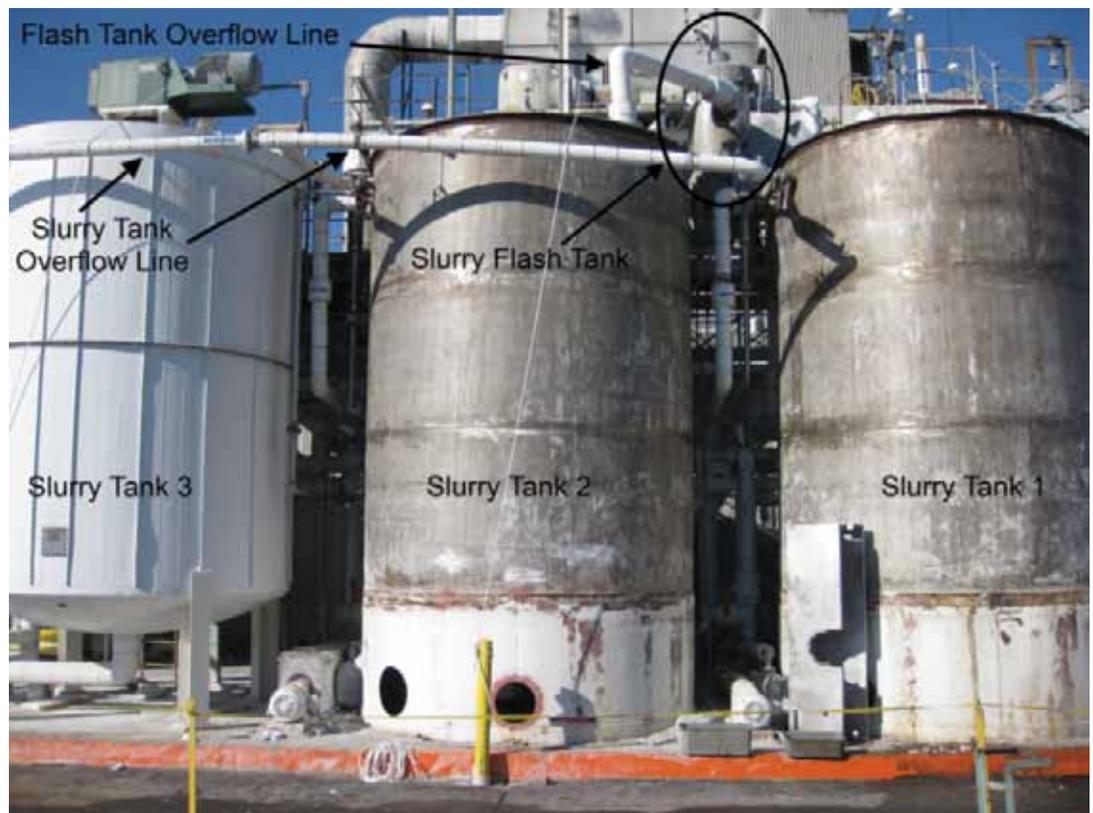
FIGURE 2

The flash tank and three slurry tanks are located in a tank farm adjacent to the Tedlar manufacturing building. The slurry tanks are 11 feet in diameter, 19 feet tall, and have a capacity of 10,800 gallons (Figure 2). The tank shell and top are one-quarter inch thick stainless steel. Each tank top has a hinged, unsealed steel cover on a 24-inch diameter manway and a large agitator motor drive and gearbox⁵. The agitator assembly is bolted to structural steel beams that are welded directly to the tank top.

PVF slurry holding tanks
