March Public Meeting

U.S. Chemical Safety and
Hazard Investigation Board

Public Business Meeting
March 19, 2026

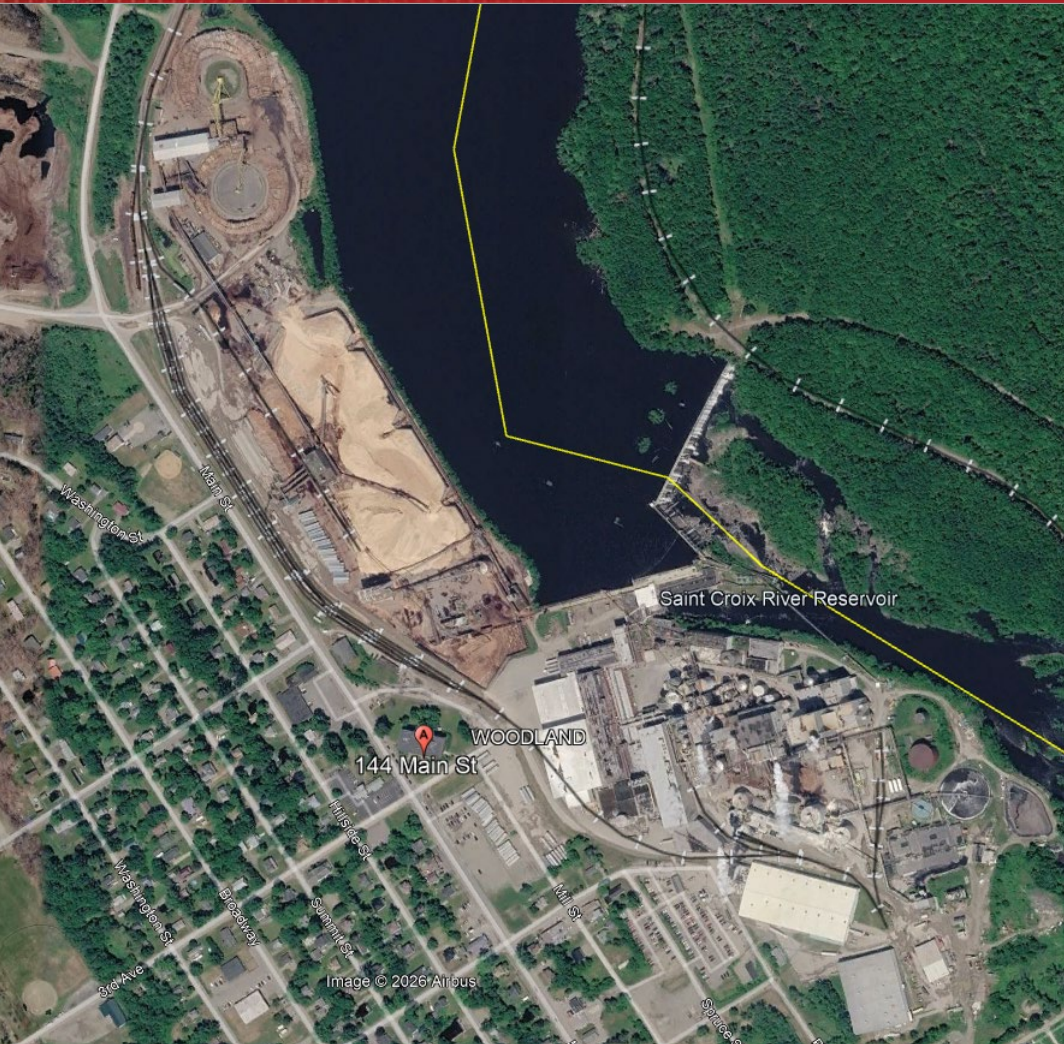
- The Woodland Pulp Mill, located in Baileyville, Maine, has been in operation since the early 1900s and manufactures wood pulp for use in paper products.
- On January 27, 2026, in the early afternoon, sulfuric acid mixed in an enclosed sewer pipe with other sulfurous compounds, resulting in the generation and release of hydrogen sulfide.
- Hydrogen sulfide is a highly toxic gas, which is considered immediately dangerous to life and health at 100 ppm, and at low concentrations smells like rotten eggs. Continued exposure or high concentrations may limit the ability to detect the odor.

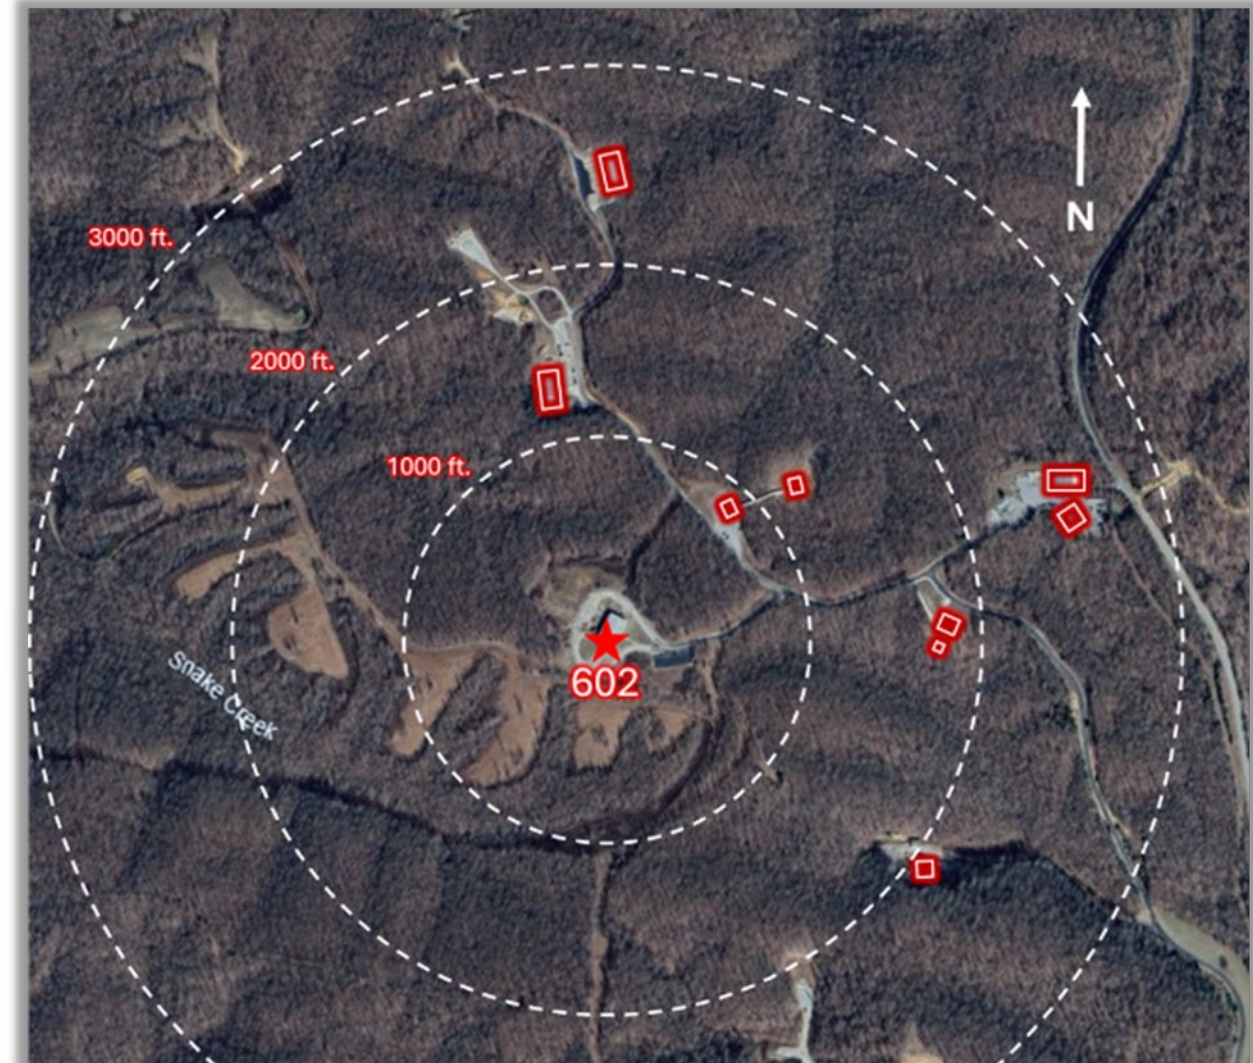
- All sixteen employees in the building were fatally injured
- One employee was hospitalized
- Six other employees reported injuries
- Nine additional buildings were damaged

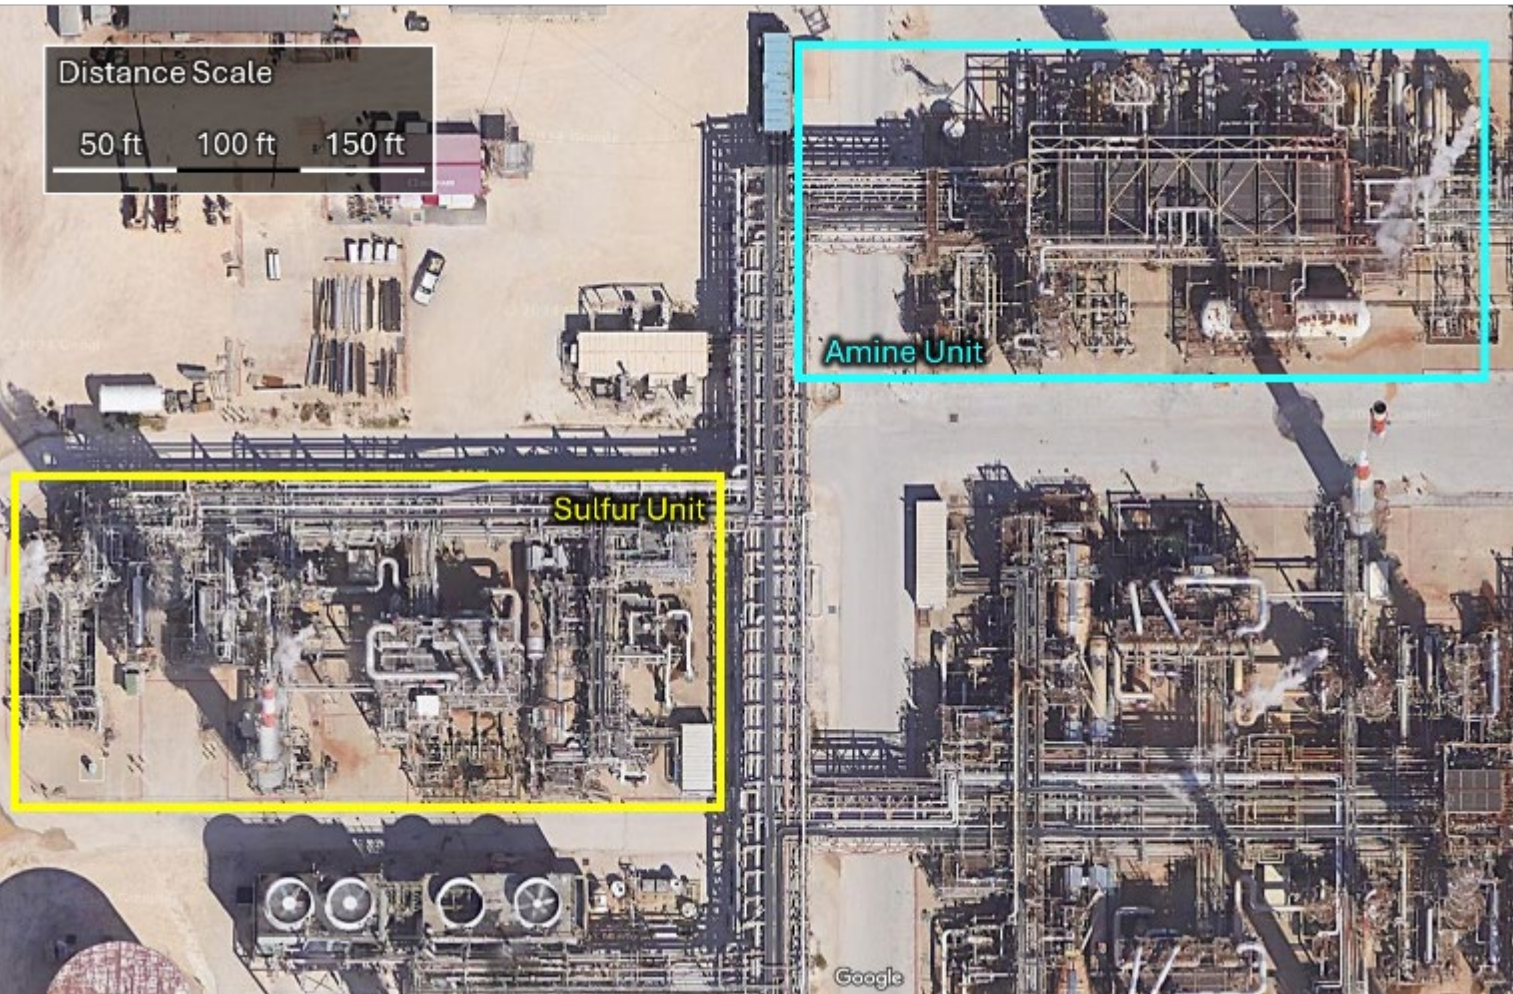
- On October 8th, PEMEX Deer Park prepared the Amine Unit for maintenance.
- Unlike the Sulfur Unit, the Amine Unit was partially operational.
- To prepare for maintenance, PEMEX Deer Park operators hung blind tags on piping like they would do in the Sulfur Unit.
- On Blind 407, the operator hung the tag on the platform railing above the piping.
- That night, Repcon workers installed 15 blinds in the Amine Unit piping and placed flange-locking devices on each flange.
- PEMEX Deer Park did not require flange-locking devices for the Amine Unit task and the PEMEX Deer Park operator was unaware the workers placed the devices.
- On October 9th, Amine Unit maintenance was complete.

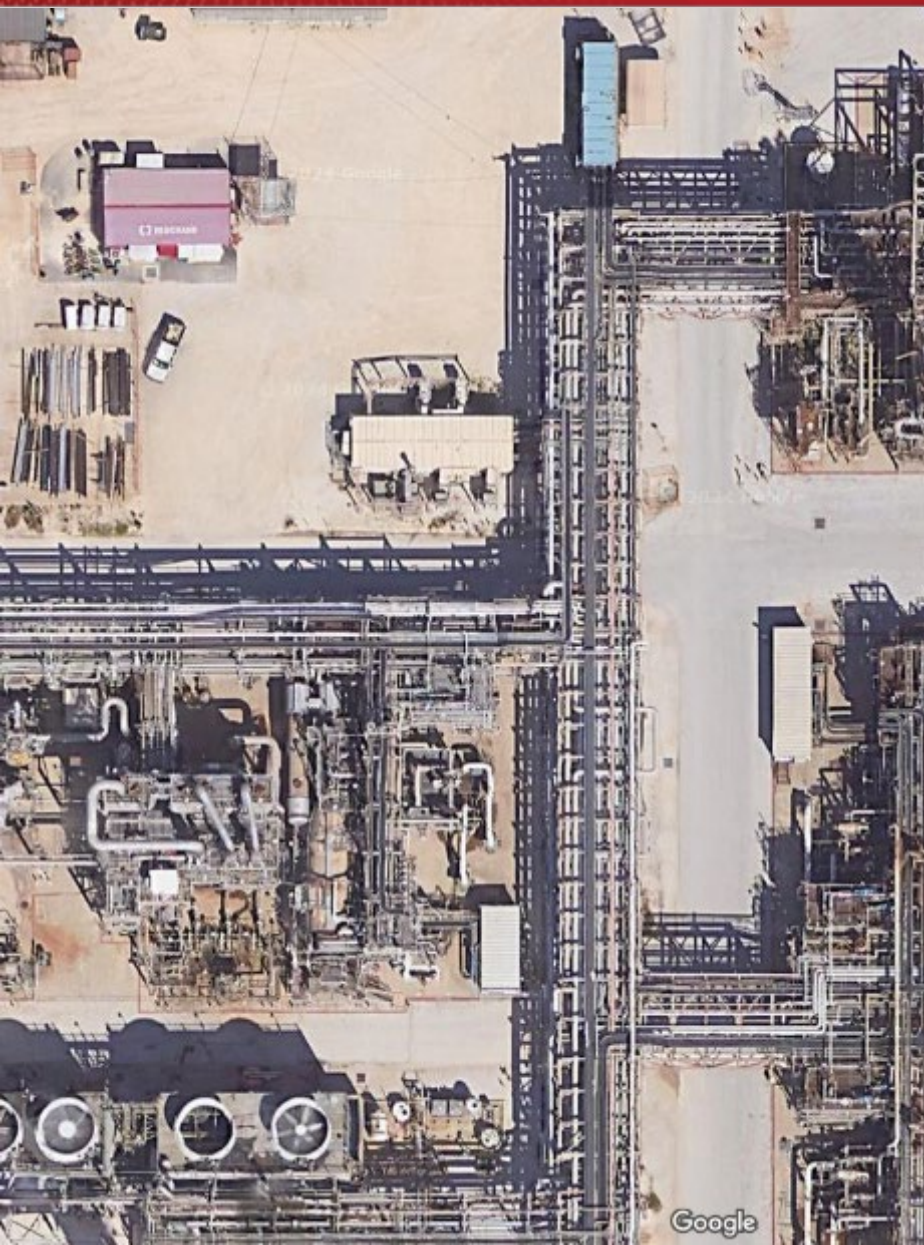
- The wind carried the hydrogen sulfide into the nearby Sulfur Recovery Unit, where portable alarms activated. The Amine Unit alarms activated 4 minutes after the release began.
- Two contract workers 250 feet downwind were in the path of the hydrogen sulfide release. One worker was fatally injured from the release, and the other was able to evacuate to the primary assembly point.
- Other contractors heard alarms and evacuated to the primary assembly point, which was located upwind towards the direction of the release.
- 47 contractors from 10 companies were evaluated for hydrogen sulfide poisoning. An additional 13 contract workers were taken to medical facilities.
- The sitewide alarm sounded 12 minutes after the release began.
- An hour after the release began, emergency responders bolted the flange, stopping the leak.

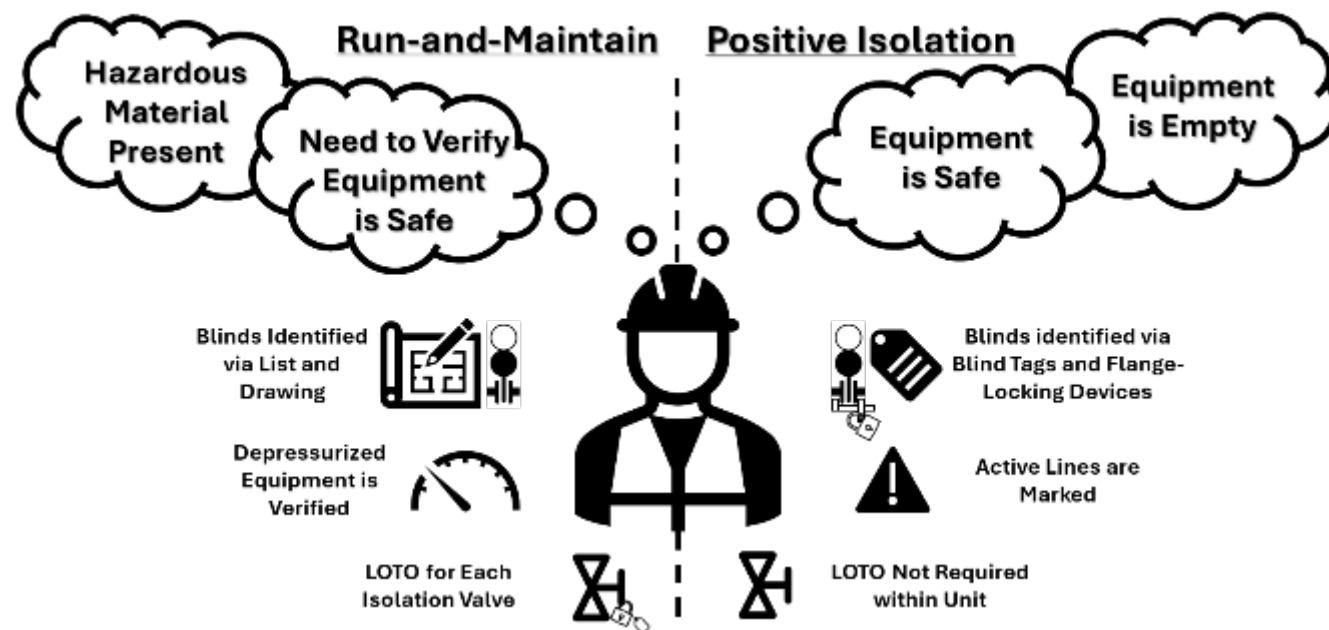
Turnaround Contractor Management

- Repcon workers were reassigned from a shutdown, isolated, and emptied unit undergoing turnaround to the partially operational unit where the incident occurred.
- Due to the abrupt shift in the work environment and the proximity of the two units, the workers were neither aware that they were working in a different unit nor that the unit was operational and contained hazardous hydrogen sulfide
- PEMEX Deer Park had trained the Repcon workers on the precautions for working in the shutdown turnaround unit but neither PEMEX Deer Park nor Rpecon informed them of the hazards associated with working in the operational unit before assigning them the flange opening task. As a result, the Repcon workers overlooked the usual precautions associated with working around live equipment.

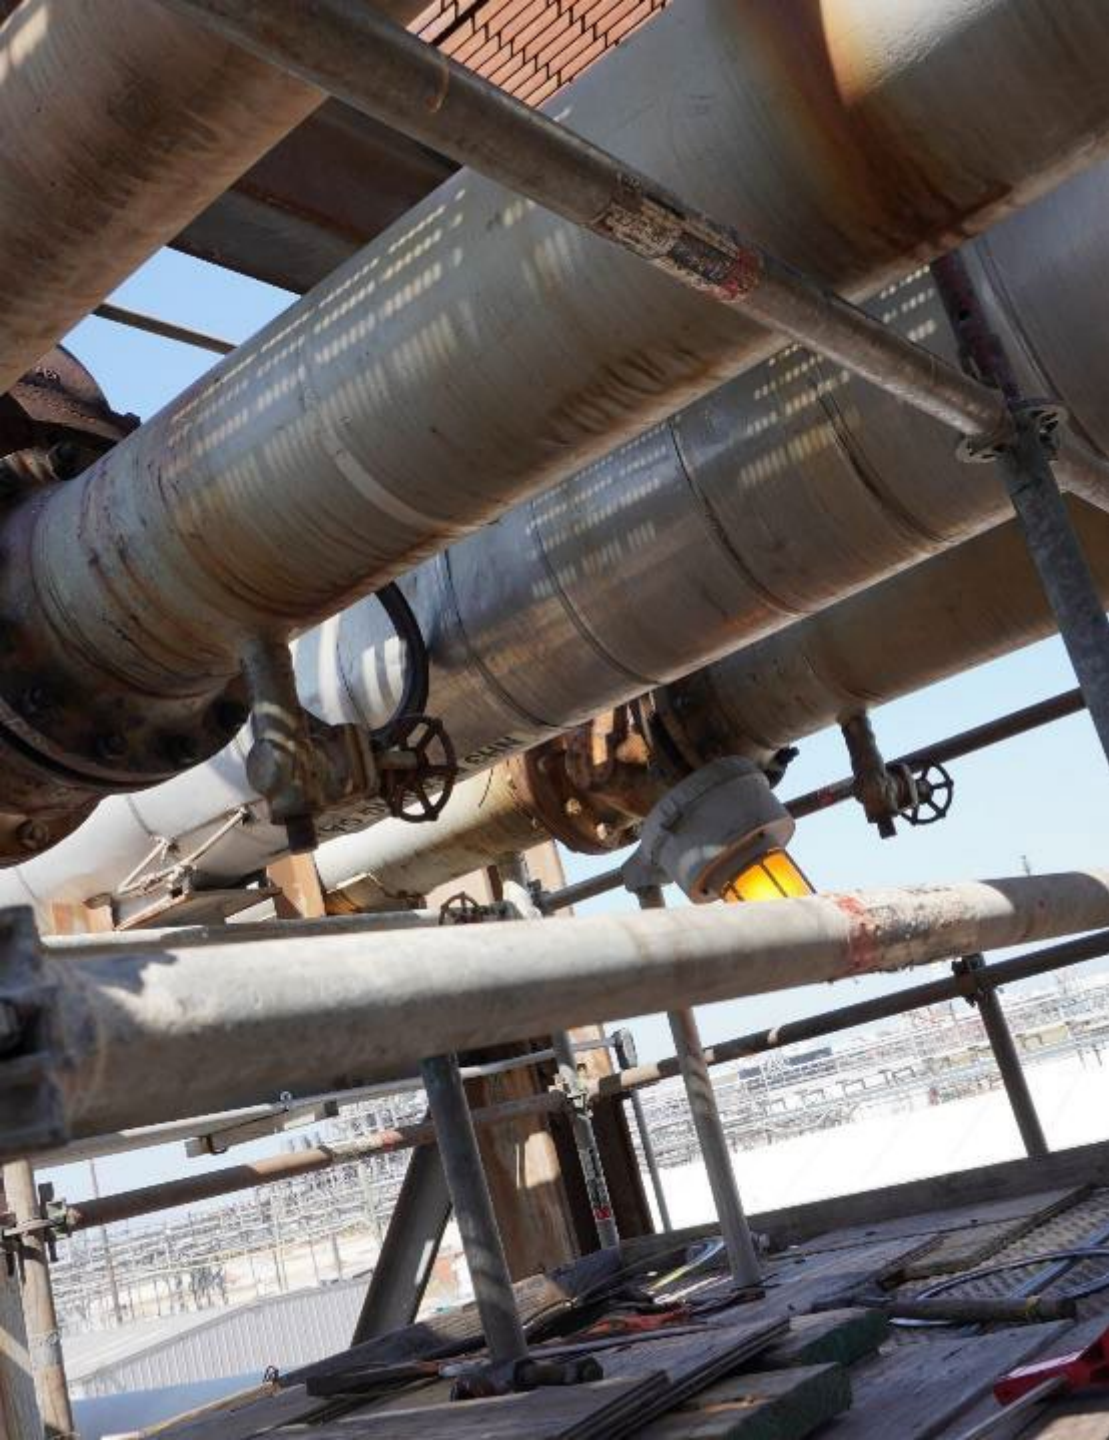
Conduct of Operations

- Numerous instances where PEMEX Deer Park policies and procedures were not aligned with actual practices.
- Written documentation was consistent with industry guidance and accepted best practices; however, both management and operations personnel often misunderstood or were unaware of the expectations and frequently deviated from required practices.
- PEMEX Deer Park deviated from documented work permitting requirements, emergency procedures, hazard evaluation, and management of change processes, which all contributed to the incident.

Standard of Behavior	Organizational Performance
Procedures specified that a drawing and a written blind list were to be used to locate blinds during Run-and-Maintain, and blind tags and a Circle-X marking are used for identification during turnaround.	A sketch, a blind list, blind tags, and Circle-X markings were all present but inconsistently used in the Amine Unit.
Procedures state that piping must be distinctly labeled per ANSI/ASME A13.1 <i>Scheme for the Identification of Piping Systems</i> .	PEMEX Deer Park did not label identical Amine Unit piping segments located 5 feet apart.
Permitting procedures require separate work permits for jobs with different hazards.	All ARU6 blinds were included on a single permit, even though the acid gas blinds posed a higher risk.
The work permit included notes to hold the job until an operator could be present.	Noted permit hold points were ambiguous, and the permit receiver and craftworkers misinterpreted the requirement.

Permitting procedures require permit authorizers to evaluate and control hazards to neighboring units.	Impacts to surrounding processes were not controlled as part of the permitting process, and permit issuers were unaware of how to conduct a review of conflicting processes.
PEMEX Deer Park operators will communicate with a contractor representative, who will then communicate all requirements directly with craftworkers.	Boilermakers were unaware that their work in the Amine Unit was not a part of the Sulfur Unit turnaround and were unaware of the differing hazards and requirements.

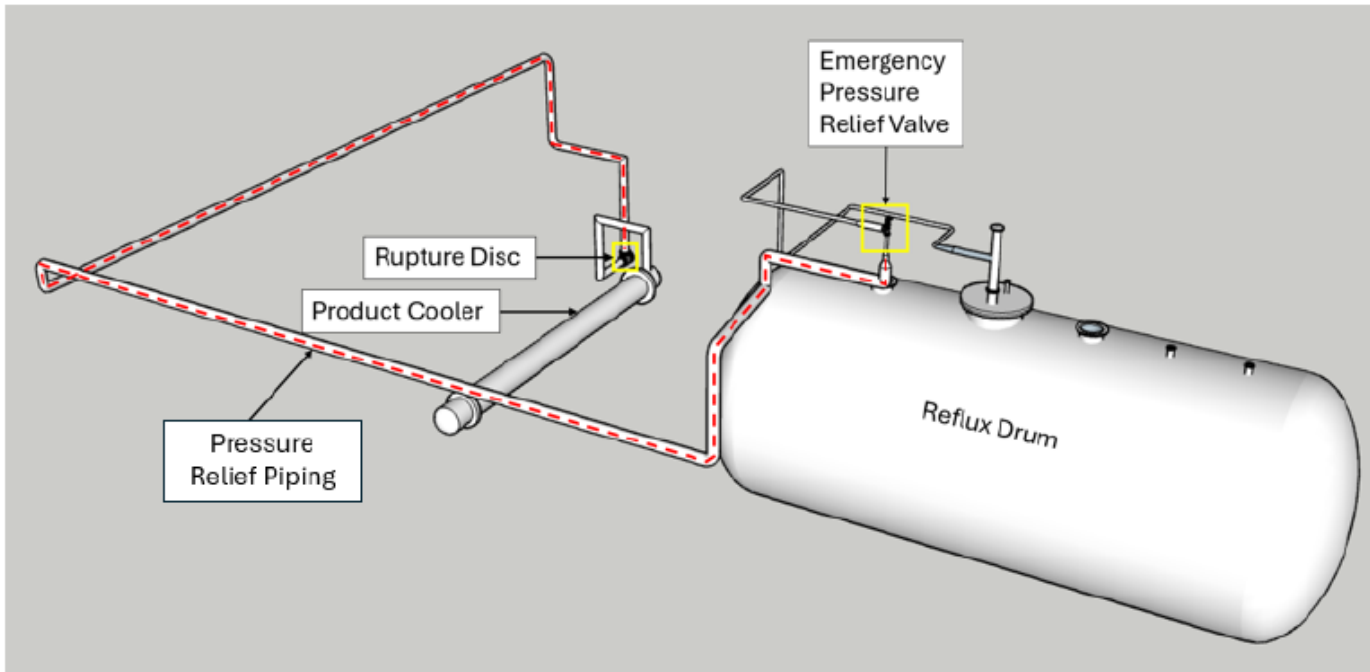
November 2020 Maintenance Activities

- On November 20, 2020, the rupture disc protecting the product cooler was replaced as part of regular maintenance and inspection activities. Upon completing the installation of the rupture disc, Dow workers pressurized the pressure relief piping between the rupture disc and PRV with nitrogen, which was used as an inerting gas in the Glycol II unit to prevent ethylene oxide decomposition and reaction.
- Over the next two months, the nitrogen pressure in the rupture disc discharge piping gradually decreased and the piping filled with air. No additional nitrogen was added to the pressure relief piping between the November 2020 maintenance activities and the incident.

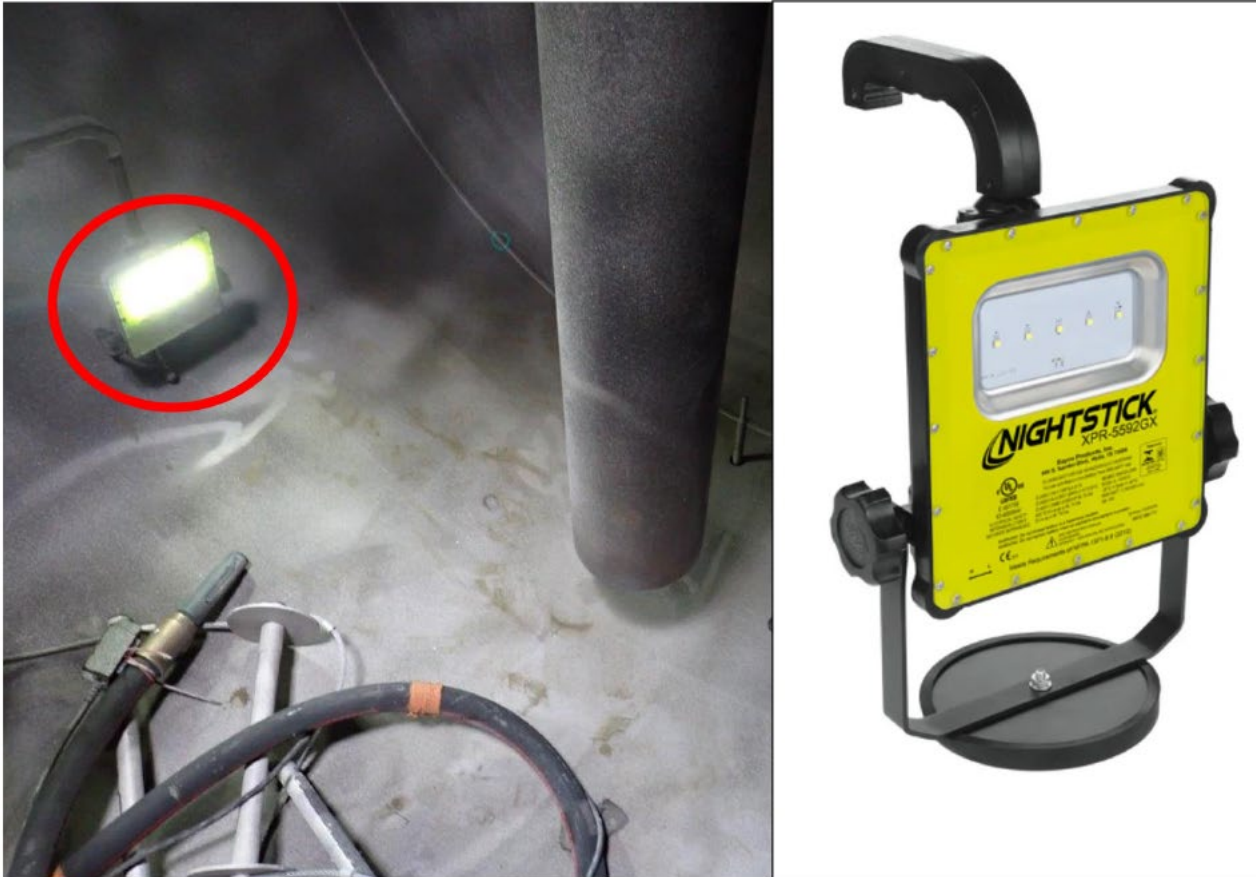
2023 Turnaround Activities

- In May 2023, the Glycol II unit underwent a turnaround. One of the turnaround activities included cleaning out and performing an internal inspection of the reflux drum.
- The work order for this activity included tasks to “install low voltage lights” prior to the work beginning and “remove internal low voltage lights” after the work was completed inside of the reflux drum.
- After the work was completed, the reflux drum was closed for restart.
- Unbeknownst to the workers, some of the portable work lights from the turnaround work were left behind in the reflux drum.
- After the turnaround work was complete, the ethylene oxide unit was started up and began operating without issues. During this time, the reflux drum filled with ethylene oxide, and the reactive chemical began to degrade the work lights.

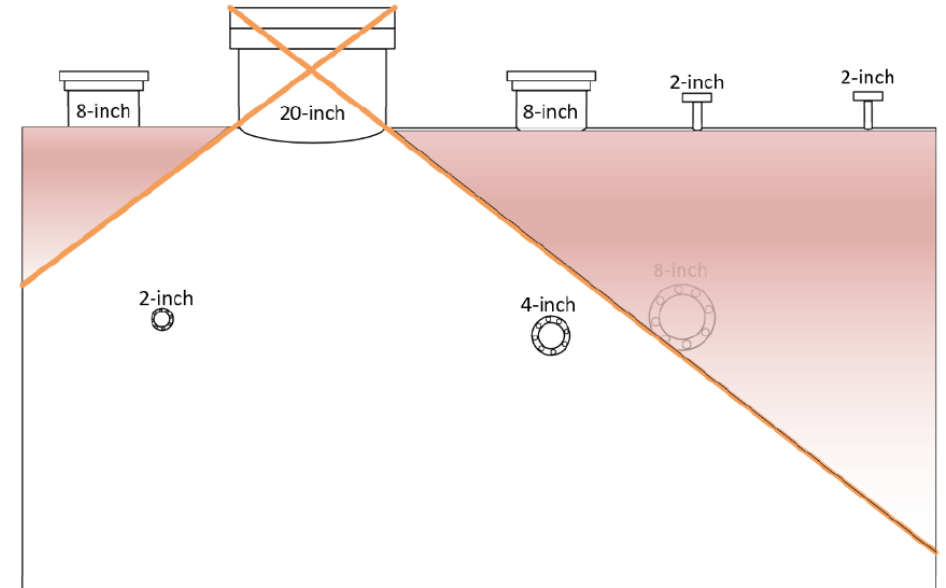
Vessel Closure Practices

- Portable work lights were left in the reflux drum after the May 2023 turnaround work in the drum had concluded. Debris consistent with the work lights was found in the reflux drum, the downstream pumps, the product cooler, and the rupture disc after the incident.
- At the time of the incident, Dow's vessel closure process had no official procedure in place related to tracking equipment placed inside a vessel during maintenance and inspection activities requiring confined space entries.
- Dow's vessel closure process and practices did not adequately identify whether the reflux drum was clean and empty after maintenance was completed.

- Dow's vessel closure procedure did not give adequate guidance related to ensuring the cleanliness of the equipment. For example, the document did not tell the operator what steps to follow or what it means for a vessel to be "clean" after maintenance.
- As part of the vessel closure process, the permit writer would be "looking for anything visible to the eye that could be in the drum." The permit writer would use a flashlight to inspect the inside of the vessel without actually entering the vessel. If the permit writer did not see anything in the vessel, the permit writer would order the vessel to be bolted and closed. However, not only did the operators not actually enter the vessel, they also did not use inspection mirrors or other means, such as a boroscope, to check the inside of the vessel.
