U.S. Chemical Safety and  
Hazard Investigation Board

# Pressure Vessel Explosion at Loy-Lange Box Company

St. Louis, MO | Incident Date: April 3, 2017 | No. 2017-04-I-MO

## Investigation Report

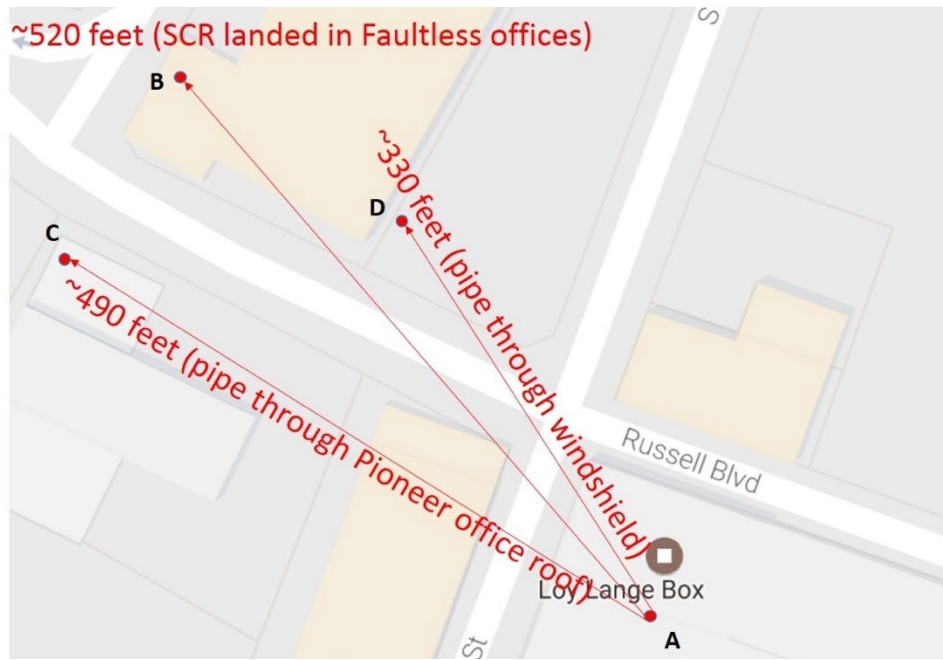
The vessel remained airborne for approximately 10 seconds<sup>a</sup> and traveled laterally approximately 520 feet (**Figure 11A, Figure 12**). The SCR fell through the roof of the nearby Faultless Healthcare Linen company one block away, where it came to rest (**Figure 11B**). Various other pieces of debris from the explosion also fell into the surrounding area. A third building in the vicinity, owned by Pioneer Industrial Group, suffered damage when a large piece of pipe from the Loy-Lange explosion punctured the roof and ruptured its water sprinkler system

Figure 12. Debris map from incident. (Credit: Google, annotations by CSB)

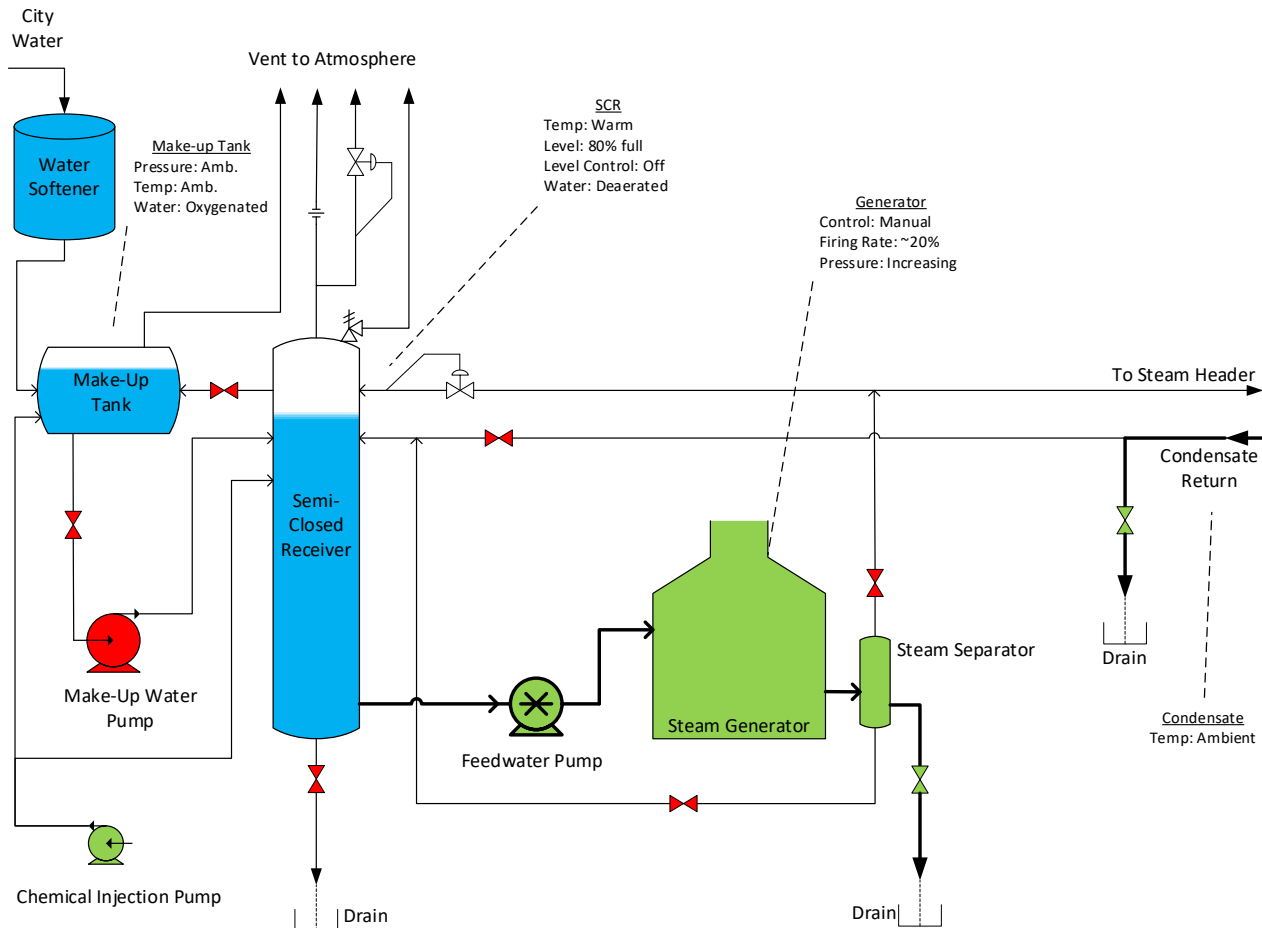
**Figure 23.** Simplified process flow diagram illustrating steam system initial conditions. (Credit: CSB)

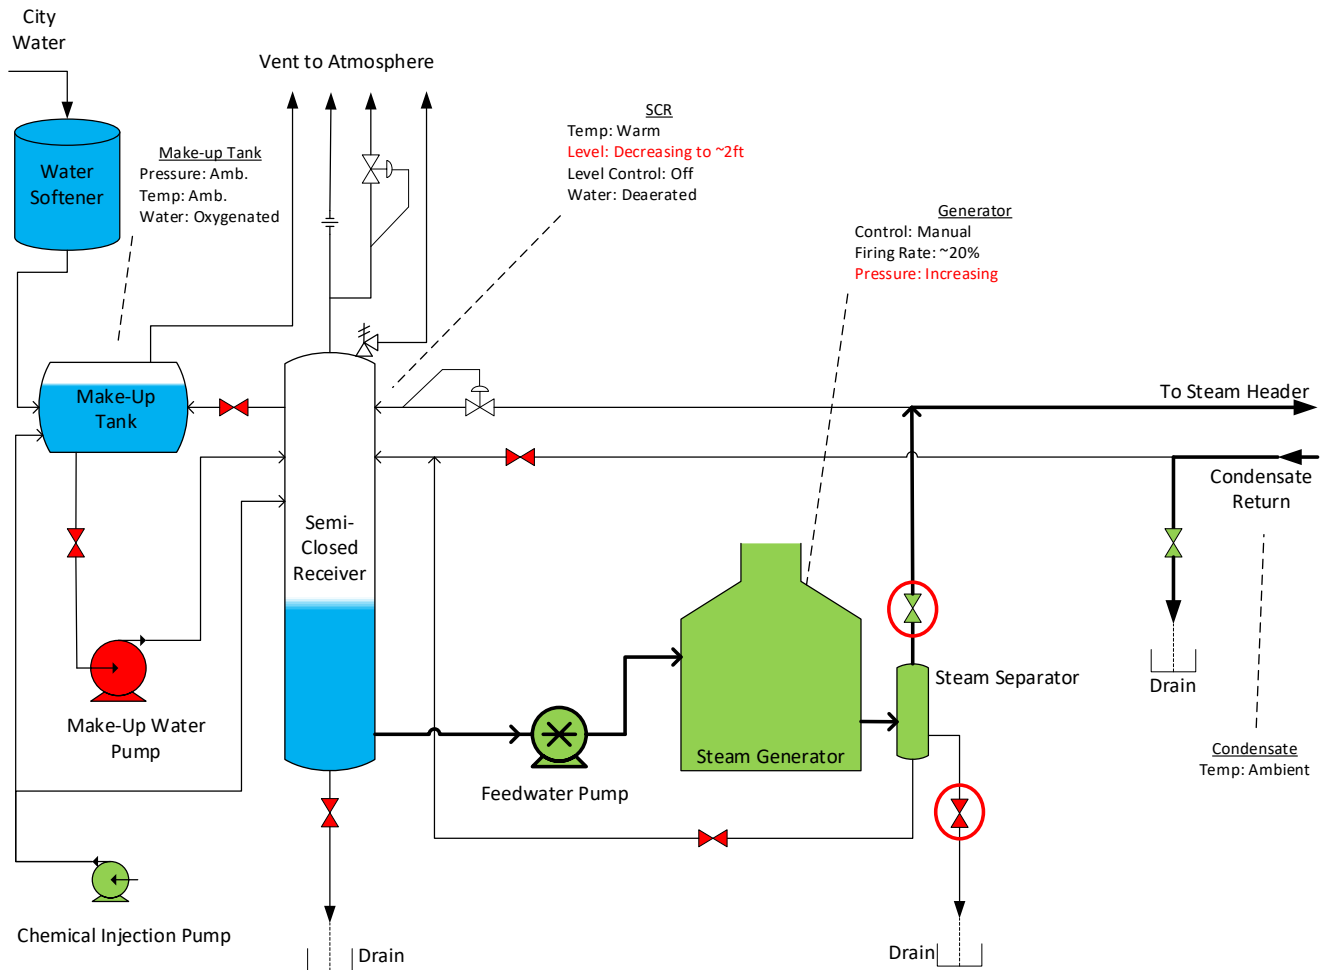
4. Once the generator was producing steam, operators slowly opened the valve isolating the steam generator and separator from the process steam header, allowing steam to flow out to the corrugation process equipment.
5. During this time, the liquid level inside the SCR slowly fell from approximately 14 feet to approximately 2 feet,<sup>a</sup> nearly emptying the SCR (**Figure 24**).

**Figure 24.** Simplified process flow diagram illustrating steam flowing to the steam header. (Credit: CSB)

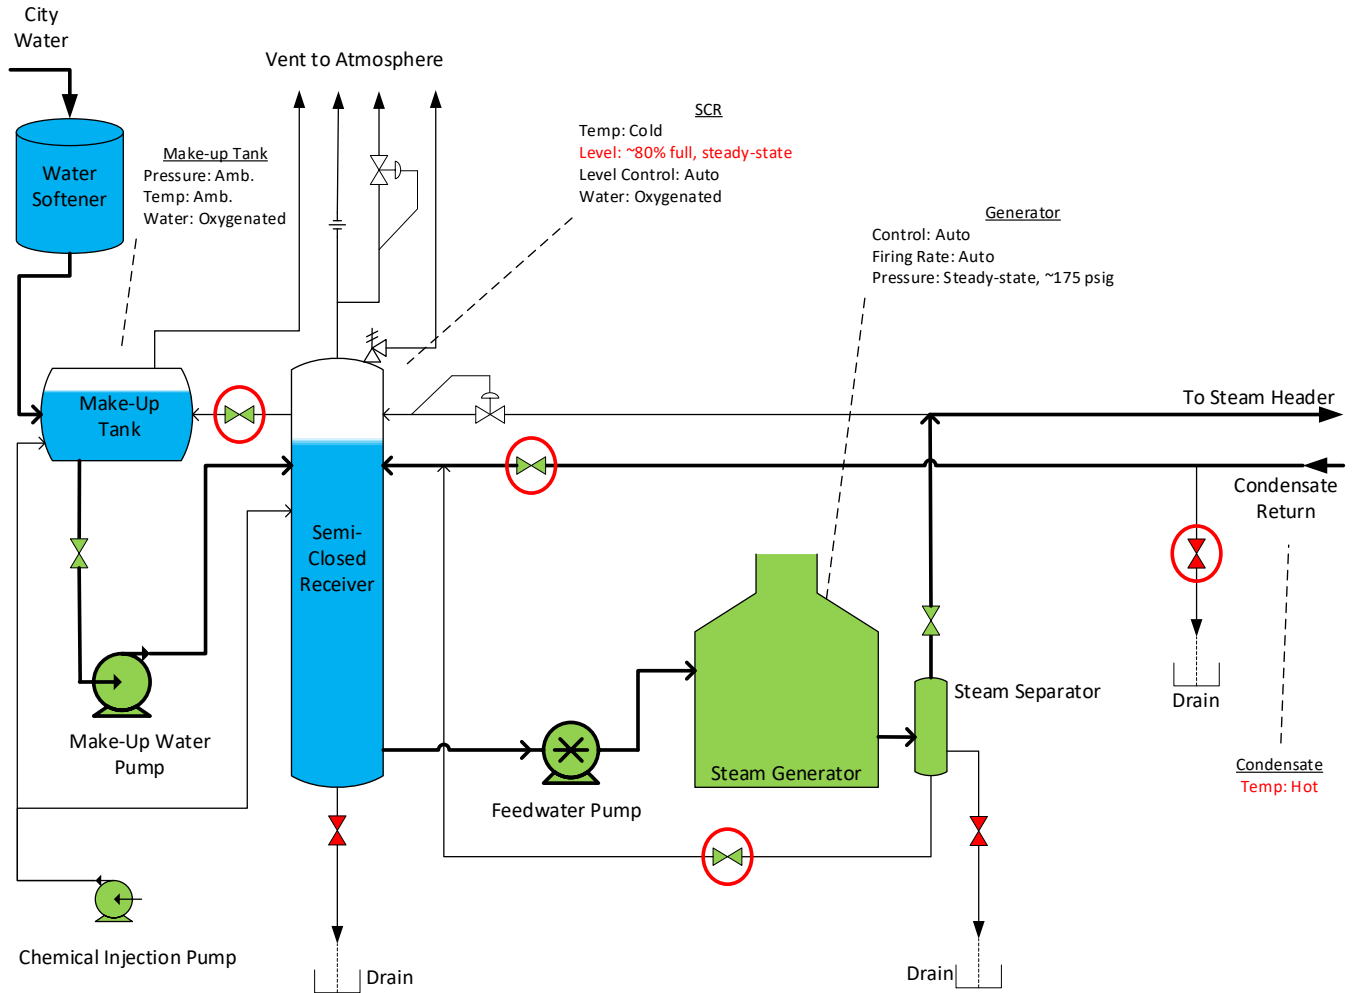
7. Eventually, operators routed the returning condensate back to the SCR instead of to drains (circled valves in **Figure 26**).
8. Unless operators performed a procedure called *blowdown* (see **Figure 27** and Section 1.7.3), a portion of water in the SCR below the outlet nozzle likely was trapped in the bottom head.

Figure 26. Simplified process flow diagram illustrating steady-state conditions. (Credit: CSB)
