**API 653
Inspection Report**

Report Prepared For
**U.S. CHEMICAL SAFETY AND HAZARD INVESTIGATION BOARD
FREEDOM INDUSTRIES**

4-METHYLCYCLOHEXANEMETHANOL (MCHM)

Tank Number
397

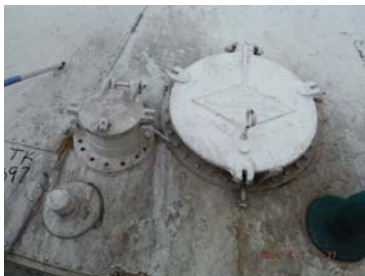
CORROSION ALONG THE ROOF DECK
