BETA LAB No.M10198- LS3 BOTTOM	TESORO REFINING AND MARKETING COMPANY ANACORTES REFINERY 10200 W. MARCH POINT ROAD T91WA4428 ANACORTES, WA 98221	CUSTOMER P.O. NO.: 4501667904
PART: 6600-E HEAT EXCHANGER LS 3 BOTTOM PART 14		DATE: JULY 30, 2010
PAGE 1 OF 88

**LABORATORY REPORT-LS3 BOTTOM**

This report is the first of a series on the failed parts of the 6600E heat exchanger. The LS# and CS# refer to longitudinal and circumferential weld seams while the part number refers to the chain of custody number.

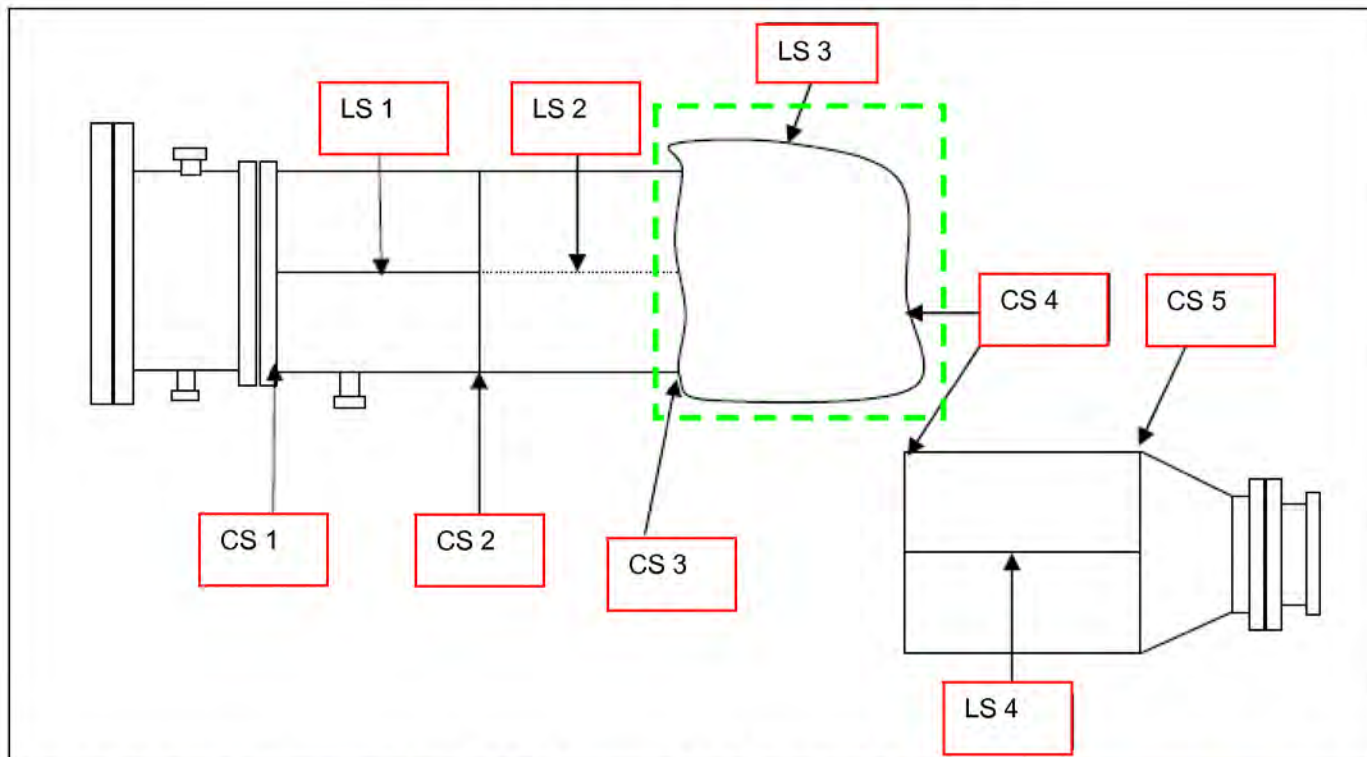
Sketch of main heat exchanger Cans 1-3 and separated back head can 4

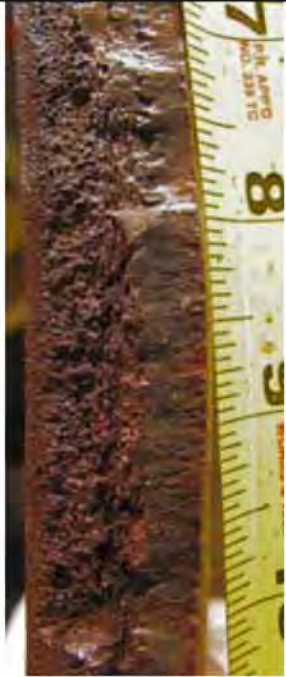
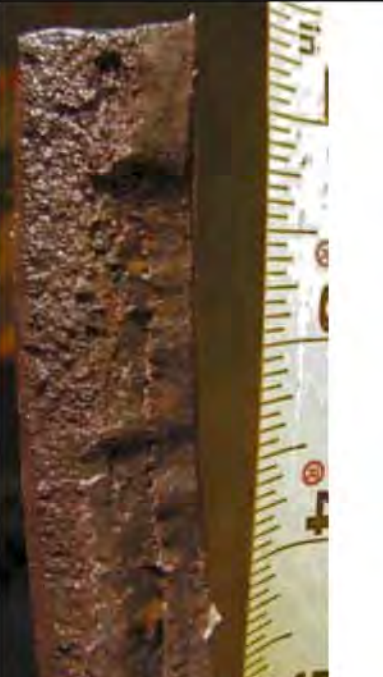
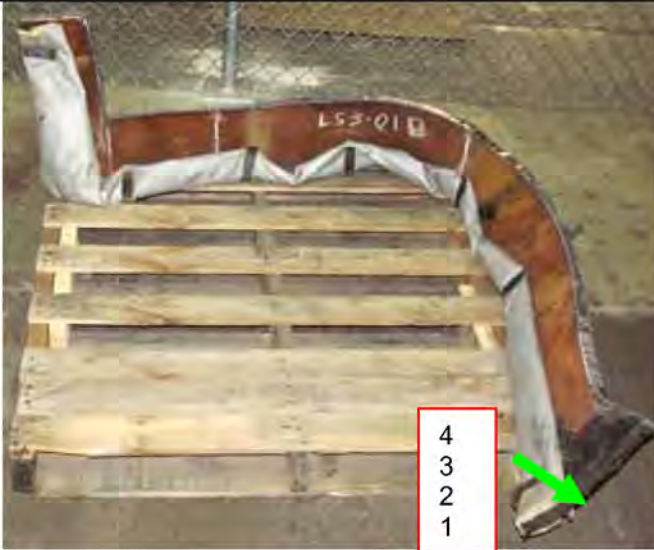
<p><b>FIGURE 9</b> Photos of the fracture along CS4 from LS3 CS4 corner as shown in the upper right (scale against OD)</p>
Location 1	Location 3

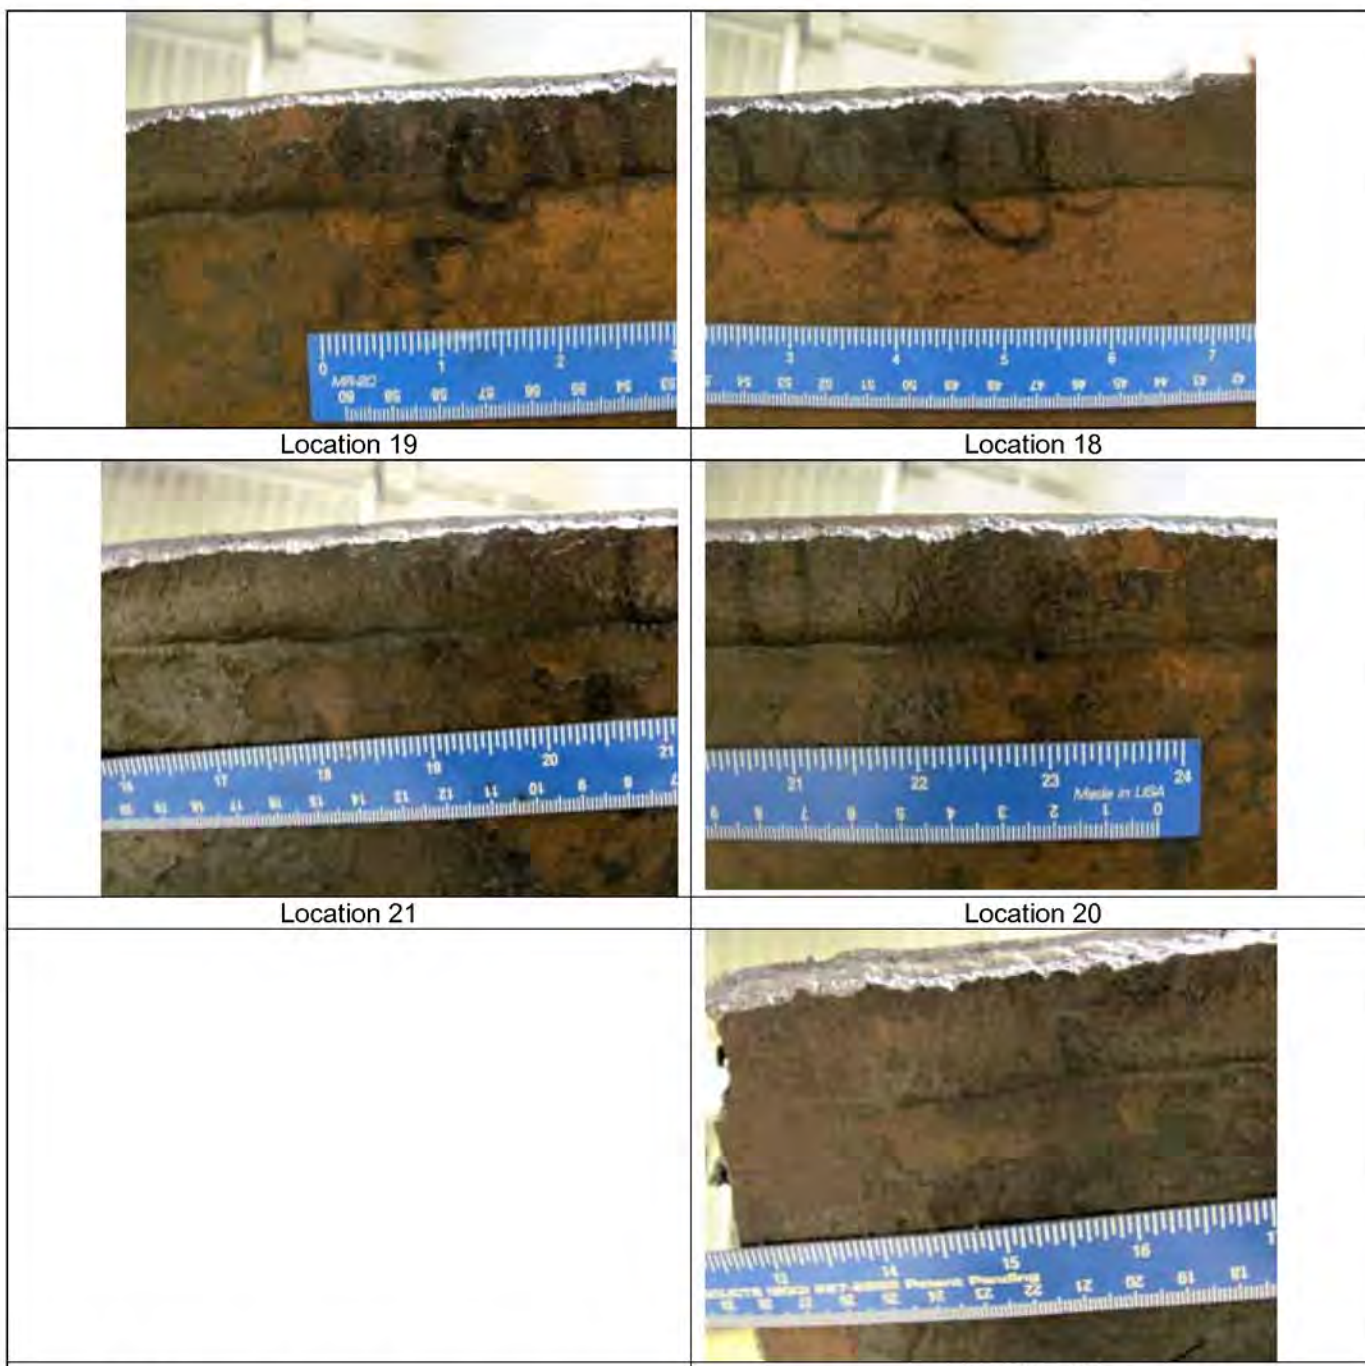
**FIGURE 13 Magnetic Particle inspection indications circled (fracture on top and looking at ID surface)**

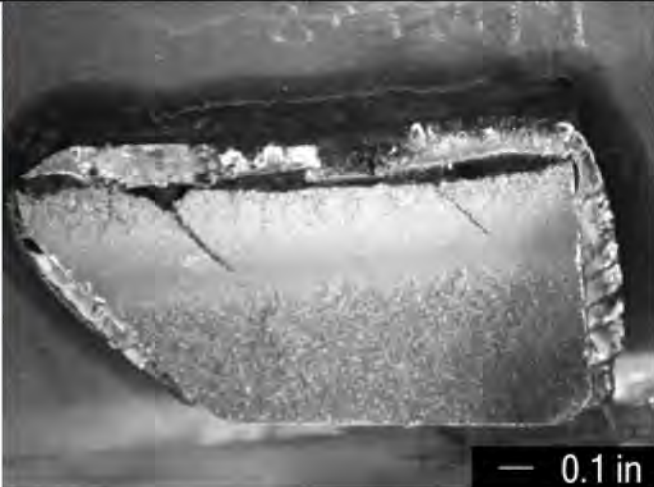
<p>Mount M 4 longitudinal face of LS3 with the fracture on top and can 3 on bottom –Polishing down on ID surface</p>

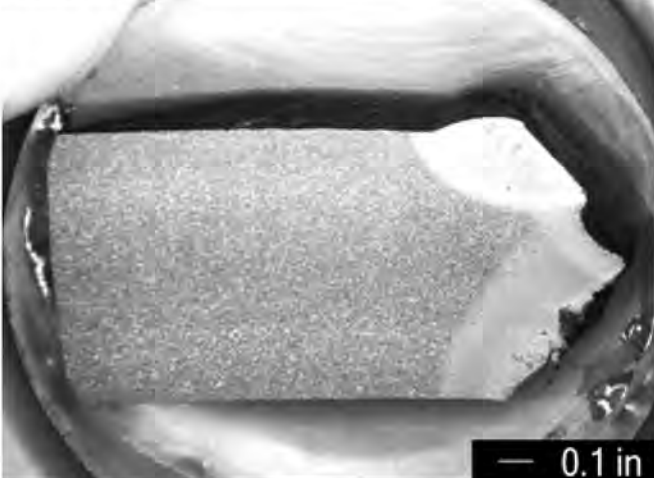
<p>Mount M 4T transverse through LS3 can 3 on left and fracture on right, ID on the bottom</p>

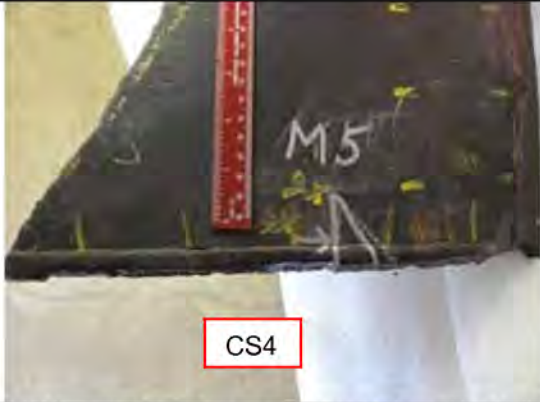
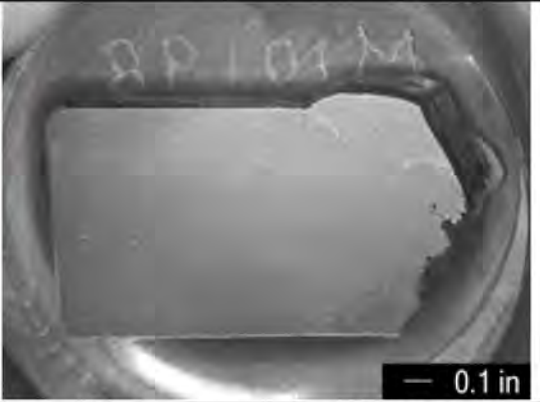
<p style="text-align: right;">— 0.1 in</p>
<p>Looking at OD surface, on right is LS3 and CS4 corner</p>	<p>Mount M5 transverse through CS4 can 3 on left and CS4 fracture on right- ID on bottom</p>

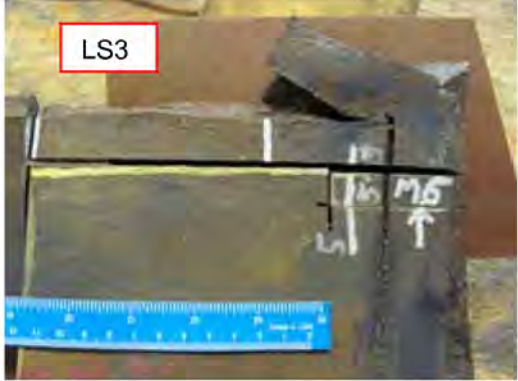
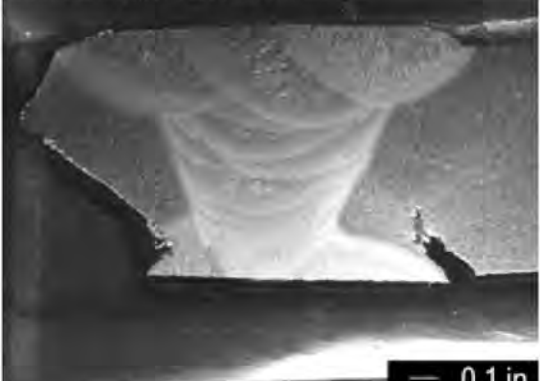
<p style="text-align: right;">— 0.1 in</p>
<p>Looking at ID surface LS3 top and CS3 right</p>	<p>Mount M6 transverse through CS3 can 3 on right CS3 fracture on left- ID on bottom</p>

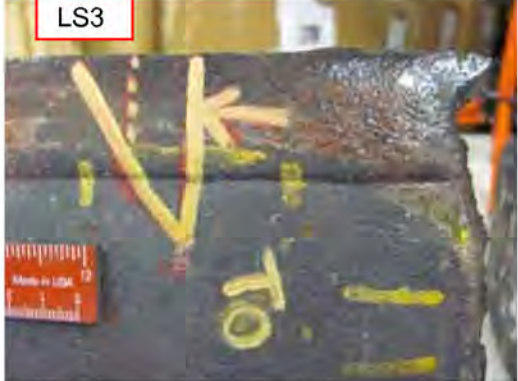
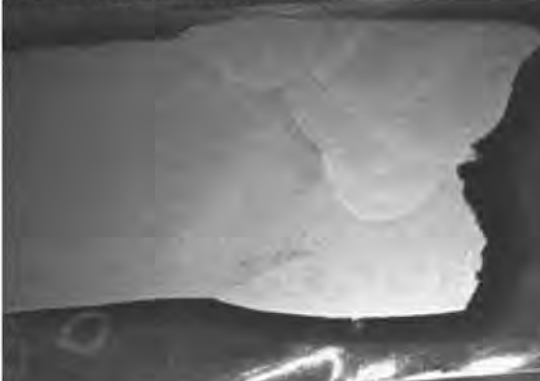
<p style="text-align: right;">— 0.1 in</p>
<p>Looking at OD surface LS3 top and CS4 right</p>	<p>Mount T0 transverse through LS3 can 3 on left fracture on right- ID on bottom</p>
<p style="text-align: center;"><b>FIGURE 16 Mounts M4, M4T and TO for LS3, CS3 and CS4 welds</b></p>

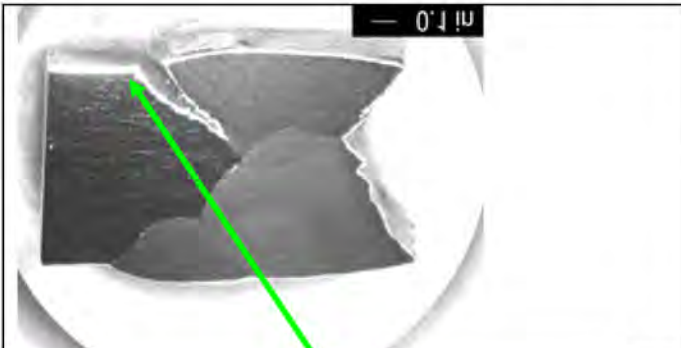
<p>Un-etched base metal side of secondary crack near ID</p>

<p>Etched base metal side of secondary crack at ID</p>

<p><b>FIGURE 28 Secondary crack in M3 on base metal side can 3 on LS3 fracture</b></p>

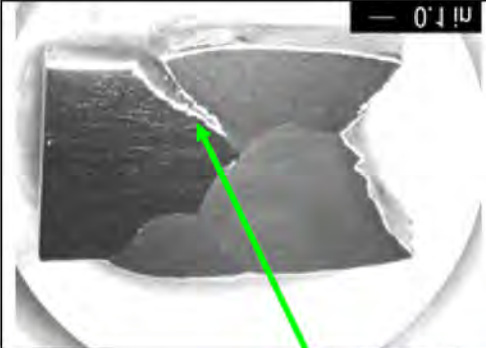
<p>Un-etched base metal side of secondary crack at <math>\frac{3}{4}</math> depth of crack</p>	<p>Etched base metal side of secondary crack at <math>\frac{3}{4}</math> depth of crack</p>

<p>Un-etched base metal side of secondary crack tip</p>	<p>Etched base metal side of secondary crack tip</p>
<p><b>FIGURE 30 Secondary crack in M3 on base metal side can 3 on LS3 fracture</b></p>

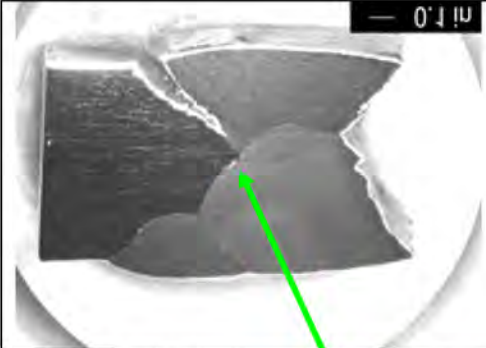
<p>Detail of Un-etched cusp- brown circles are artifacts</p>	<p>Detail of etched cusp</p>
<p><b>FIGURE 32 Secondary crack in M3 on base metal side can 3 on LS3 fracture</b></p>

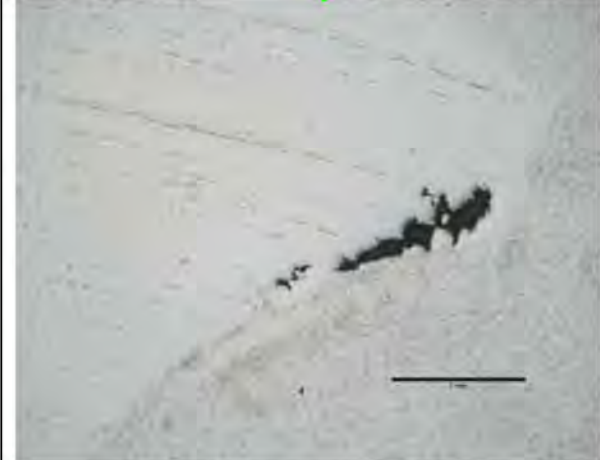
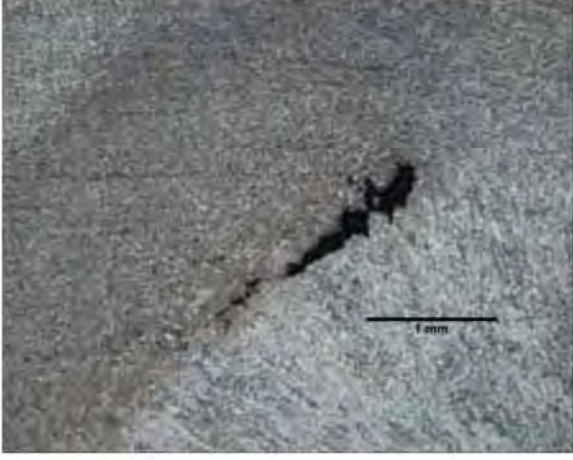
<p>Un-etched cusp</p>	<p>Etched cusp</p>

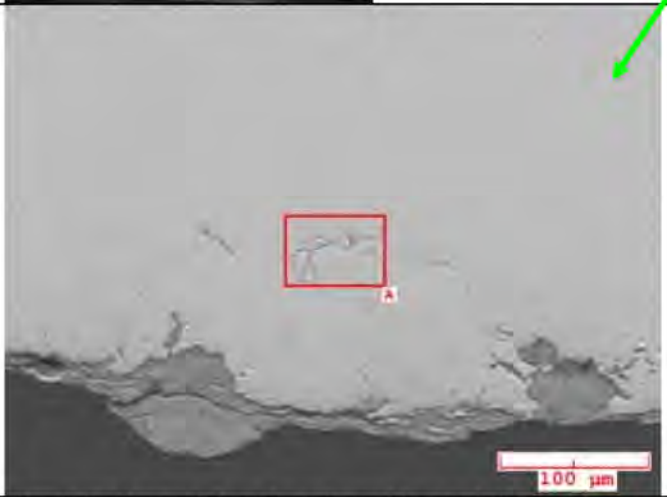
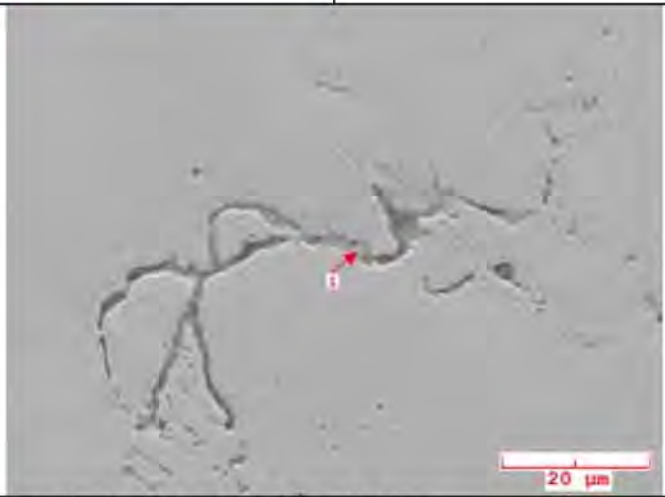
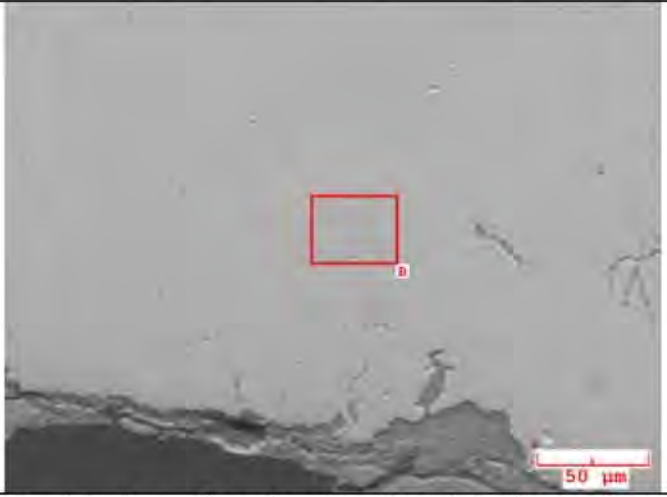
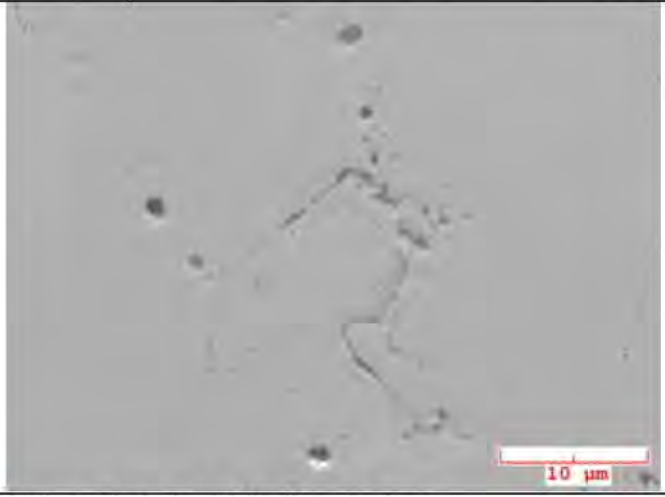
<p>Un-etched near ID surface in weld metal- ID on bottom</p>	<p>Details of photo at left- ID on bottom</p>

<p>Un-etched near ID surface in weld metal –ID on bottom</p>	<p>Details of photo at left- ID on bottom</p>																						
<p><b>FIGURE 51 Transverse mount TO on LS3 near CS4- SEM photomicrographs- note SEM images are 180 degrees with optical photomicrographs</b></p>

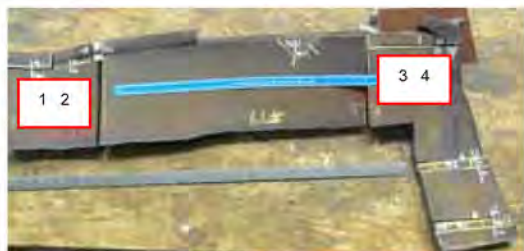
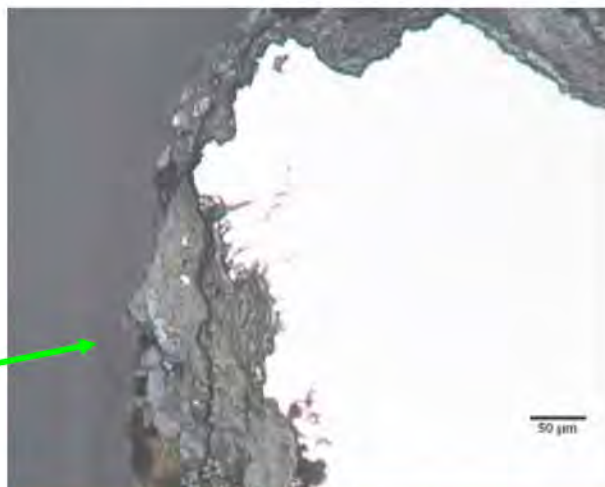
Mount M3 with oxide on after cutting and mounting

As received fracture surface

**FIGURE 52 Sample selected for SEM fractography in as received and partial cleaning condition-SEM1**

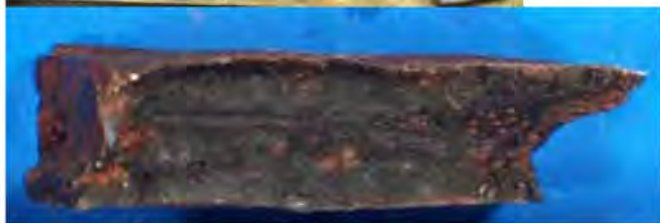
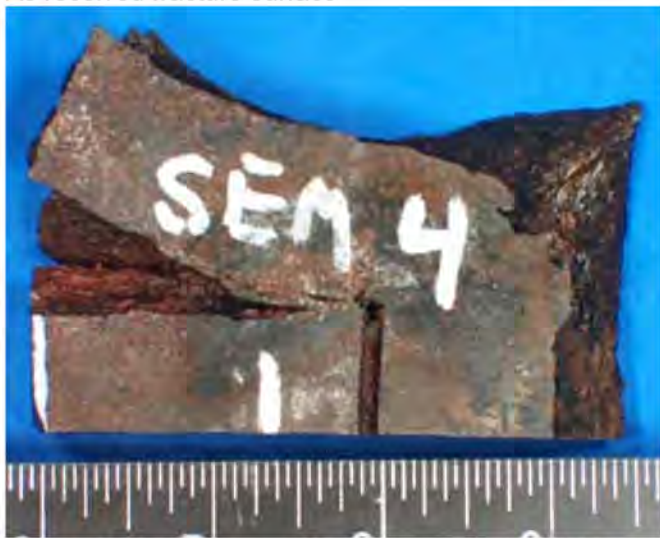
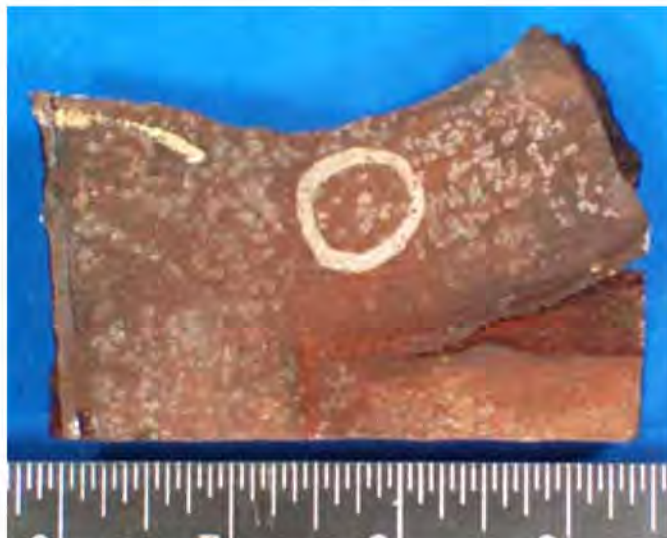
As received fracture surface

As received ID surface-note junction with of LS3 top horizontal and CS3 vertical

As received OD surface

**FIGURE 55 Sample selected for SEM fractography in as received (sample not cleaned)-SEM4**

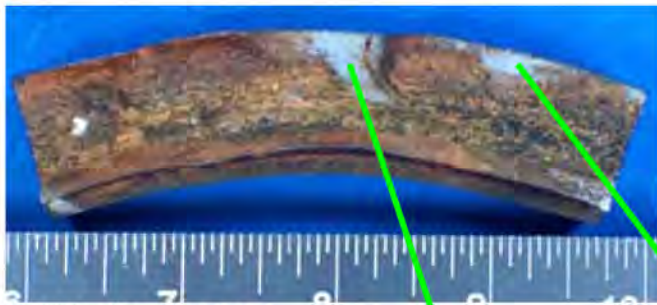
SEM 1 after cleaning

**FIGURE 56 SEM fractography of two areas where the scale/corrosion products were removed on the fracture surface of SEM1**

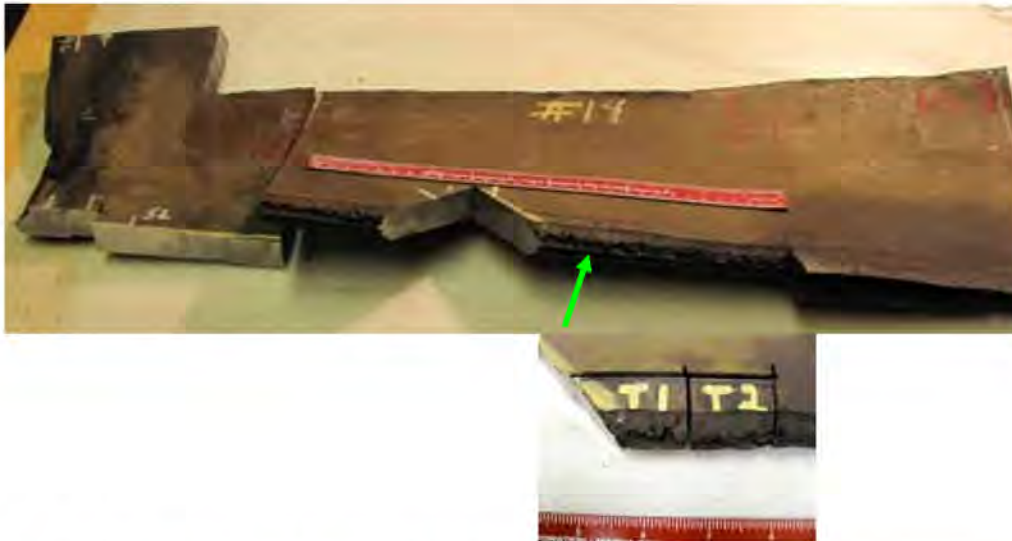
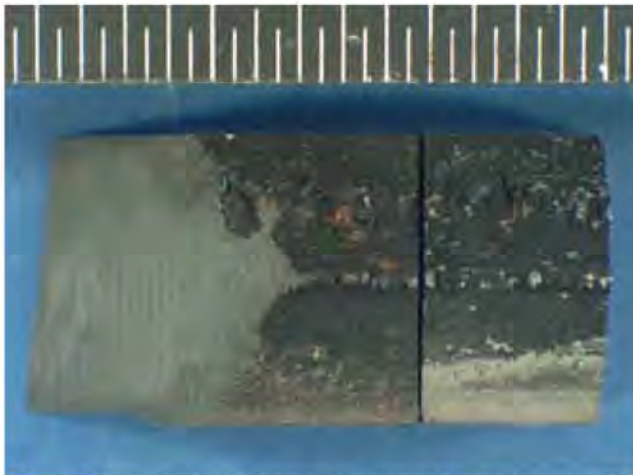
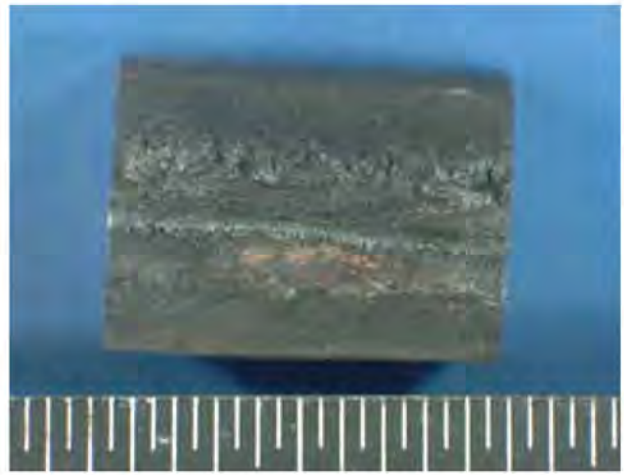
Sample T-1 split into T1a left and T-1b right- scale 1/16"

Sample T-2- scale 1/16"

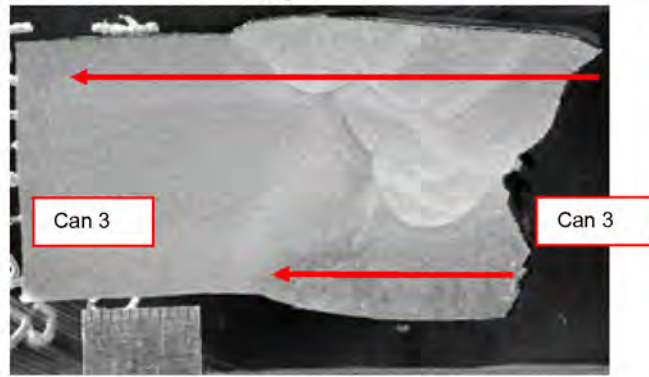
M6

**FIGURE 58 Vickers micro-hardness Traverse (Red) Lines for Data in Table 6 thru 11-green line is 10Kg Vickers**
