BETA LAB No.M10198- LS3 TOP	TESORO REFINING AND MARKETING COMPANY ANACORTES REFINERY 10200 W. MARCH POINT ROAD T91WA4428 ANACORTES, WA 98221	CUSTOMER P.O. No.: 4501667904
PART: 6600-E HEAT EXCHANGER LS 3 TOP PART 15		DATE: SEPTEMBER 20, 2010
PAGE 1 OF 53

LABORATORY REPORT-LS3 TOP

This report is the seventh of a series on the failed parts of the 6600E heat exchanger. The LS# and CS# refer to longitudinal and circumferential weld seams while the part number refers to the chain of custody number.

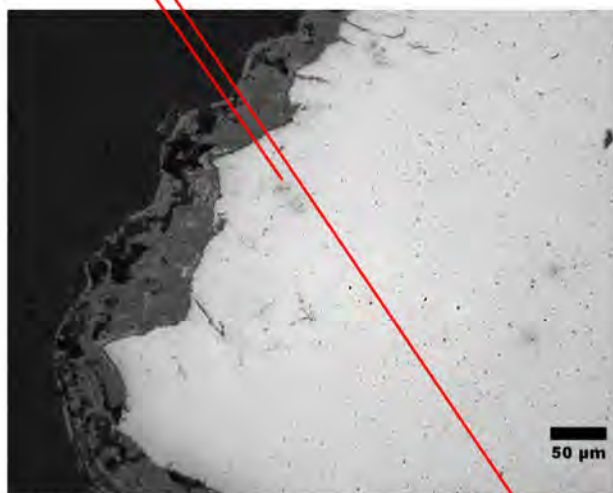
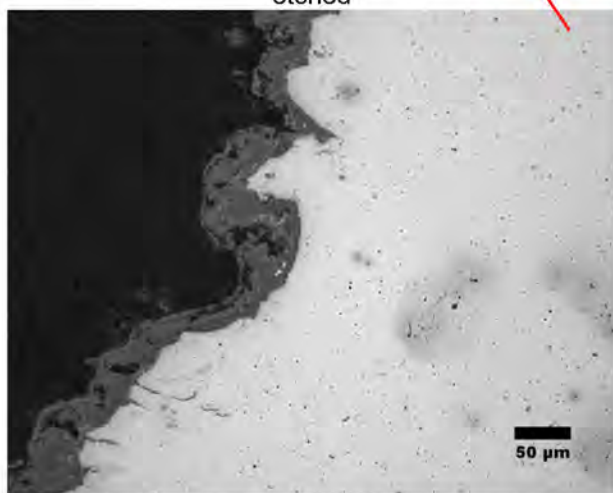
Figure 22

Wed toe at the weld metal side of the crack, un-etched

Same as at left, etched

One field up along the crack edge, un-etched
