**Client: United States Chemical Safety Board**

**Report Title: Didion Milling Explosion Assessment**

***Incident: May 31, 2017***

**Final Report R0**

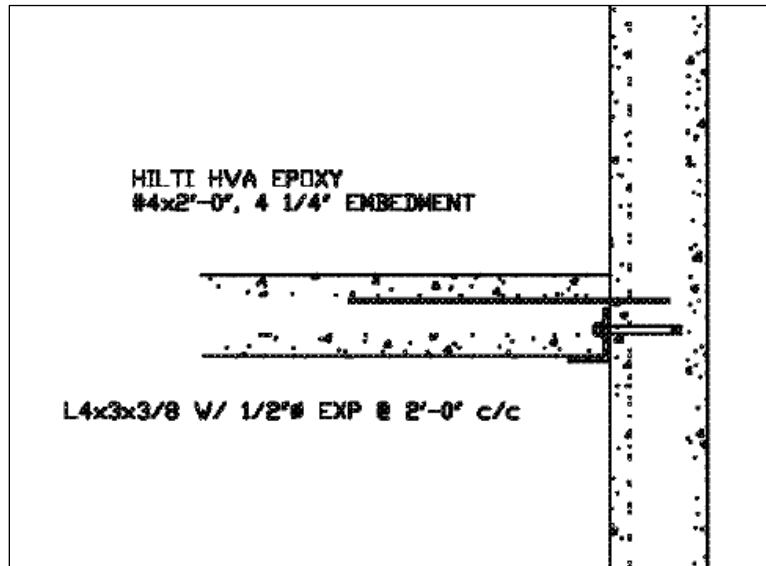
**Figure 2-5. Typical Precast Wall Panel Connection to Floor Slab**

Failure of the connections between the Mill B precast wall panels and the Mill B floor slabs were observed after the Didion explosion. A perspective of the failure at level 2 of Mill B is provided in Figure 2-3 and shown in detail in Figure 2-4. Provided drawings show the precast wall panel connection to be an embedded #4 reinforcing bar dowel secured with adhesive at each floor slab at various spacing

along the perimeter of Mill B. The dowels were specified to be drilled into the walls using the Hilti HVA capsule adhesive system with 4 ¼ in. embedment into the walls, as shown in Figure 2-5.

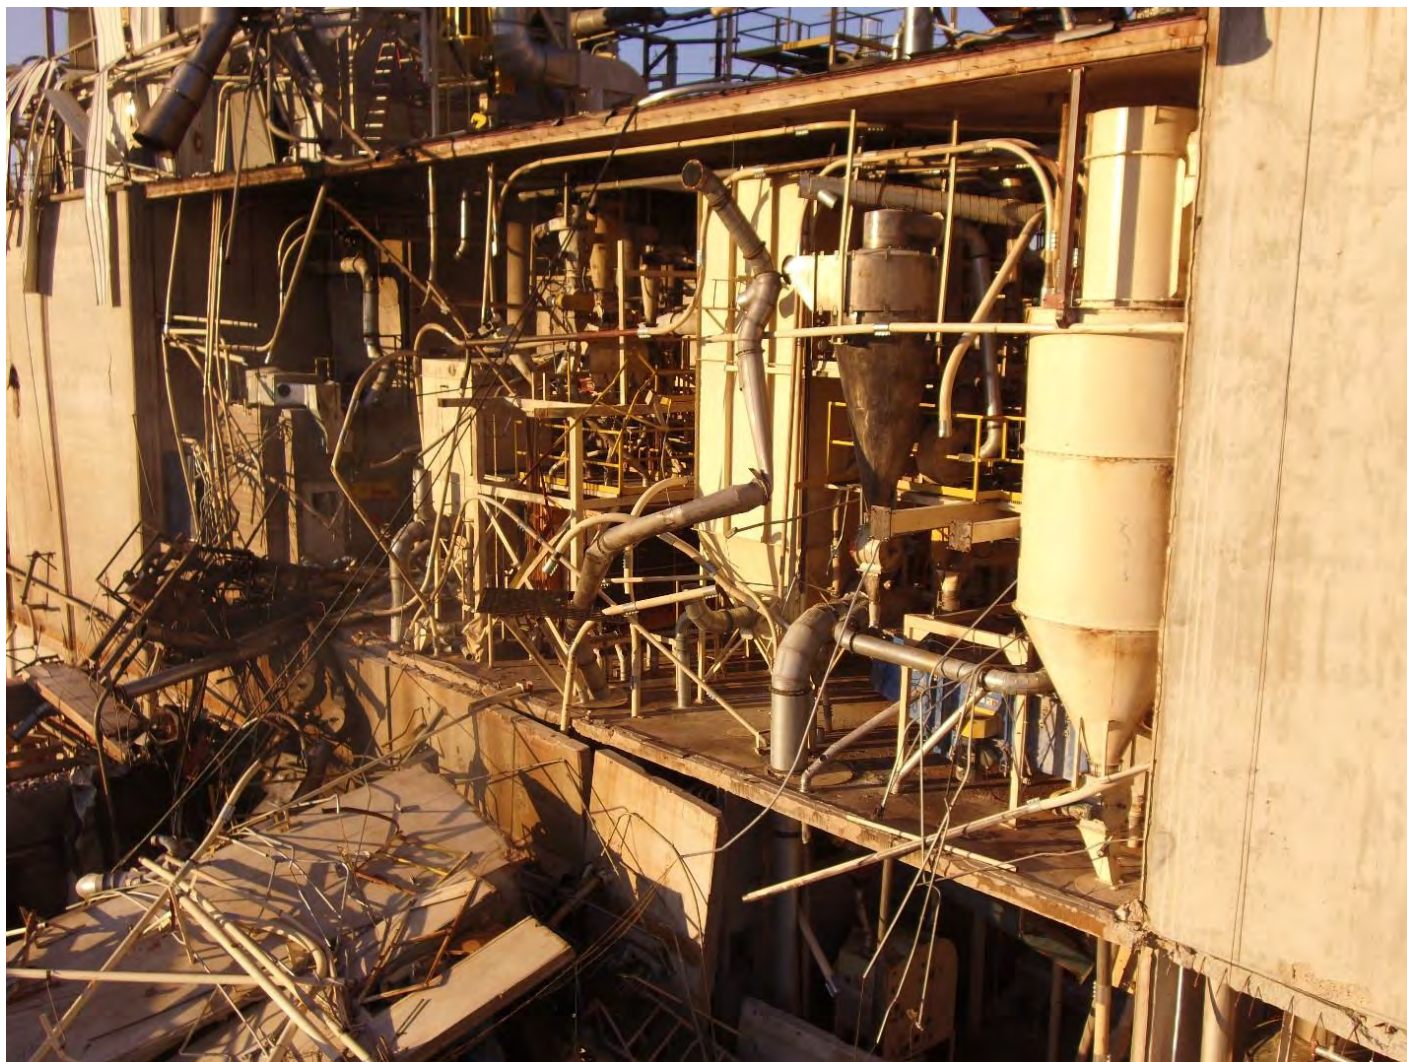
**Figure 2-6. Mill B West Façade at 4<sup>th</sup> Level**

Both the west and east facades of Mill B collapsed at the 4<sup>th</sup> level as shown in Figure 2-6 and Figure 2-7, respectively. The Mill B wall panels at the 4<sup>th</sup> level rested on the 4<sup>th</sup> floor slab and abutted the 5<sup>th</sup> level / roof as shown in the drawing section in Figure 2-8. The bottom of the 4<sup>th</sup> level wall connection to the 4<sup>th</sup> floor slab was assumed to be (2) #7x10 in. long dowel pins per 9 ft. wide panel (similar to Mill F detail 2/A6). The dowels at the bottom of the wall panel are visible in Figure 2-9. The dowels extended vertically into the top of the slab and were assumed to be centered on the 9- $\frac{1}{4}$  in. thick wall.

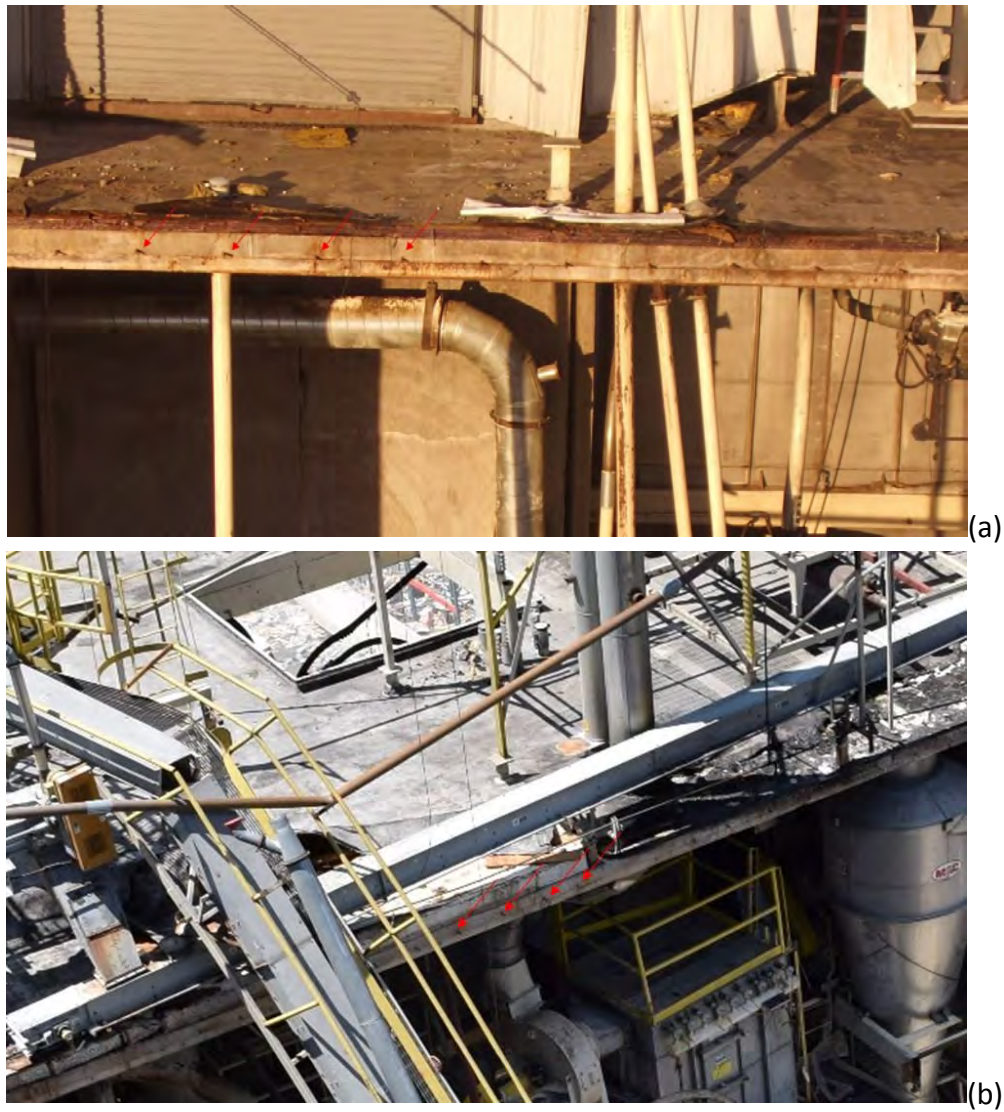
**Figure 2-10. Mill B Wall Panel Roof Slab (a) West Façade (b) East Façade**

The top of the 4<sup>th</sup> level wall connection to the 5<sup>th</sup> floor/Roof slab was detailed on the original Mill B drawings with the #4 horizontal dowels into the face of the wall with 4  $\frac{1}{4}$  in. embedment and are shown in Figure 2-10. The wall panels extended 6 in. above the top of 5<sup>th</sup>/Roof slab. The spacing of these dowels varied along the east and west facades resulting in varying wall connection capacities.

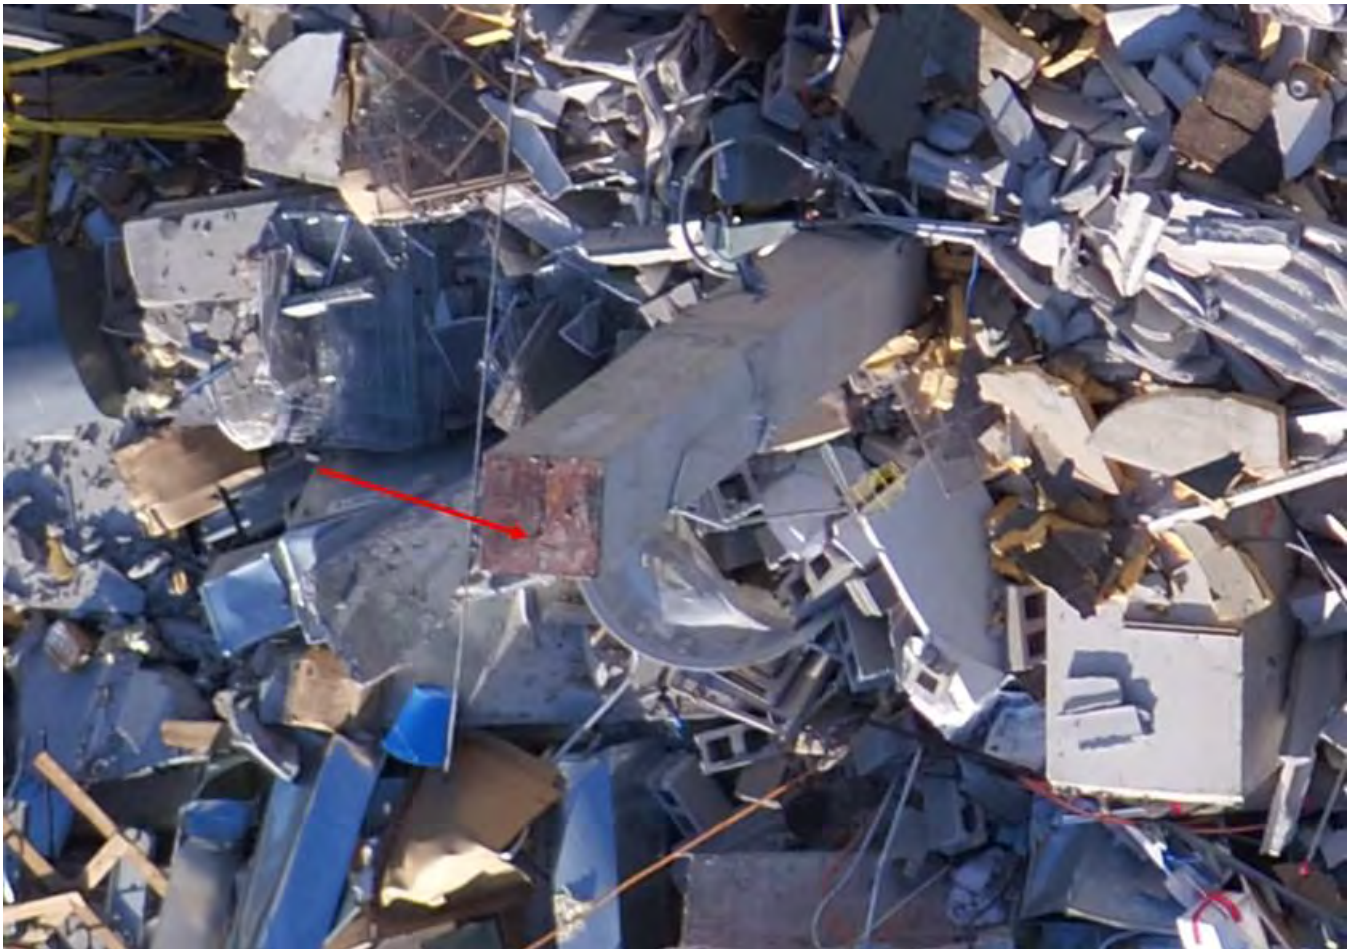
**Figure 2-17. Multipurpose Building Top of Column with Visible Dowel**

In the few bays in which the beam was dislodged from the columns, the grout hole in the bottom of the beam is observable in the overhead drone photos shown in Figure 2-16. It is noted that there does not appear to be grout visible in the holes. Dowels extending from the top of the columns are visible in the photographs, including the example in Figure 2-17. However, the grout holes in the beams appear to be ungrouted when viewed from the underside of the beam. Therefore, it is concluded that the beams were resting on top of the columns with little to no physical connection between elements other than an ungrouted dowel.

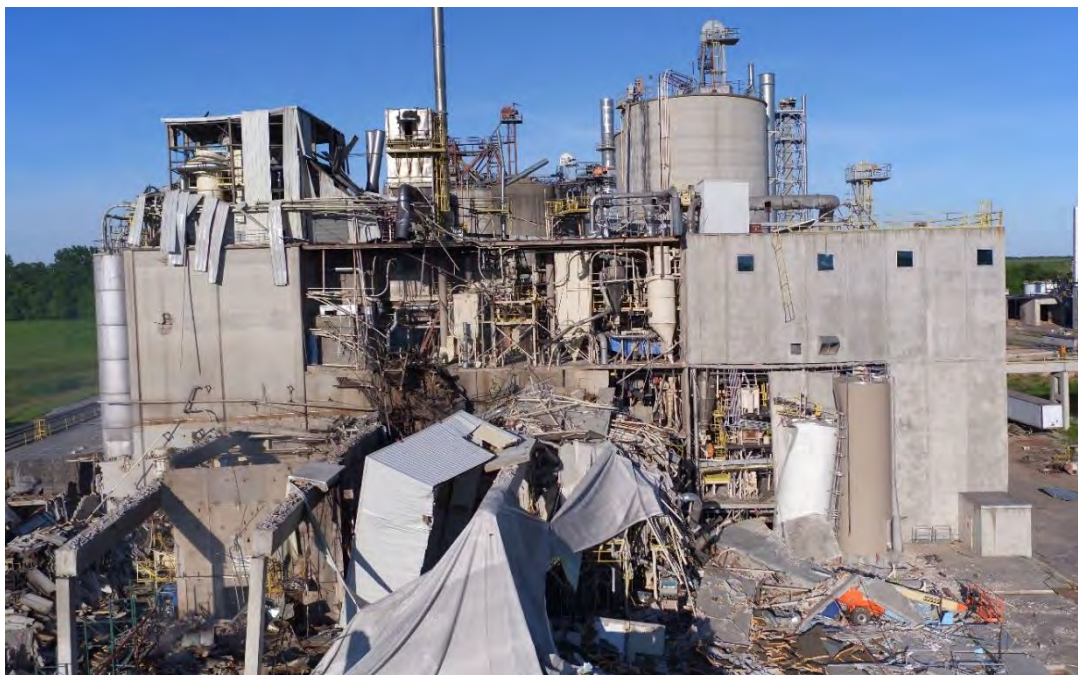
**Figure 3-2. Milling Building West Façade**

Propagation of the explosion resulted in the complete collapse of the overhead concrete roof of the Multipurpose Building, Mill F, and the Boiler Room. Precast walls of Mill B collapsed above the 3<sup>rd</sup> level and were failed at the south end of Mill B on both the west and east facades. Mill D precast panel connections failed and the wall panels were deflected at the 2<sup>nd</sup> level. Mill D was determined (by others) to be too unstable for entry and demolition of this mill was planned. An overhead view of the milling complex damage and collapse is shown in Figure 3-1. Damage to the west façade is shown in Figure 3-2, and the east façade in Figure 3-3.

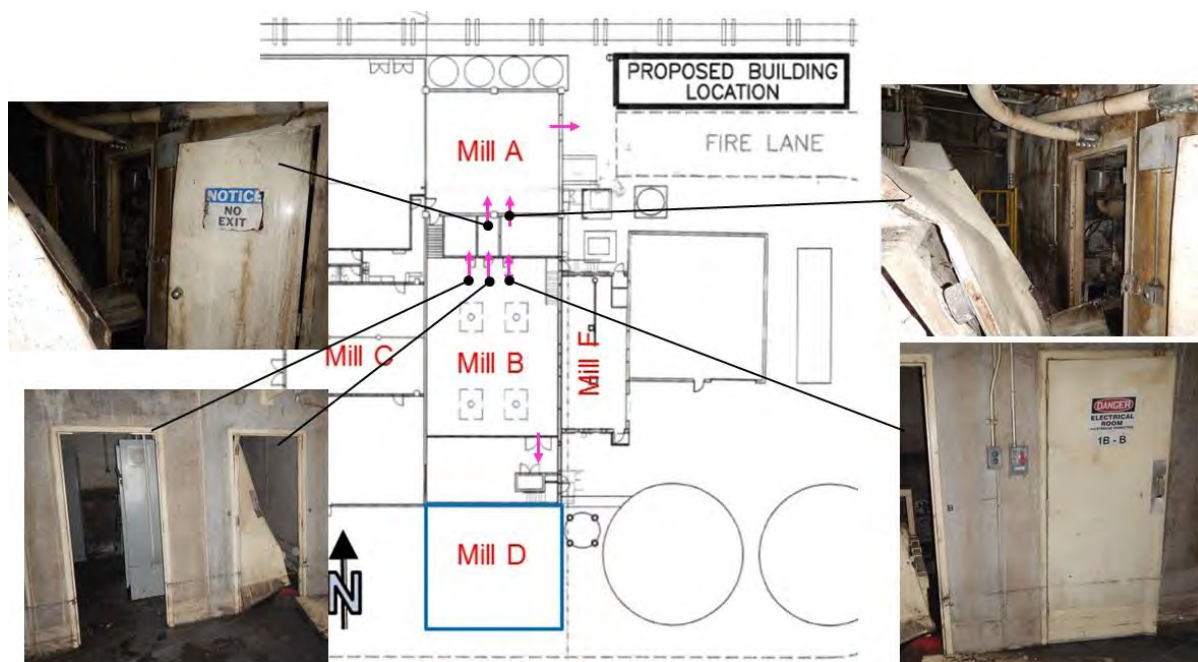
**Figure 3-6. Mill A and Mill B Level 1 Exemplar Directional Indicators**

Directional indicators for the first level of Mill A and Mill B as well as the truck bulk loading are presented in Figure 3-5 and identified in Table 3-1 below. Exemplar indicators provided in Figure 3-6 indicate that overpressure which initiated in Level 1 of Mill B entered the vertical air shaft and exited the air shaft into Level 1 of Mill A. In addition, fire damage to the piping to the exterior of the Level 1 Mill B air shaft opening, highlighted in Figure 3-7, is consistent with a flame traveling from Mill B into the air shaft. The piping was also charred on the mill side of the pipe highlighted in Figure 3-7. The directional indicators are consistent with an explosion occurring in Level 1 of Mill B.

This door may have been open during the event.

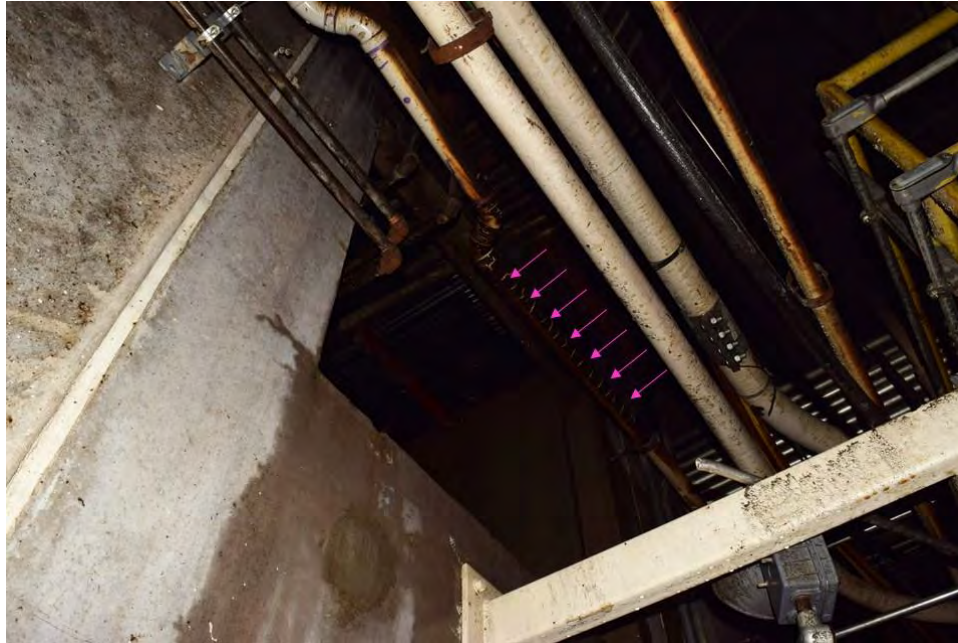
**Figure 3-7. Mill B Level 1 Air Shaft Opening Fire Directional Indicator**

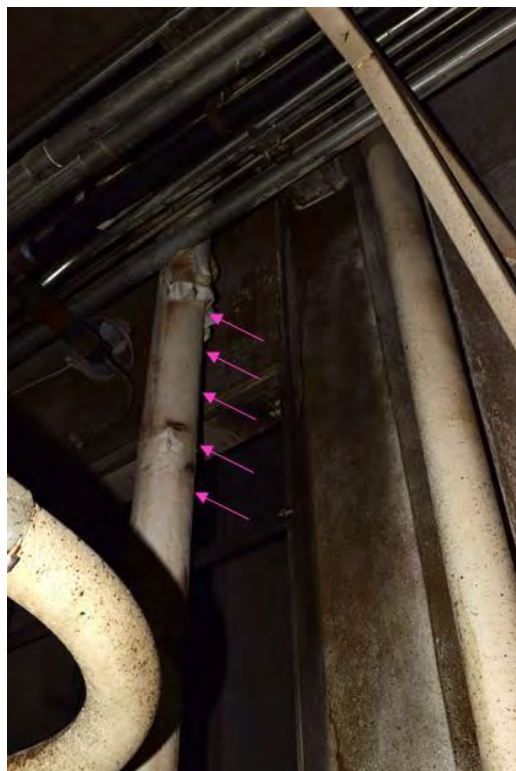
**Figure 3-11. Mill A Level 2 Air Shaft Opening Fire Directional Indicator**

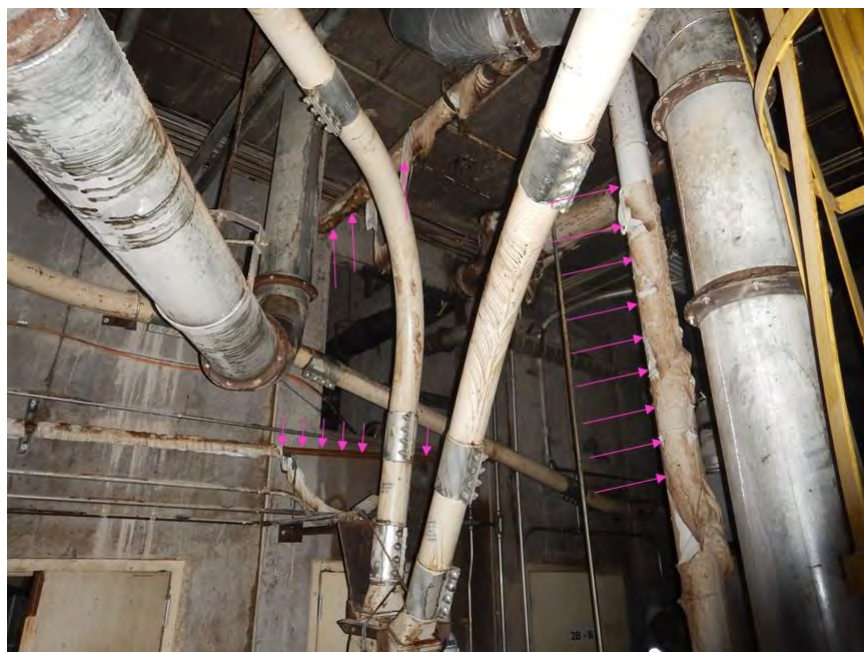
**Figure 3-12. Mill B Level 2 Air Shaft Opening Fire Directional Indicator**

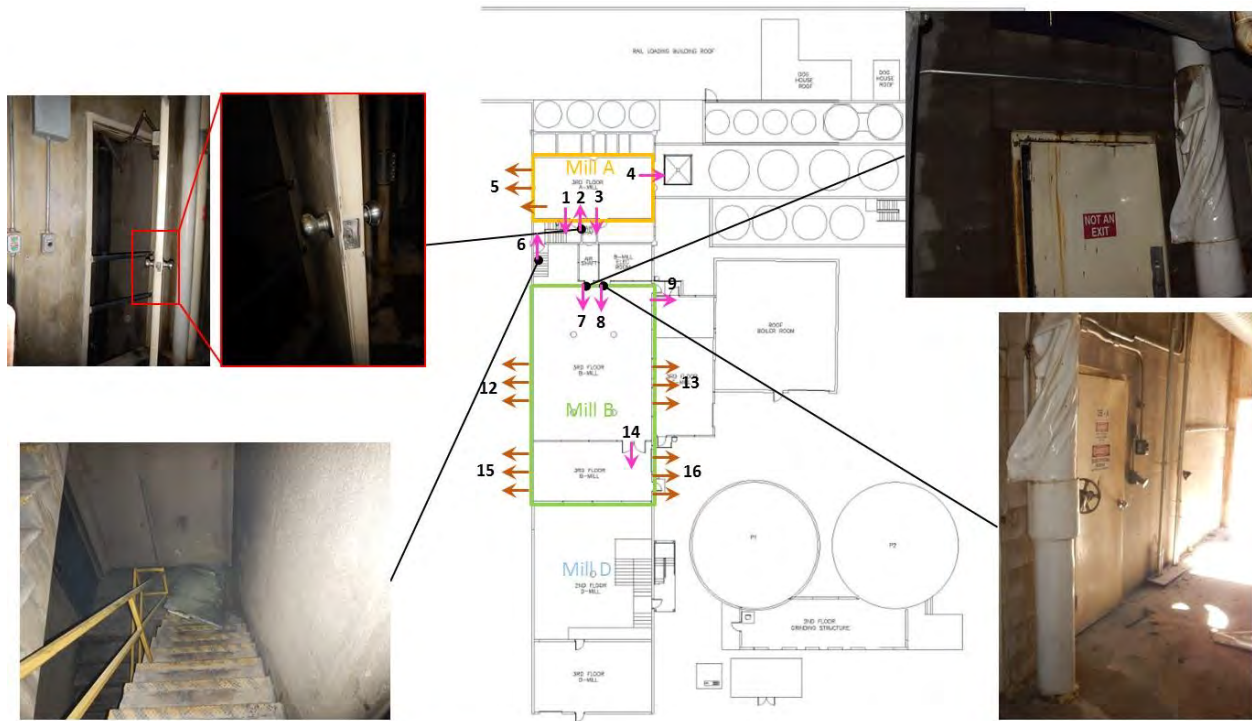
Figure 3-14. Mill A and Mill B Level 3 Exemplar Directional Indicators

Directional indicators for the third level of Mill A and Mill B are presented in Figure 3-13 and identified in Table 3-3 below. Examples of the directional indicators are shown in Figure 3-14. Fire exiting the vertical air shaft into both Mill A and Mill B at the third level was indicated by melting of pipe coverings and scorching as shown in Figure 3-15 and Figure 3-16, respectively. These directional indicators are consistent with an explosion propagating into Level 3 of Mill A and Mill B from the vertical air shaft.

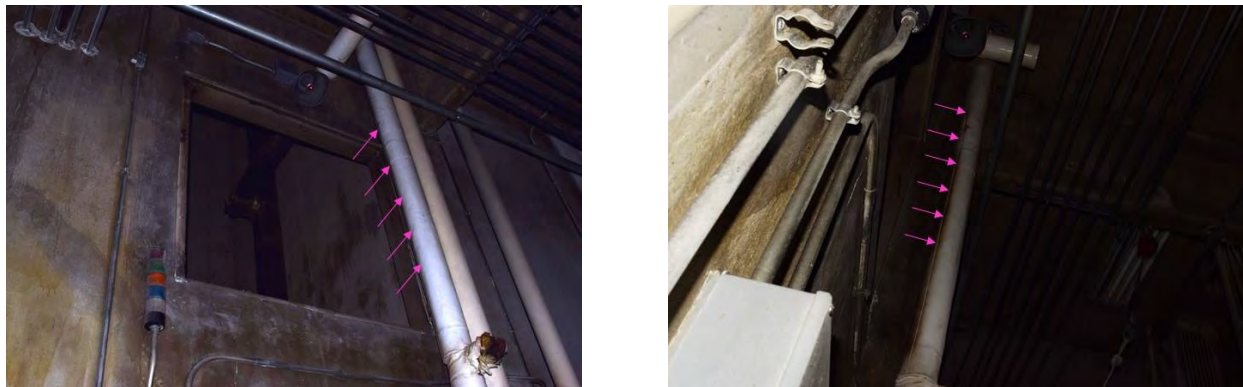
Figure 3-15. Mill A Level 3 Air Shaft Opening Fire Directional Indicator

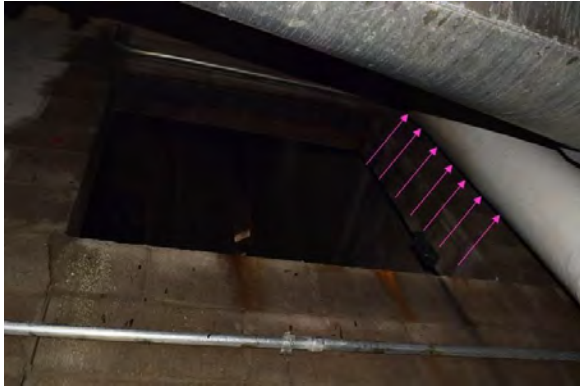
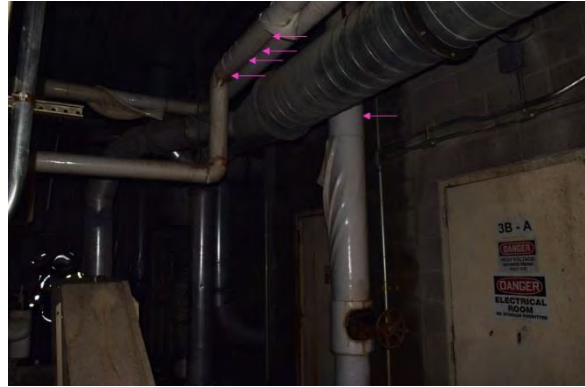
**Figure 3-16. Mill B Level 3 Air Shaft Opening Fire Directional Indicator**

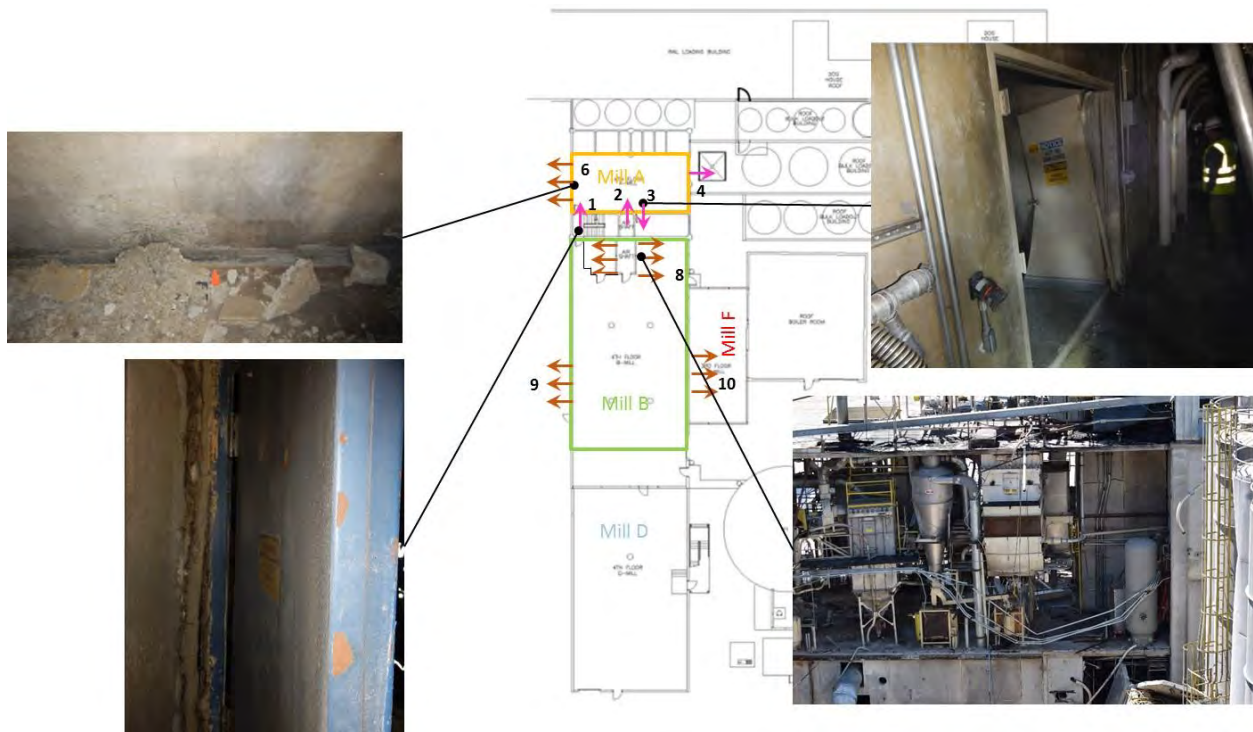
Figure 3-18. Mill A and Mill B Level 4 Exemplar Directional Indicators

Level 4 of Mill B could not be accessed safely due to the collapsed side walls and unprotected fall hazards. Drone photos were reviewed in lieu of access. Directional indicators for the fourth level of Mill A and Mill B are presented in Figure 3-17 and identified in Table 3-4 below and examples are provided in Figure 3-18. The exemplar directional indicators show overpressure in the air shaft pushing out of the air shaft into Mill B and overpressure in Mill A that forced the west Wall of Mill A away from the slab. Fire exiting the air shaft into the fourth level of Mill A is evident as shown in Figure 3-19; however, the drone photographs of the fourth level Mill B opening, provided in Figure 3-20, were inconclusive for fire indicators due to the range from which the photographs were taken. The directional indicators are consistent with an explosion propagating into Level 4 of Mill A and Mill B from the vertical air shaft.

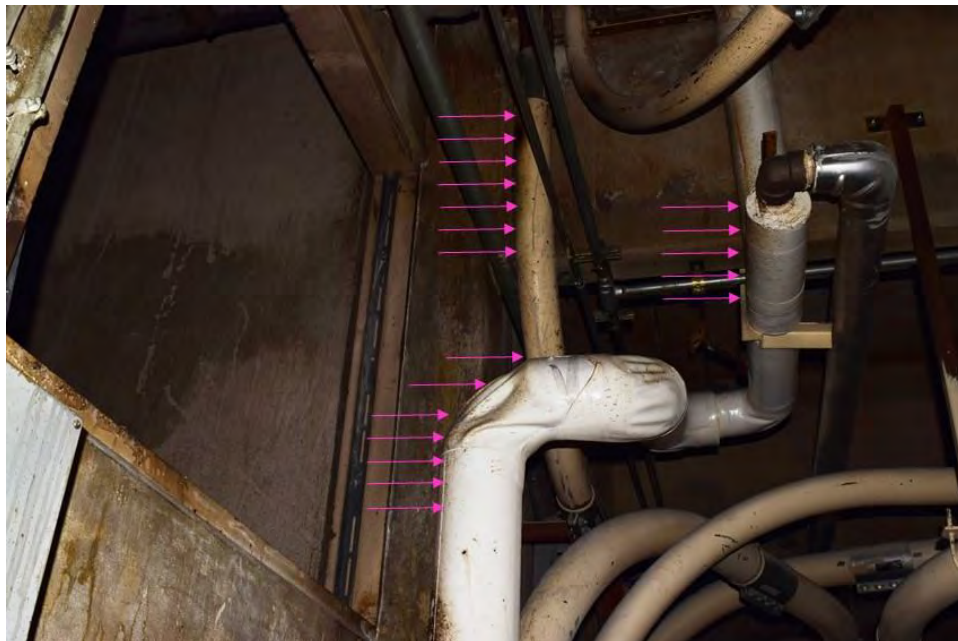
Figure 3-19. Mill A Level 4 Air Shaft Opening Fire Directional Indicator

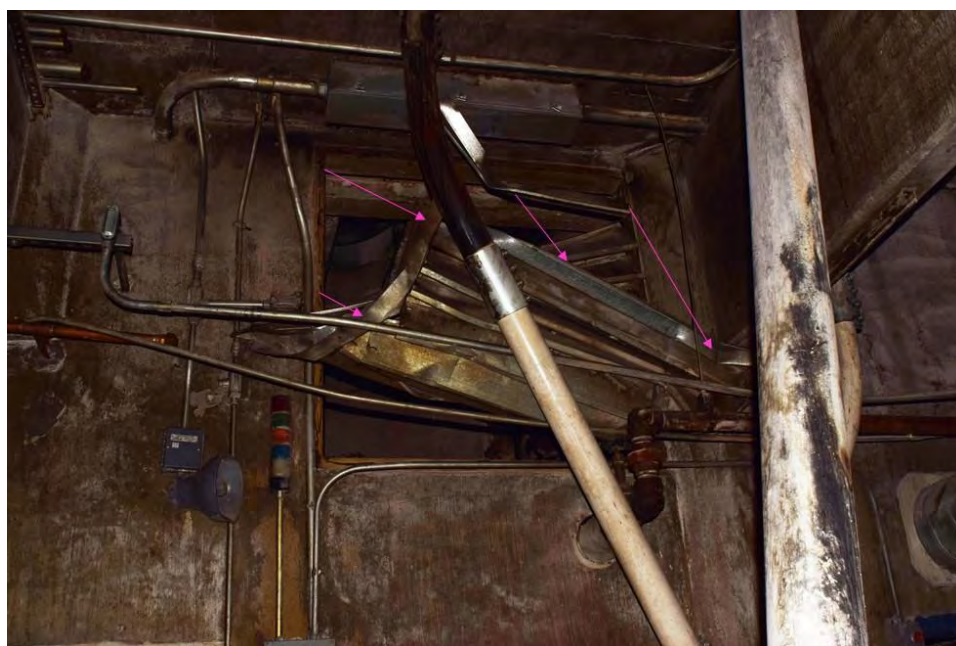
Directional indicators for the fifth level of Mill A are presented in Figure 3-21 and identified in Table 3-5 below. Examples of the observed directional indicators on level 5 of Mill A indicate overpressure proceeding from the vertical air shaft into Mill A as shown in Figure 3-23. The directional indicators are consistent with an explosion propagating into Level 5 of Mill A from the vertical air shaft.

Figure 3-23. Mill A Level 5 Air Shaft Opening Directional Indicator

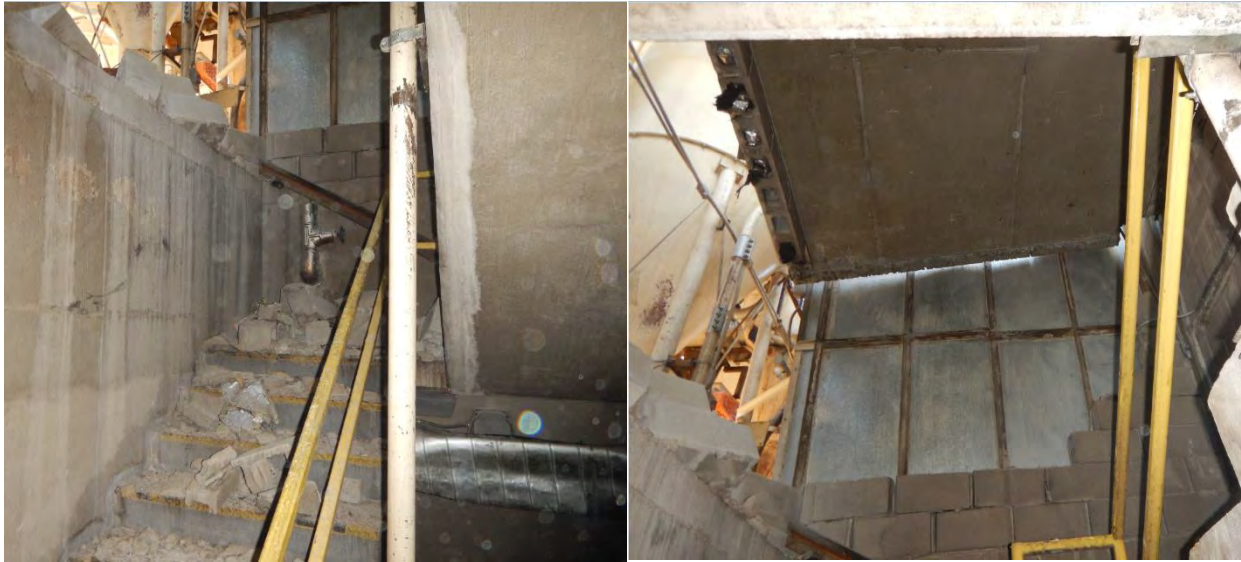
**Figure 3-24. Mill A Level 6 Access**

The sixth level of Mill A could not be accessed due to overhead hazards as shown below in Figure 3-24.

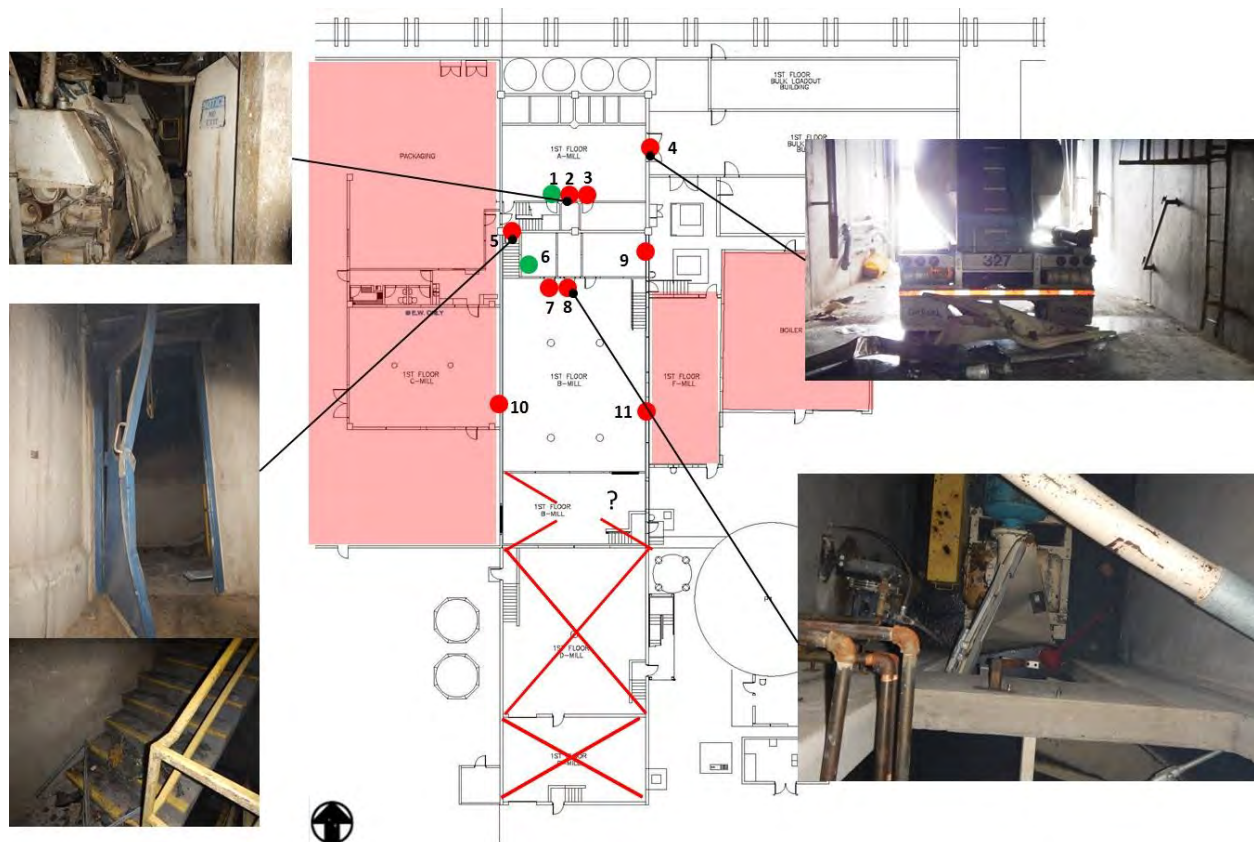
**Figure 3-26. Mill A and Mill B Level 1 Exemplar Blast Indicators**

Blast indicators for the first level of Mill A and Mill B are presented in Figure 3-25 and identified in Table 3-6 below. Examples of indicators provided in Figure 3-26 indicate that an explosion in Level 1 of Mill B was severe enough to cause significant damage to the stairwell door as well as the doors to the air shaft and electrical rooms. Overpressure in Level 1 of Mill B damaged the double door between Mill A and the bulk loading. In addition, a significant overpressure event occurred in the east electrical room attached to Mill A.

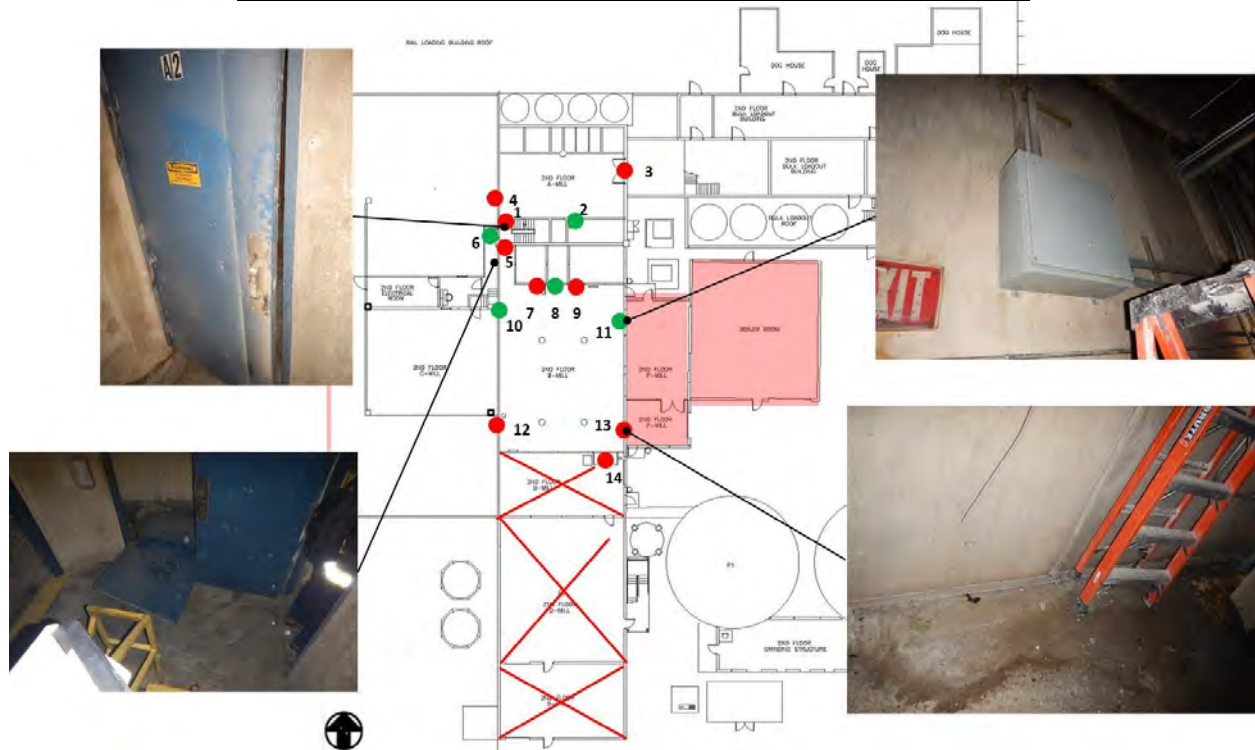
**Figure 3-28. Mill A and Mill B Level 2 Exemplar Blast Indicators**

Blast indicators for the second level of Mill A and B are presented in Figure 3-27 and identified in Table 3-7 below. Examples of indicators provided in Figure 3-28 indicate that overpressure in level two of Mill B was substantial enough to force the entry door through the frame into the stairwell but did not result in permanent deformation to the undamaged electrical boxes. In addition, the west precast wall of Mill B was separated from the 2<sup>nd</sup> level slab. Overpressure in Level 2 of Mill A unseated the entry door with sufficient energy for the door to strike the jamb at the stairway landing that led to the corridor and the control room. Not shown in Figure 3-28 is the roll up door on the west face of Mill A that was pushed through the tracks into the packaging area of the Multipurpose Building.

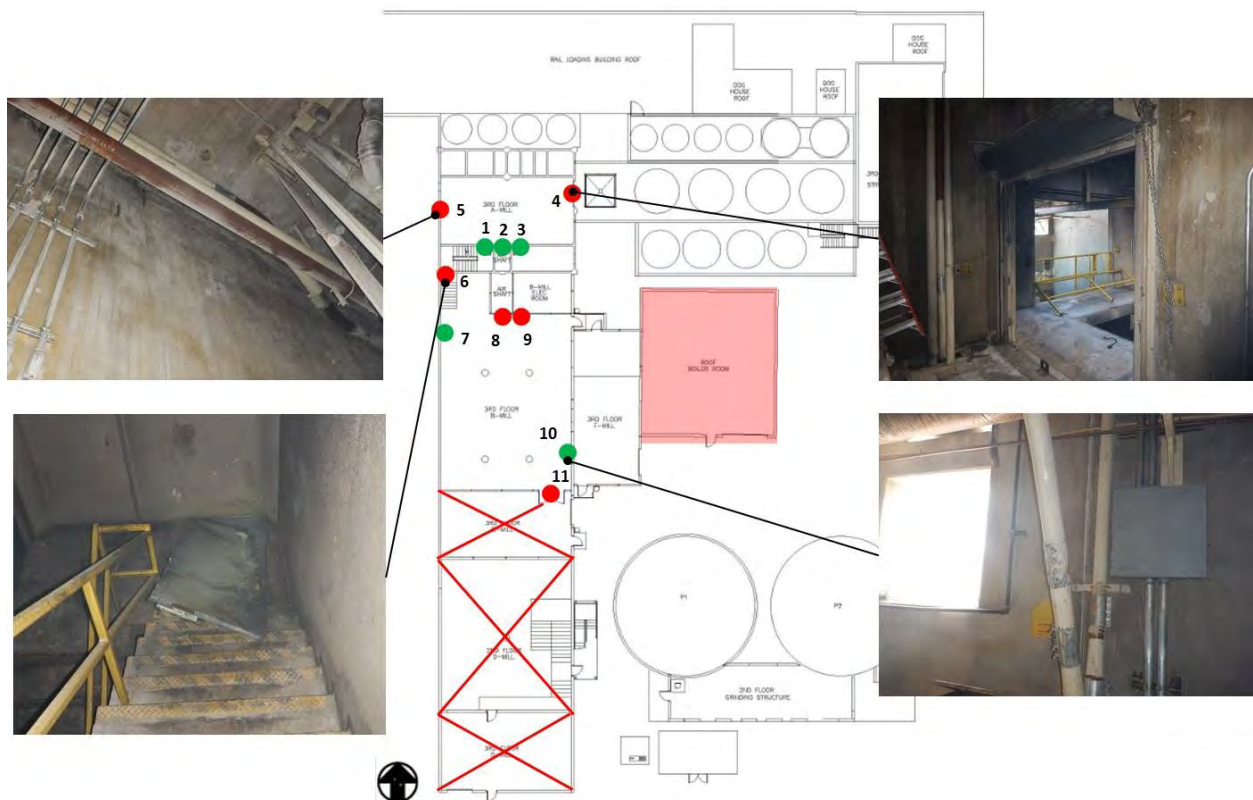
**Figure 3-30. Mill A and Mill B Level 3 Exemplar Blast Indicators**

Blast indicators for the third level of Mill A and Mill B are presented in Figure 3-29 and identified in Table 3-8 below. Exemplars of the directional indicators are shown in Figure 3-30. Overpressure in Mill B pushed the stairwell entry door through the frame with such force that the entry door separated from the hinges and came to rest on the landing between levels 3 and 2 of the stairwell. The electrical boxes in Mill B were undamaged by the overpressure. The overpressure in Mill A at the third level was sufficient to damage the third level west wall at the ceiling (4<sup>th</sup> level slab) and fail the double doors on the east face.

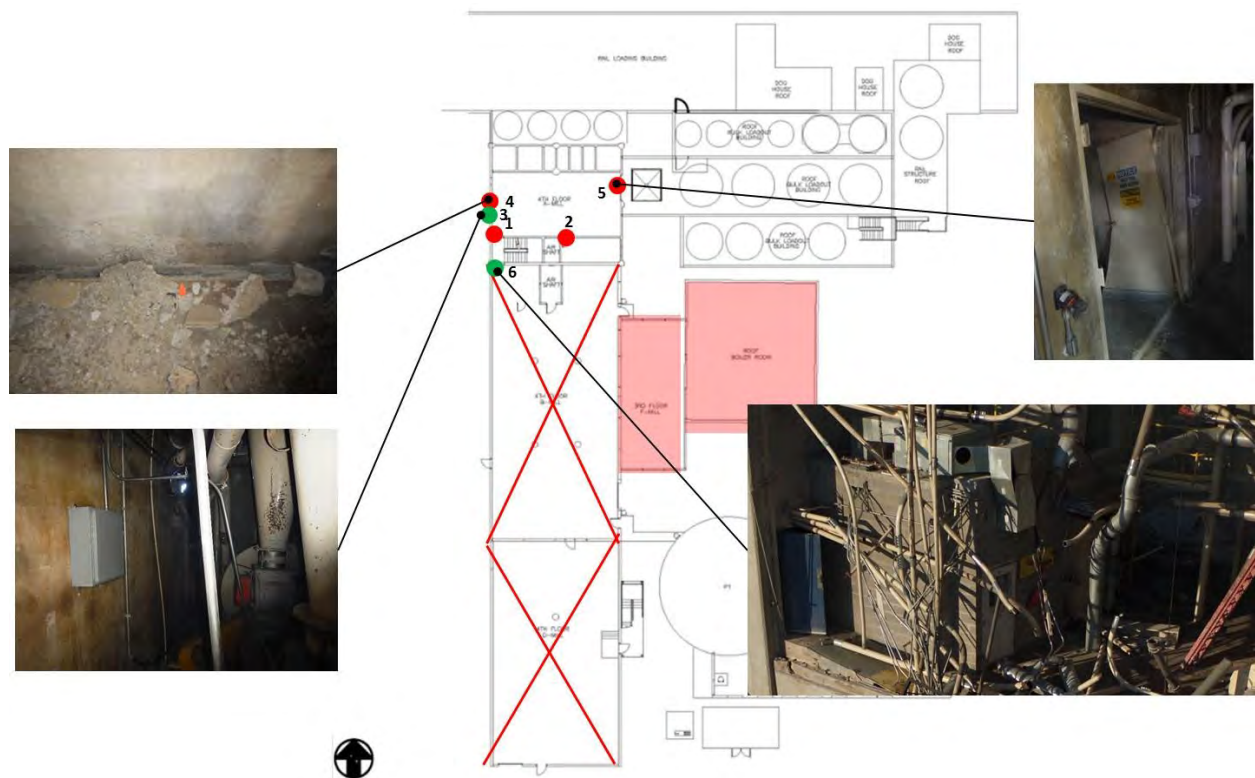
**Figure 3-32. Mill A and Mill B Level 4 Exemplar Blast Indicators**

Level 4 of Mill B could not be accessed safely due to the collapsed side walls and unprotected fall hazards. Drone photos were reviewed in lieu of access. Blast indicators for the fourth level of Mill A and Mill B are presented in Figure 3-31 and identified in Table 3-9 below and examples are provided in Figure 3-32. The exemplar blast indicators show that overpressure the 4<sup>th</sup> level of Mill B was insufficient to damage the stairwell entry door and only slightly damage the HVAC ducting above the mechanical rooms. Overpressure in Mill A at the 4<sup>th</sup> level separated the west concrete wall from the 4<sup>th</sup> level floor slab, pushed the electrical room double doors through the opening into the electrical room, but did not damage the electrical box on the west wall.

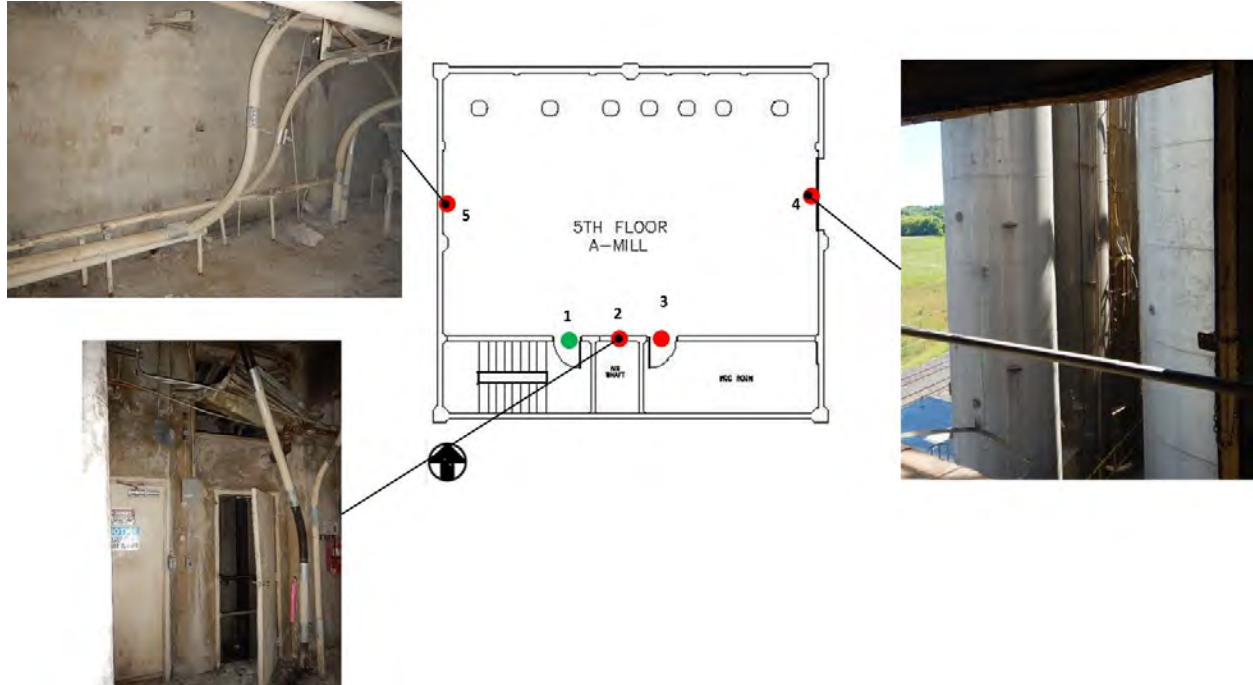
**Figure 3-34. Mill A and Mill B Level 5 Exemplar Blast Indicators**

Blast indicators for the fifth level of Mill A are presented in Figure 3-33 and identified in Table 3-10 below. Examples of the observed blast indicators on level 5 of Mill A again indicate overpressure separated the west wall from the Mill A slab, this time at the 5<sup>th</sup> level. The overpressure failed the east view windows and door as shown in Figure 3-34 and damaged the air shaft door between Mill A and the air shaft.

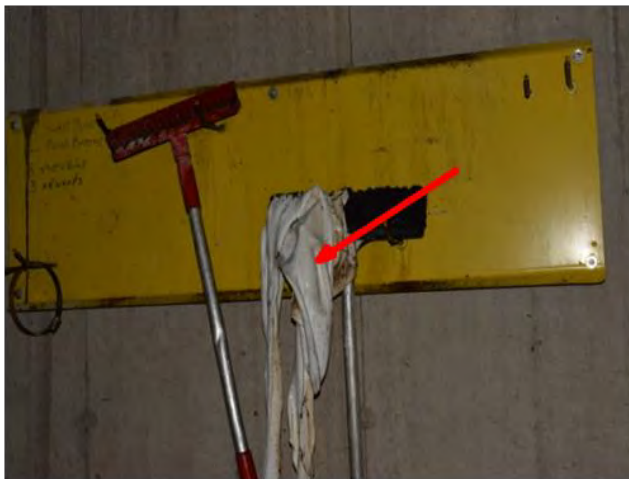
ABS Group conducted a fire damage survey within the mill. Fire damage indicators are broken into three groups. Low fire damage indicators include damaged papers, straw and plastics, soot, and bubbled or charred rubber conduit (Figure 3-35). Medium fire damage indicators include charred wood, and bubbled industrial coating on steel (Figure 3-36). High fire damage indicators include charred or burned steel (coating burned off), warped or ruptured pipe, and warped or torn structure (Figure 3-37). These levels allowed for a map to be generated that demonstrated fire locations and severity (heat).

**Figure 3-35. Example of Low Fire Damage Indicator (Melted Plastic)**

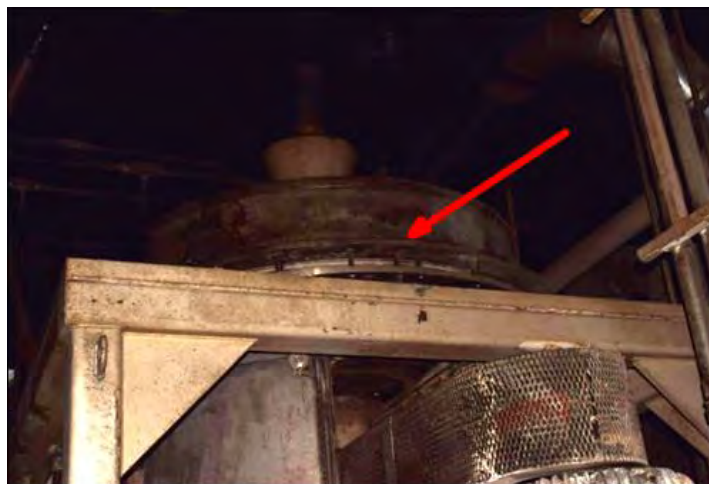
**Figure 3-36. Example of Medium and High Fire Damage Indicator (Bubbled and Lost Coating)**

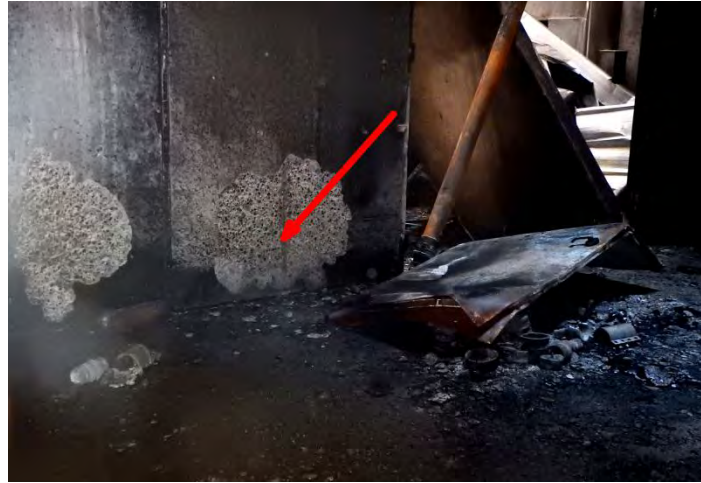
Figure 3-37. Example of High Fire Damage Indicator (Spalled Concrete)

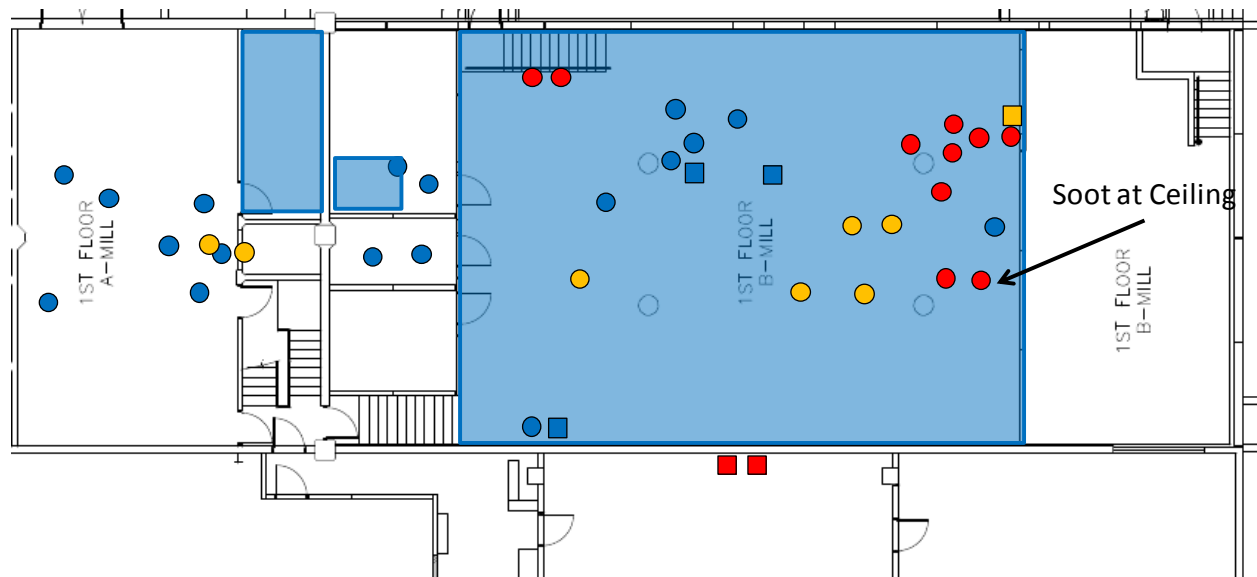
The maps in Figure 3-38 through Figure 3-42 show fire damage on the levels of Mill A and Mill B. The first level of Mill B had more extensive fire damage than the remainder of Mill A and Mill B. The Transformer room adjacent to the bulk loading area showed signs of an intense fire that may have been the result of an increase in fuel loading ignited by the fire traversing through the facility. The fire damage indicators from within Mill A and Mill B are consistent with a prolonged fire in Level 1 of Mill B.

Figure 3-38. Level 1 A and B Mill (Low – Blue, Medium – Orange, High – Red)

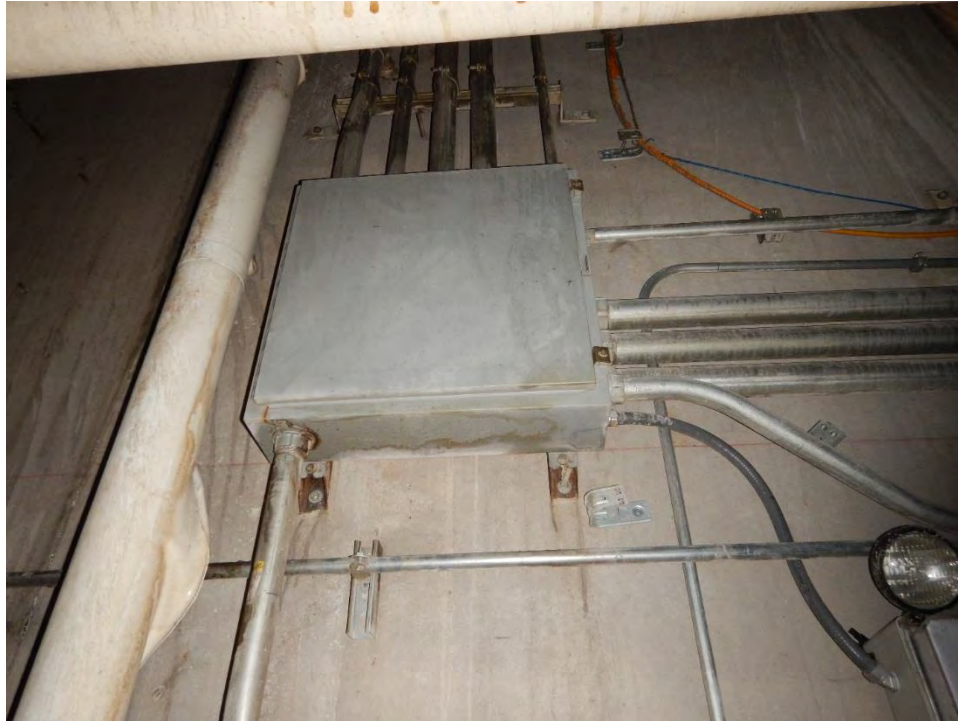
Electrical junction boxes were observed with undamaged doors at levels 2 and 3 of Mill B as well as level 4 of Mill A. An example is provided in Figure 4-5. The electrical box door was measured in the field and analyzed as a two way flat plate. The box is undamaged; therefore, the analysis was performed to the elastic limit to indicate the threshold at which damage to the electrical box would be observable indicating an upper limit to the applied blast loads at this location. A P-i diagram for the electrical boxes is presented in Figure 4-6.

Figure 4-5. Mill B Undamaged Electrical Junction Box
