**Client: United States Chemical Safety Board**

**Report Title: Didion Milling Explosion Assessment**

***Incident: May 31, 2017***

**Final Report R0**

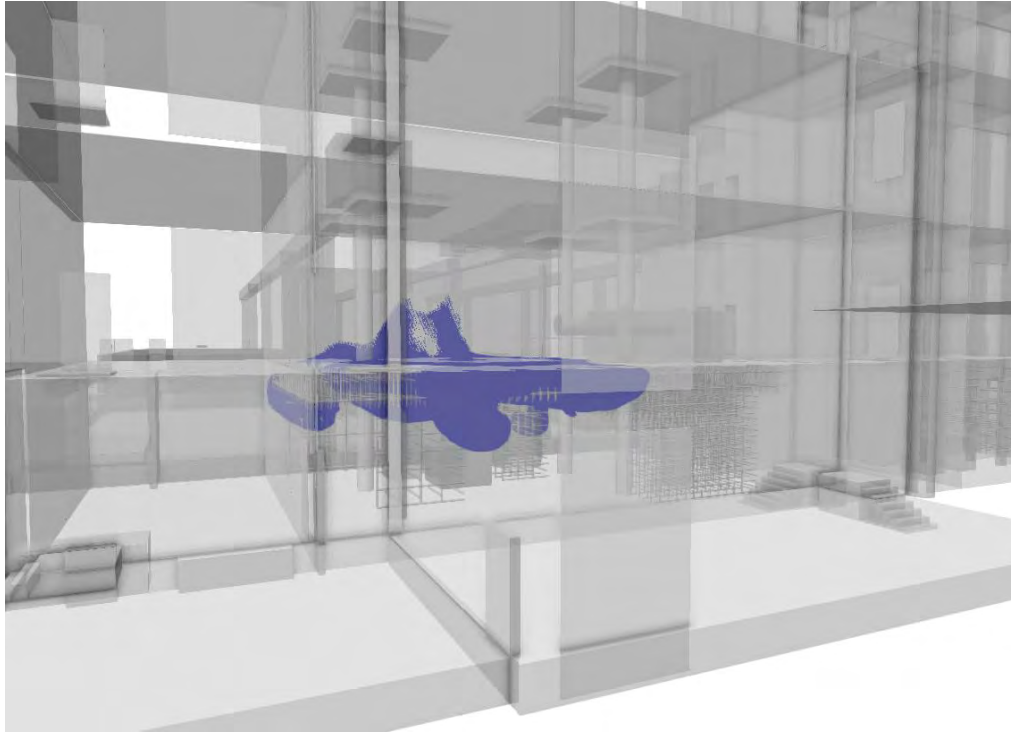
Figure 5-1. Dust Cloud Released from the South Gap Mill

An explosion ignited at the base of the South Gap Mill which is located in level 1 of Mill B. As the material burns within the Gap Mill, unburned dust is ejected into level 1 of Mill B as the flame front progresses from the bottom of the Gap Mill. The maximum flammable mass of ejected dust when the flame front reaches the exit of the mill was tracked. Figure 5-1 shows the location of the dust cloud at the maximum flammable mass and the corresponding vertical section through the South Gap Mill and Mill B is shown in Figure 5-2. The total mass of dust expelled from the South Gap Mill into level 1 of Mill B was approximately 5.8 kg (12.8 lb.). This mass is well below the minimum mass of dust in level 1 of Mill B necessary to cause the observed damage as described in Section 5.3.

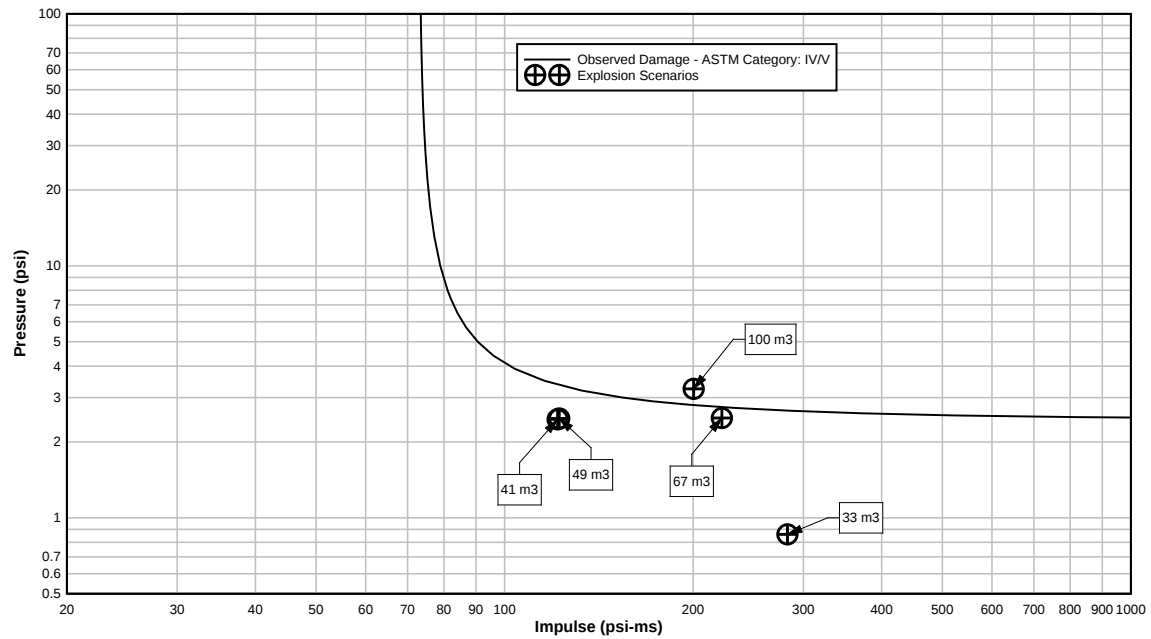
Figure 5-3. Level 1 Mill B Stairwell Door P-i Diagram and Scenarios

Five scenarios of varying dust cloud sizes were evaluated in Level 1 of Mill B as identified in Table 5-1. Applied pressures and impulses determined in the analysis at locations of the damage indicators are shown in Table 5-2. The stairwell doors and air shaft and electrical room doors were the primary damage indicators evaluated. These doors were severely deformed in the explosion consistent with ASTM Level IV damage. The P-i diagrams for the stairwell door is provided in Figure 5-3 and the air shaft and electrical room doors in Figure 5-4. Scenario 610016, a 33 m<sup>3</sup> dust cloud, was insufficient to cause the observed damage to the doors; however, the remaining scenarios were consistent with the observed damage in Level 1 of Mill B. This places the lower bound of dust mass above 33 m<sup>3</sup>.

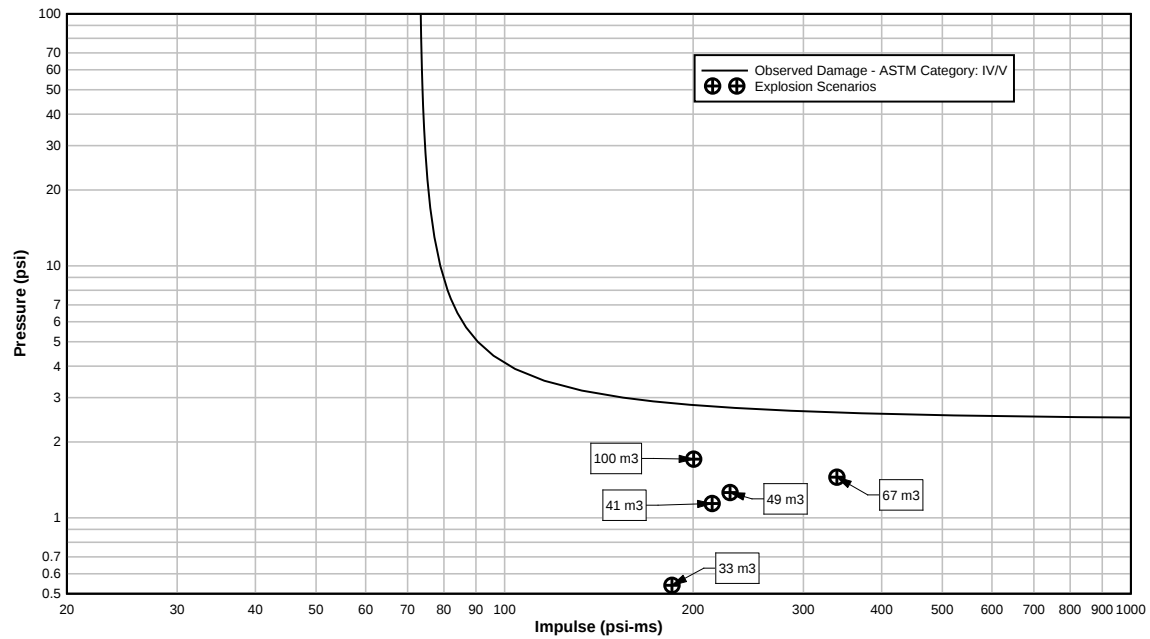
Figure 5-5. Level 2 Mill B Stairwell Door P-i Diagram and Scenarios

The damage to the stairwell door at Level 2 of Mill B, which was forced through the frame and thrown into the stairwell landing, is consistent with ASTM Level V damage. Applied blast loads on the stairwell door for each scenario are presented in Figure 5-5. None of the evaluated scenarios are capable of explaining the observed damage to the stairwell door at Level 2 of Mill B.

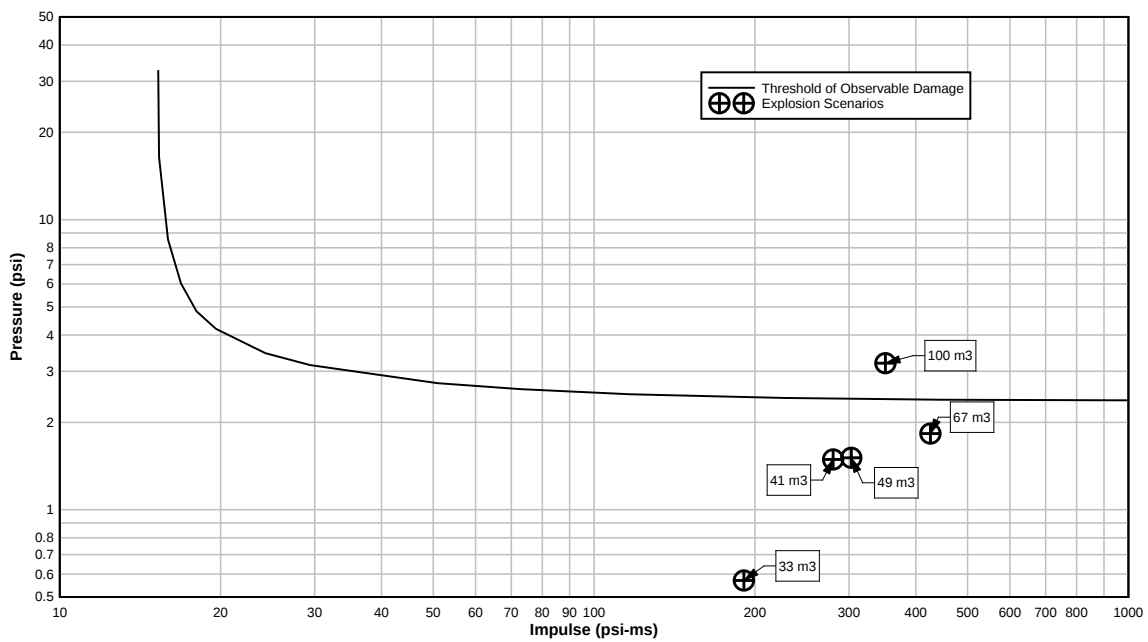
Figure 5-6. Level 2 Mill B Undamaged Electrical Box P-i Diagram and Loads

Applied blast loads on the P-i diagram for the undamaged electrical box at Level 2 of Mill B nearest the stairwell are shown in Figure 5-6. Scenario 610115 with the 100 m<sup>3</sup> cloud is predicted to cause loads which would produce damage and is inconsistent with this undamaged blast indicator. All other scenarios fall below the P-i diagram in Figure 5-6 and are consistent with this undamaged blast indicator. This would place the maximum dust volume between 67 m<sup>3</sup> and 100 m<sup>3</sup>.

The blast indicator assessment of the scenarios in Table 5-1 indicate that the evaluated dust cloud most consistent with the observed damage in Levels 1 and 2 of Mill B was between 40 m<sup>3</sup> (45 lbs.) and 100 m<sup>3</sup> (110 lbs.). Further, to explain the damage to the remainder of the Mill, including Levels 2 through 4 of Mill B, Levels 1 through 5 of Mill A, the Multipurpose Building and Mill F requires propagation of the explosion from Level 1 of Mill B to other rooms within the Mills. This is evident due the 100 m<sup>3</sup> cloud in scenario 610115 being insufficient to cause the observed damage to Level 2 of Mill B but exceeding the threshold of damage to the undamaged electrical box in Level 2 of Mill B.

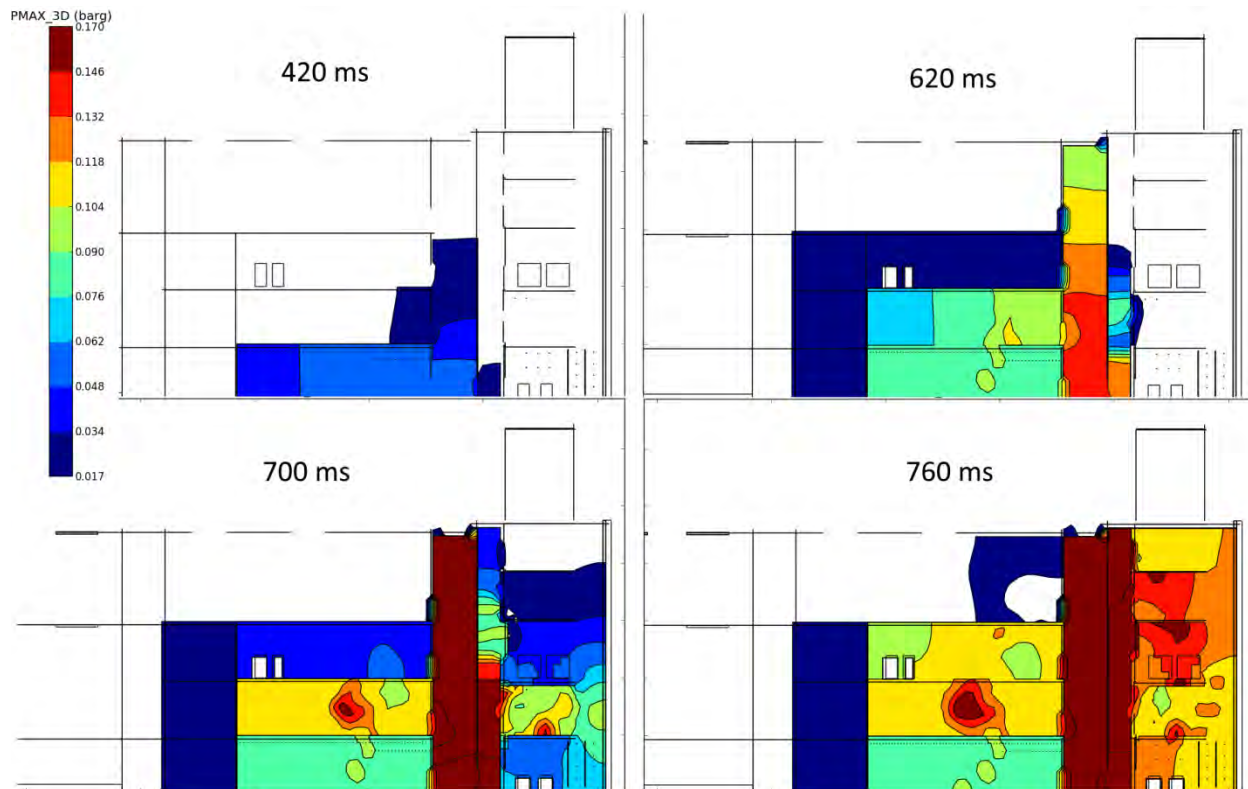
Figure 5-8. Progression of Pressure through the Vertical Vent Shaft

The progression of an explosion, initiated on Level 1 of Mill B, to the third level and separated by vent shaft doors, floors, and walls is shown in Figure 5-8. As the pressure loads fail doors and the flame front propagates through the air shaft and ignites additional dust, pressure is increased throughout Mill A and Mill B. This result is consistent with the observed damage and directional indicators.
