DuPont La Porte, Texas Chemical Facility Toxic Chemical Release

Interim Recommendations

Investigation: 2015-01-I-TX
Incident Date: November 15, 2014
Issue Date: September 30, 2015

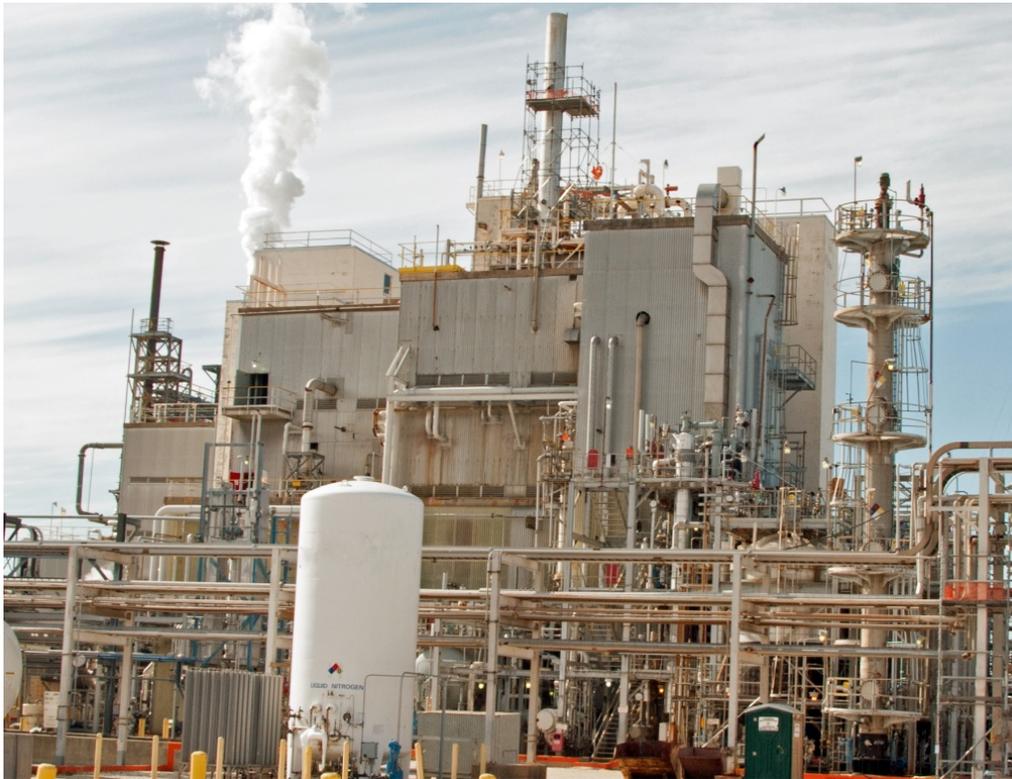
Figure 1. East side of the manufacturing building at the DuPont La Porte insecticide production facility.

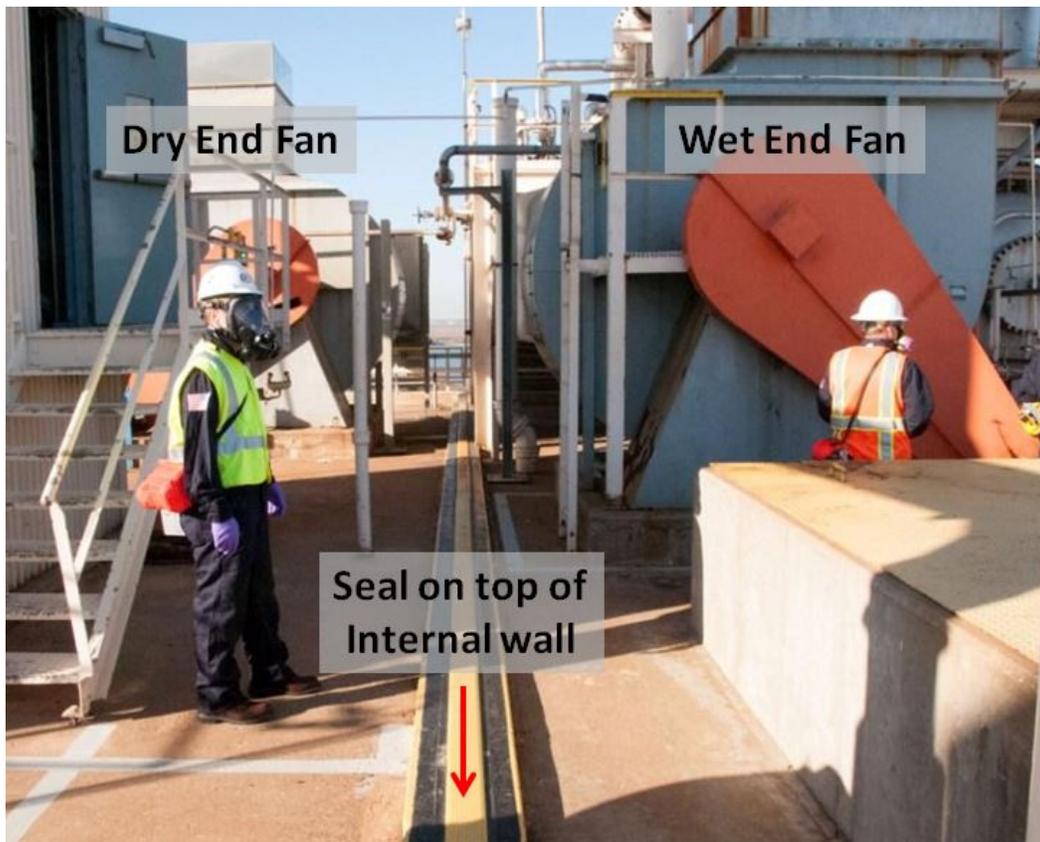
Figure 4. Roof of the manufacturing building showing the dry end fan (left), wet end fan (right), and location of the internal wall (middle) that separates each side within the building.

9. The two sides of the building are separately ventilated by fans located on the roof of the building as shown above in Figure 4. The manufacturing building is designed to make use of these roof-mounted fans via a dilution air ventilation system that operates as shown in Figure 5 through Figure 8. Fresh air is drawn into each floor on each side of the building, entering at floor level through a mechanical louver system.³⁷ Air is designed to flow from the fresh air louvers, across the process equipment, and up into return ducts located at the ceiling along the internal wall to sweep away any flammable gases.³⁸ Exhaust air on each side of each floor moves inside the ceiling-mounted duct towards the north end of the building (Figure 5 and Figure 7), where it is collected in a vertical duct header that directs the exhaust air from all of the floors on each side up towards the respective (wet or dry end) dilution air exhaust fan on the roof (Figure 6 and Figure 8). Exhaust air from the fans is discharged directly to atmosphere. Contaminants are not removed via any kind of environmental destruction system such as a scrubber or incinerator.

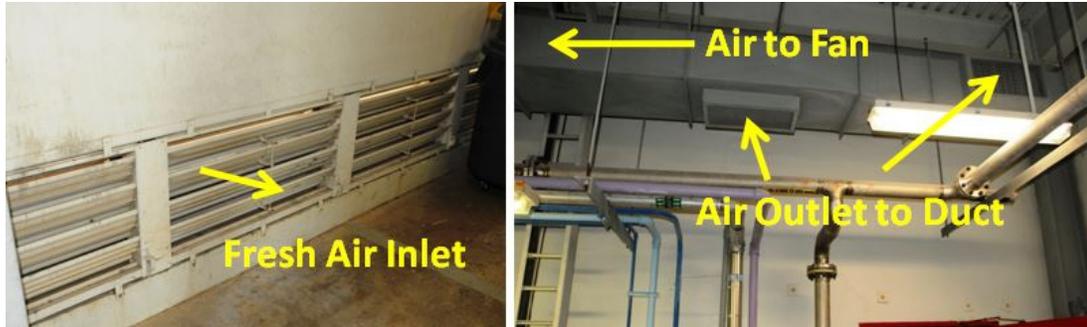
Figure 7. Typical air inlet louvers (left) and air outlet duct that exhausts the air towards the fans on the roof. The air louvers are located near the floor on the outside walls of each side of the manufacturing building and air is drawn to the center. The exhaust air ducts are located near the ceiling on the internal wall of each side of the manufacturing building.

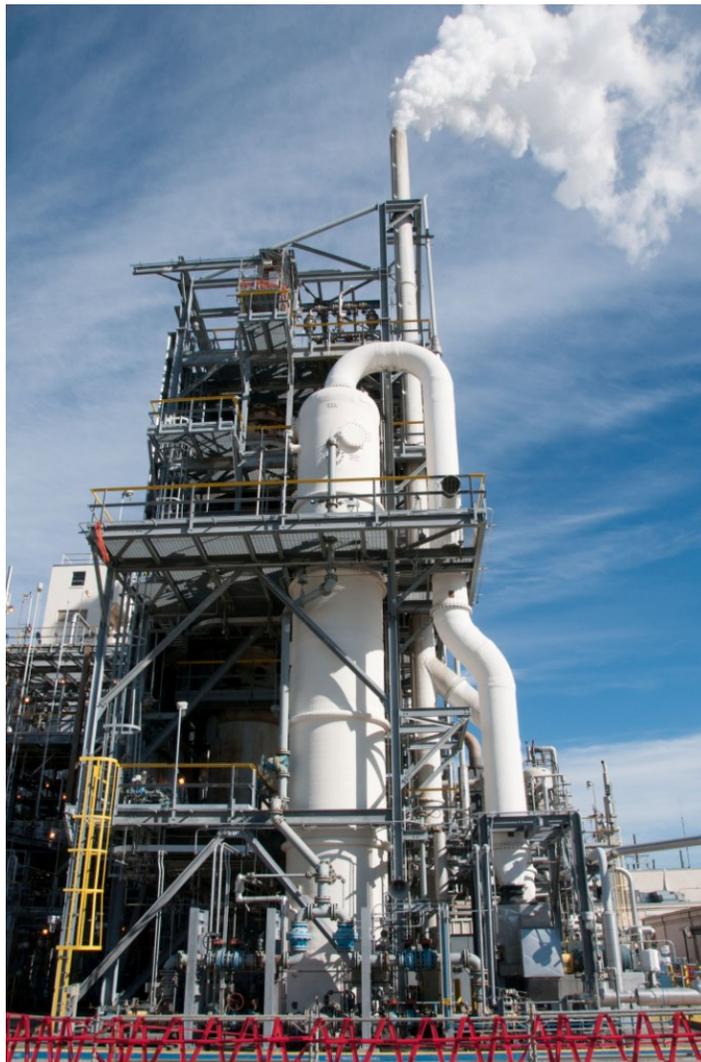
10. In 2011, DuPont invested approximately 20 million dollars to implement a project to increase production rates and reduce environmental emissions for the IBU.³⁹ The key piece of equipment installed was the nitrogen oxides (NO_x) reduced scrubbed incinerator (NRS) shown in Figure 9.⁴⁰

Figure 9. NRS Incinerator installed in 2011 to reduce emissions and allow increased production at the DuPont La Porte insecticide manufacturing facility.

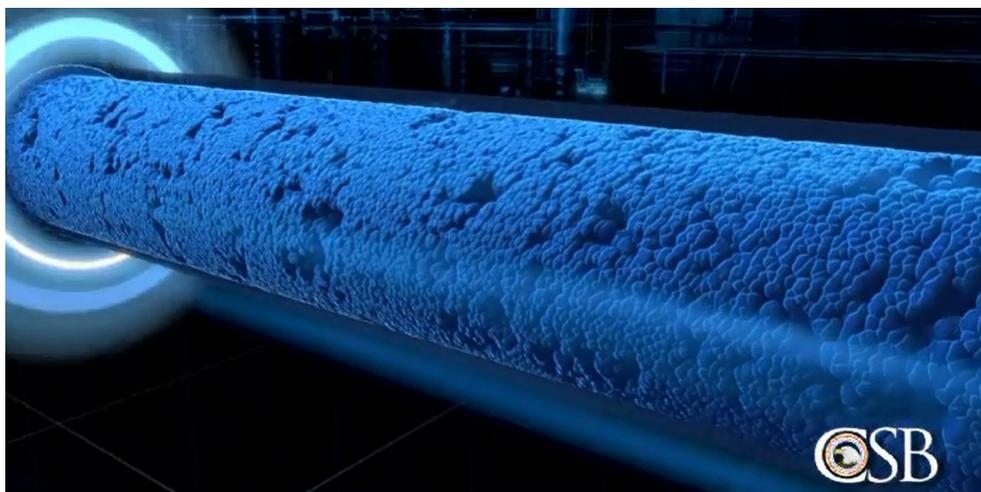
15. Modifications to the AAO concentration control system were made to address the diluted AAO. On Wednesday, November 12, 2014, DuPont operators attempted to restart the Lannate[®] process. However, during the shutdown, the methyl mercaptan reaction section, which generates a salt-slurry material, had plugged (Figure 12), and flow could not be established to accomplish the restart.

Figure 12. Snippet from CSB animation depicting the salt-slurry plugging within the methyl mercaptan reaction system.

16. Plugging of the equipment by the salt-slurry material following a shutdown is common. However, even though routine practices existed there were no written procedures for how to clear the reaction system. To clear the system, operators put hot water both outside and inside of the equipment, a historical site practice that typically clears the plug. Eventually, the salt-slurry material within the methyl mercaptan reaction system was cleared and another startup was

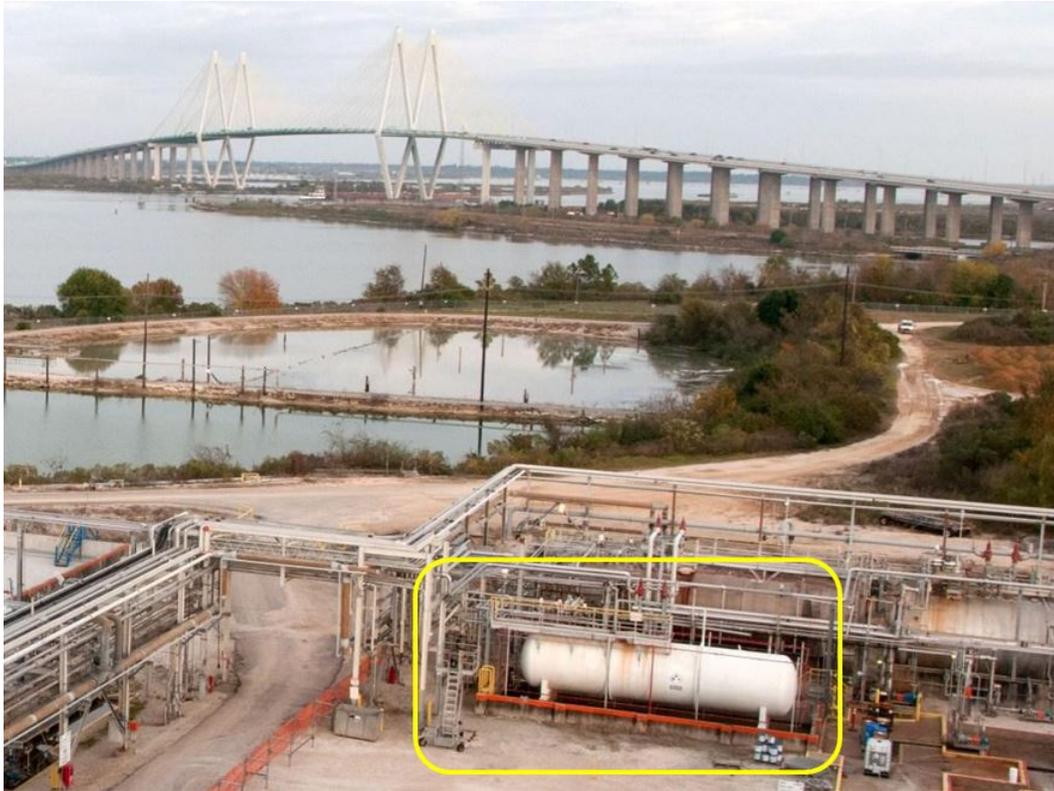
17. A review of process data revealed that on Wednesday night (November 12, 2014), the level in the methyl mercaptan storage tank (Figure 13) rose approximately 2%. Approximately 2,000 pounds of water had likely been inadvertently sent to the methyl mercaptan storage tank as a result of the operational activities that took place during attempts to clear process equipment plugging in the reactor system fed from the upstream methyl mercaptan storage tank.⁴⁹ This tank level rise was not noticed at the time.⁵⁰ The methyl mercaptan storage tank and the feed line to the reaction system now contained a mixture of methyl mercaptan and water.

⁵² Although the methyl mercaptan hydrate with water had been identified in DuPont’s methyl mercaptan technical standard and in PHAs years earlier, DuPont never implemented safeguards, such as heat tracing, or developed a procedure to safely dissociate the hydrate.

Figure 13. The yellow box outlines the 18,000 gallon methyl mercaptan storage tank at the DuPont facility in La Porte, Texas. Both the Lannate[®] and Vydate[®] insecticide processes use methyl mercaptan as a key raw material.

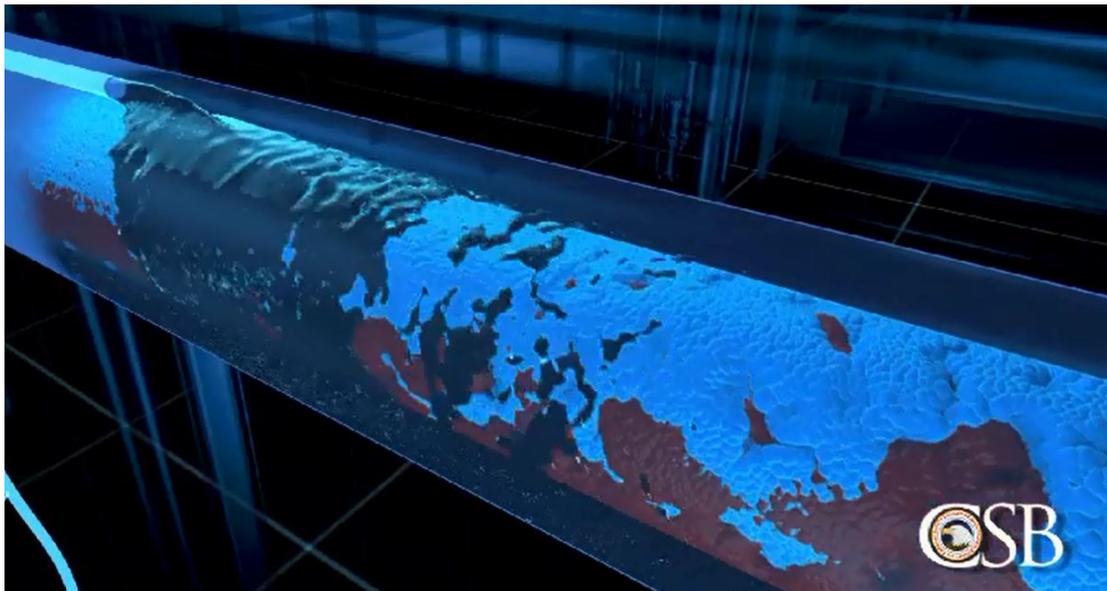
Figure 15. Snippet from CSB animation depicting DuPont's use of hot water hoses placed under the insulation to provide heat to dissociate the hydrate back to methyl mercaptan and water.

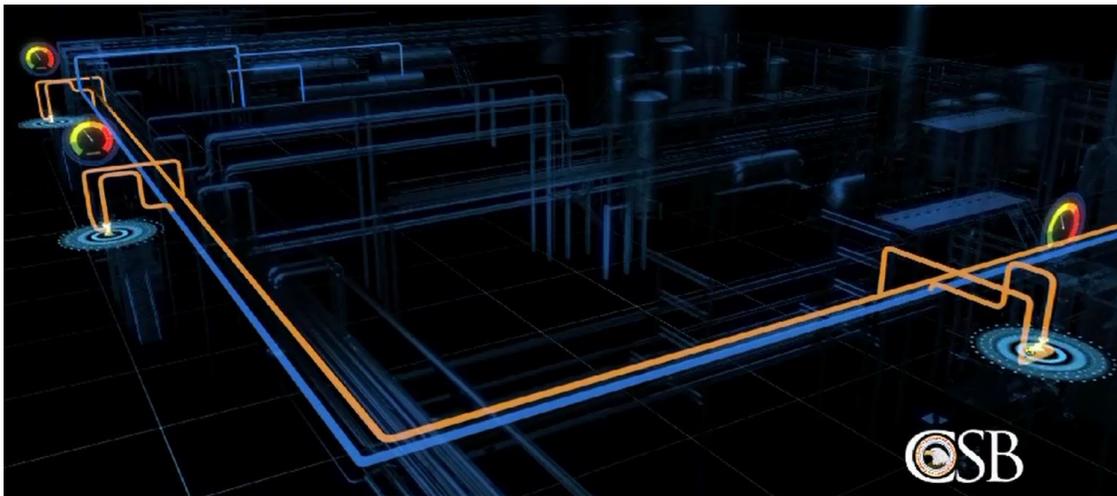
20. The DuPont Technical Team realized that when heated methyl mercaptan would expand and would need a safe place to vent to avoid overpressure of the feed line. To address this concern, DuPont operations personnel opened valves between the methyl mercaptan feed line and the waste gas vent header. Along the methyl mercaptan feed line there were three locations where it was connected by valves to the waste gas vent header— piping intended to remove excess or unwanted vapor from the process and route it to the NRS incinerator for thermal destruction. DuPont personnel used pressure gauges at those three valves (Figure 16) to determine where the blockage was, and what progress they were making to clear it. At the time of the incident, one of these three valves between the methyl mercaptan feed system and the waste gas vent header was fully open. A second valve was slightly open.

Figure 16. Snippet from CSB animation depicting the three locations where valves connected the methyl mercaptan feed line (blue) to the waste gas vent header (orange) piping. Pressure gauges shown at these locations were used to monitor the progress of clearing the hydrate blockage inside the methyl mercaptan feed line.

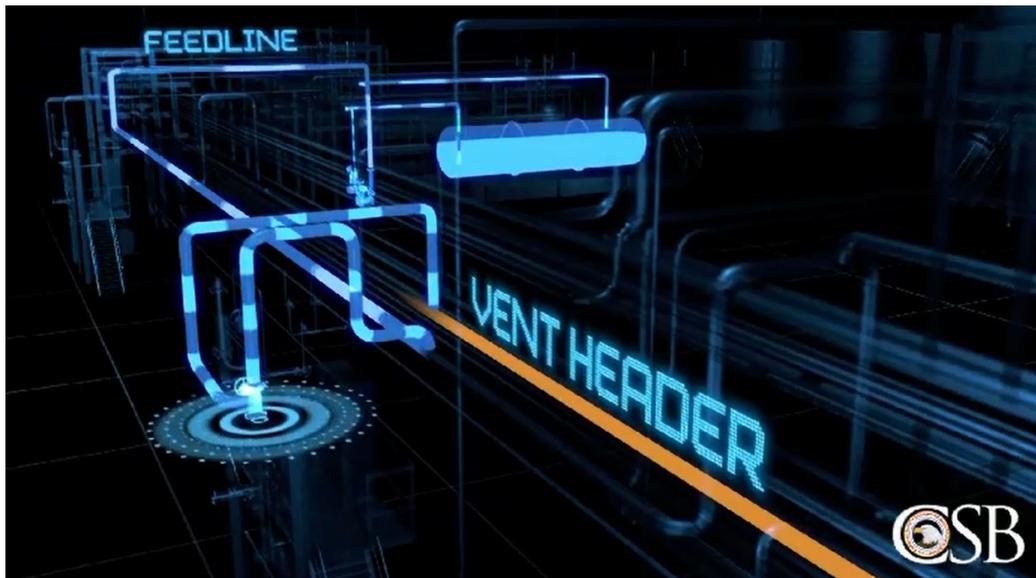
26. A post-incident evaluation of process data identified that the level in the methyl mercaptan storage tank began to drop at approximately 2:45 am. Liquid methyl mercaptan had started to flow into the waste gas vent header piping (Figure 18). This was likely caused by the hydrate being dissociated sufficiently to allow liquid to flow forward and through the connections opened between the liquid methyl mercaptan piping and the waste gas vent header piping. However, the drop in methyl mercaptan storage tank level was not detected, because the level was still within normal operating limits.

Figure 18. Snippet from CSB animation depicting the piping arrangement that allowed liquid methyl mercaptan from the feed line (blue) to flow into the waste gas vent header piping (orange).

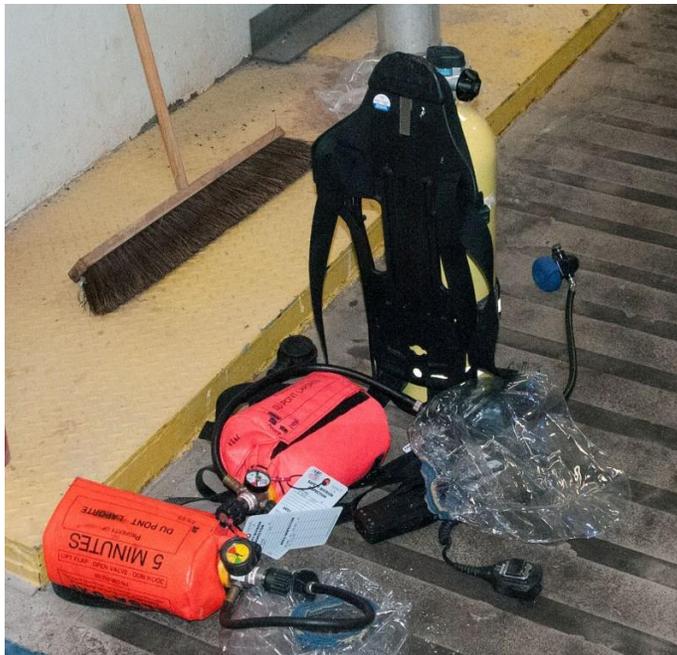
Figure 20. Photo of the 5-minute escape air bottles and 30-minute self-contained breathing apparatus (SCBA) on the third floor, dry end (west) side of the manufacturing building following the incident. The third 5-minute escape air bottle was put on Operator 4 and was left at the control room entrance. The 30-minute SCBA was originally just outside the door to the third floor entrance at the south stairway. It is presumed that Operator 6 grabbed this SCBA prior to entering the third floor.
