U.S. Chemical Safety and Hazard Investigation Board

Fire During Hot Work at  
Evergreen Packaging Paper Mill

Canton, North Carolina

September 21, 2020

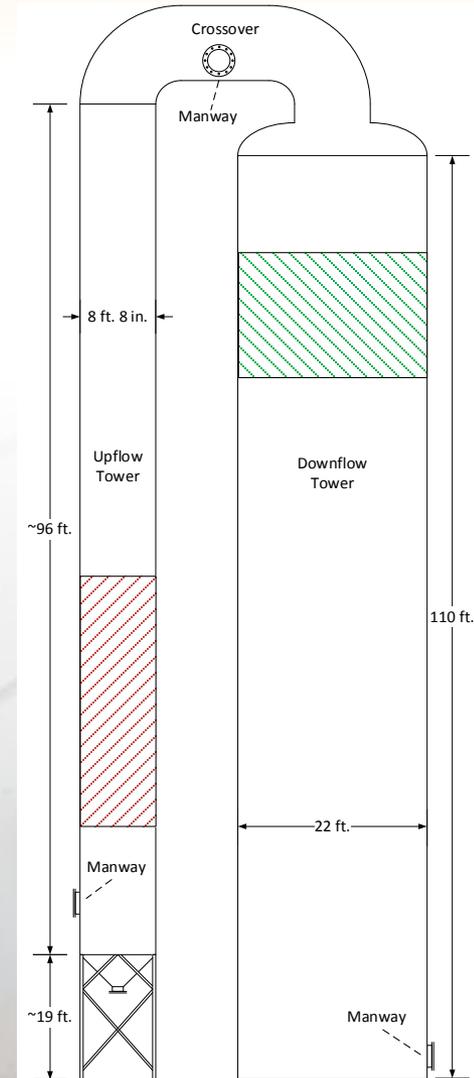
- Two contract companies hired to perform maintenance work in the #2 Fiber Line D2 upflow and downflow towers
- Blastco worked in the upflow tower (red shading)
- Rimcor worked in the downflow tower (green shading)

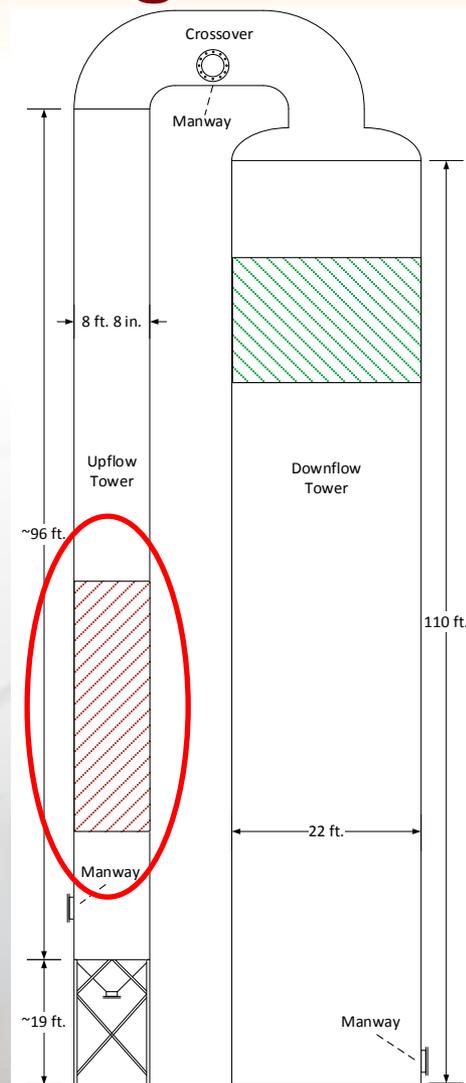
- Upflow tower constructed of fiber-reinforced plastic, or FRP
- Blastco first removed damaged material using grinders
- Blastco replaced with epoxy vinyl ester resin and fiberglass
- Using paint rollers, Blastco applied resin to the walls of the upflow tower
- Blastco then alternated layers of resin and fiberglass

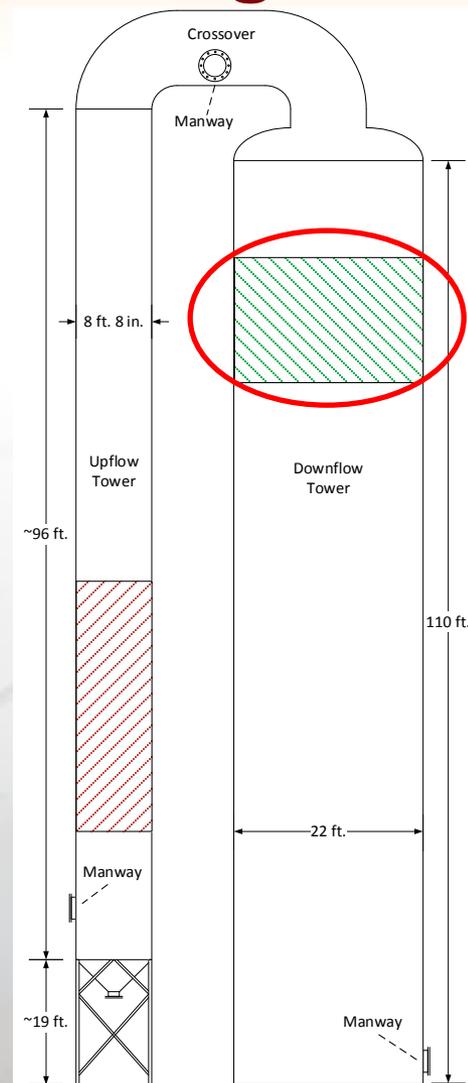
- The downflow tower was constructed of carbon steel lined with fireclay acid brick
- Rimcor removed damaged brick lining and abrasive blasted steel surface to prepare it for new brick
- Rimcor worked on a scaffolding platform suspended from the roof of the tower
- At time of incident, Rimcor was abrasive blasting
