U.S. Chemical Safety and Hazard Investigation Board

Carbide Industries, LLC, Louisville, KY Electric Arc Furnace Explosion

March 21, 2011
2 Killed, 2 Injured
No. 2011-05-I-KY

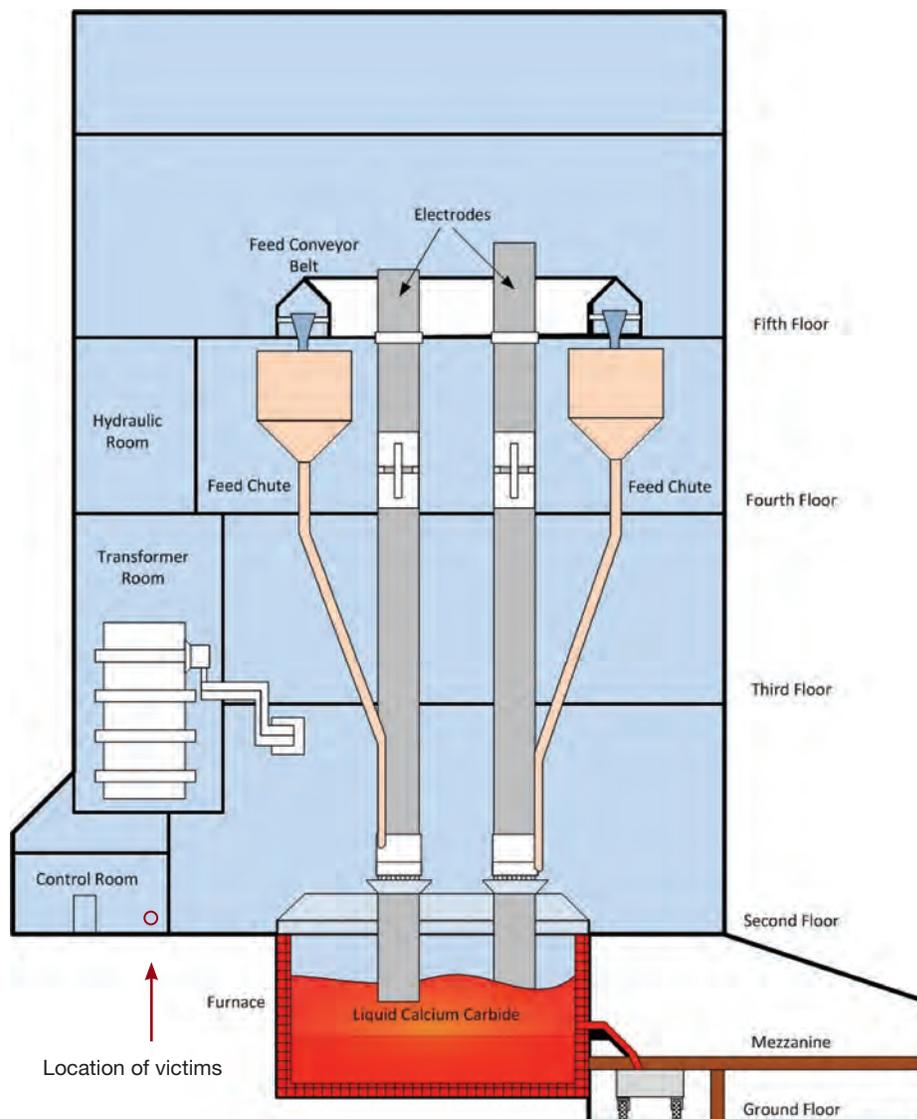
FIGURE 3

The EAF at Carbide Industries was located on the ground floor of the five-story furnace building (Figure 2). Due to the height of the furnace itself, the cover of the furnace was at the second floor level; the same level as the control room where the furnace operator controlled the chemical and electrical feeds to the furnace. The control room had a window made of dual-paned, one-half-inch thick, wire-reinforced glass. Figure 3 shows that the control room window was about 12 feet from the furnace cover.

Second floor of the furnace building and location of victims at the time of the incident
