U.S. CHEMICAL SAFETY AND HAZARD INVESTIGATION BOARD

INVESTIGATION REPORT

ALUMINUM DUST EXPLOSION

HAYES LEMMERZ INTERNATIONAL—HUNTINGTON, INC.

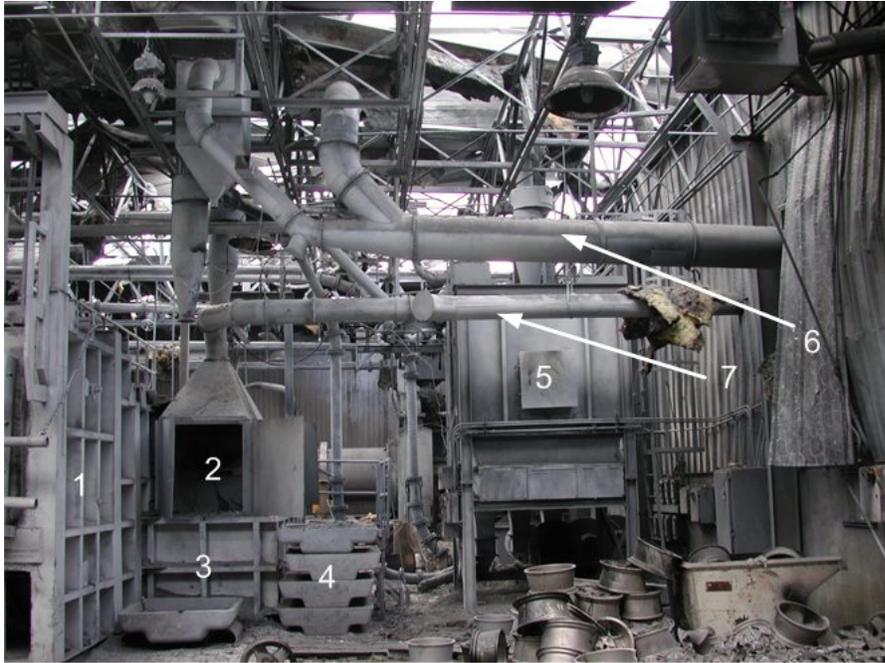
Figure 4. Photo of furnace 5 sidewell, showing fume hood, ingots, and dry chip hopper.

- 1. Furnace No. 5 Wall
- 2. Fume Hood over Side Well
- 3. Side Well
- 4. Aluminum Ingots
- 5. Dry Chip Hopper
- 6. Dust Duct
- 7. Fume Duct
- 8. Reject Wheels for Remelting

At about 2:30 pm on October 29, 2003, Hayes maintenance personnel shut down the chip feed system because of a smoldering fire located near furnace 5 inside the duct connecting the fume hood to the fume separator (see Figure 4, item 7). The glowing red duct alerted employees to the fire. According to plant personnel interviewed by CSB, fires in this duct were not uncommon. On this particular day, employees followed the usual practice for dealing with these fires by shutting down the dry chip feed and the fume hood draft fan (but not the dust collector draft fan), and allowing the fire to burn itself out. Employees judged that the fire was out when the duct had cooled, and they found burnt material that had broken free in the fume separator solids drum. They then opened the fume duct and cleaned out the remaining residue within reach. The October 29 duct fire had been out for at least 2 hours before maintenance personnel restarted the dry chip feed.¹⁶

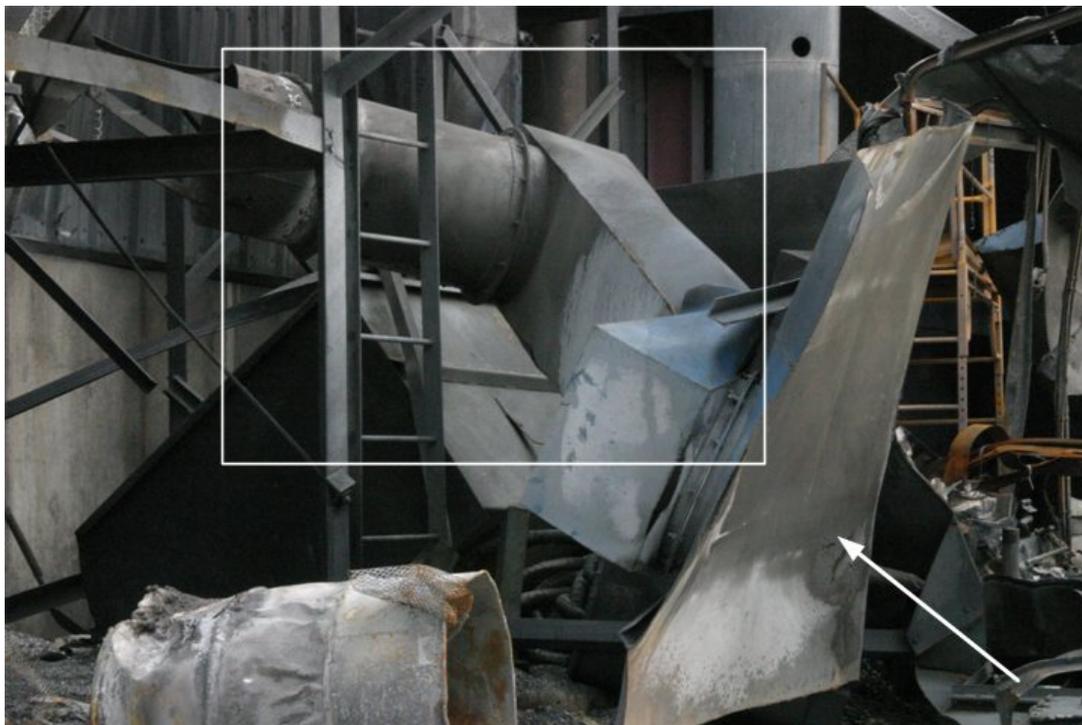
Figure 9. Drop box side panel (arrow) with outlet duct (box).

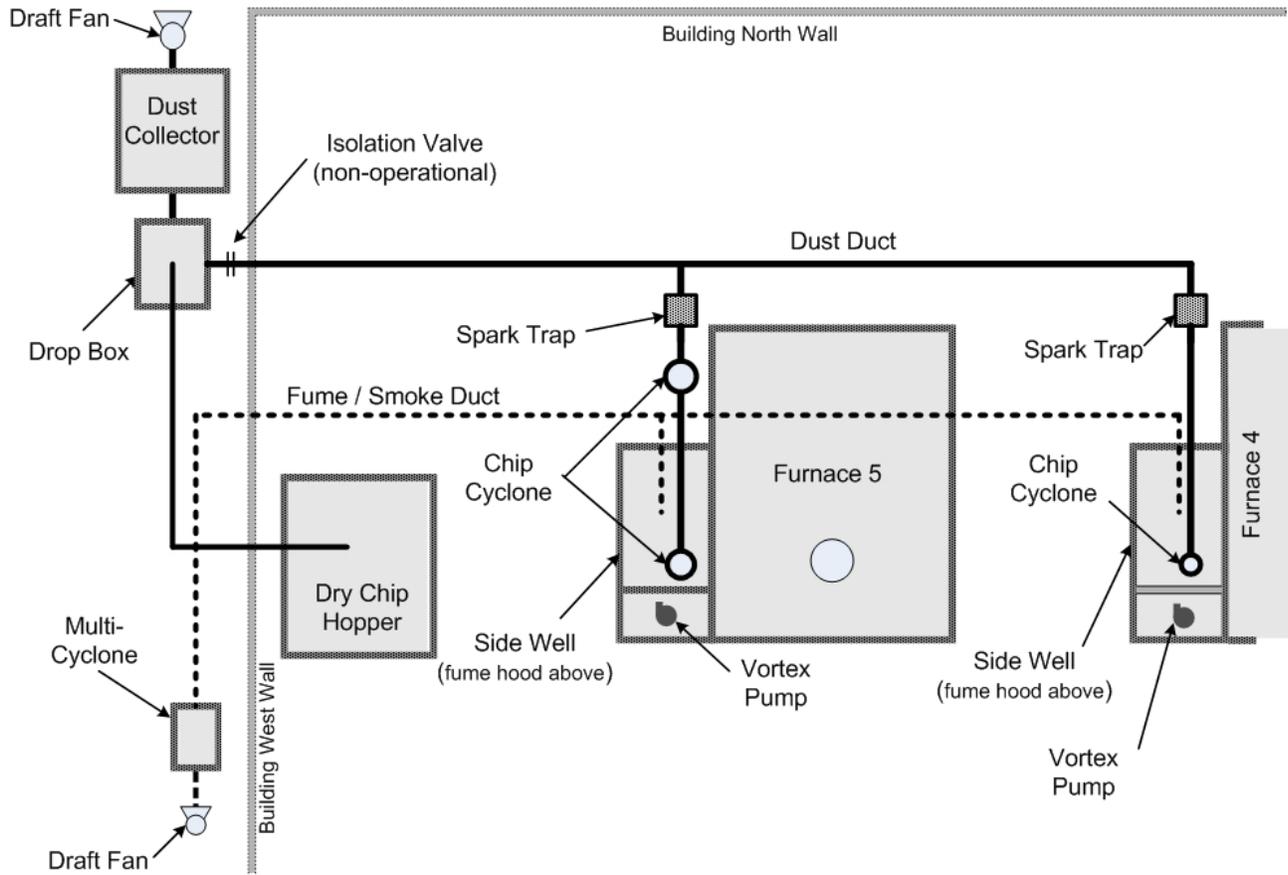
Figure 12. Layout of dust collection, furnaces, and ducts. Some ducts and equipment omitted for clarity.

A 6-inch pipe attached to the drop box roof and the dry chip hopper (Figure 12) provided a direct path for pressure to travel to the dry chip hopper and damage the access door. This pressure was sufficient to bulge the door of the dry chip hopper (Figure 18).

However, Hayes added a direct duct from the dry chip hopper to the drop box (see Figure 12) in an effort to vent what employees described as “positive pressure” within the dry chip hopper. In correspondence with CSB, Hayes opined that embers might migrate from the kiln dryer to the dry chip hopper. CSB believes that such an ember could have been pulled by the draft fan into the drop box.

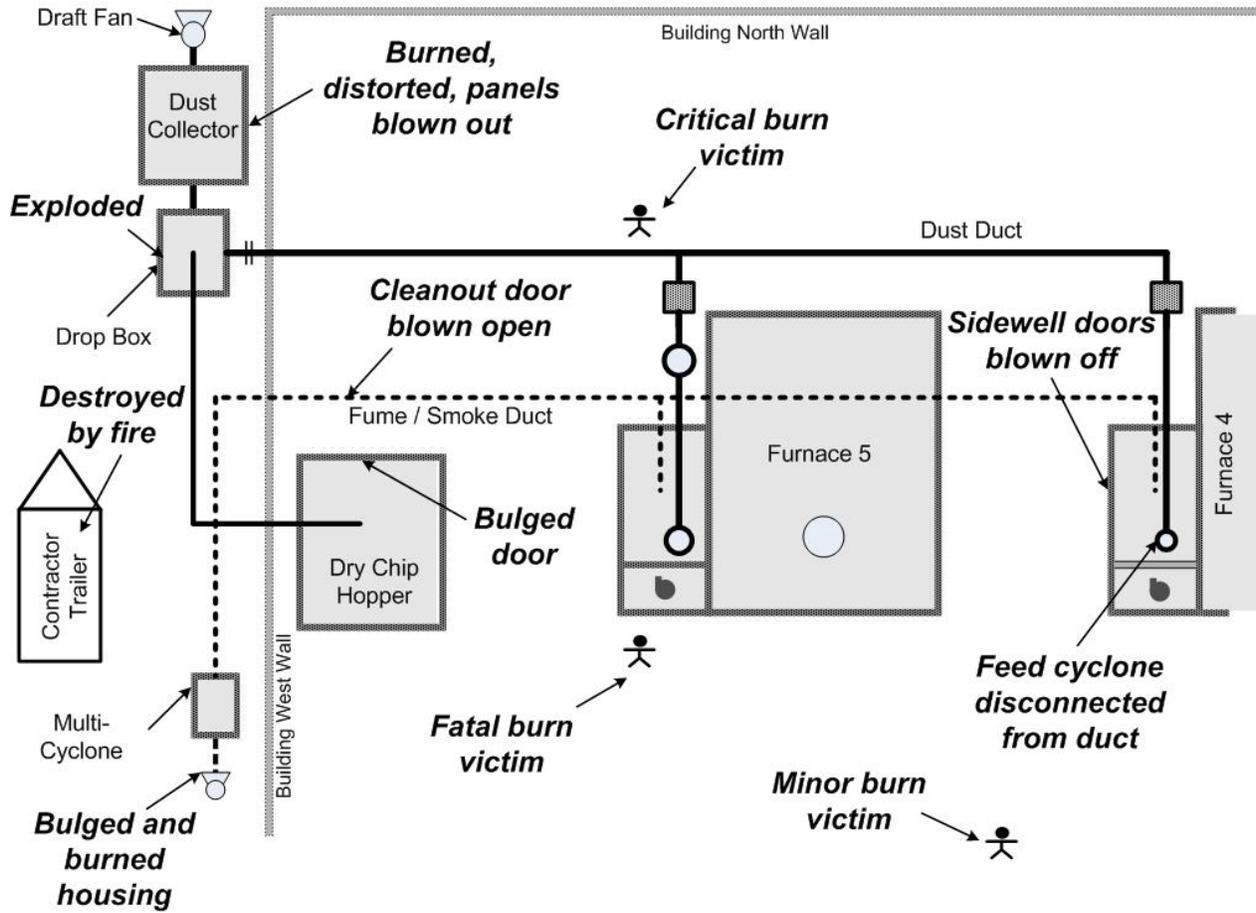
Figure 15 shows the location of most of the interior and exterior damage and the location of employees at the time of the explosion. One stack-testing contractor was on the roof above furnace 5; the other was in a trailer just southeast of the drop box. Not shown in the figure are damage to the wall south of the kiln dryer and the exterior wall southwest of the kiln, water damage inside the compressor room south of the kiln, and damage to the wet chip hopper.

Figure 15. Damage overview and location of employees (plan view). Roof over entire area sustained damage.

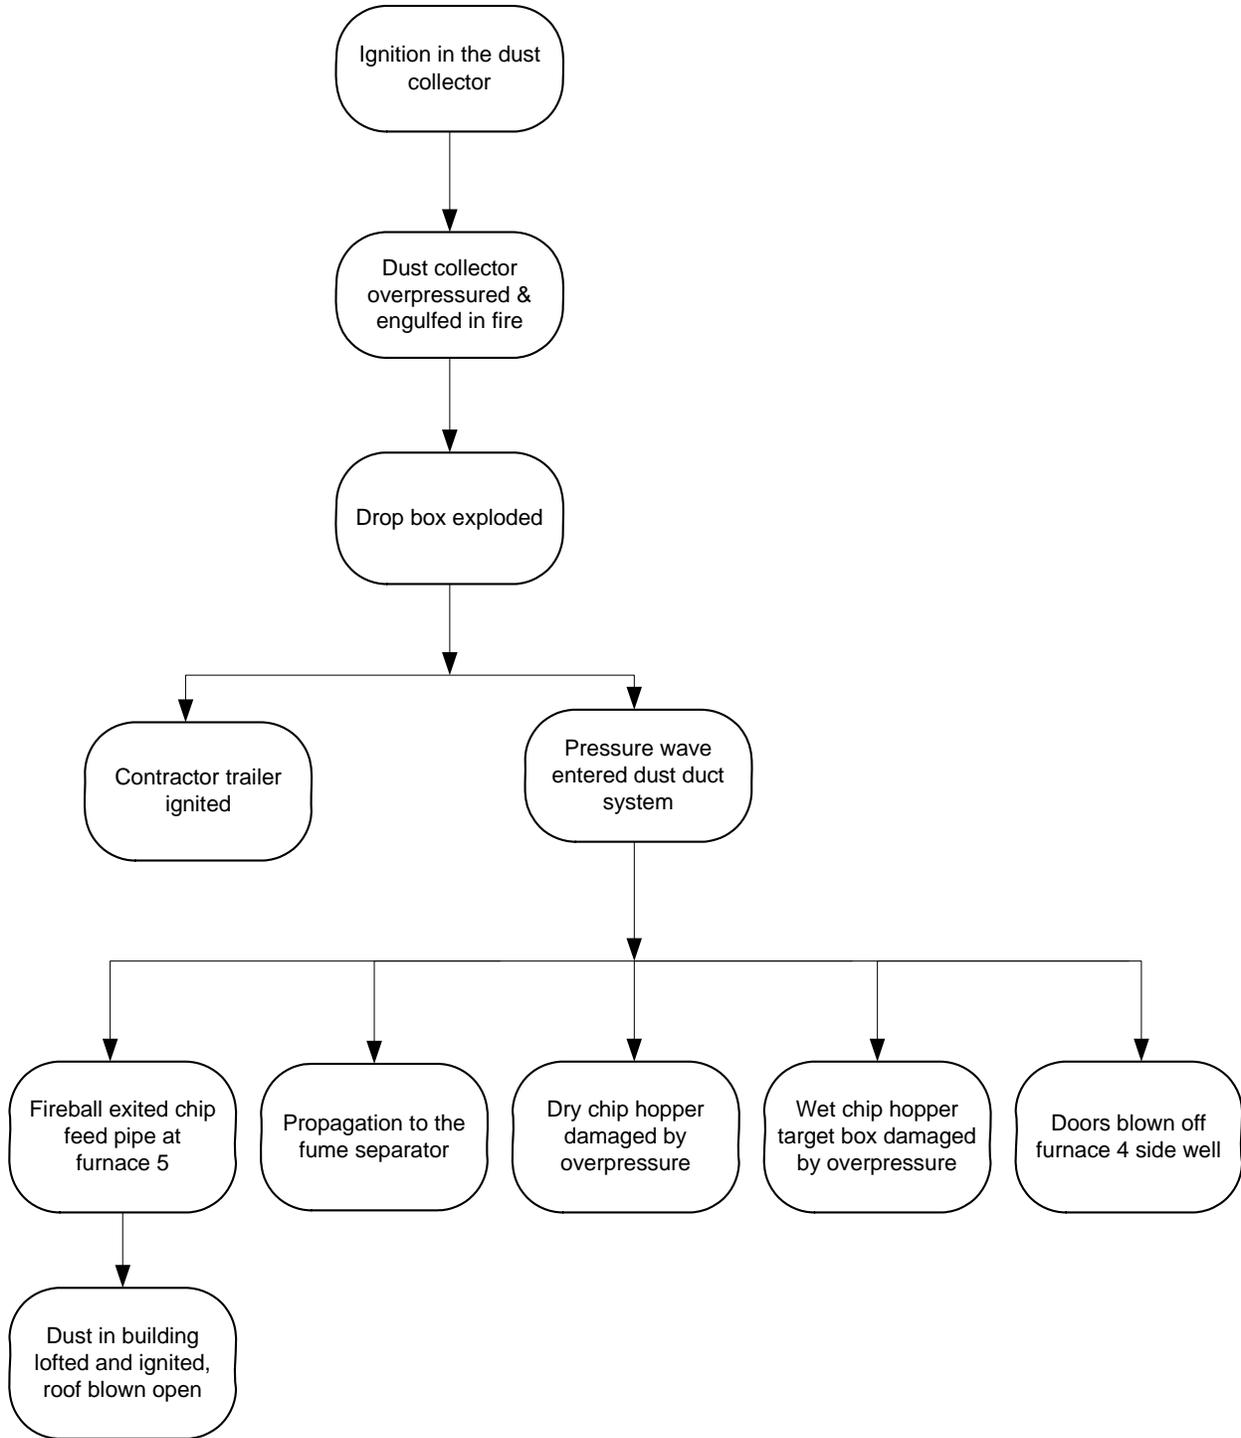
Figure 20. Sequence of events for CSB dust explosion scenario.

Figure 20 is a schematic showing the approximate order of events in the above scenario. Evidence supporting this proposed scenario follows the schematic.

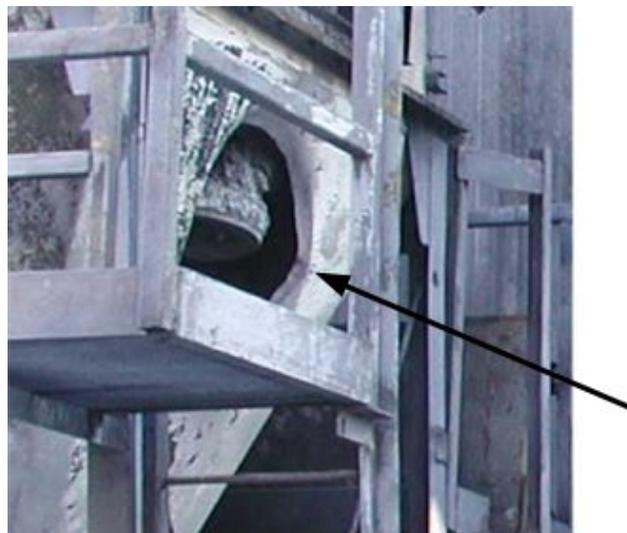
Figure 23. Air inlet (arrow) on the south side of the dust collector.

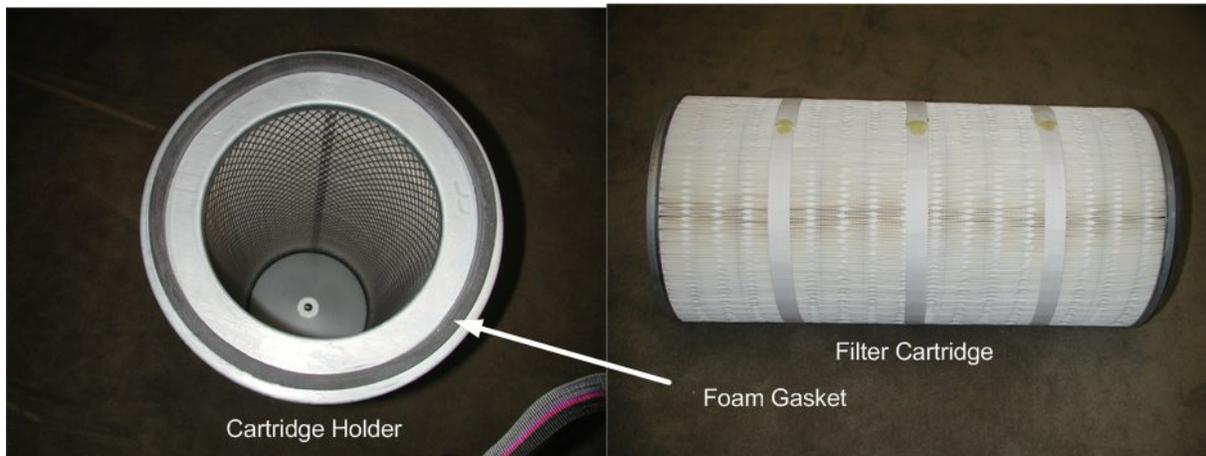
Figure 32. Dust Collector Filter Cartridge

The filter medium used in the dust collector at Hayes was a pleated cellulose cartridge on a steel cage frame, with steel end pieces (Figure 32). Each cartridge was mounted in the dust collector housing on a threaded rod through its center. The pleated filter media was non-conductive material similar to paper. A thick foam gasket separated each cartridge from its steel support plate. Further, a washer used to help hold the cartridge in place had a non-conductive coating on one side. The features of the cartridges and

installation provided an opportunity for static charge accumulation. The conductive aluminum particles in and on the filter would tend to dissipate that charge to the ground via the central rod.

The dust collector pulse jets lofted aluminum dust into the air stream every 90 seconds, resulting in dust concentration within the explosive range. If a static discharge were to occur, the most likely location would be the across the hold-down washer, since this is the smallest insulated gap in the cartridge assembly. It is unlikely that such a static discharge with sufficient energy would occur within that dust cloud created by the pulse jets. CSB concluded that electrostatic discharge is unlikely to be a credible cause for igniting the explosion in the dust collector.
