U.S. CHEMICAL SAFETY AND HAZARD INVESTIGATION BOARD

INVESTIGATION REPORT

HONEYWELL INTERNATIONAL, INC.

REPORT NO. 2003-13-I-LA

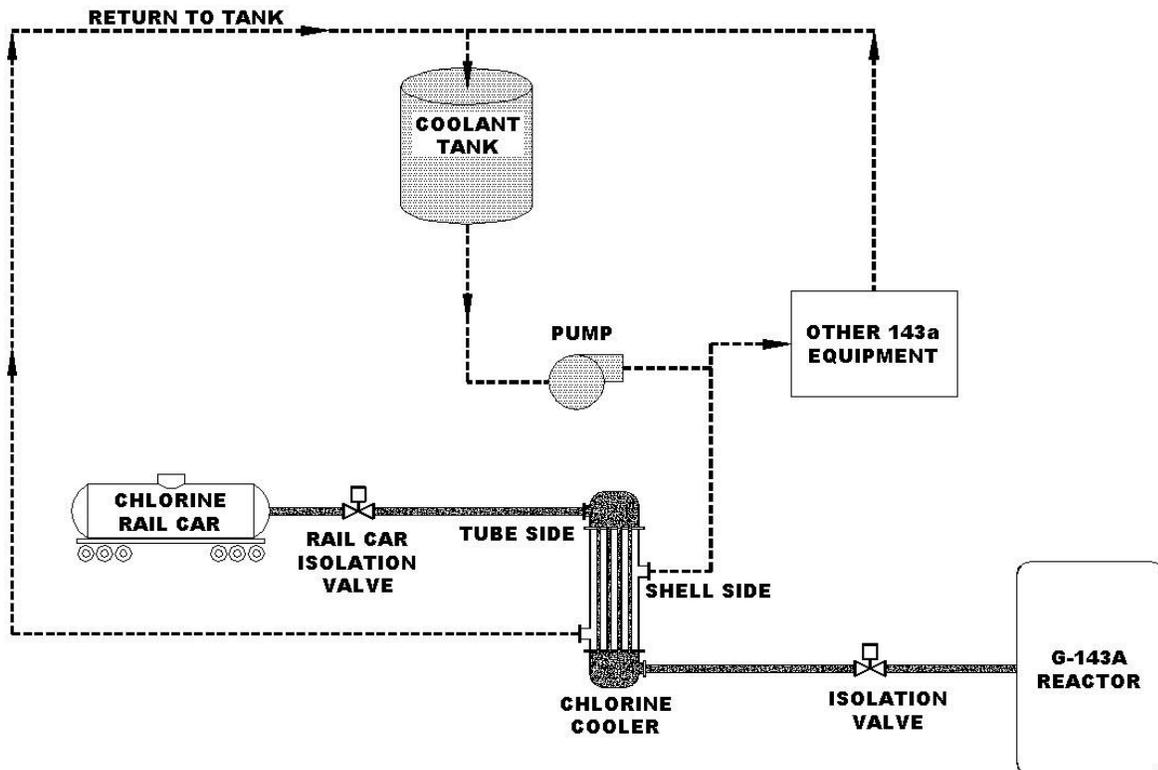
Figure 1. Simplified chlorine feed and coolant systems.

Honeywell uses chlorine as a raw material to make G-143a.³ The July 20 leak occurred in the system that feeds chlorine to the G-143a reactor. In this process—depicted in Figure 1—chlorine is fed to the reactor from a railcar through a cooler designed to ensure that the chlorine remains in the liquid phase.⁴ The railcar has an emergency shutdown system capable of isolating⁵ the railcar.

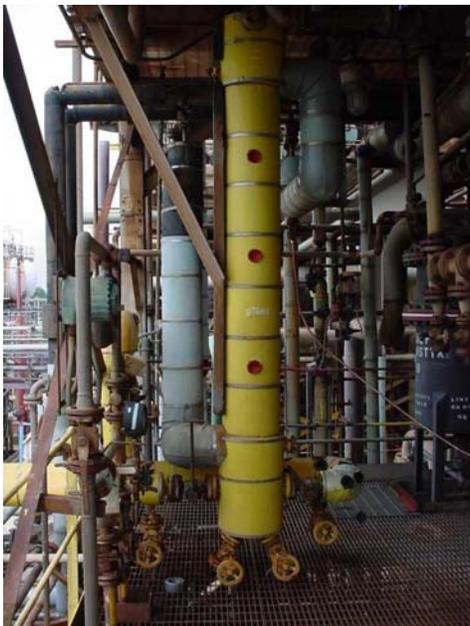
Figure 3. Vertical chlorine cooler in G-143a process.

The coolant—a chlorofluorocarbon refrigerant manufactured at the Baton Rouge facility—is continuously circulated in a loop through various pieces of equipment, including the chlorine cooler. A photograph of the cooler is shown in Figure 3.

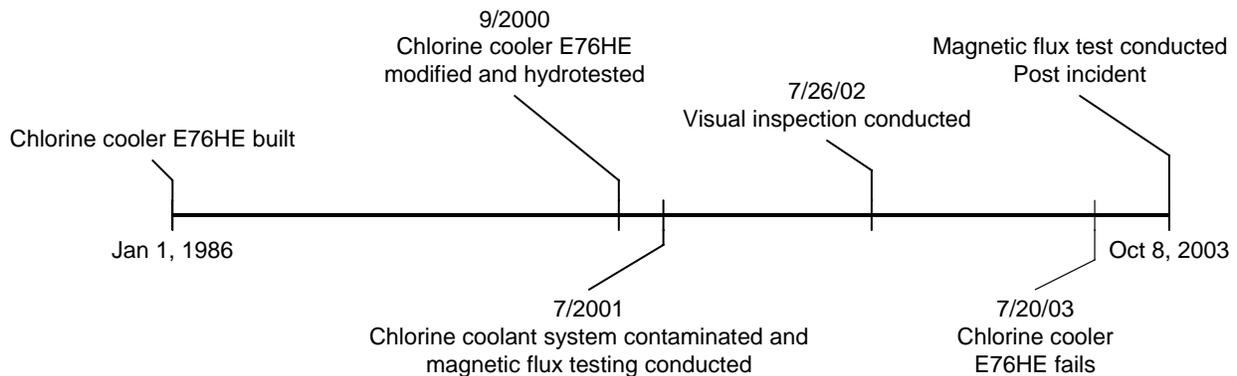
Figure 7. Chlorine cooler history.

The vertical chlorine cooler was an American Society of Mechanical Engineers (ASME)-code certified pressure vessel¹⁴ built and installed in 1986. It had a fixed tube design with 0.109-inch-thick tube walls.

Figure 7 shows key milestones in the history of the chlorine cooler.

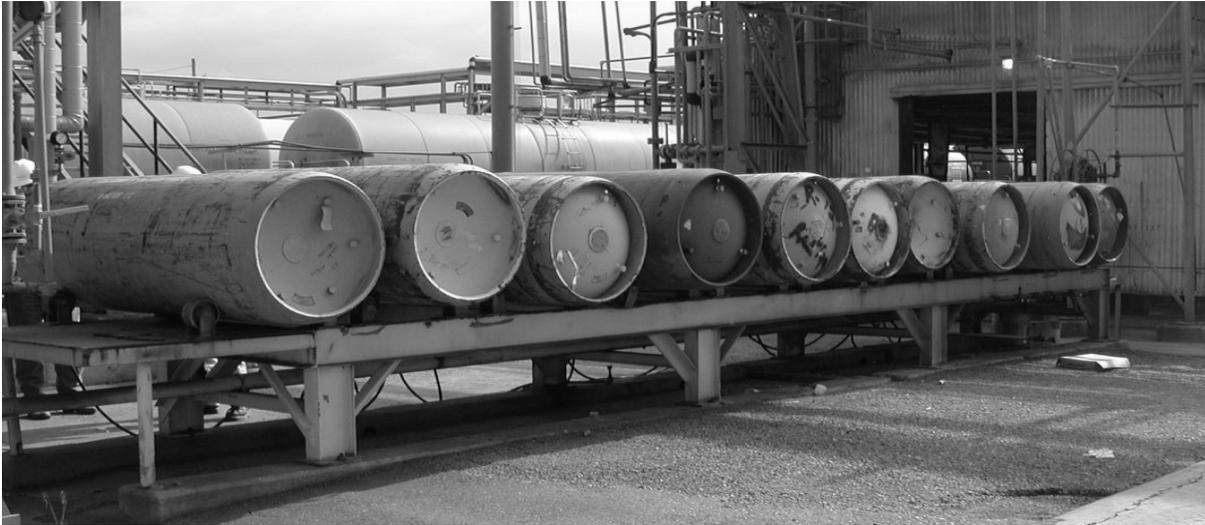
Figure 12. 1-ton refrigerant cylinder prep rack.

- Cylinders are placed on a rack, which holds 10, 1-ton cylinders (Figure 12).

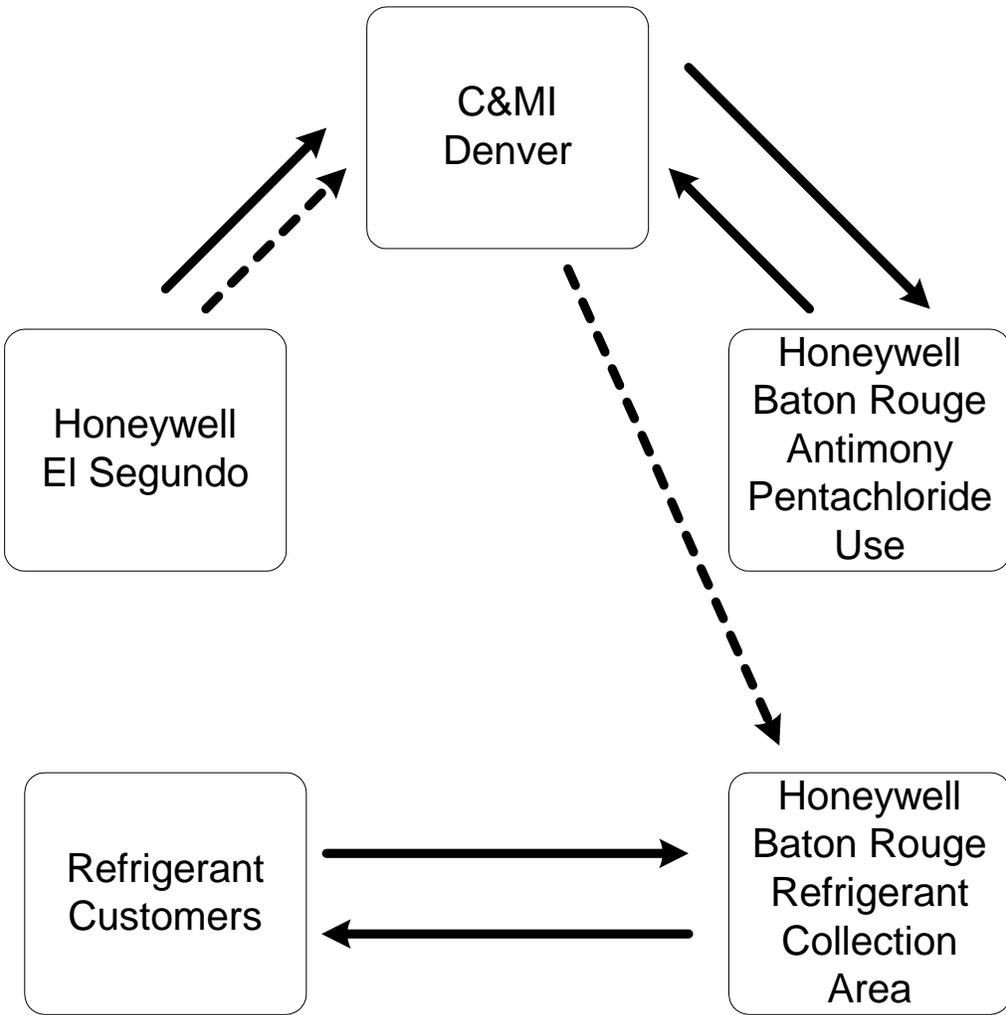
Cylinder 83-3410
Actual Route

- **December 10, 1998:** C&MI ships the four cylinders that were part of the Oct. 27, 1998 shipment, labeled as refrigerant (including 83-3410), to Honeywell Baton Rouge—along with eight full cylinders of regenerated antimony pentachloride.

Following the July 29, 2003, incident, two of the three other cylinders shipped with 83-3410 in December 1998 were analyzed by Honeywell and confirmed to contain refrigerant. The third cylinder had already been emptied.

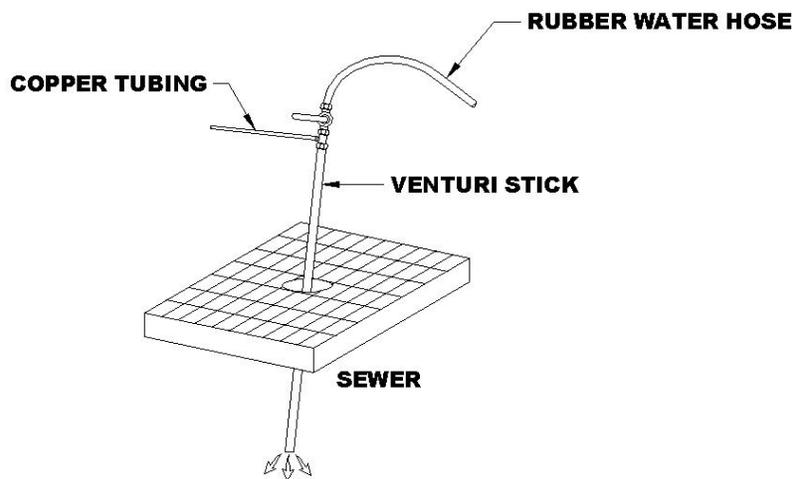
Figure 16. Venturi stick.

Because the new liquid HF draining system could not be used, a venturi stick procedure was used to evacuate the liquid from the G-22 vaporizer. The plant had a general written procedure for using venturi sticks to evacuate various liquids—but no specific procedure for removing liquid hydrogen fluoride from process equipment.

A venturi stick uses the same principle of operation as the spray application of fertilizer with a garden hose and attachment. In the Honeywell procedure, water flowing through a 1-inch pipe (venturi stick) creates a slight vacuum in attached tubing (Figure 16). The liquid (in this case, hydrogen fluoride) being

evacuated mixes with water and is discharged to the plant sewer. The plant also uses nitrogen to help push the liquid hydrogen fluoride out; however, the procedure does not specify how to secure the venturi stick or to select the appropriate nitrogen pressure to apply to the system.

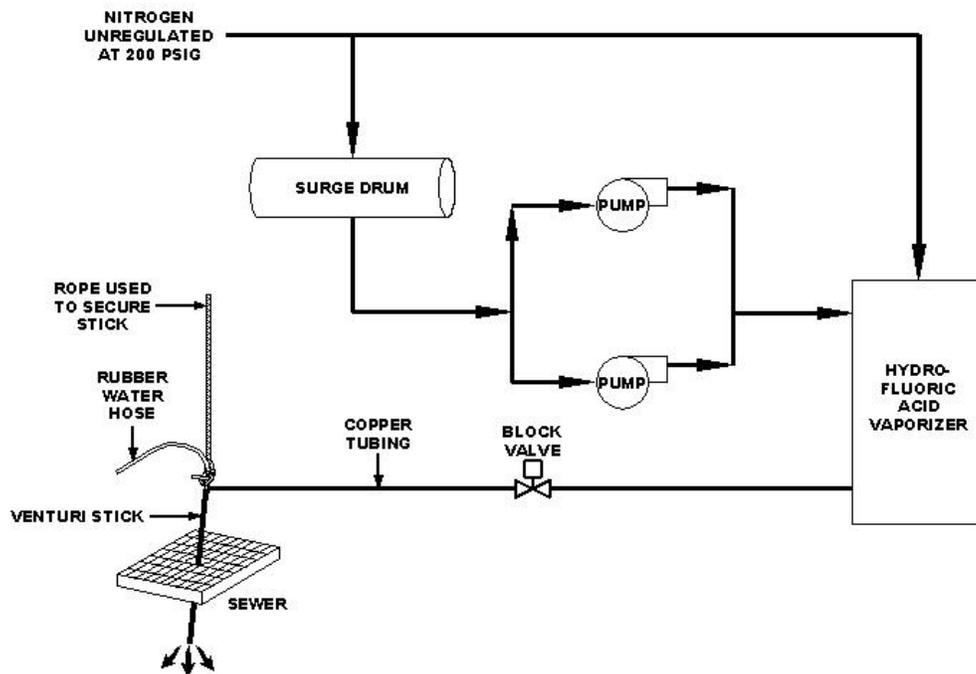
Figure 17. Simplified diagram of the setup to remove liquid hydrogen fluoride utilizing a venturi stick.

On August 12, the operations department set up a venturi stick to empty the G-22 HF vaporizer. Personnel fed plant nitrogen—with a 200-pound-per-square-inch gage (psig) supply pressure—to the equipment upstream of the vaporizer. They attached a venturi stick with copper tubing to the vaporizer, inserted it into the plant sewer, and attached a water hose to the end of the stick to draw the liquid hydrogen fluoride to the sewer (Figure 17). The venturi stick was tied off with a rope.

Once the system was in place, operations personnel began to empty the liquid hydrogen fluoride from the vaporizer. This draining operation continued into the next day, August 13. At approximately 9 am on that day, an operator monitoring the venturi process checked on its progress. The operator suspected a problem with nitrogen flow to the vaporizer, and opened and closed some valves to create a surge in the system and clear any blockage. Flow to the sewer rapidly increased, causing the venturi stick to lift out of the sewer—which created a cloud that likely contained hydrogen fluoride.
