U.S. CHEMICAL SAFETY AND HAZARD INVESTIGATION BOARD

## SUGAR DUST EXPLOSION AND FIRE

### IMPERIAL SUGAR COMPANY

Report No. 2008-05-I-GA  
September 2009

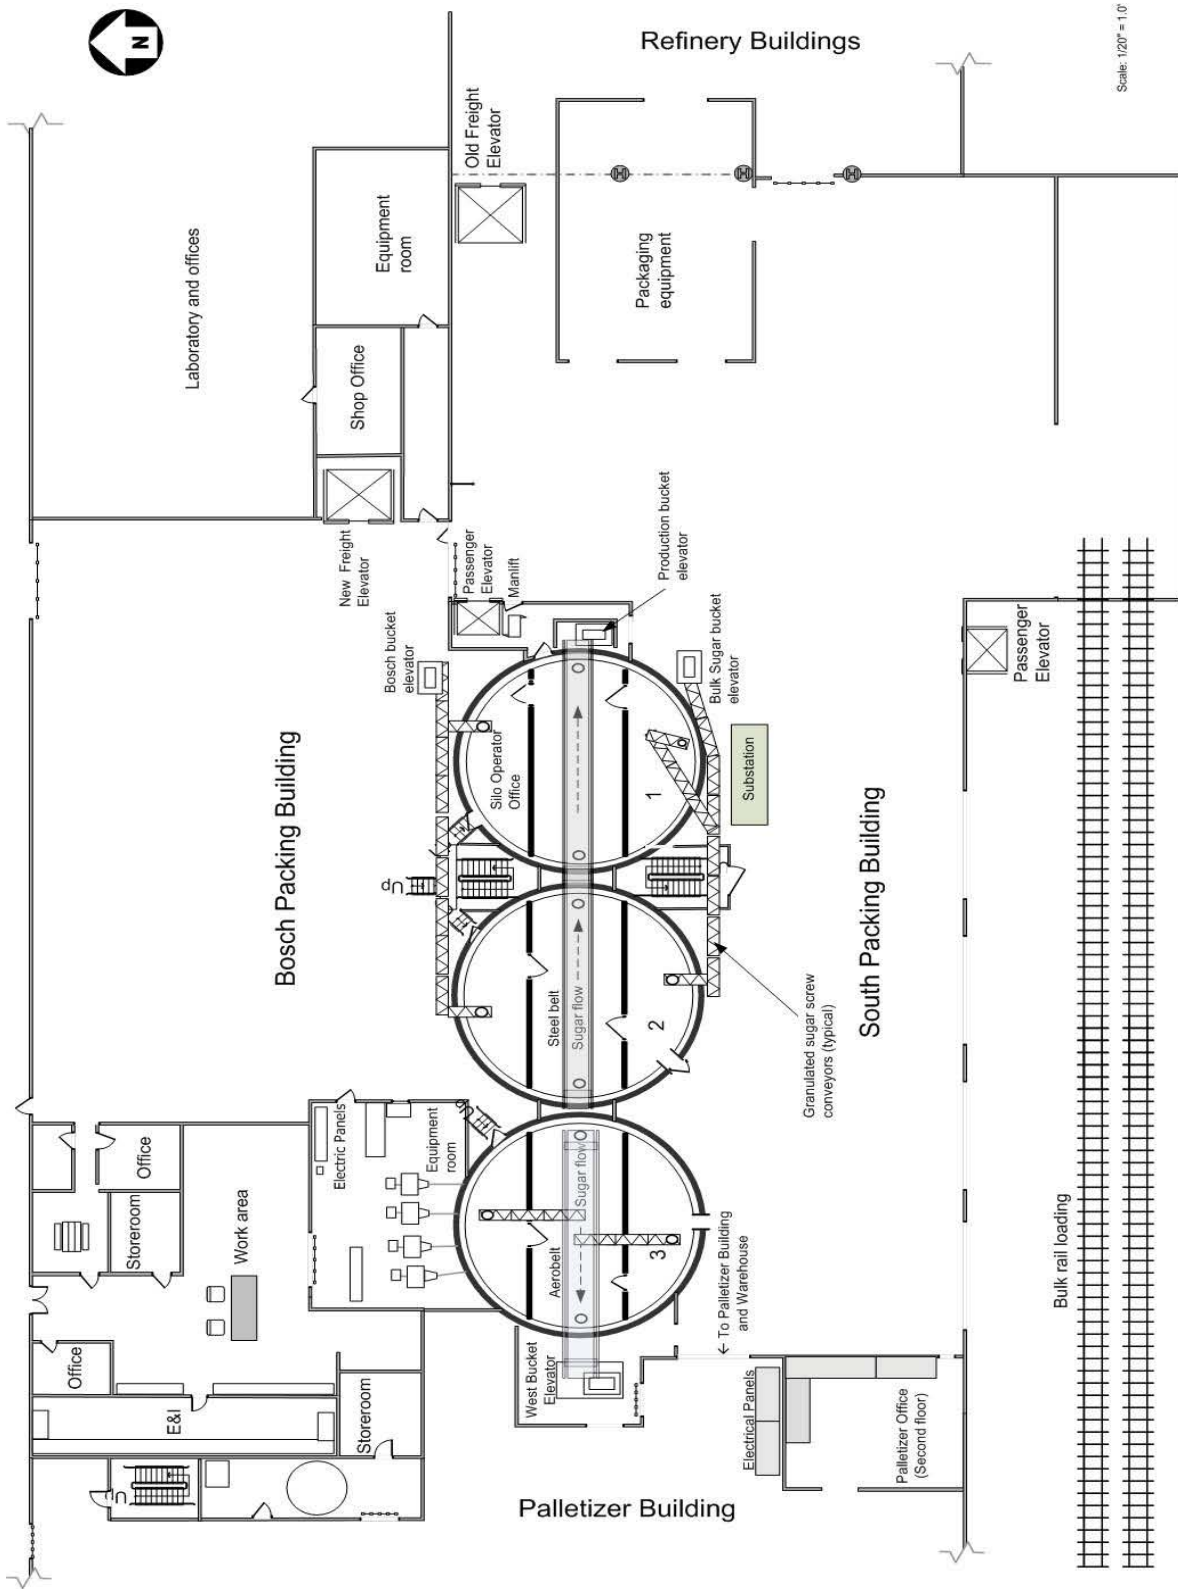
Figure 5. Packing buildings first floor plan

Dozens of screw conveyors,<sup>6</sup> bucket elevators,<sup>7</sup> and horizontal conveyor belts transported granulated sugar throughout the packing buildings (Figure 5). Although bucket elevators were enclosed and screw conveyors were covered, they were not adequately sealed to prevent releasing sugar dust and sugar into the work areas. Because the large open work areas were not equipped with airborne dust removal equipment, sugar dust accumulated on overhead conduit, piping, ceiling beams, lights, and equipment. The closed granulated sugar screw conveyors located throughout the facility were not

<sup>23</sup> Although the enclosure on the belt conveyors in the penthouse could have been designed to safely vent an explosive overpressure outside the building, designing a deflagration vent system for the belt conveyor in the silo tunnel was impractical. That conveyor was located on the ground floor in the center of the building (Figure 5) far from any building exterior wall or roof.

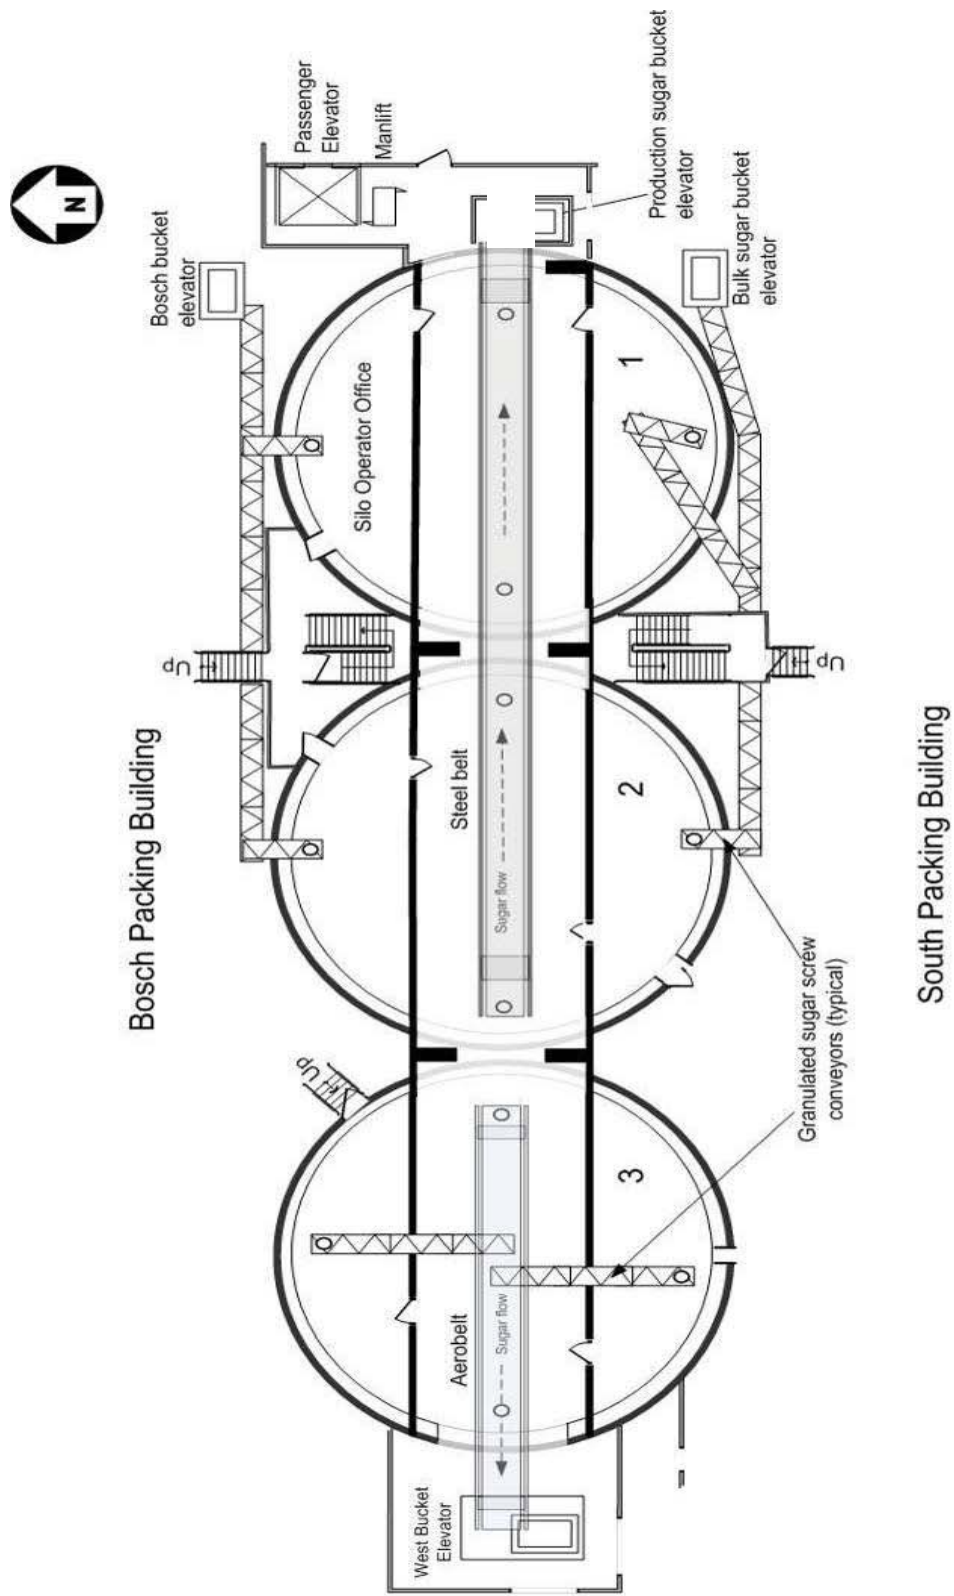
Figure 6. Silo tunnel and conveyor plan

Three 40-foot diameter, 105-foot tall concrete silos conditioned and stored the granulated sugar produced in the refinery. Each 5-million pound capacity silo sat on a raised circular concrete foundation above the packing building floor. Two belt conveyors were located under the silo floors in a 130-foot long tunnel, which was 7 ½ feet tall and 12 feet wide (Figure 6).

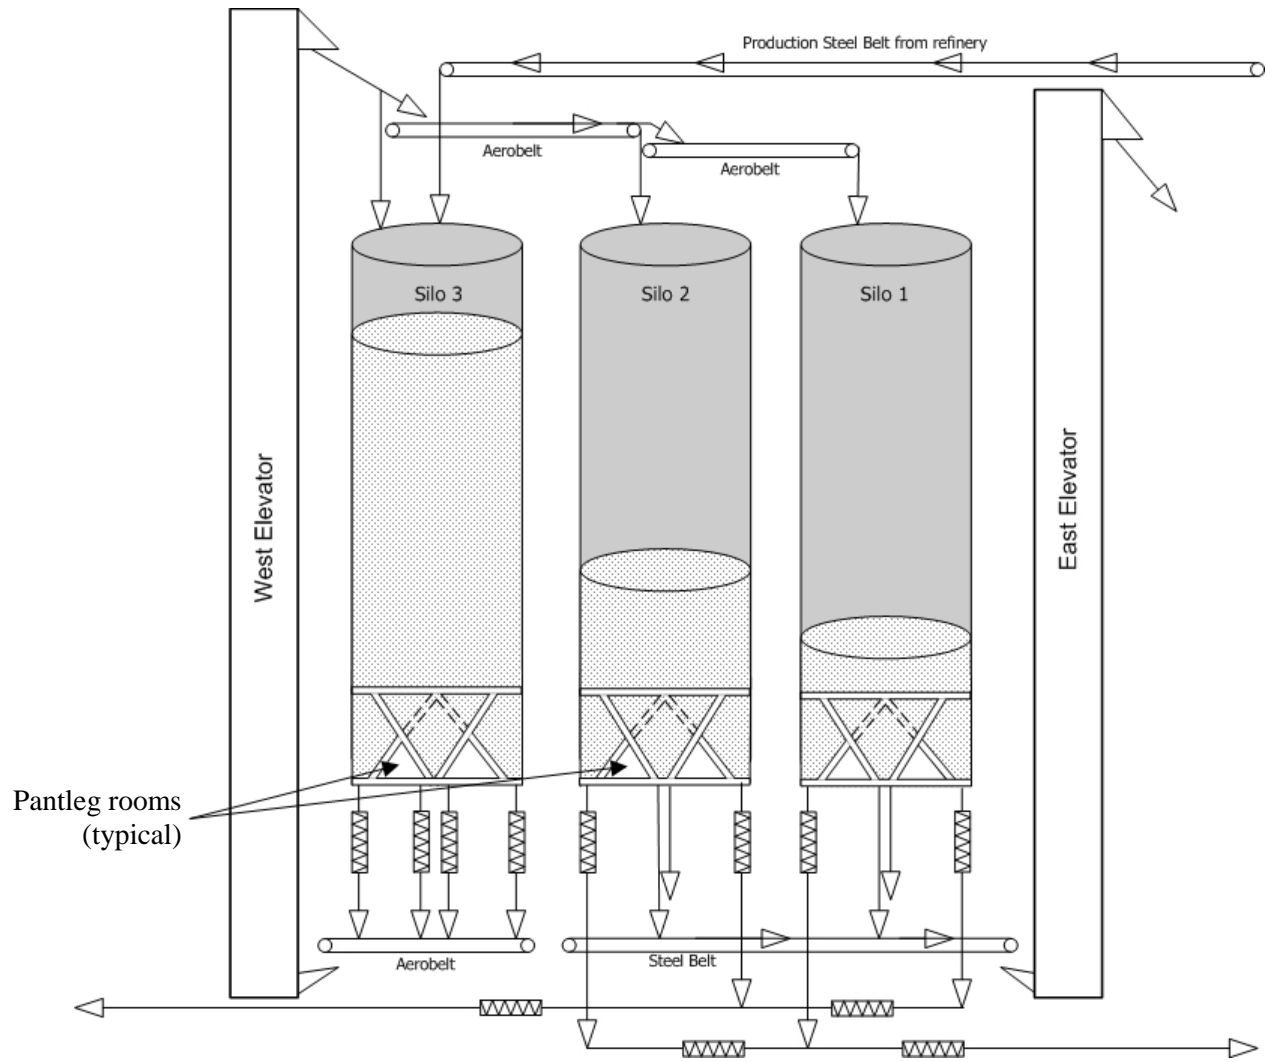
Figure 7. Granulated sugar supply and discharge through the silos

Sugar exited silo 3 into an Aerobelt<sup>® 8</sup> conveyor in the silo tunnel, which discharged the sugar into the west bucket elevator pit. The bucket elevator lifted the sugar to the penthouse and onto another series of conveyor belts, into silos 1 and 2 (Figure 7 and Figure 8). Granulated sugar exited two 18-inch diameter penetrations in the floors of silo 1 and 2 onto a steel conveyor belt in the silo tunnel. Separate 18-inch diameter floor openings fed sugar to the screw conveyors under the north and south quadrants of each silo. Various conveyors and bucket elevators distributed the sugar to the powdered sugar mills, the packaging equipment, and the bulk sugar building.<sup>9</sup>

above the silo tunnel (pantleg rooms, see Figure 7) and concluded that the primary dust explosion most likely occurred in the silo tunnel, approximately midway along the length of the steel belt.
