Ethylene Release and Fire at Kuraray America, Inc. EVAL Plant

Pasadena, Texas | Incident Date: May 19, 2018 | No. 2018-03-I-TX

Investigation Report

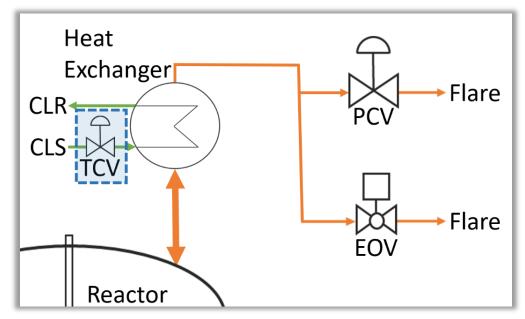
Figure 10. Temperature Control Valve. (Credit: CSB)

At approximately <u>7:00 a.m.</u>, Supervisor 1 checked on the process status by reviewing some of the displays at one of the computer control system workstations. During this review, Supervisor 1 recognized the low reactor temperature inside EVAL Reactor 2 and instructed Board Operator 1 to stop circulating chilled liquid through the heat exchanger by closing the temperature control valve (**Figure 10**). **Figure 10** shows an excerpt from **Figure 6** that highlights the chilled liquid temperature control valve (blue dashed-line rectangle).

At <u>7:00 a.m.</u> on the morning of May 19, 2018, when Supervisor 1 saw the low temperature inside EVAL Reactor 2 (17°F), he instructed Board Operator 1 to stop circulating chilled liquid through the heat exchanger by closing the temperature control valve (**Figure 10**). The supervisor had seen this situation before, and the low reactor temperature did not present a safety concern, in his opinion. When speaking to CSB investigators about the low-temperature condition in EVAL Reactor 2, he said:

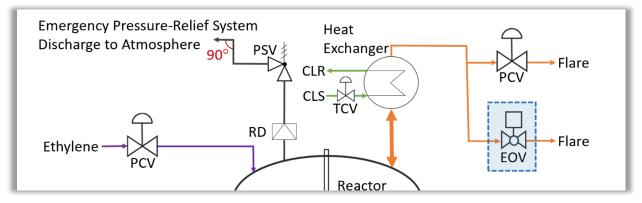
Figure 13. Emergency Open Valve to Flare. (Credit: CSB)

that Kuraray operators could have used to direct vapor from the reactor to the flare to reduce the pressure inside the reactor further.

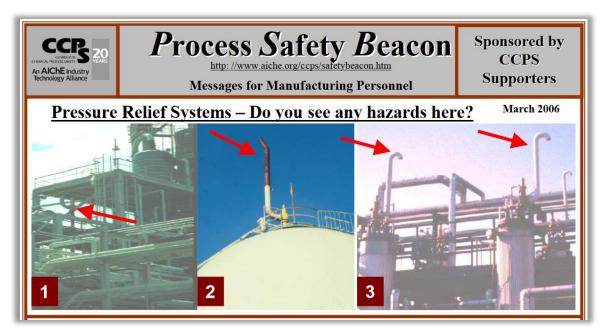
Figure 26. March 2006 Process Safety Beacon. (Credit: CCPS [78])

Any material which could be released from process equipment, including pressure relief valves or rupture disks, must discharge to a safe location. Relief devices often discharge to a 'convenient' location – and that may not be the same as a 'safe' location [78]!

The safety publication highlighted the importance of discharging to a safe location by showing a picture (**Figure 26**) of elevated emergency pressure-relief system outlet piping directed toward the ground.

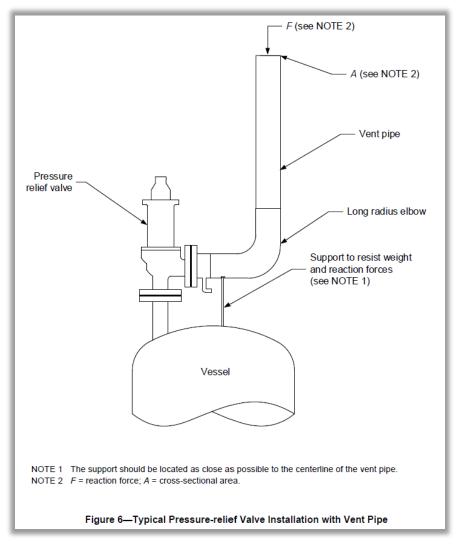
Figure 27. Vertical Outlet Piping. (Credit: API [80, p. 8, 81, p. 9])

in **Figure 27**, for atmospheric discharge, API 520 demonstrates that the piping should be aimed vertically upward [80, p. 8, 81, p. 9]. API 520 used the image in **Figure 27**, showing outlet piping aimed vertically upward, to inform users of the general design requirements for emergency pressure-relief system outlet piping.

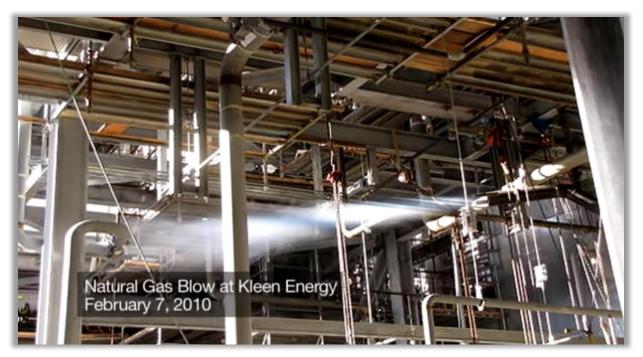
Figure 28. Horizontal Natural Gas Blow at Kleen Energy. (Credit: CSB [83])

The incident occurred during the planned cleaning of fuel gas piping, part of the commissioning and startup phase of the Kleen Energy project. At the time of the incident, workers were conducting a "gas blow," whereby natural gas was forced through the piping at high pressure and volume to remove debris [82, pp. 2-3]. **Figure 28** shows the horizontally aimed discharge of natural gas during a gas blow at Kleen Energy. Like the outlet piping from the EVAL Reactor 2 emergency pressure-relief system, the gas blow piping did not discharge flammable gas to a safe location. At the exit of the horizontally aimed piping, the cleaning operation intentionally discharged the natural gas (and debris) into the air [82, p. 11].

Figure 30 shows the vertical discharge of natural gas during a gas blow at Kleen Energy on January 30, 2010, one week before the incident [82, p. 5].^a The brown color is from the piping debris. The natural gas that propelled the debris out of the piping was colorless. Workers conducted multiple gas blows to clean the piping. With each successive gas blow, the amount of debris and the color of the release decreased. Although most of the gas blows at Kleen Energy discharged natural gas and debris vertically upward (**Figure 30**), the gas blow that resulted in the explosion on February 7, 2010, was a horizontally aimed discharge (**Figure 28**) [82, p. 2].

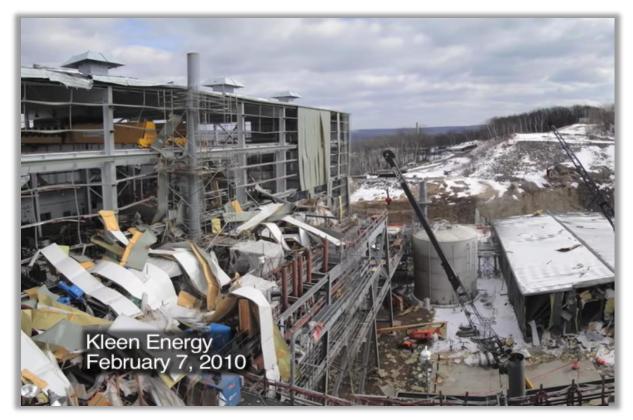
Figure 29. Explosion Damage at Kleen Energy. (Credit: CSB [84])

Figure 29 shows a portion of the Kleen Energy facility that was heavily damaged when flammable gas (used to clean piping) was discharged into the air horizontally, ignited, and exploded. This release of natural gas into the air was similar to an atmospheric discharge from an emergency pressure-relief system.

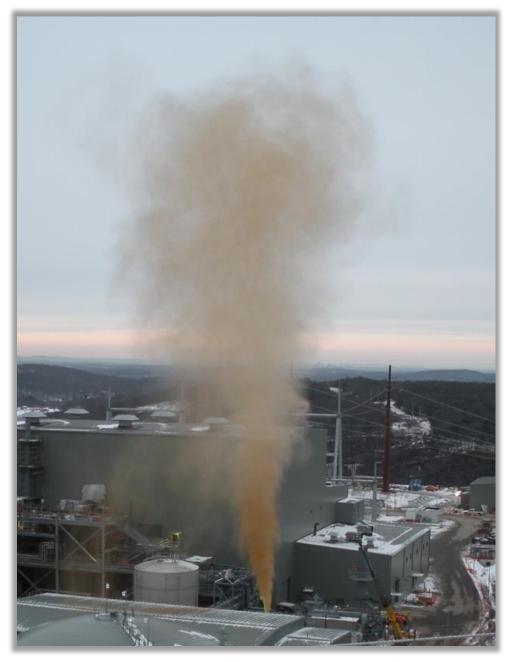
Figure 30. Vertical Natural Gas Blow at Kleen Energy.^a (Credit: CSB [83])

^a Although the gas blow show in **Figure 30** did not ignite, the release discharge point may not have been sufficiently elevated to be considered as discharging to a safe location.

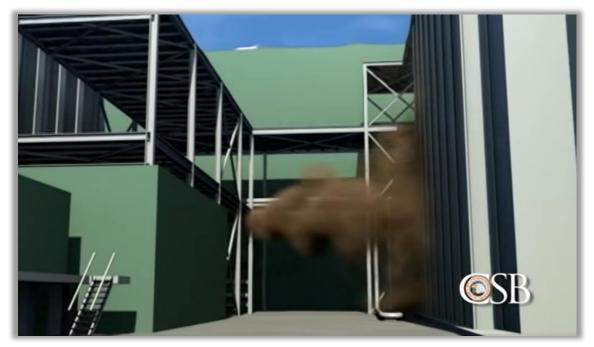
Figure 31. Animation of Horizontally Aimed Gas Blow. (Credit: CSB [83])

At the time of the explosion, workers were blowing natural gas into the air from open-ended piping between two large structures known as heat recovery steam generators [82, p. 2]. This location, though outdoors, was congested by the surrounding power generation equipment. **Figure 31** is an image from <u>Deadly Practices</u>, a CSB safety video, showing how the horizontally aimed discharge of flammable gas in a congested area led to the explosion at Kleen Energy.

Like the outlet piping from the EVAL Reactor 2 emergency pressure-relief system, the gas blow piping was installed in a horizontal orientation and did not discharge the flammable gas to a safe location. At Kleen Energy, both the congested area and the vent pipe's horizontal orientation likely adversely affected the dispersion of the natural gas [82, p. 2].

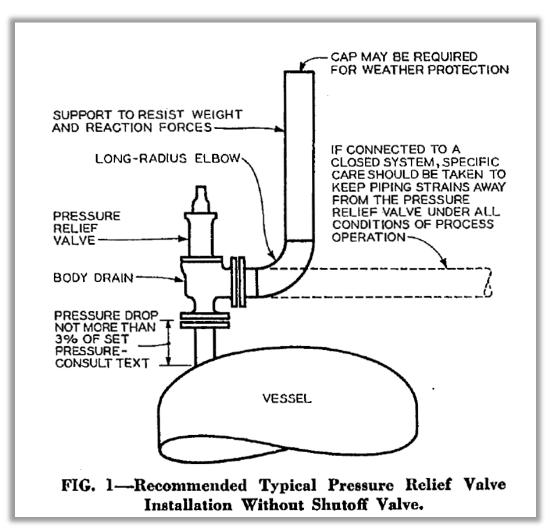
Figure 35. Emergency Pressure-Relief System Piping. (Credit: API)

Although API 521 guided users on outlet piping configuration, the industry standard also referred readers to API 520. API 521 stated that piping "installation details should conform to those specified in API Recommended Practice 520, Part II" [127, p. 44]. **Figure 35** shows that even the 1963 and 1973 editions of API 520 recommended aiming the outlet piping from emergency pressure-relief systems vertically upward [126, p. 5].
