U.S. Chemical Safety and  
Hazard Investigation Board

# Pressure Vessel Explosion at Loy-Lange Box Company

St. Louis, MO | Incident Date: April 3, 2017 | No. 2017-04-I-MO

## Investigation Report

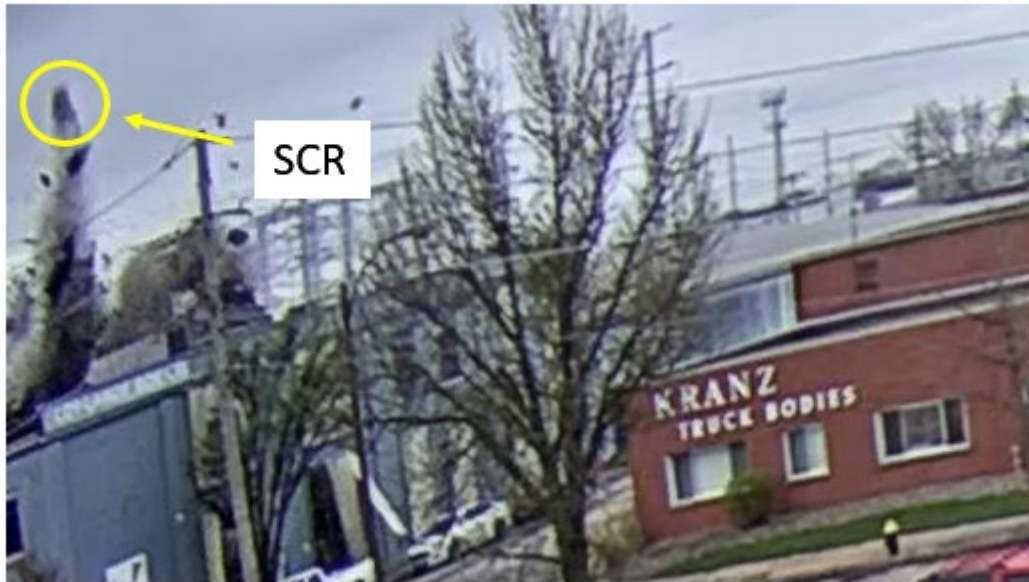
On Friday, March 31, 2017, Loy-Lange stationary engineers observed a leak that appeared to be coming from underneath the SCR. One stationary engineer took photos of the underside of the vessel to confirm the leak. Another contacted a local welding company and requested that it assess the vessel and make a repair recommendation. The welding company was not available to visit the Loy-Lange facility until the following Monday, April 3, 2017. Loy-Lange continued operating the leaking pressure vessel throughout the remainder of the Friday production schedule and shut down the steam system as normal that evening. The following Monday a Loy-Lange stationary engineer began his normal start-up routine at about 6:00 a.m. At around 7:20 a.m. on April 3, 2017, the SCR bottom head catastrophically failed. The SCR was launched from the Loy-Lange building and into the air (**Figure 9, Figure 10**).

Figure 9. Surveillance video still capturing explosion. (Credit: Kranz Body Co., annotations by CSB)

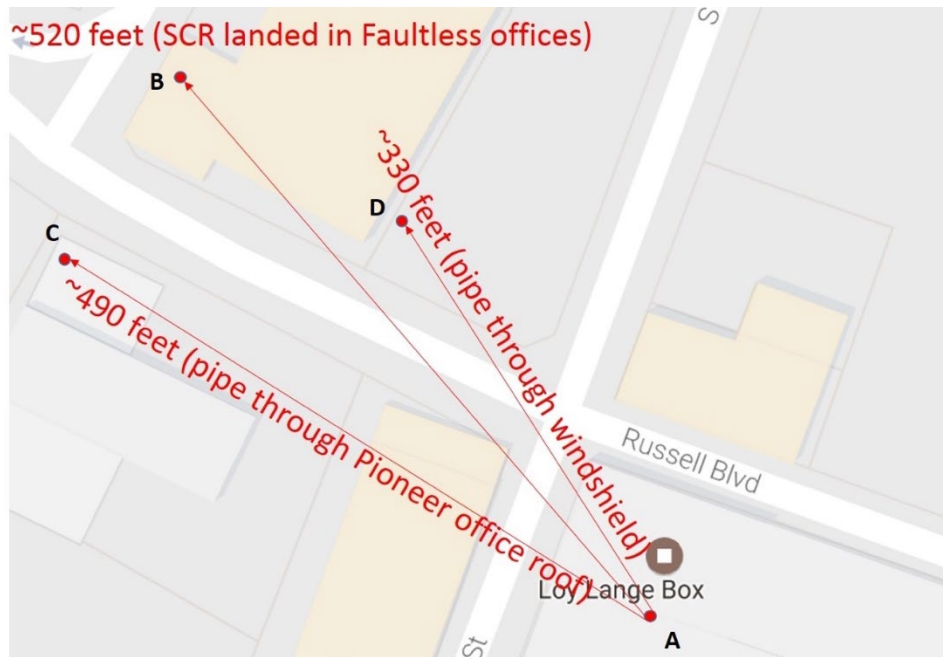
The vessel remained airborne for approximately 10 seconds<sup>a</sup> and traveled laterally approximately 520 feet (**Figure 11A, Figure 12**). The SCR fell through the roof of the nearby Faultless Healthcare Linen company one block away, where it came to rest (**Figure 11B**). Various other pieces of debris from the explosion also fell into the surrounding area. A third building in the vicinity, owned by Pioneer Industrial Group, suffered damage when a large piece of pipe from the Loy-Lange explosion punctured the roof and ruptured its water sprinkler system

Figure 12. Debris map from incident. (Credit: Google, annotations by CSB)

As shown below in **Figure 29**, the Loy-Lange facility was located in an urban area, less than two miles south of downtown St. Louis. As shown in **Figure 12** the Faultless Healthcare Linen Company, where the SCR came to rest, was located roughly 520 (less than one quarter mile) feet from the Loy-Lange facility.

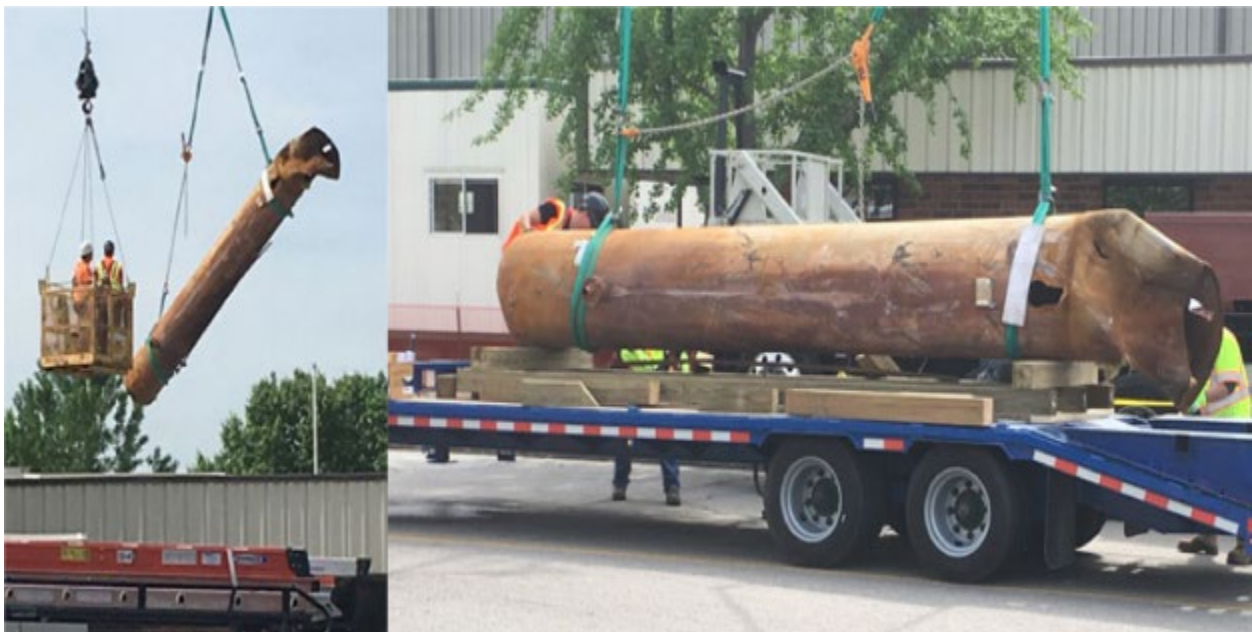
Figure 13. Removal of the SCR from Faultless Healthcare Linen facility. (Credit: CSB)

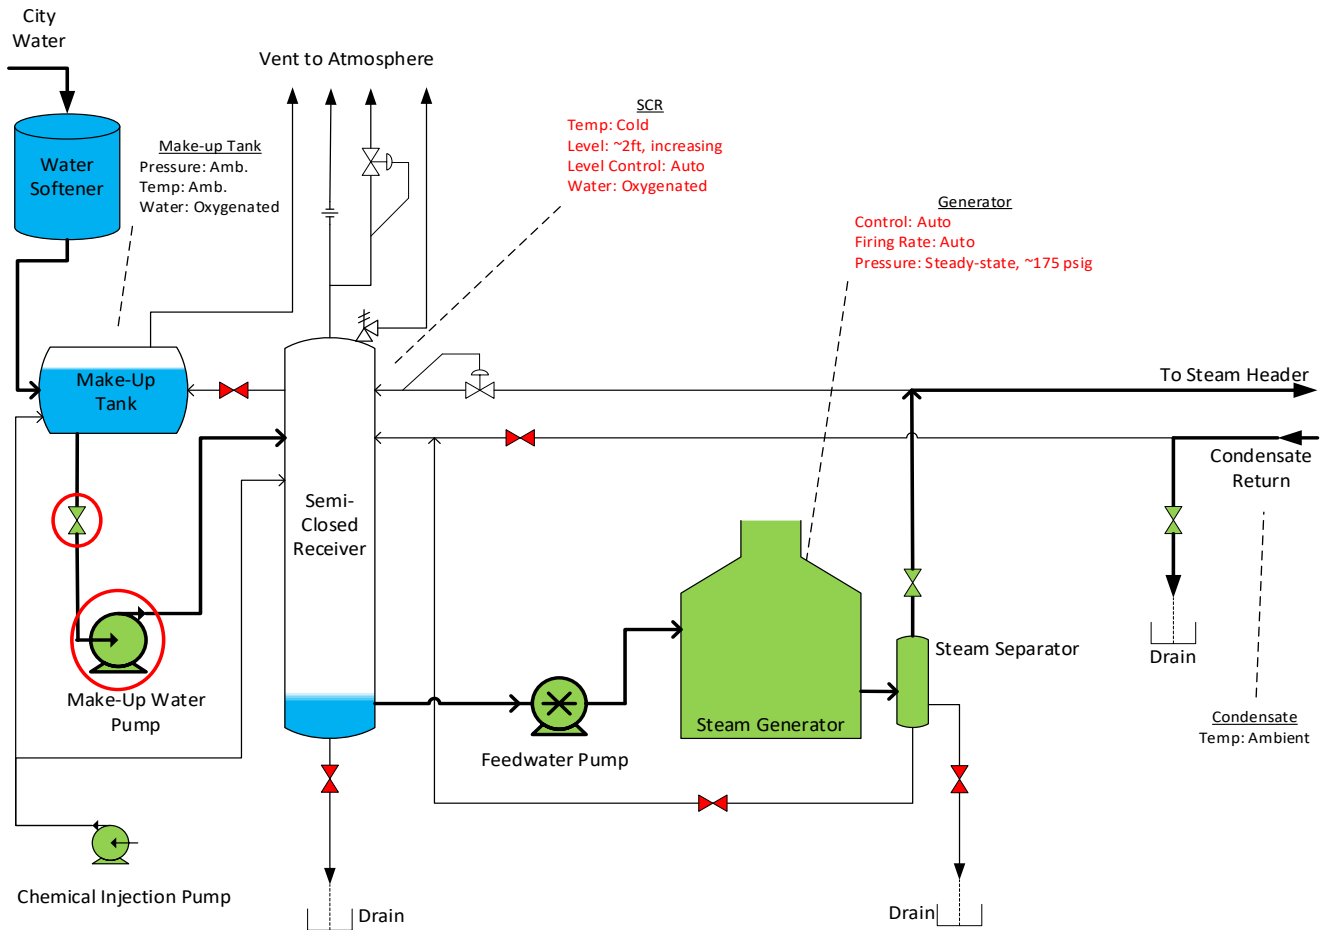
6. Once the SCR was nearly empty, operators placed the SCR level controller in automatic and opened the make-up water supply valve to the SCR. The level controller began calling for make-up water, which turned on the make-up water pump, refilling the SCR with make-up water (**Figure 25**). Because Loy-Lange claimed that its relevant records were destroyed in the explosion, the CSB could not review documentation or data<sup>a</sup> indicating that the make-up tank water was effectively heated by steam and mechanically deaerated—which would occur at temperatures between 190-200°F—before the water was introduced to the SCR. In the event the makeup tank was not heated to the requisite temperature before the water was introduced to the SCR, oxygenated water would be fed to the SCR at this point during the steam system startup operation.

**Figure 25.** Simplified process flow diagram illustrating the introduction of make-up water. (Credit: CSB)

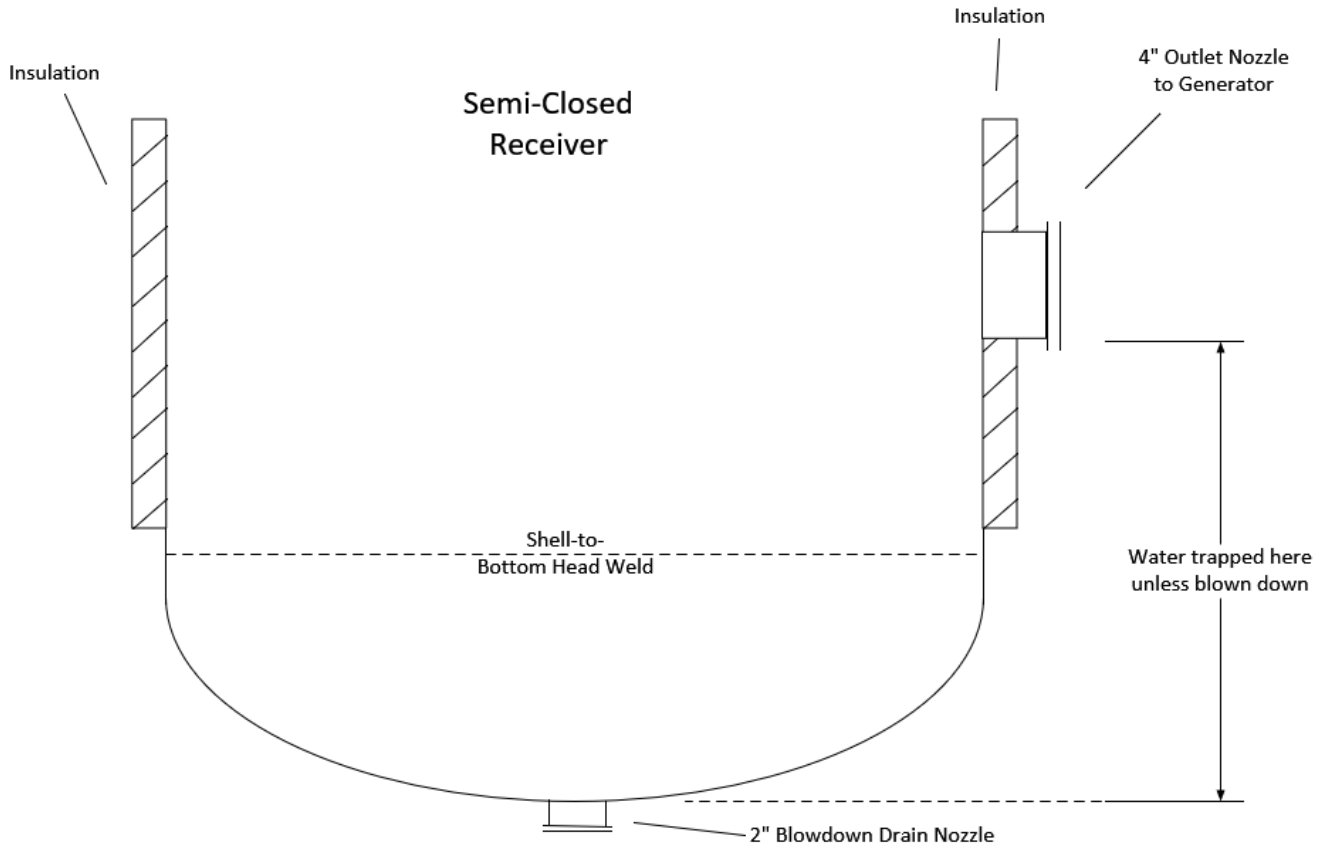
7. Eventually, operators routed the returning condensate back to the SCR instead of to drains (circled valves in **Figure 26**).
8. Unless operators performed a procedure called *blowdown* (see **Figure 27** and Section 1.7.3), a portion of water in the SCR below the outlet nozzle likely was trapped in the bottom head.

**Figure 27.** Conceptual diagram of the SCR bottom head. (Credit: CSB)

Water in the SCR bottom head remained stagnant during normal operation. To achieve flow in the bottom head of the SCR, operators had to manually open the drain line (blowdown) (**Figure 4, Figure 27**). Blowdown was intended by Clayton to drain precipitated solids produced by the water treatment chemicals. Clayton's 1995 operation manual recommended blowdown of the SCR weekly at minimum. In the absence of daily water tests, the manual requires a blowdown frequency of every 10-12 hours. Loy-Lange operators told the CSB that the vessel was rarely and irregularly blown down prior to 2012. In 2012, after the repair to the SCR bottom head (discussed in Section 1.3), they increased the blowdown frequency to weekly.

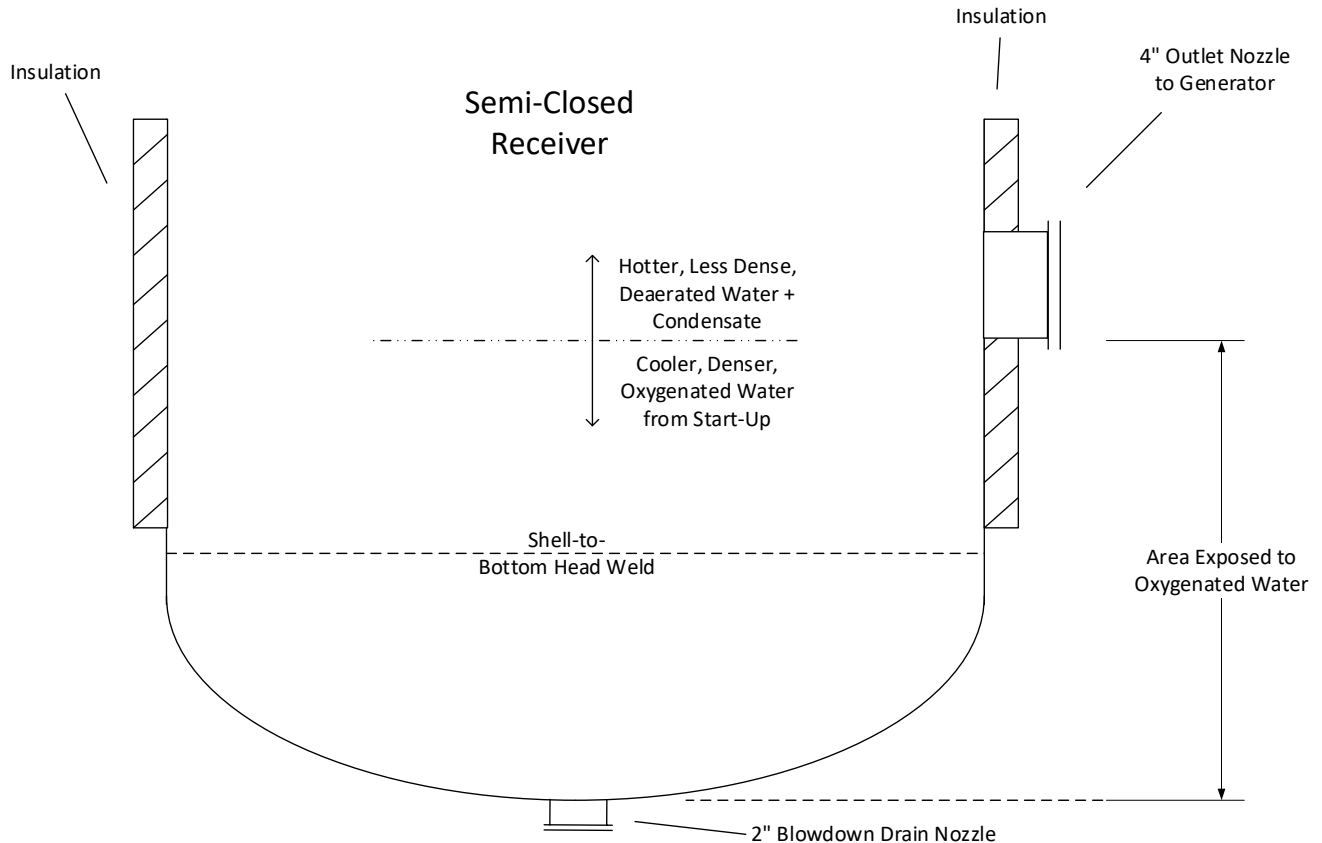
This oxygen, likely introduced into the SCR during daily startup operations, was the result of either insufficient mechanical deaeration, chemical deaeration, or both. Because the SCR bottom head trapped water below the SCR outlet nozzle (illustrated by **Figure 32**), some oxygenated water from startup would remain trapped at the bottom of the vessel until operators performed the weekly blowdown. Although blowdown was not expressly intended by Clayton to remove dissolved oxygen from the system (Section 1.7.3), given that oxygenated water likely remained trapped in the SCR bottom head, it is likely that blowing down the SCR daily after startup would have drained oxygenated water from the bottom head and filled it with treated water. The CSB concludes that Loy-Lange likely introduced oxygen into the SCR during its daily startup operation.

Figure 32. Conceptual diagram of the SCR bottom head. (Credit: CSB)

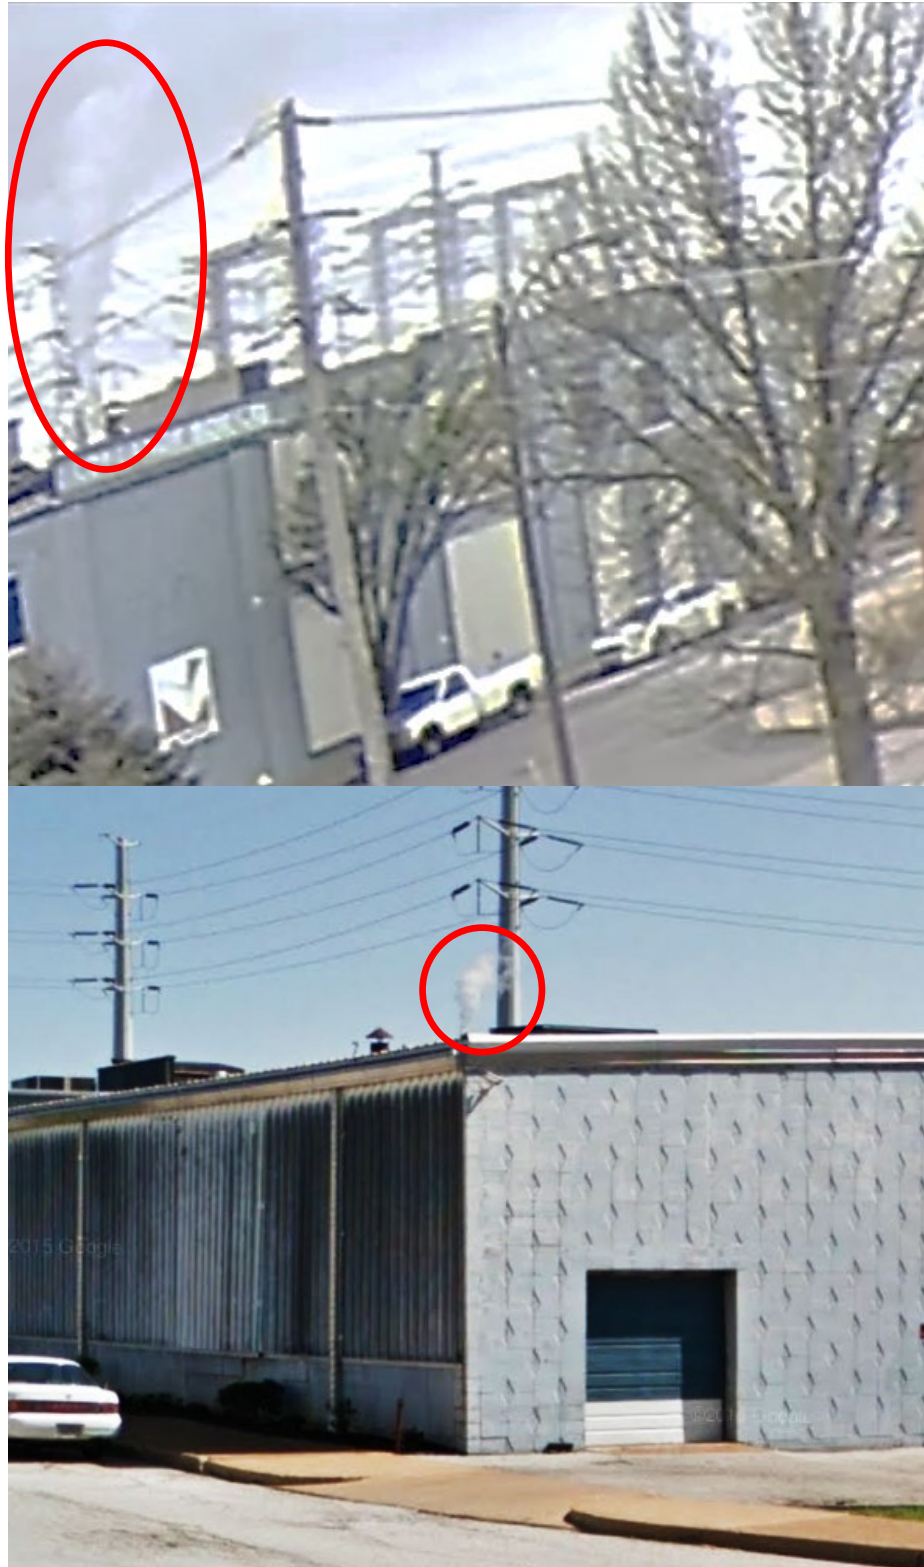
Evidence available to the CSB suggests that a steam system process upset may have occurred during the steam system startup on April 3, 2017. A surveillance video capturing the explosion shows a large plume of steam venting with high velocity from the roof of the building just before the incident (**Figure 36**, top). This steam plume appears substantially larger than the normal plume seen venting from the building historically.

For comparison, using Google Earth<sup>®</sup> and Google Street View<sup>®</sup>, the CSB evaluated historical images of the Loy-Lange facility. These images show a small white steam plume emanating from the roof of the facility, which may be from the normal venting of vapor during the deaeration process to remove dissolved gases [31]. One representative photo of the typical steam plume is shown in **Figure 36**.

One of the Loy-Lange stationary engineers confirmed to CSB investigators that the vapor venting from the roof of the facility immediately before the SCR rupture was abnormally large. After seeing the surveillance video, the stationary engineer said:

That was coming off awful hard. That sure looks like it's coming out faster than normal. [...] That's blowing out awful hard. That is much larger than I would have expected from it. [...] Normally, it's like a little wispy cloud [...]

**Figure 36.** Steam plume comparison. (Credit: Top: Kranz; Bottom: Google, edited and annotated by CSB)
