U.S. CHEMICAL SAFETY AND HAZARD INVESTIGATION BOARD

INVESTIGATION REPORT

TOXIC CHEMICAL VAPOR CLOUD RELEASE

REPORT NO. 2004-09-I-GA

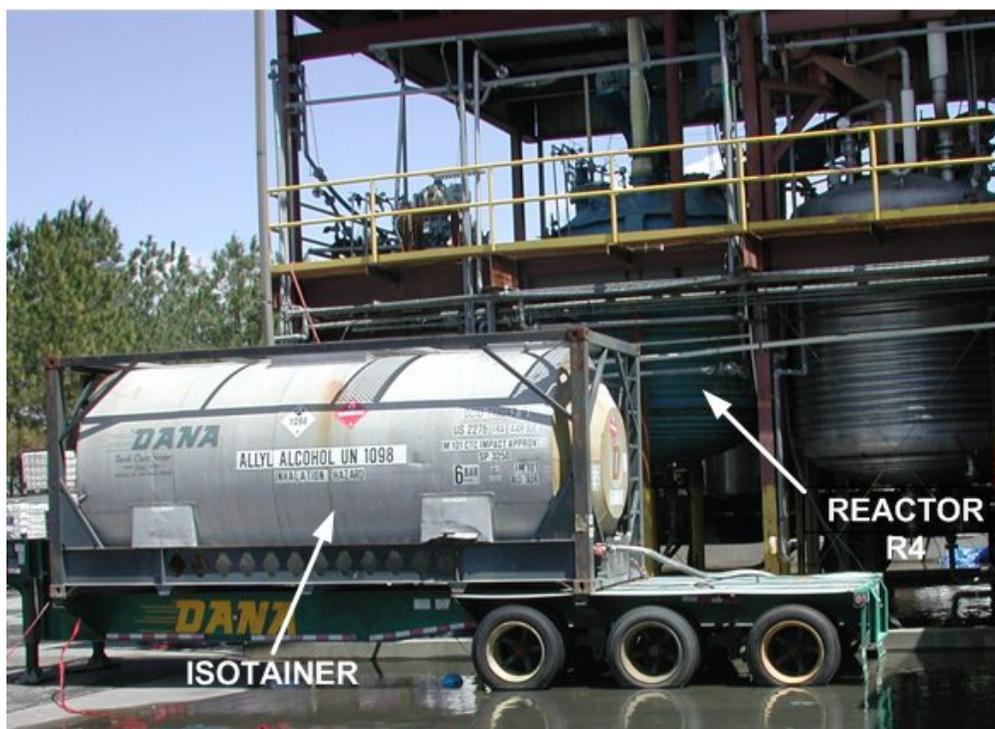
Figure 2. Isotainer (tanker) used to ship 35,000 lbs of allyl alcohol (looking east).

Lyondell maintains a product stewardship program⁵ for all hazardous chemicals that they manufacture. Three months before delivering the allyl alcohol, Lyondell personnel visited the MFG facility and conducted an assessment to evaluate the preparedness of MFG to handle a large quantity of allyl alcohol safely. Lyondell concluded that MFG could safely handle production quantities of allyl alcohol after they made improvements in fire suppression equipment, and provided additional personal protective equipment and training to employees who would be working with the chemical. On April 4, 2004, GPC issued a purchase order to Lyondell to supply 35,000 pounds (4940 gallons) of allyl alcohol to MFG. An isotainer of allyl alcohol arrived on April 12, 2004, a few hours before the incident occurred, and was parked adjacent to the reactor (Figure 2).

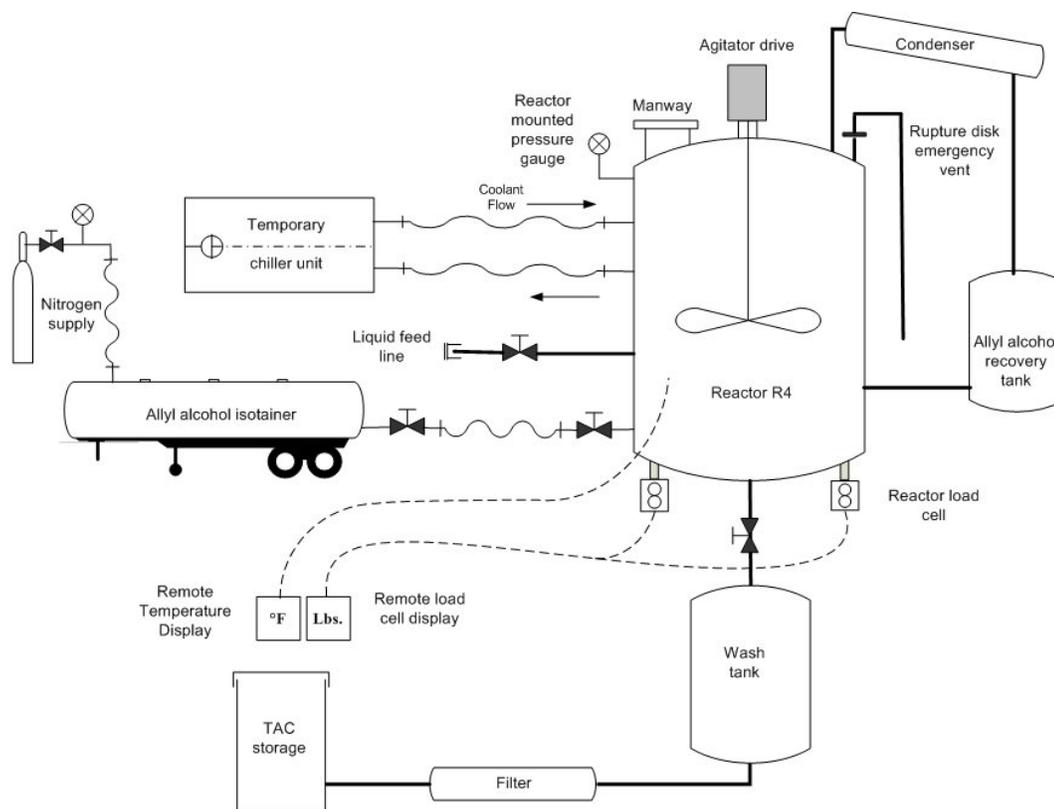
Figure 5. Basic TAC process diagram.

The operators loaded the dry-powder cyanuric chloride into the reactor on Friday, April 9, 2004 three days before the allyl alcohol and the temporary reactor cooling system arrived. They wore the personal protective equipment recommended on the MSDS. The reactor load cells on the reactor (Figure 5) measured the weight of the chemical specified in the procedure. The operators closed the reactor manway and installed some of the hold-down clamp bolts (Figure 6), after which a nitrogen gas blanket was established. The dry-powder chemical remained in the reactor throughout the weekend.

After a few minutes of transferring allyl alcohol into the reactor through the transfer piping, they concluded that it was going to require many hours to complete the transfer at the established flow rate. Because the procedure did not restrict the allyl alcohol fill-rate, the operators increased the nitrogen pressure to speed the transfer. At the higher flow rate, they completed the transfer in less than an hour. The operators closed both transfer-hose isolation valves, but left the hose attached to the equipment. The reactor agitator had been started sometime during the transfer operation to mix the chemicals (See Figure 5).

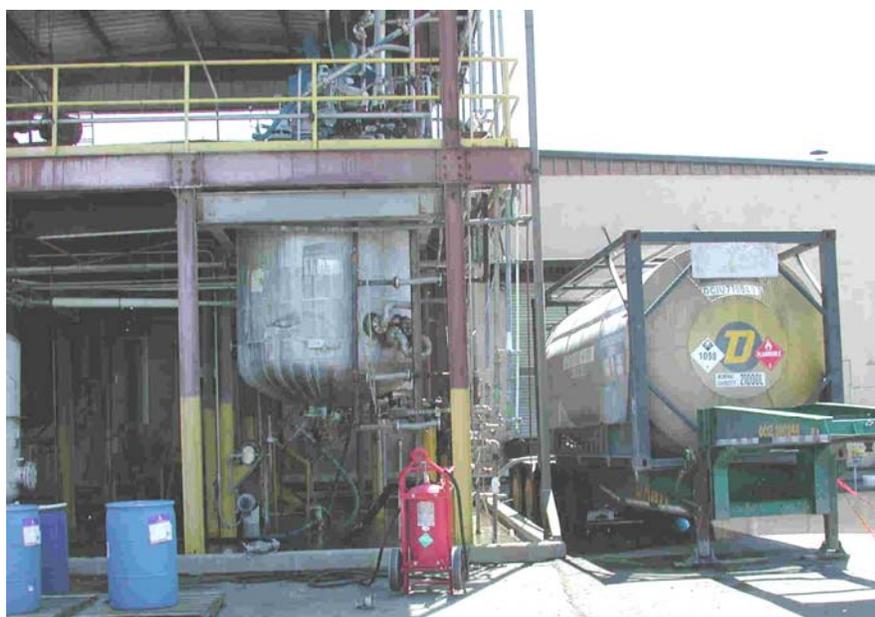
Figure 7. Isotainer (right) positioned adjacent to the process equipment.

The allyl alcohol isotainer arrived in the afternoon on Monday, April 12 and was parked adjacent to the reactor (Figure 7). The engineering and compliance manager met with the operators and discussed the precautions and personnel protective equipment required for the allyl alcohol transfer into the reactor. They then connected the transfer hose to the process piping. The operators concluded the chiller was providing sufficient cooling to the reactor because the reactor interior temperature reading was 32° F and the reactor cooling-jacket and chiller piping were frost covered. They were finally ready to proceed with the remaining steps in the procedure.

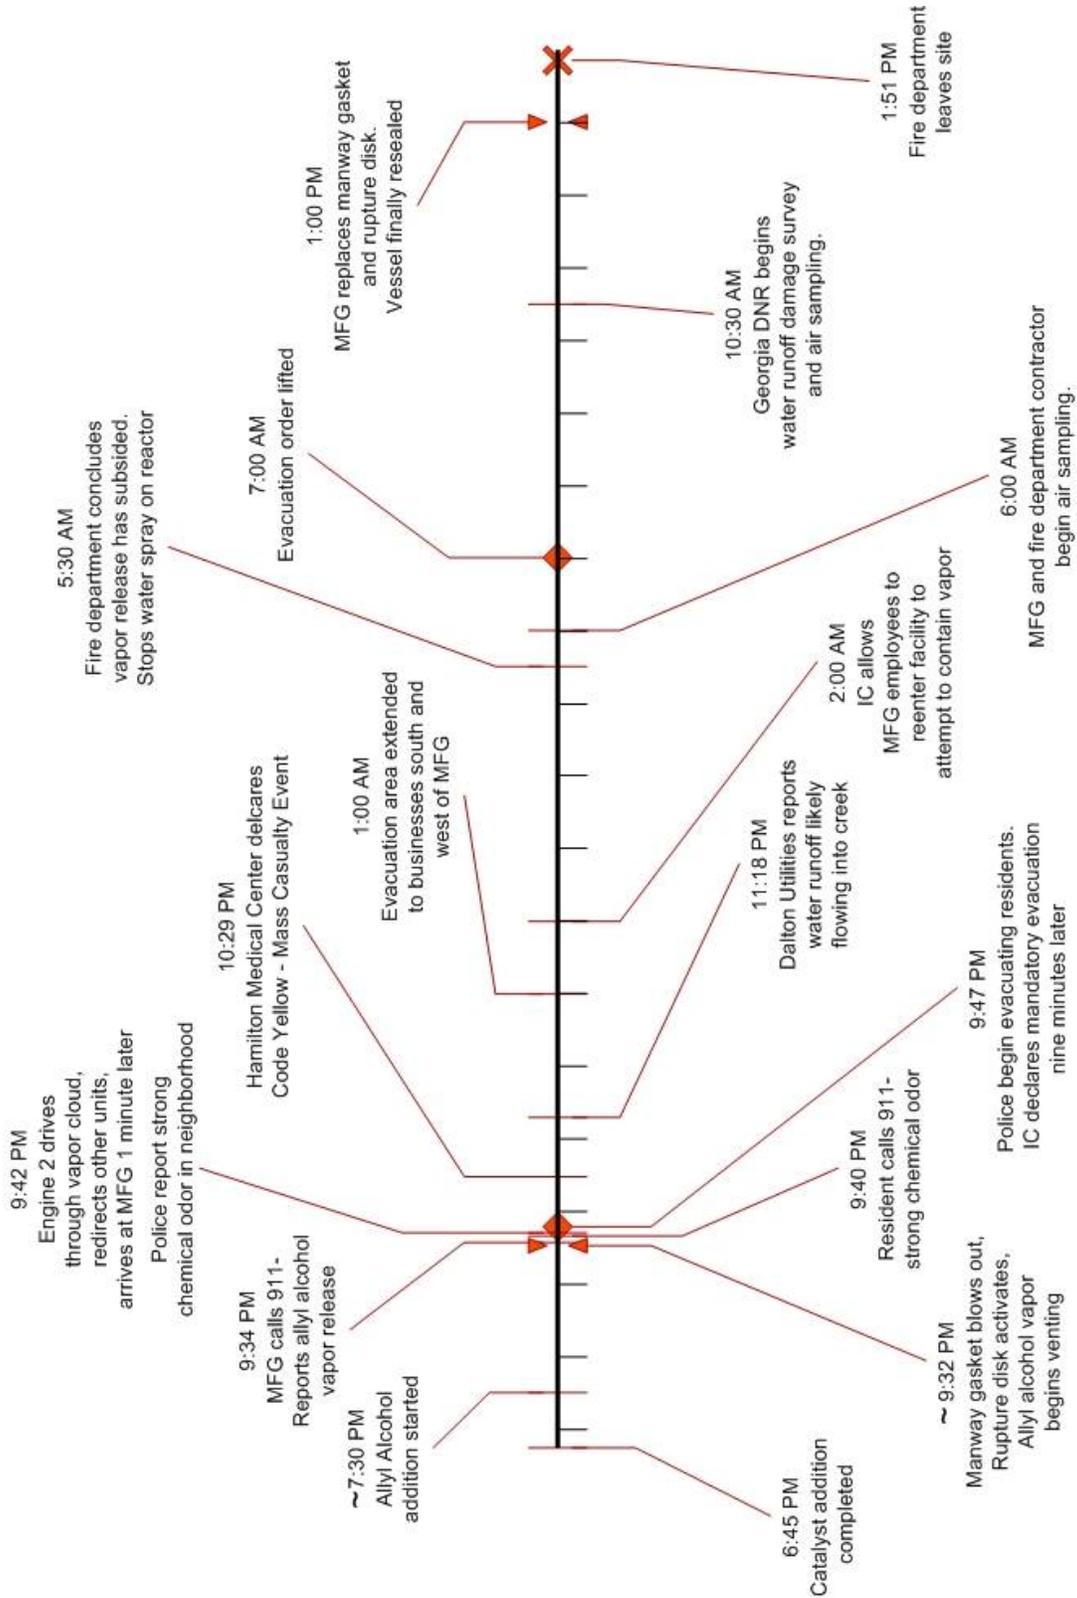
Figure 9. Event Timeline (Scale: 60 minutes / division).

The event timeline is shown in Figure 9. The following is a discussion of the significant events during the emergency response and community impact from the toxic vapor release.

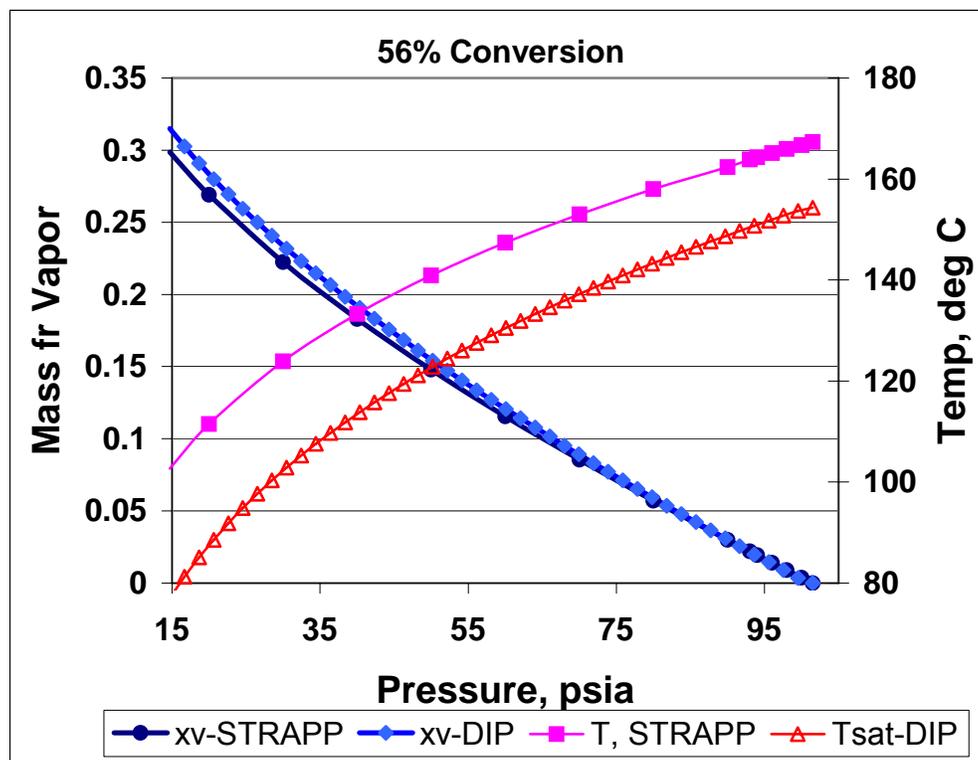
Figure 1. Flash Curves by STRAPP and DIPPR Properties

Next, the SafeSite3G™ and STRAPP models were used to develop a flash curve (Figure 1) for the initial conditions of the release. Two different models were required because the vapor liquid equilibrium properties of allyl alcohol and allyl chloride are distinctly non-ideal. The STRAPP model was used to determine the initial two-phase discharge rate using non-ideal vapor/liquid equilibrium correlations while the SafeSite3G™ model was used to predict the blowdown and dispersion.
