Investigation Report

Published: June 12, 2019

On January 22, 2018, a blowout and rig fire occurred at Pryor Trust 0718 gas well number 1H-9, located in Pittsburg County, Oklahoma. The fire killed five workers, who were inside the driller's cabin on the rig floor. They died from thermal burn injuries and smoke and soot inhalation. The blowout occurred about three-and-a-half hours after removing drill pipe ("tripping") out of the well.

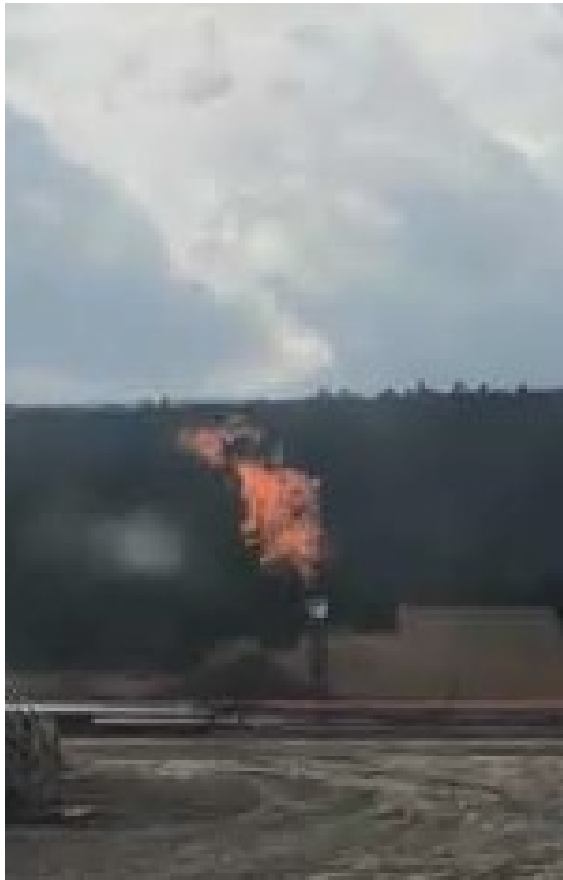
^f The CSB considered whether the flare might have been produced by “drilled gas,” which is gas contained in the drilled rock cuttings. The CSB concluded that the flare likely was not produced by drilled gas because during the two-and-a-half bottoms up circulations, most, if not all, drilled gas would be circulated out of the well. The flaring at 6:21 pm indicates the well was likely underbalanced.

Figure 9. Video still of flare at 11:10 am on January 21, 2018.

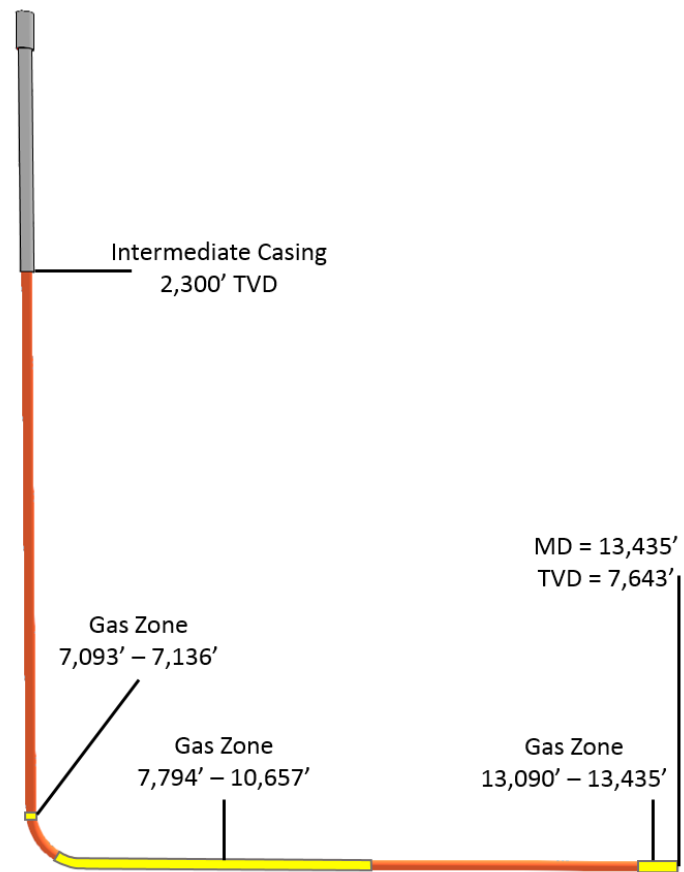
The well profile at this point is shown in Figure 10. Post-incident analysis of the well data shows that the 11,000 feet of uncased, open wellbore included three areas where some amount of gas had entered the well while drilling, as interpreted from measured gas units during the drilling operation and the flaring at the surface that occurred on January 21.

Figure 10. Areas where gas entered the wellbore while drilling.

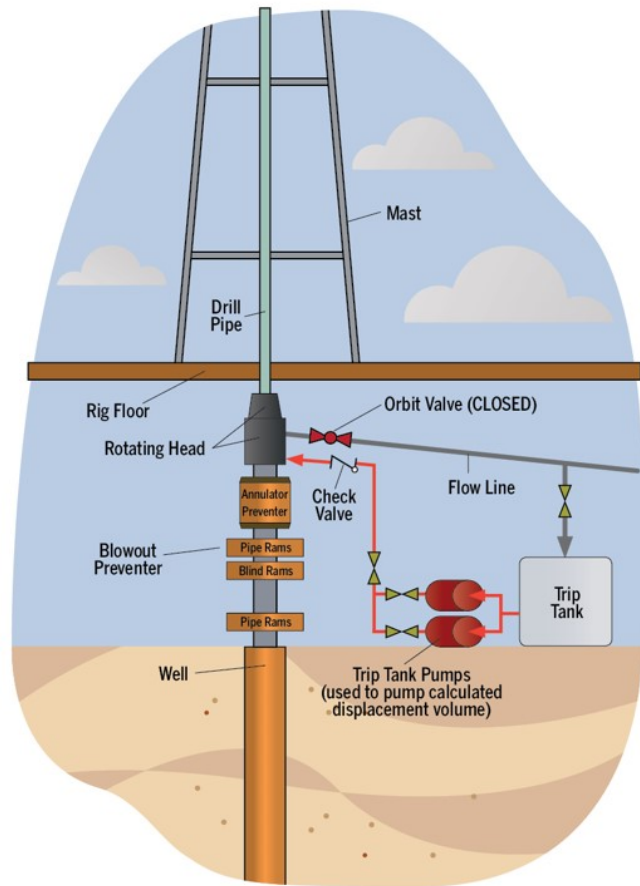
The Calculated Fill tripping method involved stopping all mud flow from the well by closing the *flow line isolation valve* (commonly called the *orbit valve* by Patterson, the drilling engineer, and the company man) with the pressure-containing *rotating head* installed. The plan was then to periodically pump a calculated volume of mud into the well with the intent to replace the calculated volume of the drill pipe removed by turning on and off the trip tank pumps (Figure 12). For example, for five drill pipe stands removed, the driller would need to pump 3.2 *barrels* of mud into the well to replace the drill pipe. The drilling engineer communicated to the CSB that, using this method, there was extra protection against gas influx into the well by, if needed, allowing surface pressure to build against the closed orbit valve and rotating head. The thinking was that if the well did flow, there would be no outlet for the mud, so this would keep the well contained.

Discussed below, by the time the drill bit reached the top of the curve, 20 barrels of mud less than the calculated drill pipe displacement volume had been pumped into the well. While the well appeared to be filled to the surface, the volume discrepancy is an indication that gas had entered the well, occupying this 20-barrel portion of the drill pipe displacement volume (Sections 5.1.2.1 and 5.1.2.2). The company man and drilling engineer were aware the well did not take proper fill, but the full extent of the discrepancy might not have been known because the driller had difficulties with the electronic trip sheet used to track the calculated drill pipe displacement against measured fill volumes during the tripping operation (Section 6.3).

Figure 12. Equipment configuration during Calculated Fill tripping method

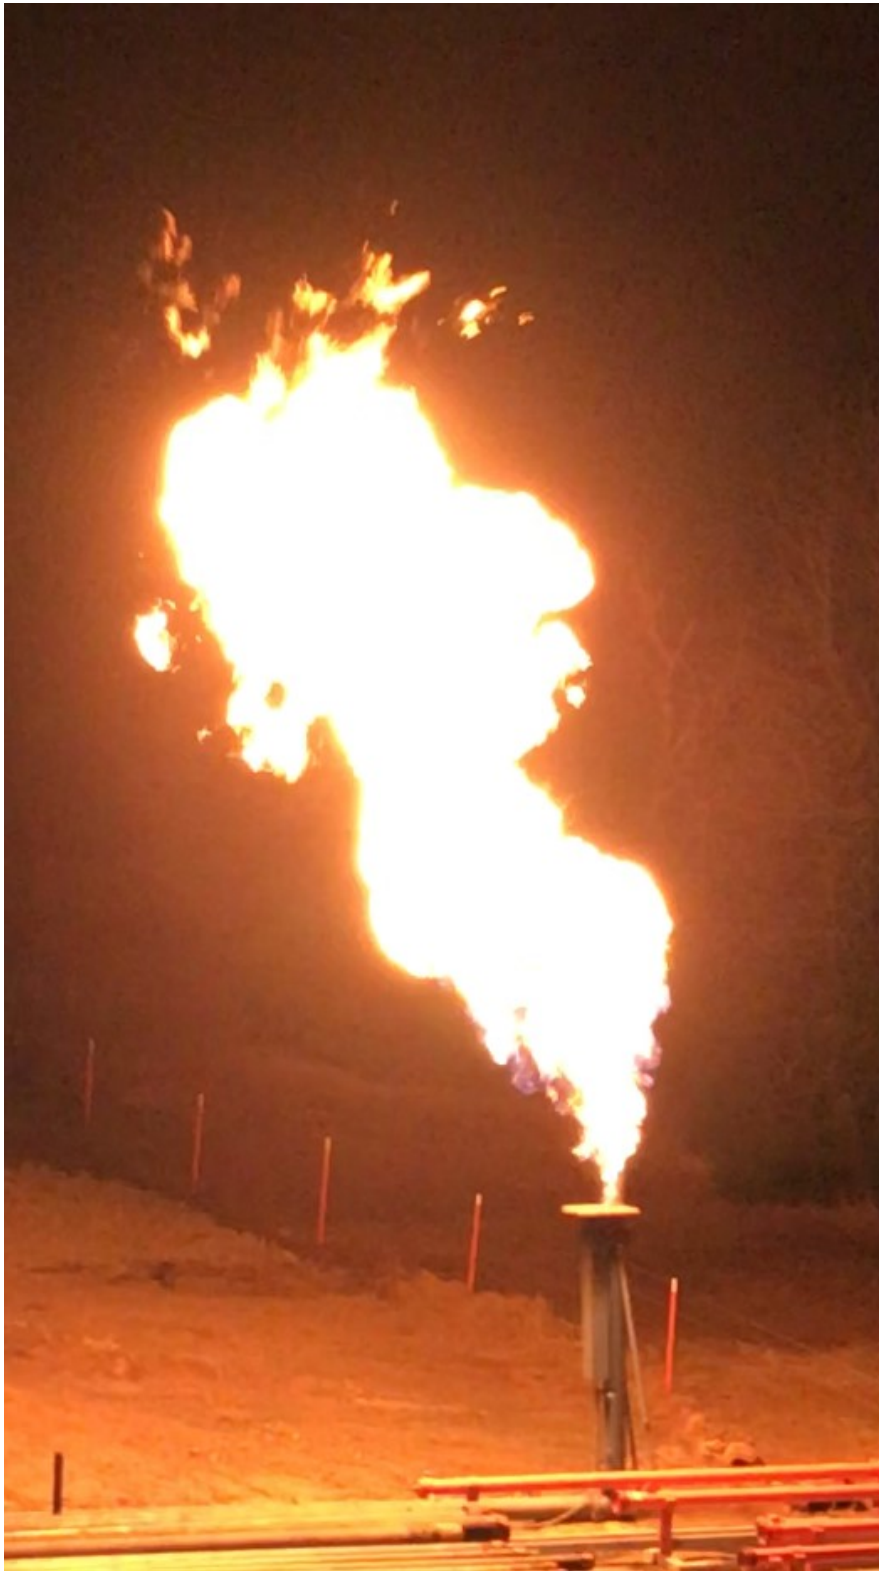
Accepting the indications of a successful flow check, the driller ramped up the mud pumps at 11:02 pm and proceeded with circulating the well by pumping mud down through the drill string with the mud returning to the surface and flowing through the flow line. The crew remembered the flare activating during this activity (Figure 19), indicating gas was coming out of the mud returning at the surface, and then going out at 6,700 strokes of the positive displacement mud pumps (11:57 pm)^a (Figure 20). Appendix F shows a comparison of Figure 20 with a circulation operation performed days earlier, illustrating the difference in the appearance of the data. While circulating, the slug that had been pumped into the drill pipe at about 6:30 pm before tripping exited the drill pipe and entered into the annulus, adding additional pressure to the well until the slug was circulated out of the annulus during the operation.

Figure 19. Image of flare from video captured at 11:06 pm on January 21, 2018.

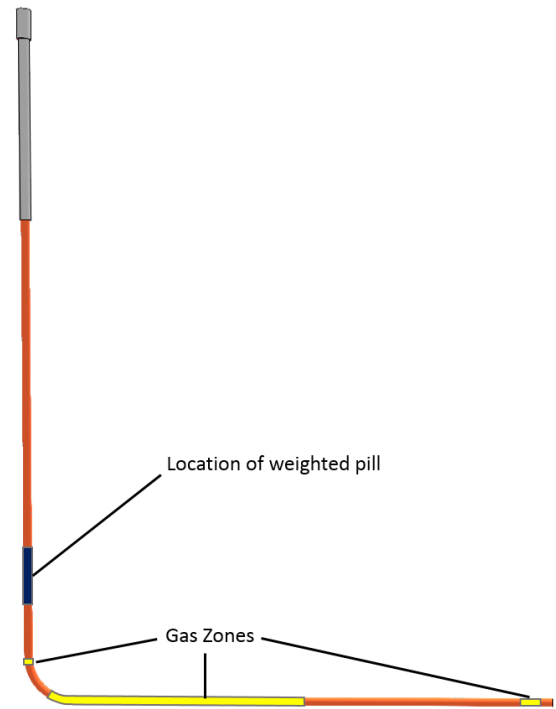
At 12:35 am, the drilling crew pumped 46 barrels of the pill into the drill pipe. Following the pill with mud, they pumped the pill out of the bottom of the drill pipe and into the annulus with the bottom of the pill at a depth of about 6,500 feet, and with the top of the pill at about 5,800 feet (Figure 21). Some of the pill material remained in the bottom of the drill pipe.

Figure 21. Depiction of well with gas zones and location of weighted pill.

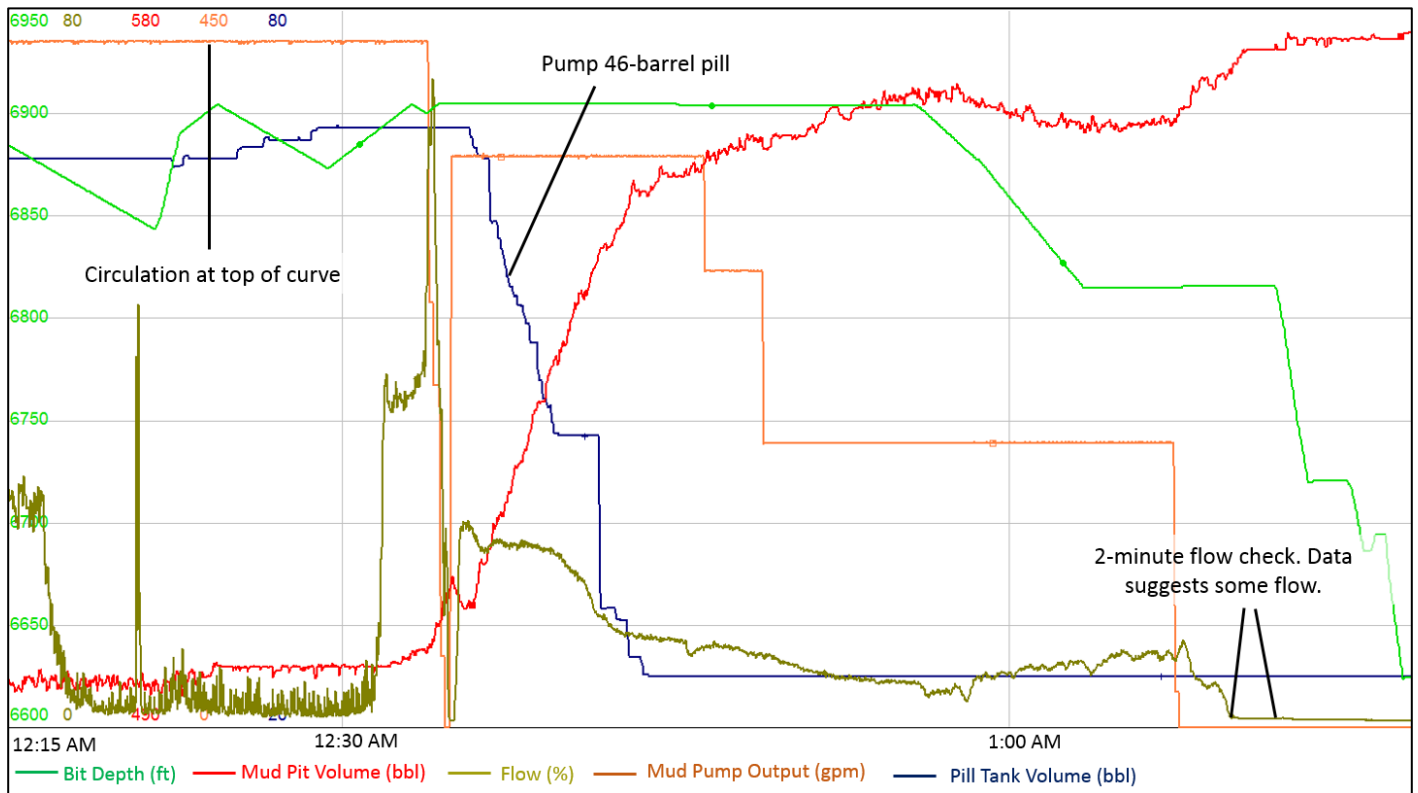
After spotting the pill, at about 1:10 am the crew performed a visual, 2-minute flow check. The flow check passed. However, the CSB could not verify that the crew observed no flow during this flow check. The return flow meter data indicates some very small flow (1% of the flowmeter scale) during this flow check (Figure 22). Despite the flow check result, gas was still entering or expanding in the well. The 50-barrel volume and 10-pound-per-gallon weighted pill did not produce the hydrostatic pressure necessary to prevent gas from entering the vertical portion of the well. After pumping the weighted pill, the well was still underbalanced and the primary well control barrier was still not in place (Section 6.5).

Figure 22. Data during pumping of pill and subsequent flow check.

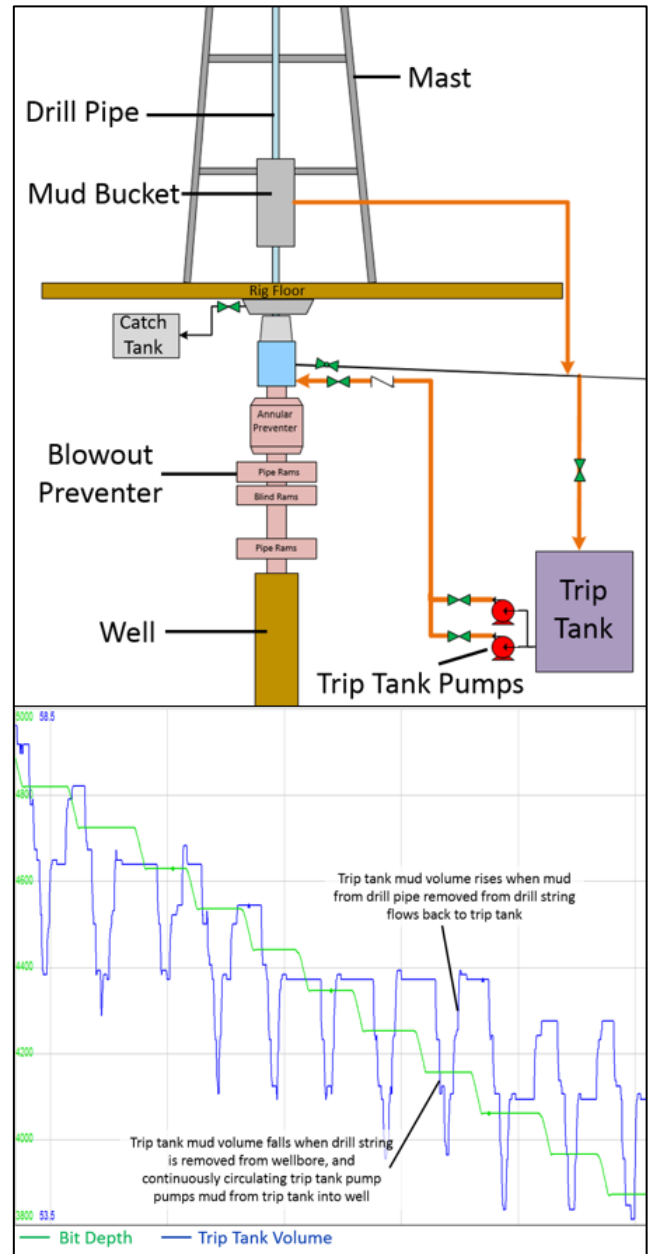
On Rig 219, the mud bucket discharge was routed to the trip tank. Level changes in the trip tank are a key indicator of mud gains or losses while tripping, and adding the mud into the trip tank from the mud bucket during the tripping operation confounded that information for the driller and company man. As the crew tripped out pipe, the trip tank volume fluctuated up and down from mud draining into the trip tank and from mud being pumped out of the trip tank (Figure 24). The driller communicated that he had never before tripped wet pipe out of the well with this lineup, and all of the volume fluctuations in the data made monitoring for the correct volume reduction in the trip tank difficult.

Figure 24. Rig equipment alignment and data during tripping operation out of vertical portion of well. The crew was tripping wet pipe, and the mud from the pipe stands removed drained back to the trip tank, causing the trip tank volume to fluctuate.

Figure 25. Rig data during trip out of vertical portion of the well on January 22, 2018. The driller and company man were confused by the trip tank volume fluctuations and about what pipe volume to use in trip sheet calculations. The company man and driller incorrectly concluded that the test they performed to determine if the well was taking proper fill had passed.

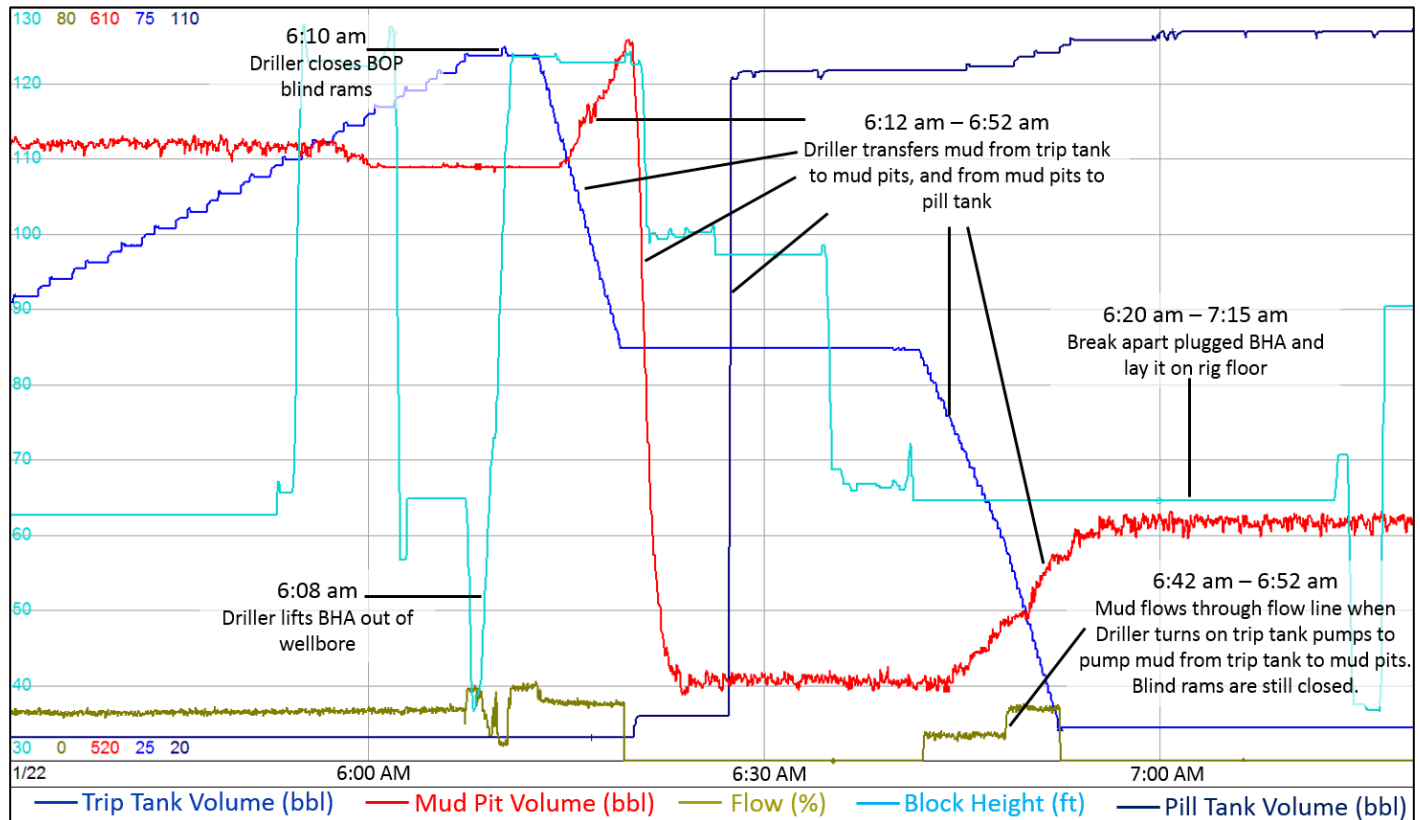
Figure 27. Rig Data between 5:32 am and 7:20 am on Monday, January 22, 2018 (day of incident).

By 7:15 am, the day crew had broken apart the plugged BHA and laid it on the rig floor (Figure 27).

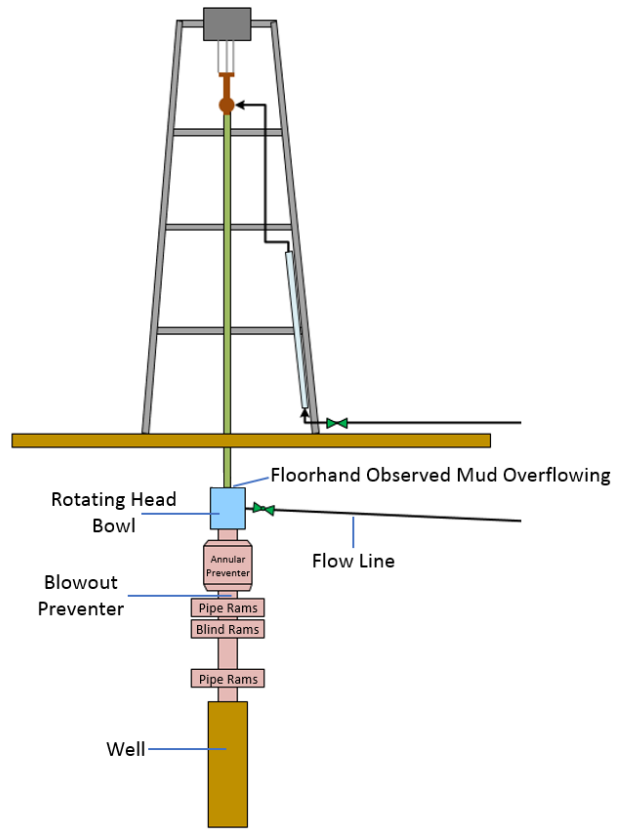
Figure 28. Depiction of where floorhand observed mud coming out of BOP stack while BHA was being tested.

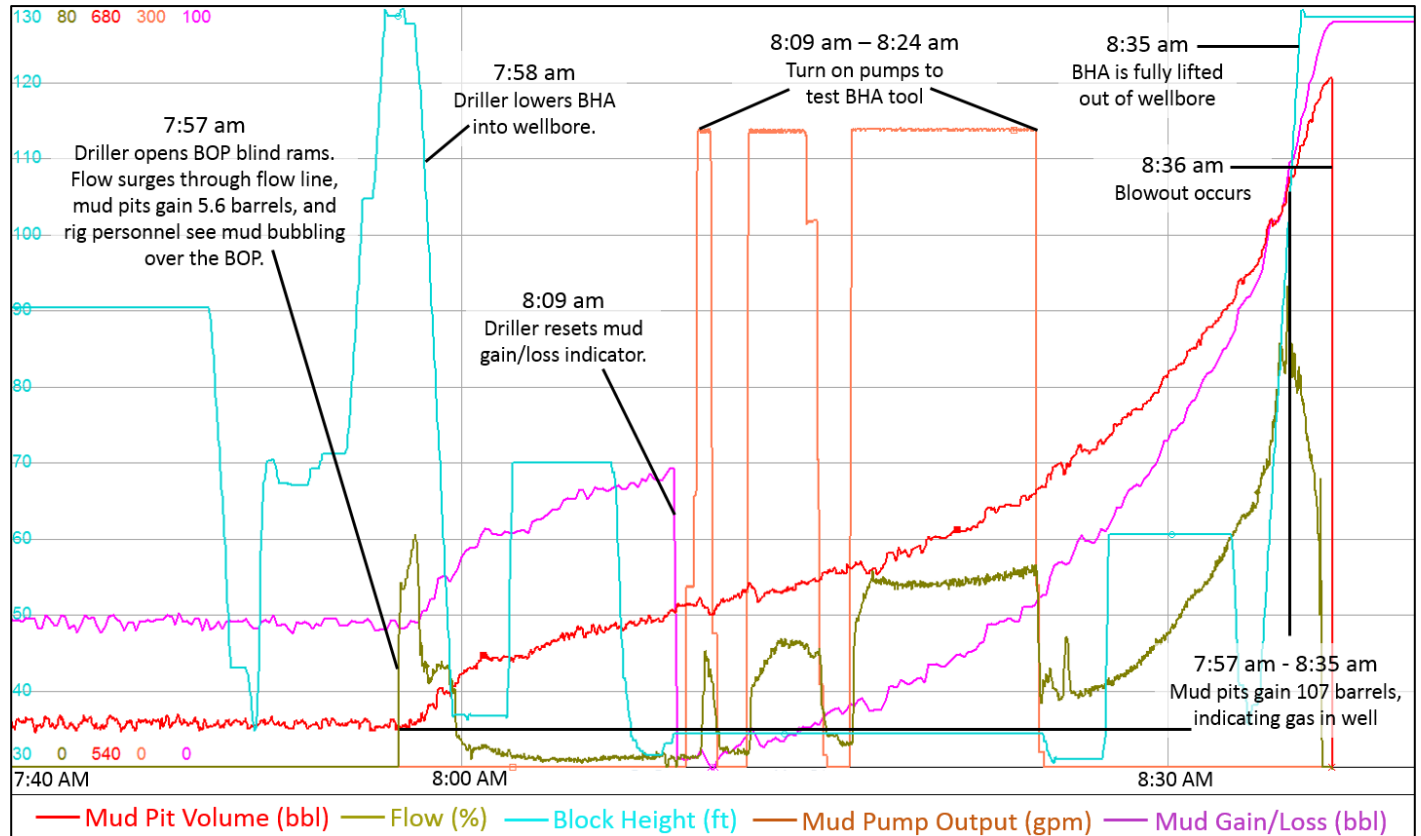
From the time the BOP blind rams were opened at 7:57 am through the completion of BHA testing and removal from well at 8:35 am, the mud pits gained 107 barrels of mud due to gas influx/gas expansion within the well (Figure 29), a

significantly large volume. It is unknown if the driller saw this gain, which would have displayed as a number on a monitor in front of him (Figure 37). No action was taken to shut in the well.

Figure 29. Rig Data between 7:40 am and 8:41 am on Monday January 22, 2018 (day of incident).

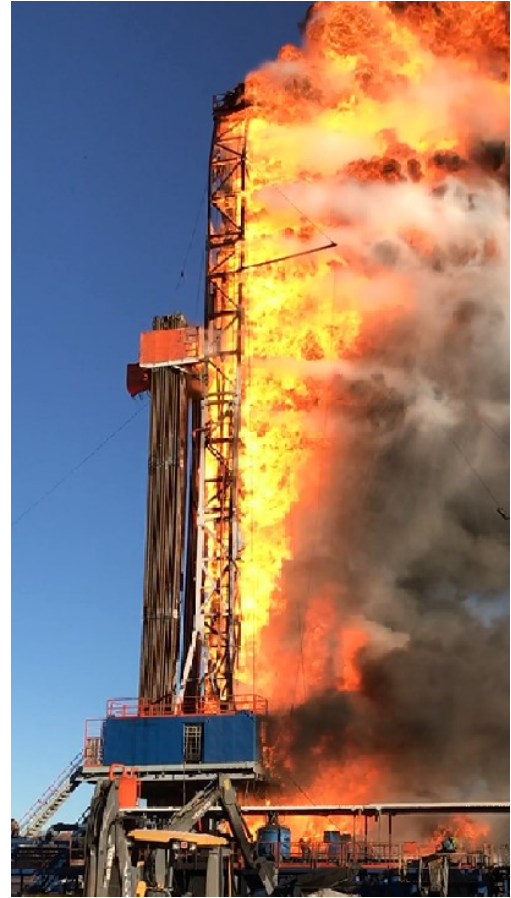
At 8:36 am,^a shortly after the driller communicated that he was going to close the blind rams, mud started spraying out of the well. The floorhand saw the motorhand and the second floorhand open the door to the driller's cabin so they could run into it from the rig floor. The mud continued to spray out of the well and covered the windows of the driller's cabin. The floorhand moved behind the drill pipe rack on the rig floor with the rig manager. Very quickly after the mud started spraying out of the well, the diesel oil-based mud and gas escaping the well caught on fire (Figure 30).^b Between the removal of the BHA from the well at 8:35 am and the blowout at 8:36 am, the mud pits gained an additional 12 barrels of mud, totaling to a 119-barrel gain since the blind rams had been opened at 7:57 am.

Figure 30. Video still of the blowout and fire taken shortly after it started.

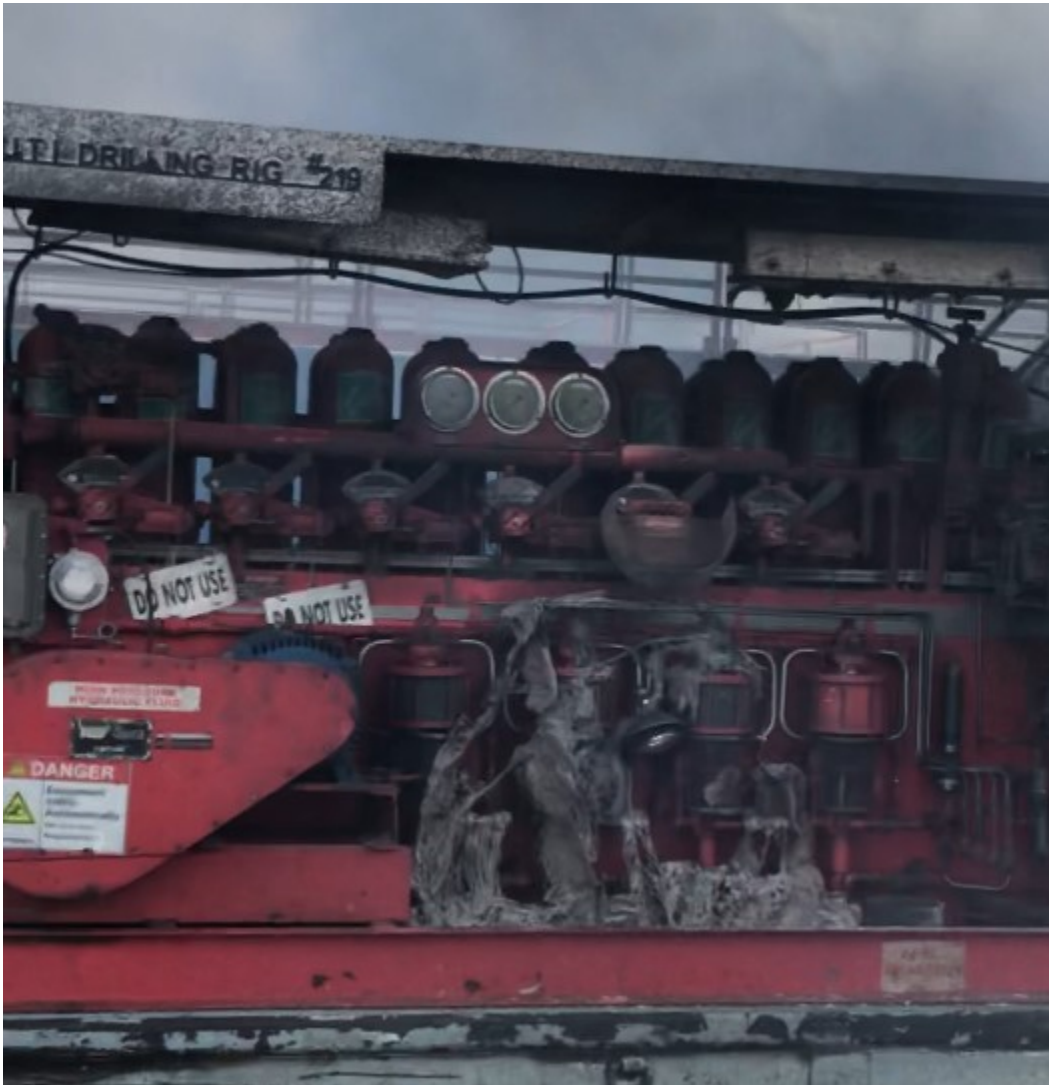
bottom pipe rams (Figure 31 and Figure 32). The BOP did not seal the well to stop the blowout. The company man from the previous shift later also tried to function the blind rams, the pipe rams, and the annular preventer, but the BOP did not seal the well. The CSB determined the BOP did not seal the well likely because the control hoses that supplied hydraulic fluid to the BOP to function the rams had burned and leaked the hydraulic control fluid, soon depleting the accumulator stored pressure to the point the BOP could not be functioned (Section 6.13).

Figure 32. Video captured at 11:51 am on January 22, 2018 shows all BOP handles in the closed position.

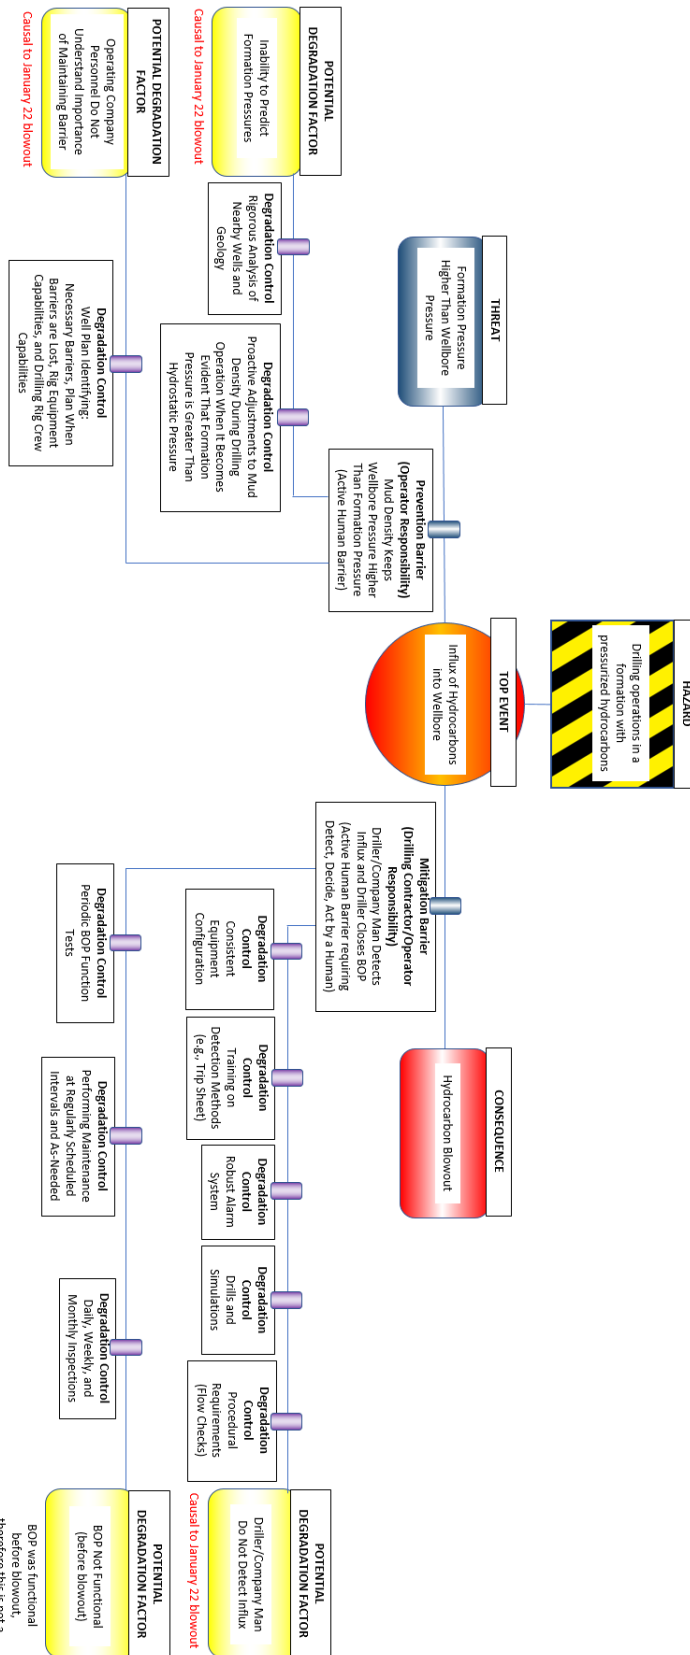
The CSB created a bowtie diagram (Figure 34) to illustrate the two planned barriers to prevent a blowout. Both barriers had associated degradation factors that could, and ultimately did, reduce the reliability and availability of the barriers.

Figure 34. Bowtie diagram of Pryor Trust Well 1H-9 barriers

Like any barrier, the mud barrier was subject to failure. Figure 34 shows two main degradation factors that contributed to the failure of the mud from preventing a gas influx, and no sufficient degradation controls were in place to prevent those degradation factors from leading to failure of the barrier.

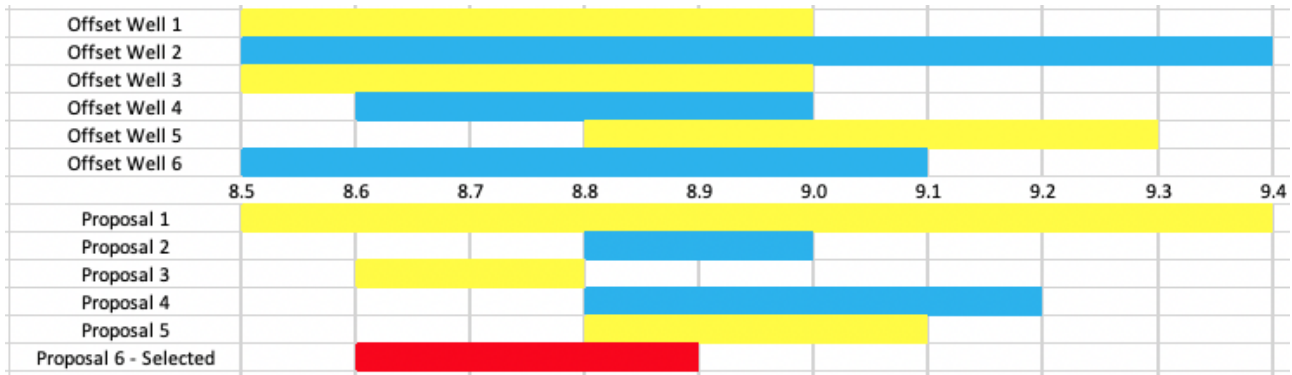
Figure 35. Comparison of the offset well mud weights, and the proposed mud weights provided in the various mud program proposals for the 2H-16 well.

During the drilling of 2H-16, the well experienced lost returns at 1,950 ft MD at a mud weight of 8.8 ppg, losing about 200 barrels of mud to a formation. After this loss event, the mud weight was reduced. The goal was “to keep [mud weight] as low as possible,” and the crew used a mud weight as low as 8.15 ppg while drilling the production zone. They drilled the remainder of the well without incident.

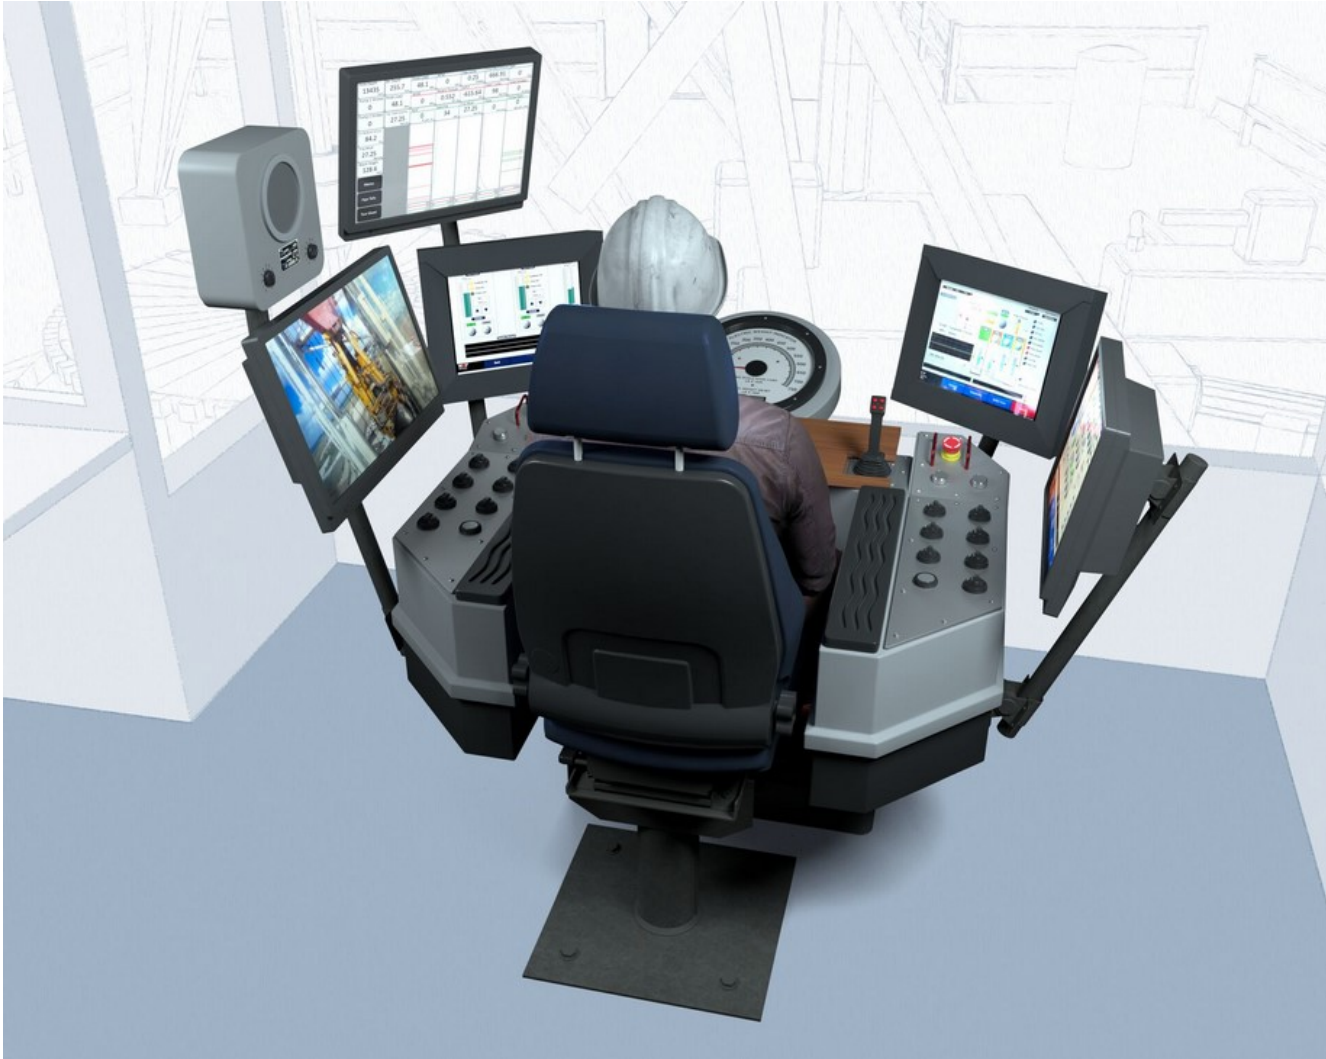
Figure 37. Depiction of driller console on Rig 219. The upper screen to the left of the driller displayed the aggregate of the drilling data.

On the drilling data monitor (upper left monitor), the driller could adjust alarm set points, silence individual alarms, silence all alarms for all parameters by turning the alarm horn off, or completely deactivating the alarm system so that both the horn and visual indications of alarms would be disabled. The data system installed was provided by Pason,

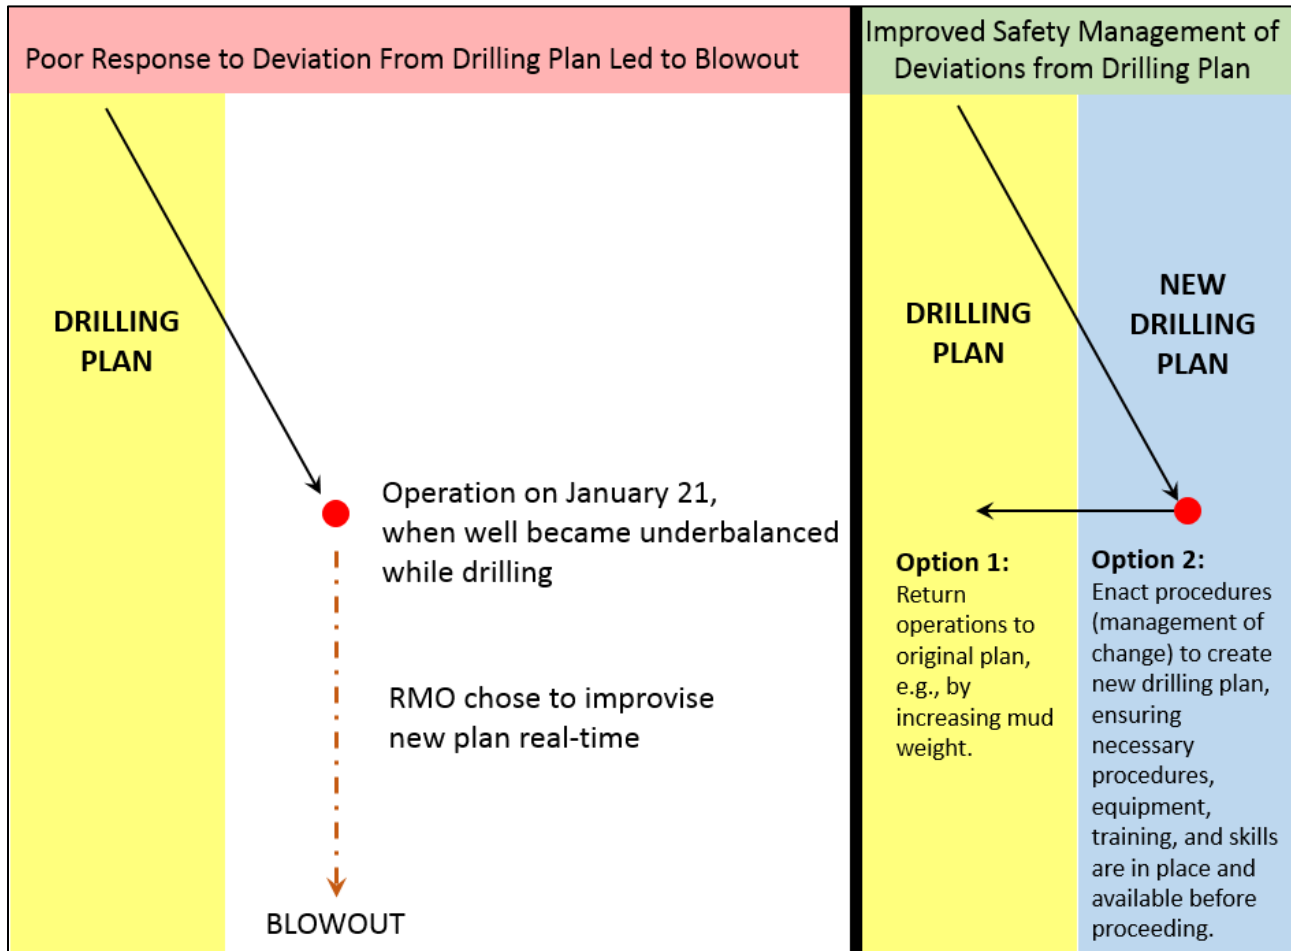
Sometimes operational excursions from original drilling plans are possible due to the inability to accurately predict geological behavior and formation pressures. Figure 39 below shows how RMO and its representatives responded to the deviation from the original drilling plan, which did not include underbalanced drilling. On January 21, when the well suddenly was underbalanced, RMO and its representatives chose to improvise a new plan as they proceeded real-time. This decision led to RMO and its representatives not fully considering the hazards of the operation or considering the need for specialized equipment and procedures.

Figure 39. Depiction of RMO's and its representatives' response to deviation from drilling plan (left), and improved safety management of deviations from drilling plan (right)

In operations with a healthy safety management system, when deviations from the original drilling plan occur, one of two options should be enacted, as shown in Figure 39. One option is to adjust parameters to return to the original drilling plan, which in this case would have required increasing the mud weight to return to overbalanced drilling. The second option is to stop operations and create a new drilling plan—using a management of change process—ensuring that necessary procedures, equipment, training, and skills are available so that the new plan can be performed safely before proceeding.

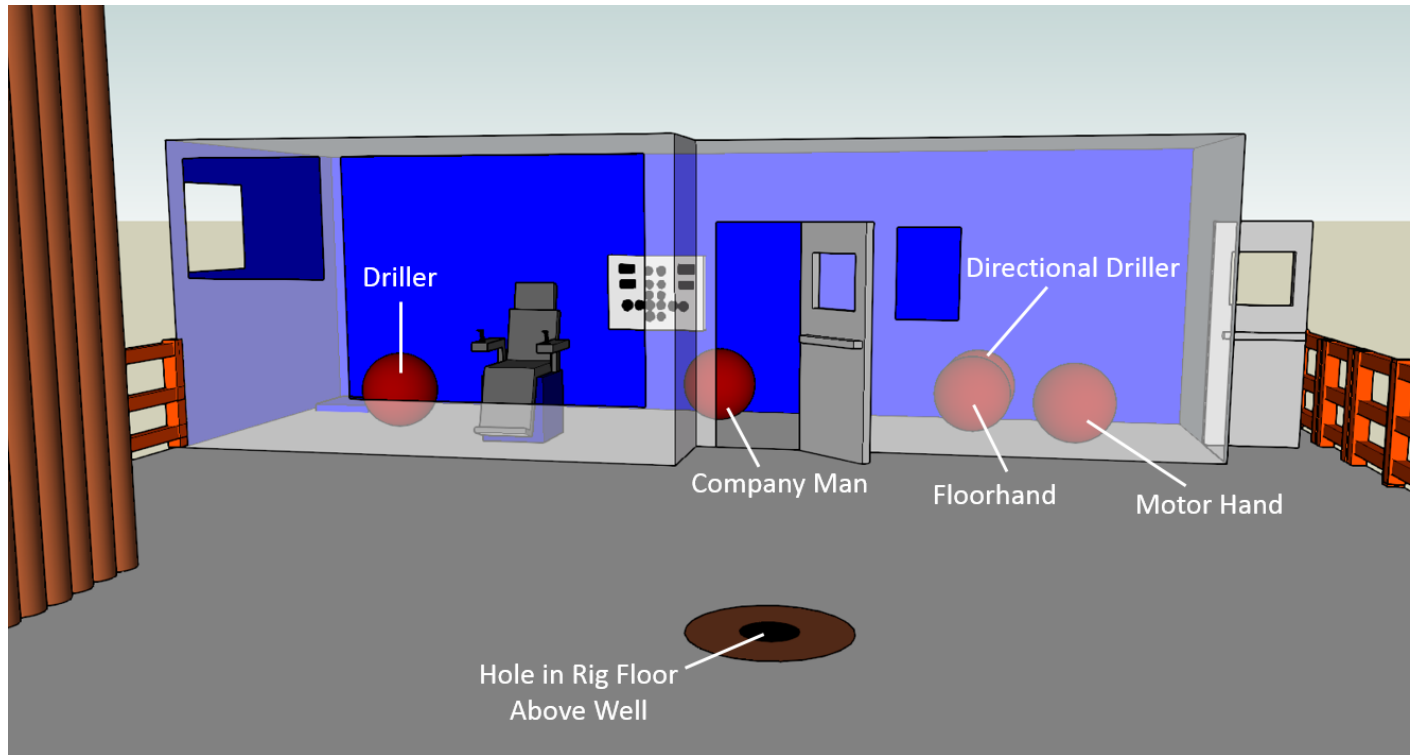
At the time of the blowout when mud started erupting from the well, the motorhand and second floorhand entered the driller's cabin. The driller, company man, and directional driller were already inside the driller's cabin when the blowout started. All five personnel were victims of the blowout and post-incident were found deceased in the driller's cabin. The locations where the victims were found is shown in Figure 42. Autopsies determined that all victims died from thermal burn injuries with found or probable smoke and soot inhalation.

Figure 42. Locations where victims were found in the driller's cabin

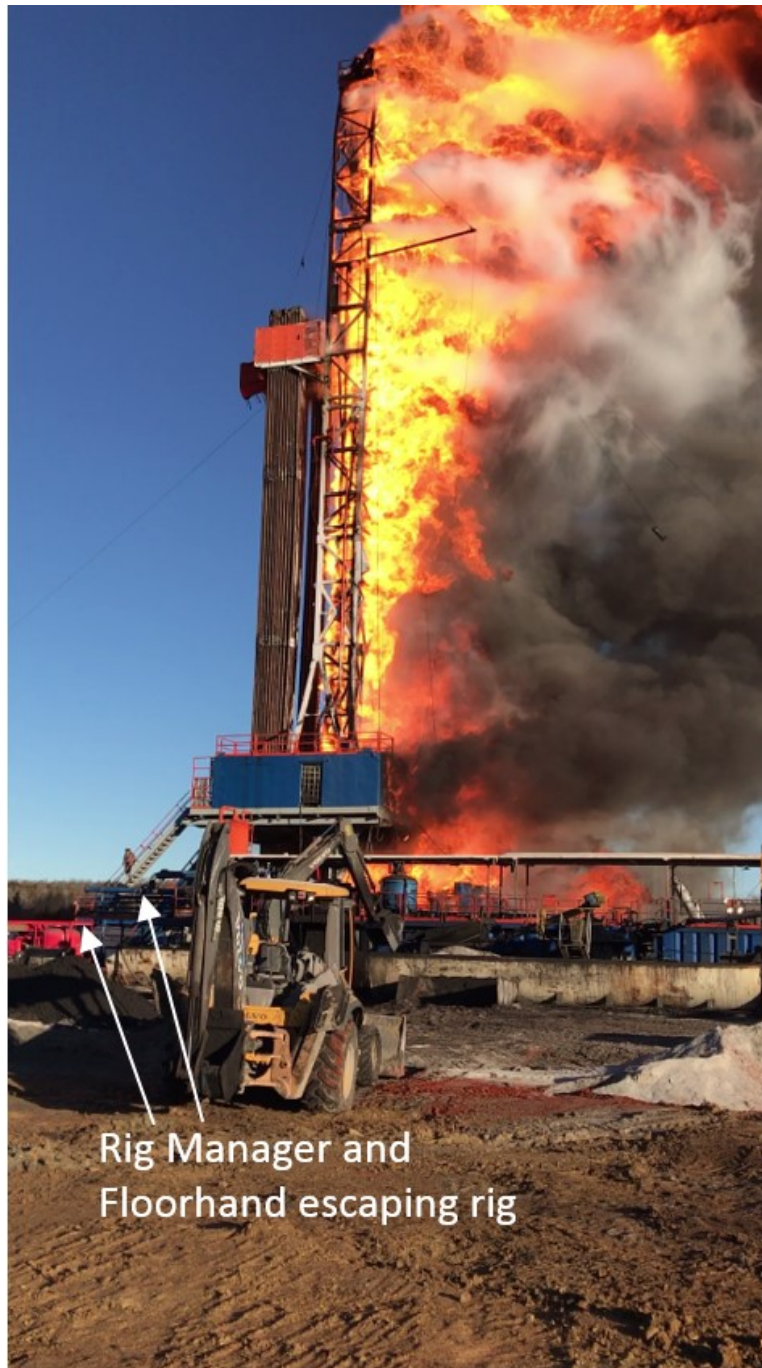
Witness testimony and video taken shortly after the blowout began confirm that the ignition of the gas and mud escaping from the well occurred within seconds after the mud started erupting onto the rig floor. The fire was massive and intense, engulfing much of the rig floor and the driller's cabin (Figure 43). It is unknown how long the victims remained alive inside the driller's cabin, but they had no viable escape routes. There were two exit doors from the driller's cabin, but both of those exit doors were blocked by flames after the gas and mud ignited (Figure 44).

Figure 43. Still from video captured at 8:36 am, shortly after blowout started. The rig manager and floorhand can be seen escaping the rig. At this point, the fire has engulfed the driller's cabin (far side of photo).

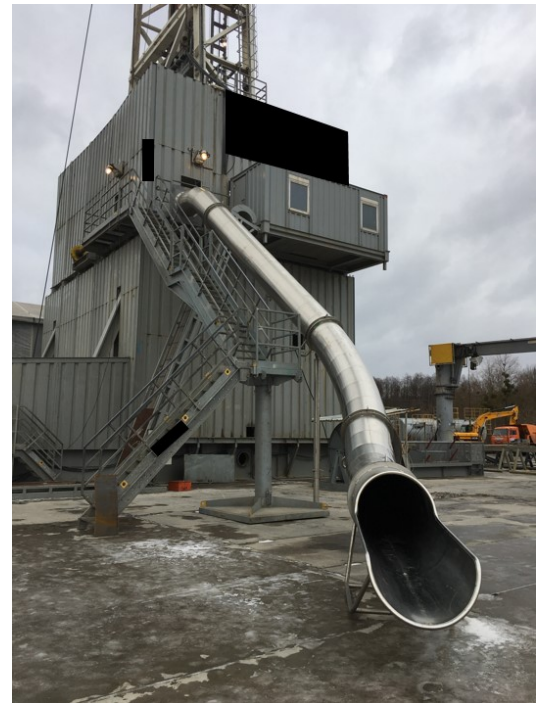
The design and location of the driller's cabin on Rig 219 appears to be typical across the industry. Drilling rig design changes are needed to help protect workers on the rig floor and in the driller's cabin from blowout and fire hazards, and to allow quick escape from the rig. Had the fire rating of the driller's cabin been ensured for a minimum time (e.g., 10 minutes), with emergency escape options from the driller's cabin floor (e.g., an escape hatch) or from the back wall, there could have been a better chance for the workers in the driller's cabin to survive this incident. As an example of a quick evacuation design, the CSB was informed that escape slides are required in Ukraine for the safety of drilling rig workers (Figure 47). This and other escape options would need to be evaluated by the U.S. drilling industry.

Figure 47. Example design strategy to provide quick egress from drilling rig during a blowout.

- (a) Protect drilling cabin occupants from blowout hazards including heat, blast overpressure, and projectiles; and
- (b) Establish the minimum required evacuation methods from the drilling cabin, rig floor, and mast in the event of a blowout so personnel can quickly escape in variable hazard location conditions.

The drilling industry should also consider alternative design methods, such as locating the driller's cabin at a safe distance from the well, for example at ground level. Such a design could incorporate the use of cameras to allow the driller to view and direct rig floor activities, keeping workers in the driller's cabin out of range of fire and explosion hazards. [**Recommendation 2018-01-I-OK-R5**]

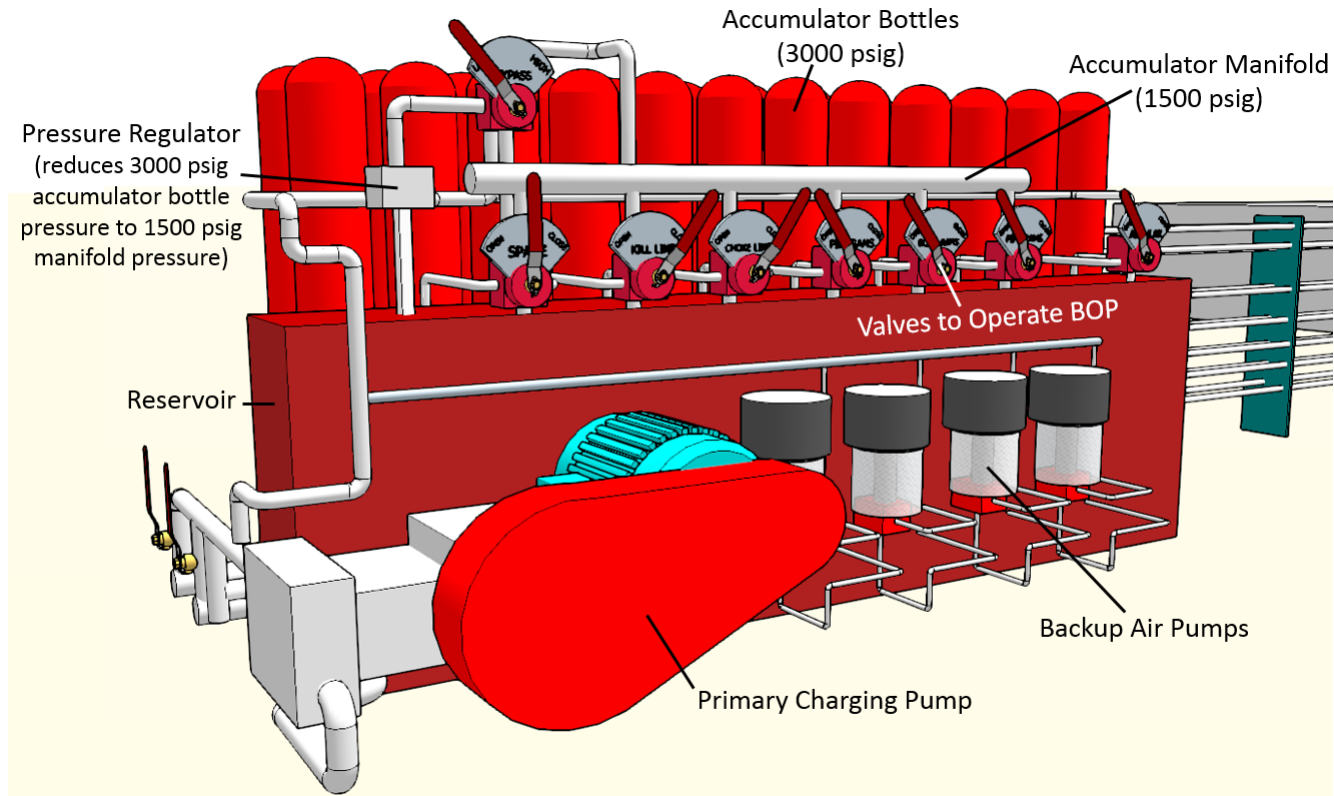
Blowout preventers are hydraulically operated equipment, using high-pressure hydraulic fluid stored in an accumulator.^a A depiction of the Rig 219 accumulator is shown in Figure 48.^b Hydraulic fluid at 3,000 psig is stored in the accumulator bottles. That pressure is reduced to 1,500 psig through a pressure regulator for the manifold. Hydraulic fluid in the accumulator manifold is used to function the blowout preventer.

^c Discussed in Appendix A, post-incident testing found that the charging pump activated at an accumulator pressure of about 2,000 – 2,100 psig and automatically switched off when the accumulator pressure reached 2,800 psig. Based upon information from Patterson rig crew members that the accumulator pressurized normally to 3,000 psig pre-incident, this change to the accumulator pump set points may have been a result of the fire and post-incident activities.

Figure 48. Depiction of the Patterson Rig 219 accumulator. The top valve on the accumulator is the Bypass valve. From left to right, the bottom valves are Spare, Kill Line, Choke Line, Bottom Pipe Rams, Blind Rams, Top Pipe Rams, and Annular Preventer.
