Investigation Report

Published: June 12, 2019

On January 22, 2018, a blowout and rig fire occurred at Pryor Trust 0718 gas well number 1H-9, located in Pittsburg County, Oklahoma. The fire killed five workers, who were inside the driller's cabin on the rig floor. They died from thermal burn injuries and smoke and soot inhalation. The blowout occurred about three-and-a-half hours after removing drill pipe ("tripping") out of the well.

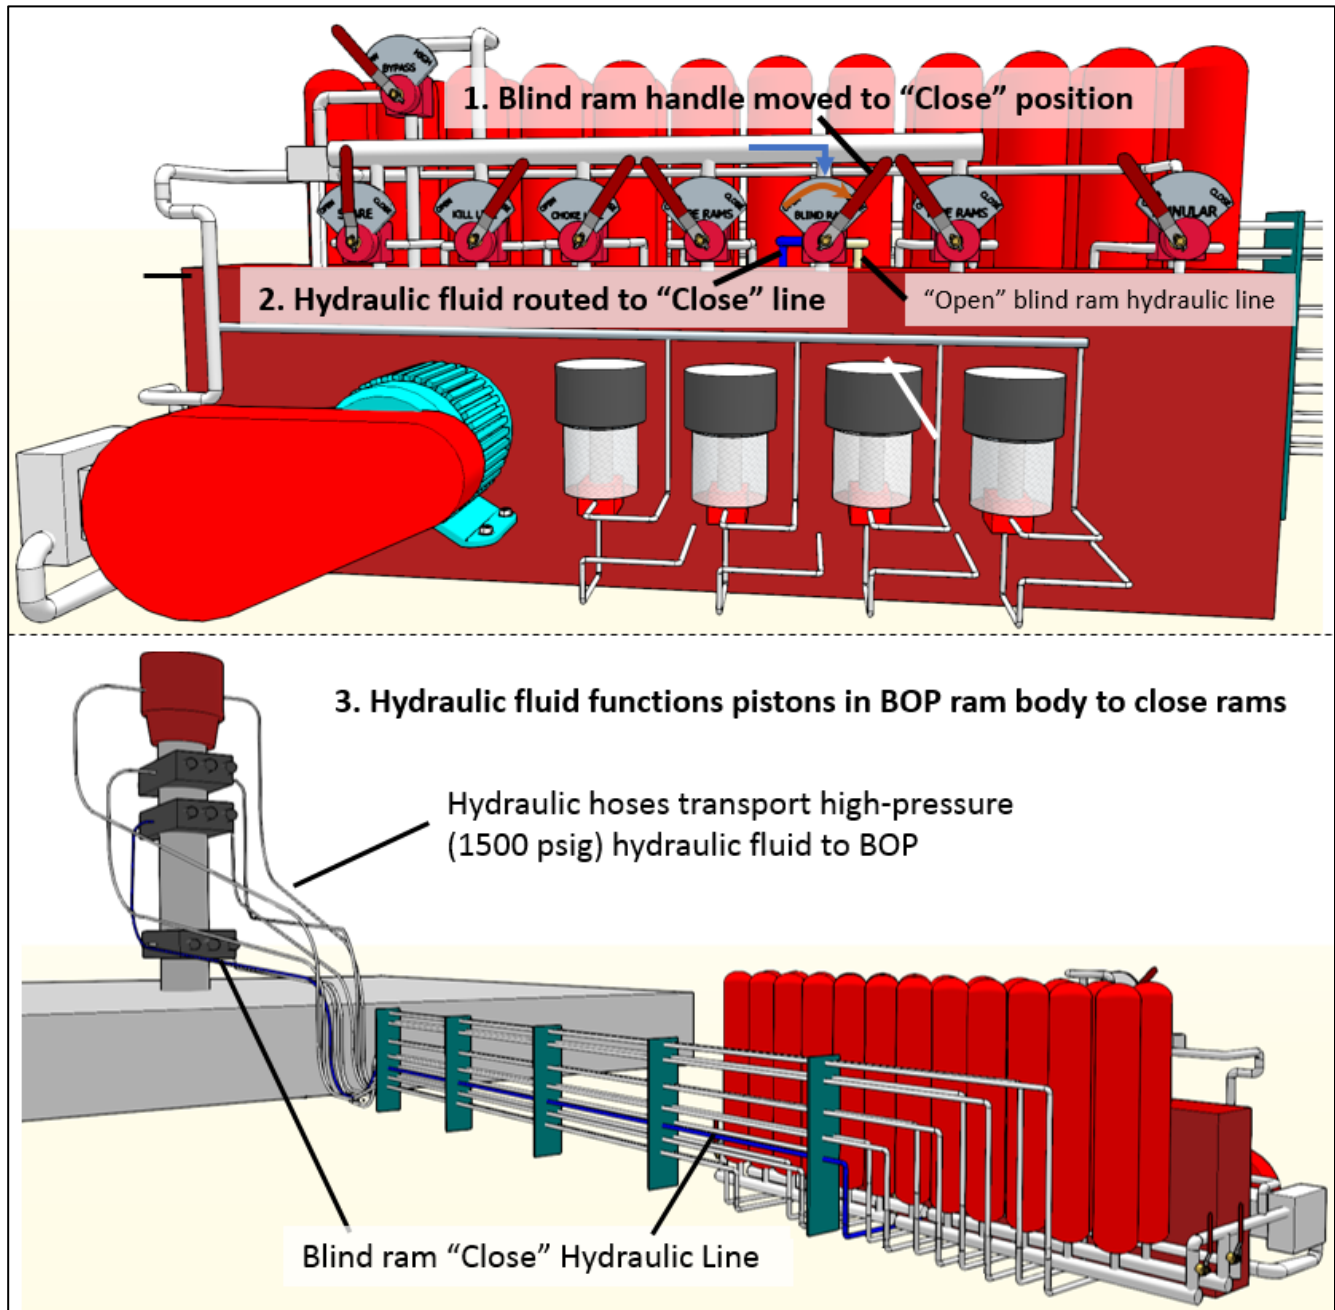
Figure 49 illustrates how the accumulator is used to function the blowout preventer. When a person moves an accumulator handle to its “close” position for, for example, the blind rams, 1500 psig hydraulic fluid from the accumulator manifold is routed to the blind ram “close” hydraulic line, which then moves two pistons inside the ram body to close the rams. The pressurized hydraulic fluid that was in the “open” piston chambers and hydraulic line drains into the accumulator reservoir. When a person then moves the handle to the “open” position, high-pressure hydraulic fluid is routed to the blind ram “open” hydraulic line, which then moves the pistons in the ram body in the opposite direction to then open the rams. The pressurized hydraulic fluid that was in the “close” piston chambers and hydraulic line drains into the accumulator reservoir.

Figure 49. Illustration of how hydraulic fluid in the accumulator functions the blowout preventer blind rams when the blind rams valve is moved to the "close" position. The portion of the hydraulic lines in the support racks is hard piping, and the portion of the hydraulic lines between the support rack and the blowout preventer is flexible hose.

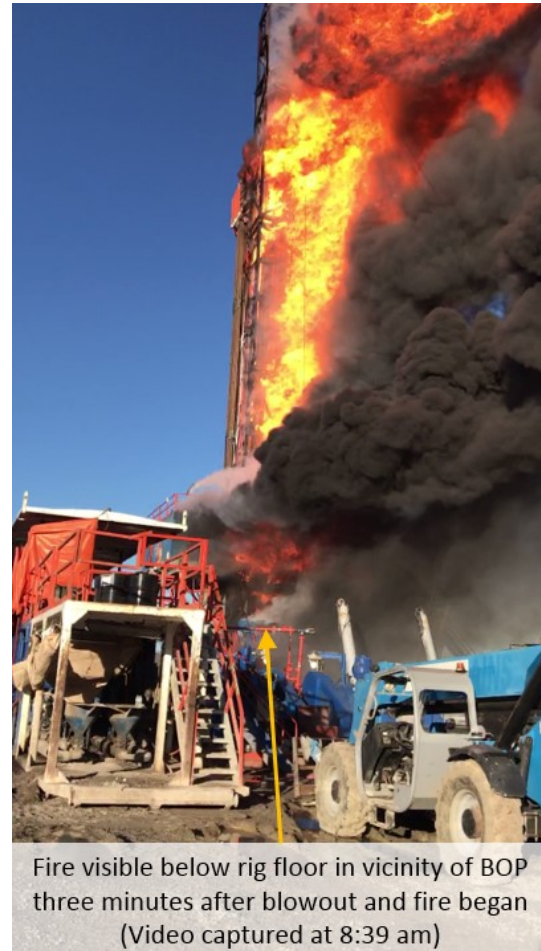
Figure 51. Video still of Patterson Rig 219 fire, taken 3 minutes after blowout began.

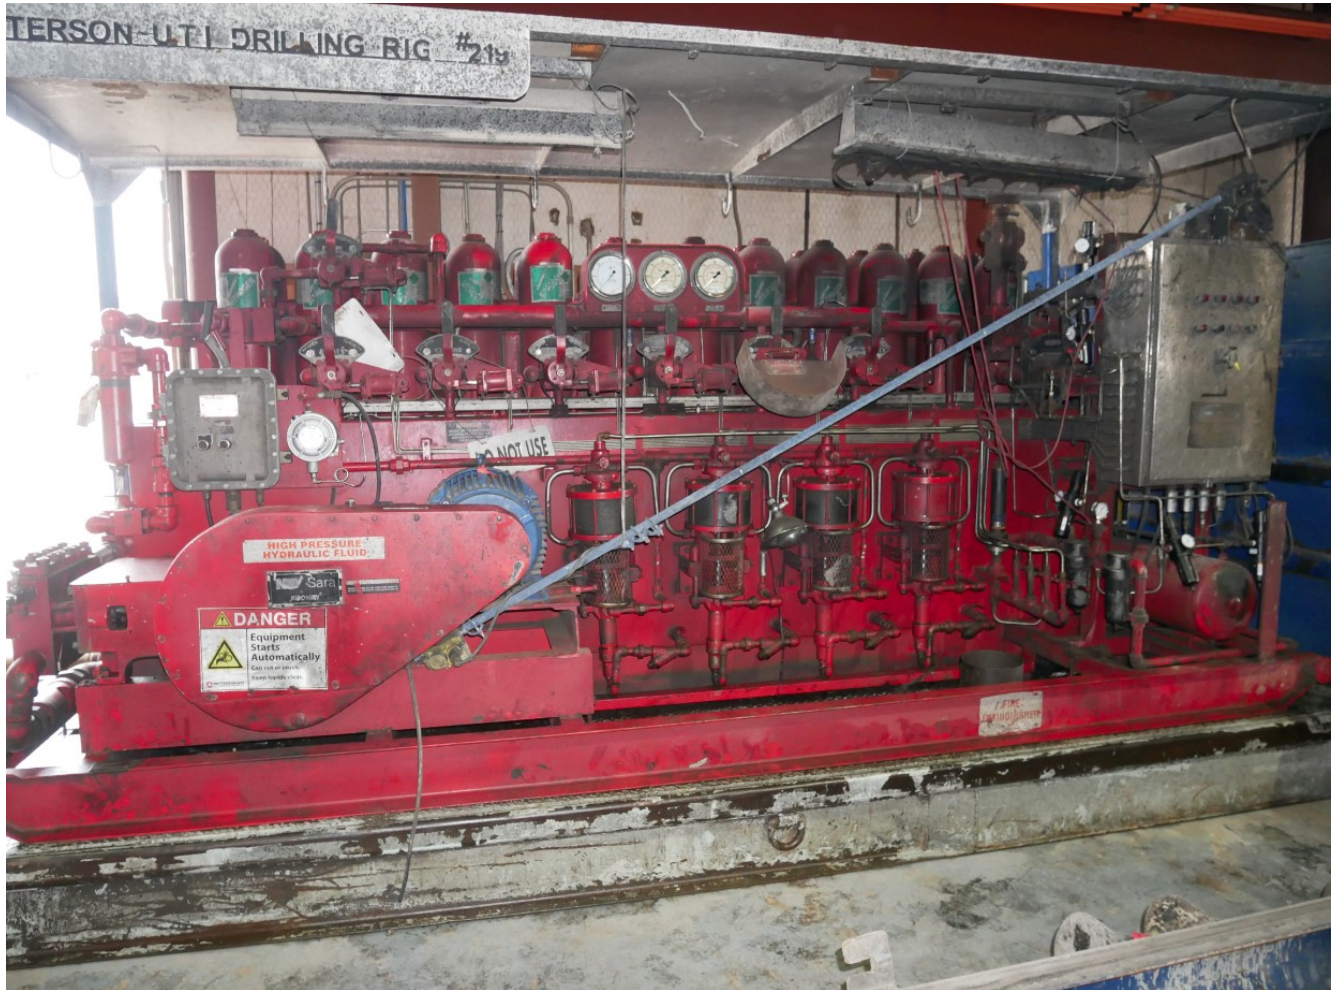
- The accumulator was manufactured by NOV SARA INDIA (P), LTD. It was manufactured in 2008 (Figure A-1).

Figure A- 1. Photo of Patterson Rig 219 accumulator

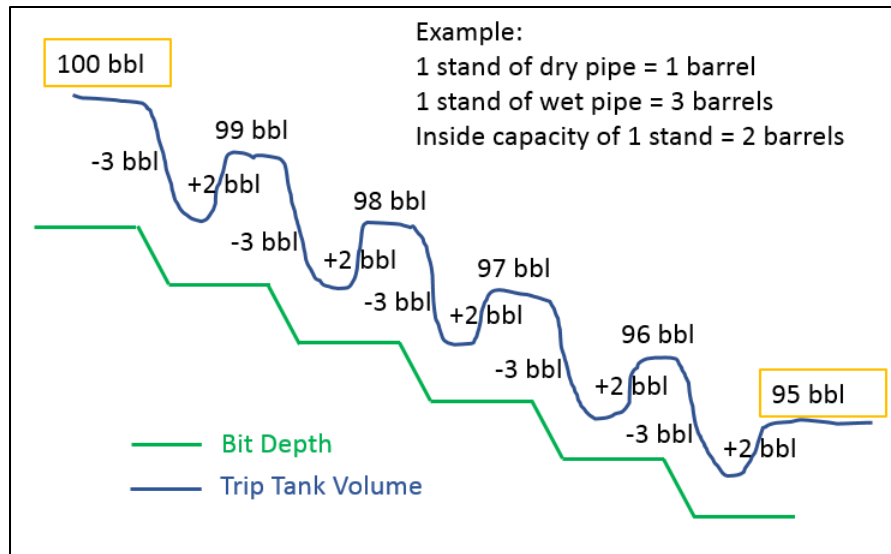
- Figure C- 1 illustrates how a trip tank volume could behave when tripping wet pipe, when the drill pipe contents drain back into the trip tank as shown in Figure C- 2.

Figure C- 1. Example trip tank fluctuation pattern when tripping wet pipe when mud bucket drains to trip tank.

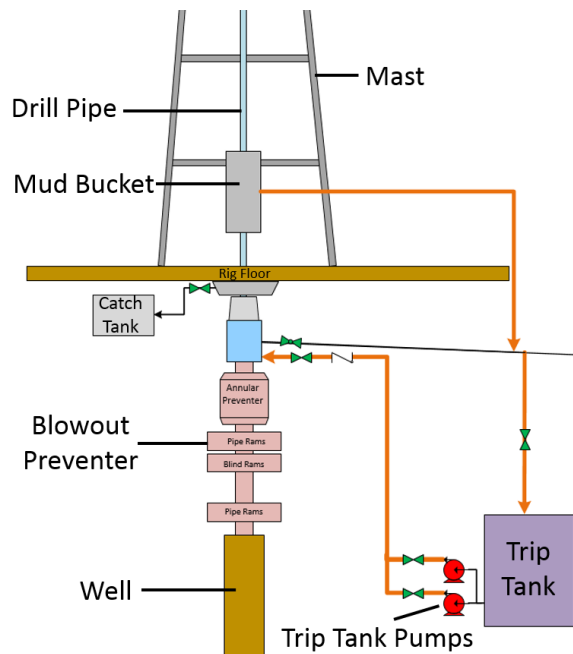
Figure C- 2. Example equipment alignment that could cause the trip tank volume fluctuations shown in Figure C- 1.

- In this example, tripping five stands of drill pipe containing mud (each stand has dry volume of 1 barrel) with the mud bucket draining to the trip tank results in a five-barrel decrease in the trip tank volume. This is a volume reduction of the *dry volume* of the drill pipe stand even though the drill pipe was being pulled “wet.”
- This calculation assumes there is no mud leakage or mud spilled on the drill floor during the tripping operation.
- The *Guide to Blowout Prevention*, created by the company Well Control School (WCS) states:

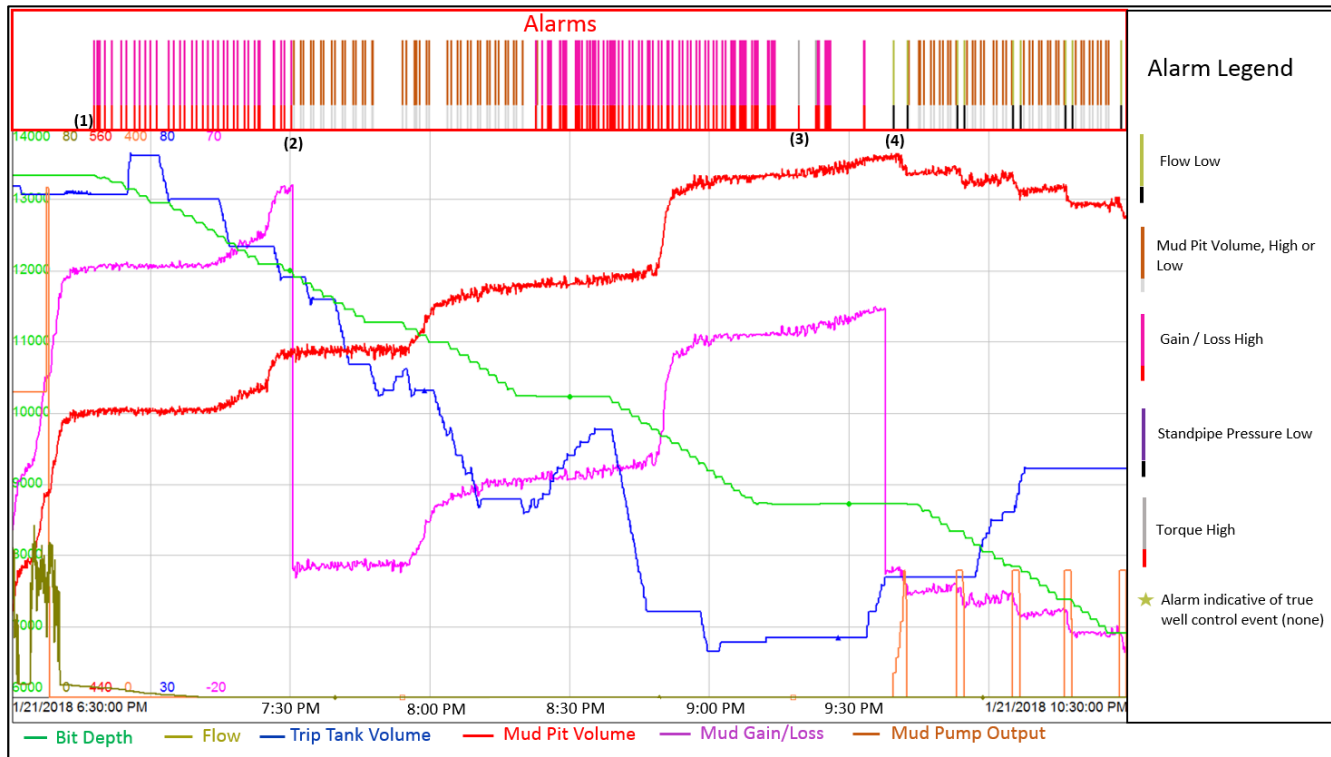
Figure E- 1 depicts what alarms would have been active during this period. Each line on the top of Figure E- 1 does not indicate a separate alarm; instead, each alarm line is simply a recorded data point above the alarm set point in the data provided to the CSB. The figure is to be interpreted that when those lines for that parameter are visible, that alarm would have been active as a continuous beeping. Had the alarm system been on during the tripping operation out of the lateral part of the well on January 21, between 6:45 pm and 10:30 pm, alarms would have activated for Gain Loss High, Total Mud, Flow Low, Standpipe Pressure Low, and Torque (Figure E- 1). While these alarms and set points would have been important during a drilling operation, none were not applicable to the tripping operation in alerting to a well control event. More information about the specific alarms is in Table E- 1.

Figure E- 1. Information from alarm system data, indicating what alarms would have activated between 6:45 pm and 10:30 pm during the trip out of the lateral section, had the alarm system been turned on. Information about the specific alarms is in Table E- 1 below. The numbers in parentheses correspond with the note numbers in Table E- 1.

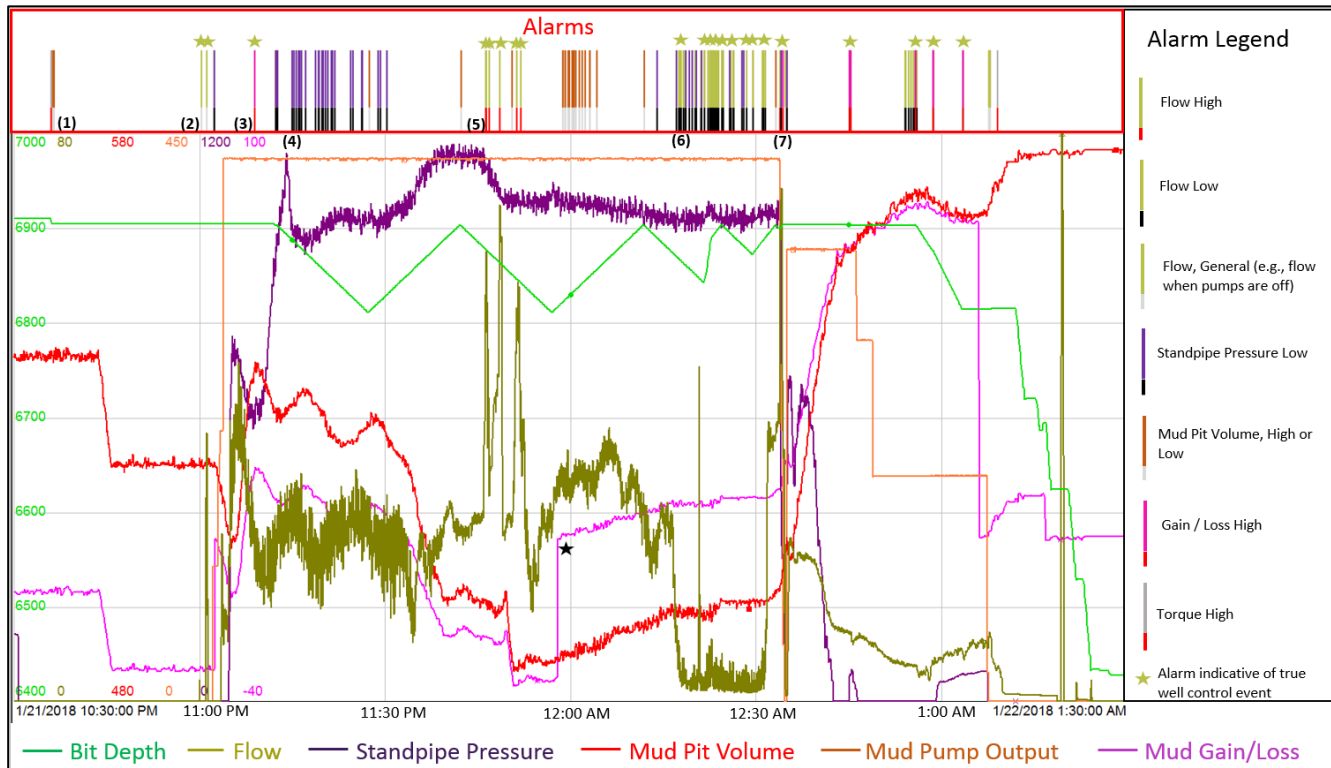
While circulating at the top of the curve, had the alarm system been active, some of the active alarming would have been potentially indicative of the well control event, but the bulk of the active alarming would have been non-critical alarms (Figure E- 2). More information about the specific alarms is in Table E- 2.

Figure E- 2. Information from alarm system data, indicating what alarms would have activated between 10:30 pm and 1:10 am while circulating at the top of the curve, had the alarm system been turned on. Some of these alarms could have alerted to the well control event. Information about the specific alarms is in Table E- 2 below. The numbers in parentheses correspond with the note numbers in Table E- 2.

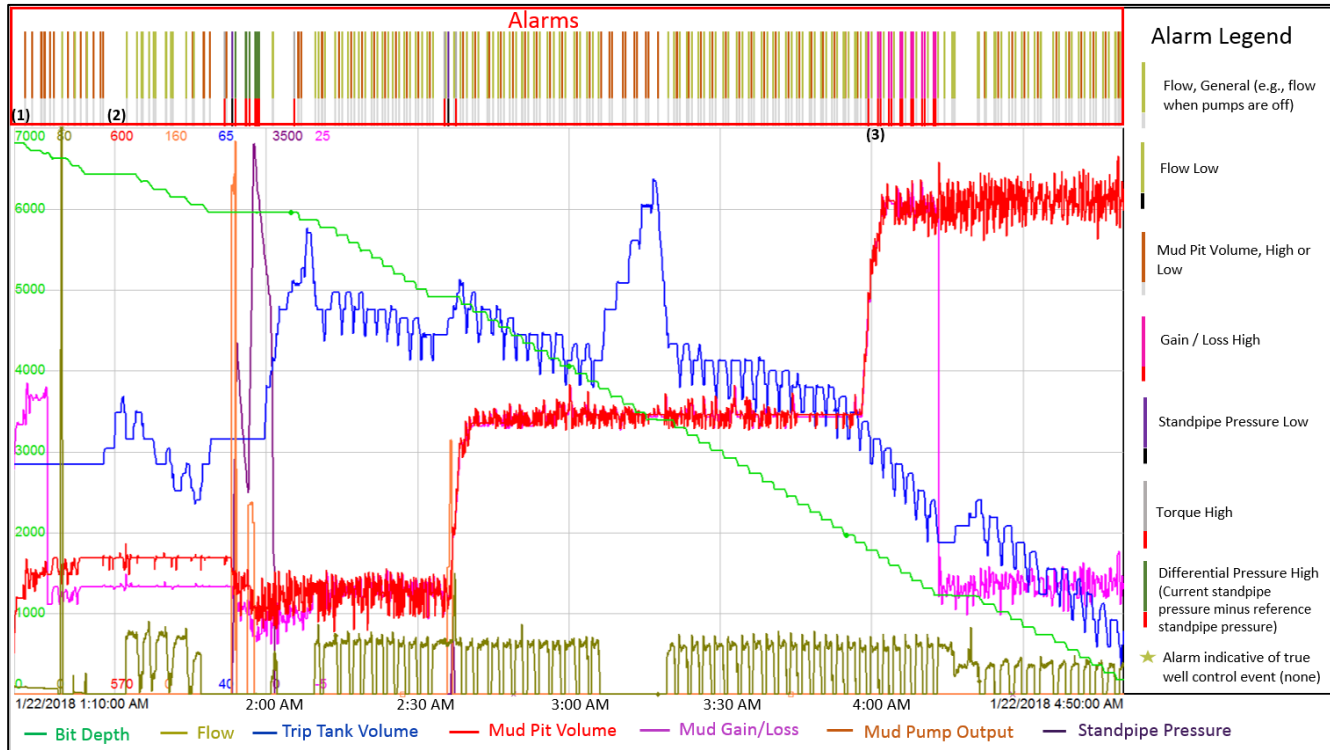
The tripping operation out of the vertical portion of the well occurred between 1:10 am and 4:50 am. During this period, alarms would have activated had the alarm system been on for parameters including mud pit volume, flow, Gain/Loss high, differential pressure, standpipe pressure, and torque. These alarms would have been activated by other rig operations (e.g., transferring mud) or parameters that would be pertinent to the drilling operation but were irrelevant to the tripping operation. As such, all alarming would have been non-critical alarms not indicative of the well control event. No alarms would have activated that warned of a potential well control event during the tripping operation.

Figure E- 3. Information from alarm system data, indicating what alarms would have activated between 1:10 am and 4:50 am while tripping out of the vertical section of the well, had the alarm system been turned on. None of the alarms would have alerted to the well control event. Information about the specific alarms is in Table E- 3 below. The numbers in parentheses correspond with the note numbers in Table E- 3.

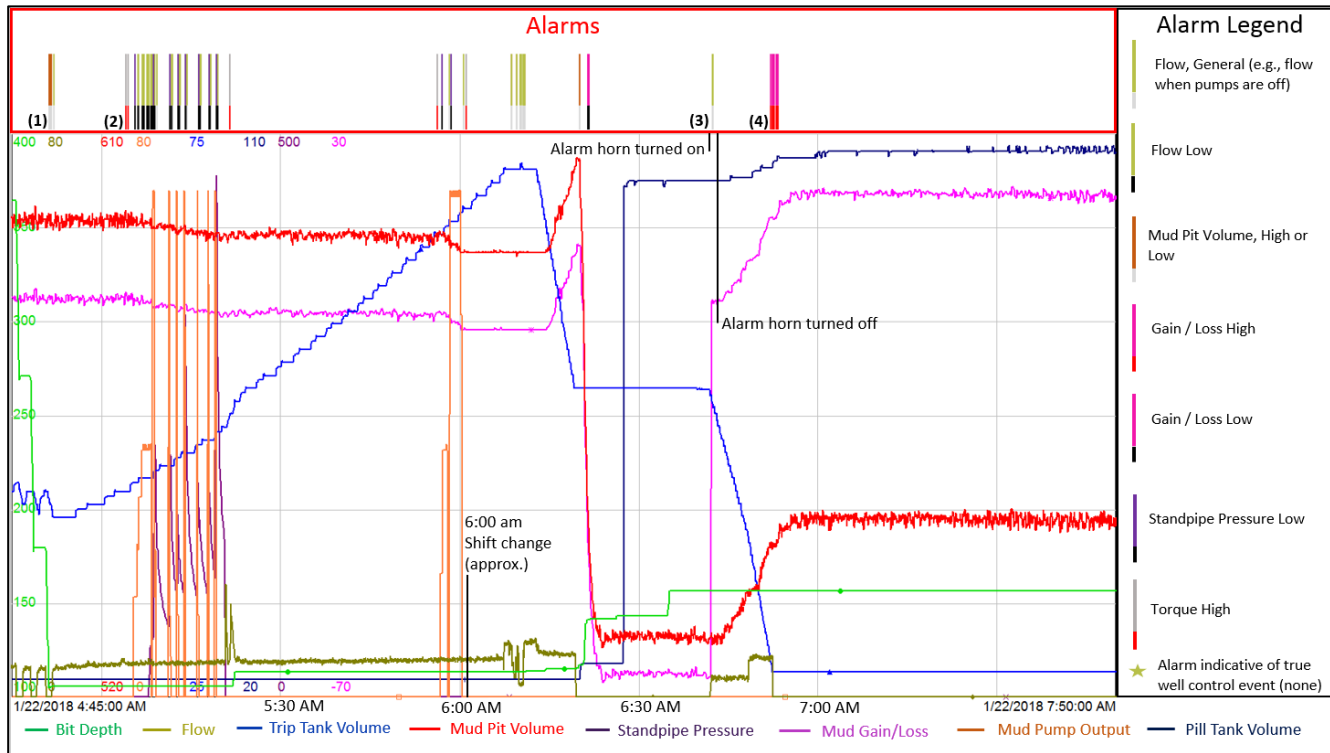
During this period a shift change occurred at around 6:00 am. At 6:42 am, the alarm system was reactivated, likely by the new driller on tour. Non-critical alarms would have been continuously sounding while the alarm system was on. Twenty seconds after the alarm system was turned on, it was turned off again. The alarm horn remained off through the blowout at 8:36 am.

Figure E- 4. Information from alarm system data, indicating what alarms would have activated between 4:50 am and 7:50 am during the rig floor operations, had the alarm system been turned on. None of the alarms would have alerted to the well control event. Information about the specific alarms is in Table E- 4 below. The numbers in parentheses correspond with the note numbers in Table E- 4.

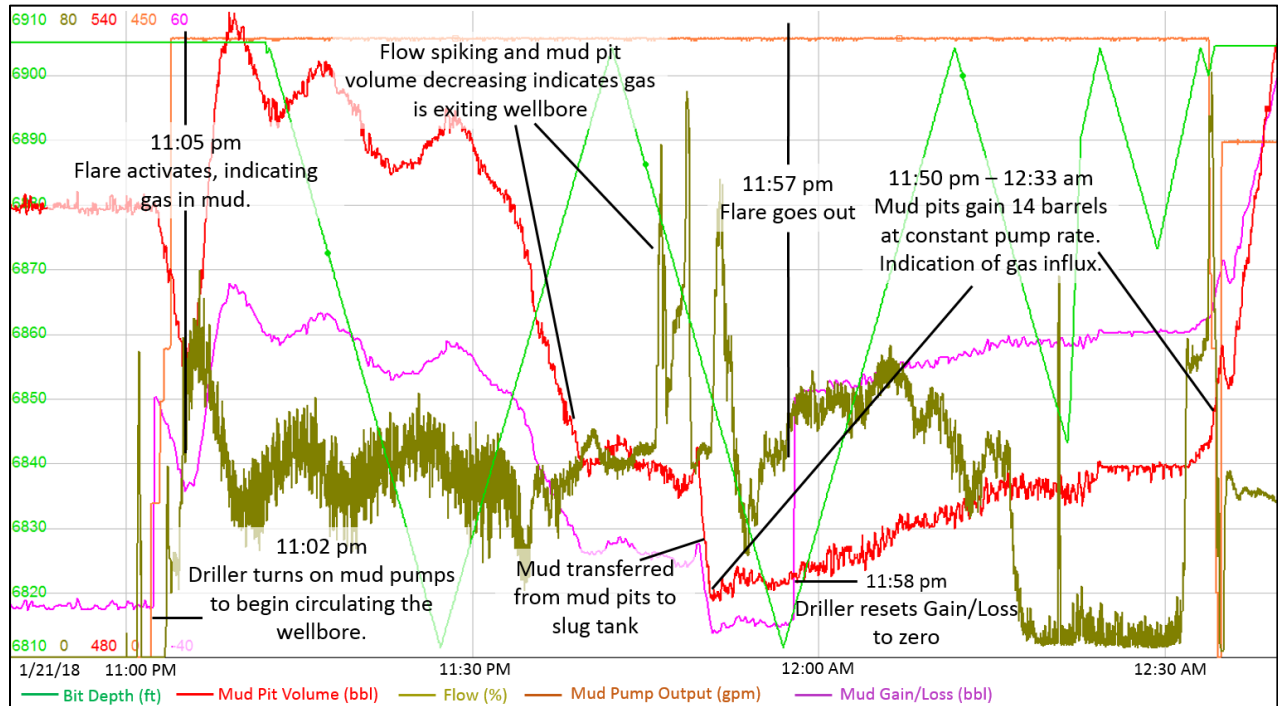
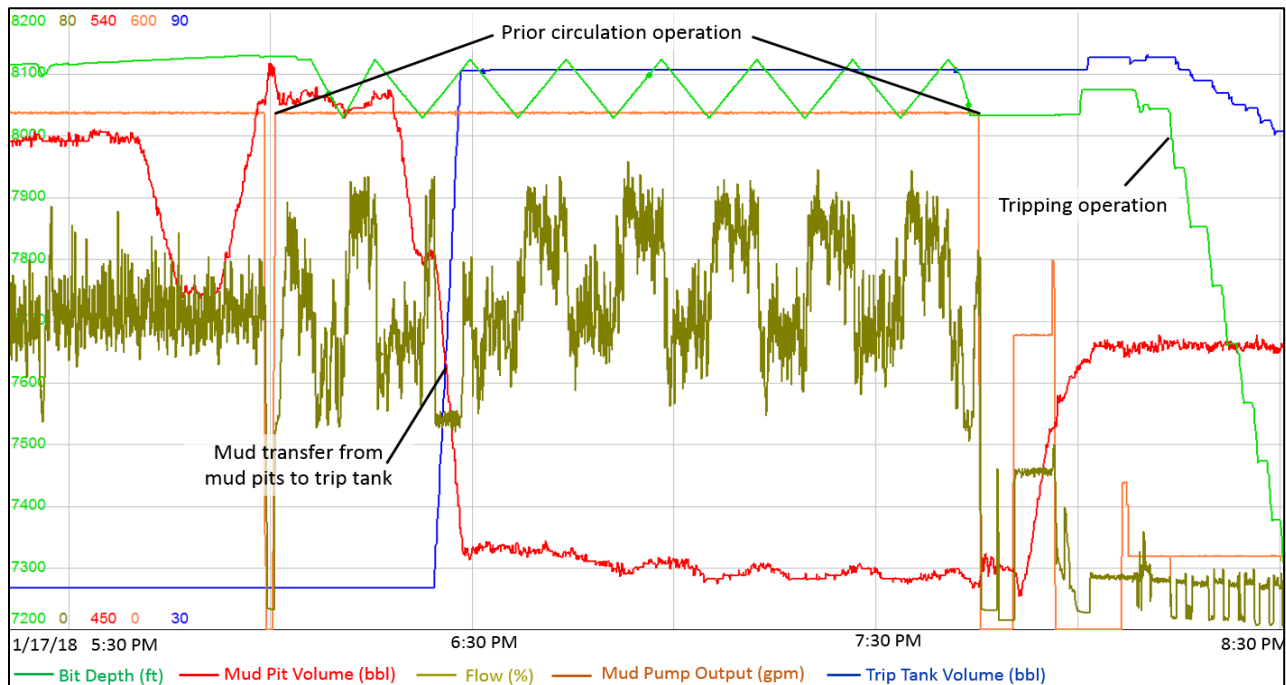
The top graph below shows rig data while circulating the wellbore at the top of the curve. The flare activated while circulating, indicating gas in the mud. Between 11:50 pm and 12:33 am, the mud pits gained 14 barrels while the mud pumps were circulating at a constant pump rate. This pit gain indicates there was a gas influx (kick). For comparison purposes, the bottom graph shows a normal circulation operation performed on January 17, 2018 on Pryor Trust Well 1H-9.
