# INVESTIGATION REPORT

Draft Report for Public Comment

## E.I. DUPONT DE NEMOURS & Co., INC.

### METHYL CHLORIDE RELEASE JANUARY 22, 2010

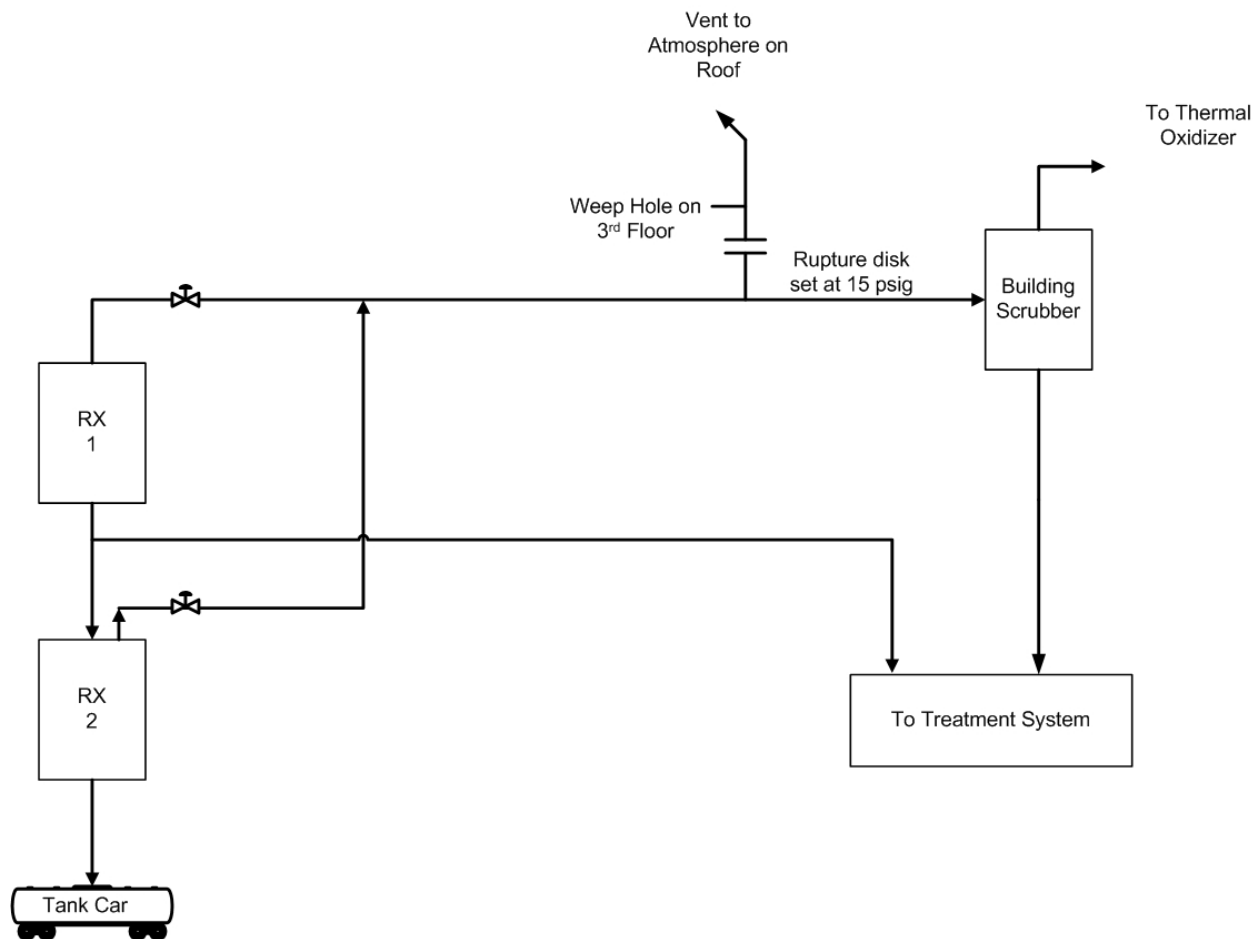
Figure 2. Simplified thermal oxidizer and rupture disc block flow diagram

The Belle plant's F3455 unit manufactures the intermediate F3455, a chemical that is shipped to another DuPont facility to make the herbicide Velpar<sup>®</sup>. Due to the exothermic reaction in the first reactor, dissolved methyl chloride vaporizes and normally exits through the reactor vent line along with carbon dioxide, nitrogen, and trace amounts of dimethylamine (DMA) vapor through a process scrubber and then to a thermal oxidizer for emission control. To protect against damage to the scrubber<sup>6</sup> if excessive pressures occur, a piping connection upstream of the vent line is routed to a rupture disc that will burst and allow for venting outside on the roof of the building, which occupies two reactors (Figure 2). However, due to a lack of safety considerations during installation, a 0.5-inch weep hole<sup>7</sup> was placed on the vent line inside the building. As a result, dangerous chemicals vent inside the building if the rupture disc bursts.

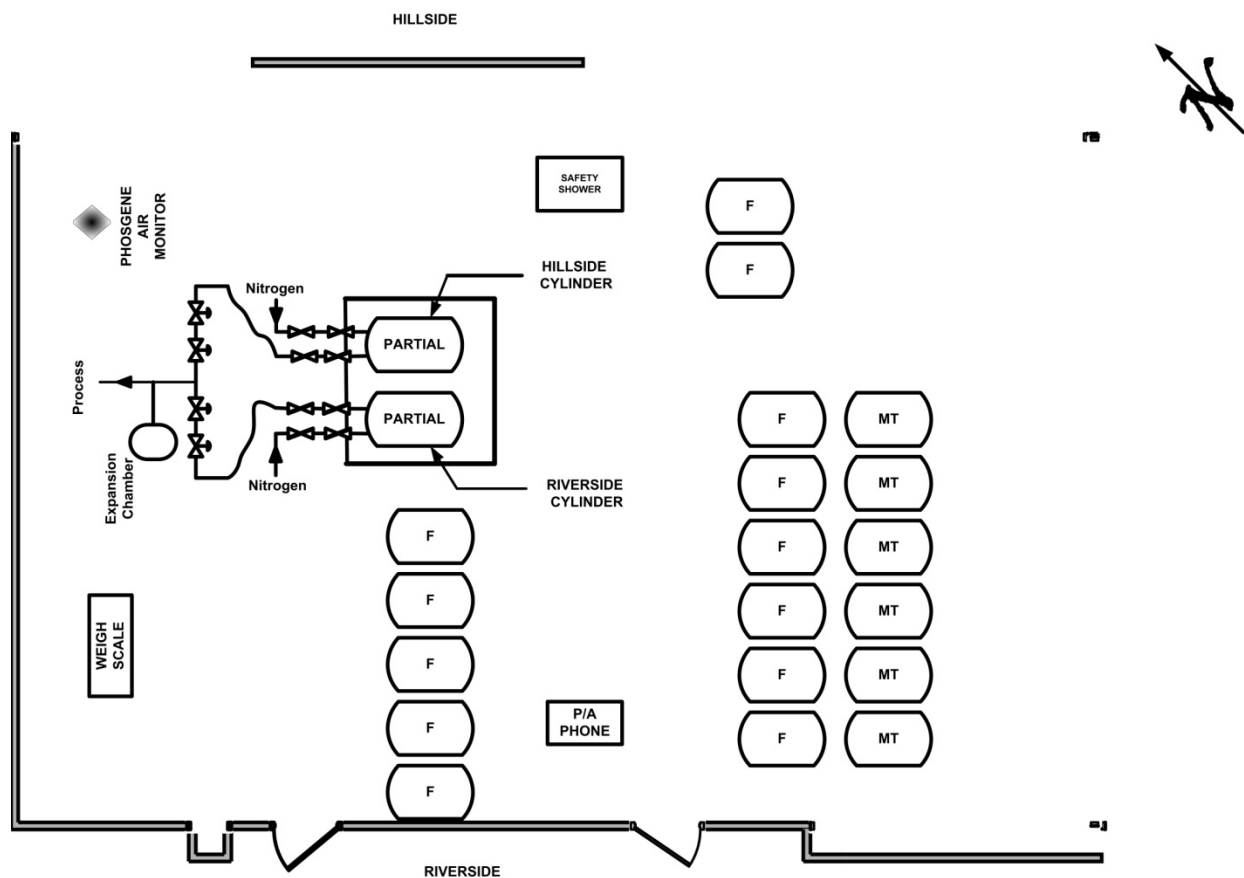
Figure 12. Phosgene shed and full (F) and empty (MT) cylinder locations on day of incident (not to scale)

Phosgene used to produce the five intermediate products is fed to a process from 1-ton cylinders stored in the phosgene shed at the SLM unit. The phosgene cylinder storage shed is a covered, partially walled structure where the phosgene transfer and storage operations occur (Figure 12). All equipment used for these purposes is in or around the shed. The shed contains no mechanical ventilation or exhaust systems to control phosgene leaks, only natural ventilation flowing through the shed wall opening from the atmosphere.

NFPA 55 includes guidelines for controls in buildings that store compressed gas cylinders, and classifies the phosgene shed structure as an indoor storage area because the walls comprise more than 25 percent of the shed perimeter (Figure 12). Indoor storage for the use of highly toxic gases must have a gas cabinet, exhausted enclosure, or a gas room, according to NFPA 55. Exhausted enclosures, gas cabinets, or gas rooms fully enclose cylinders and associated process equipment and are equipped with ventilation systems to capture and treat hazardous vapors. The phosgene shed at Belle, though considered indoor storage by NFPA, did not contain a ventilation system; instead, DuPont relied on natural ventilation from the outside to decrease concentrations of phosgene, which allowed phosgene vapors to travel downwind,

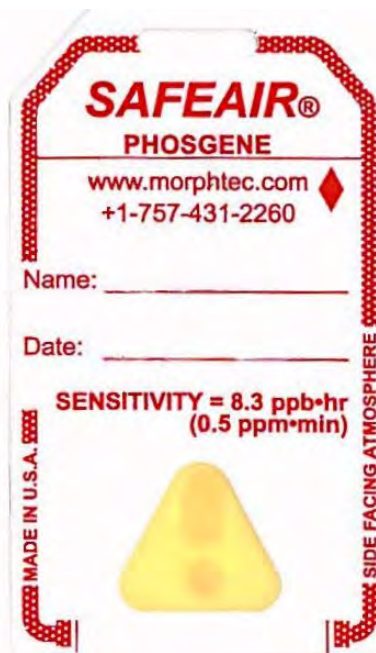
Figure 13. SafeAir Phosgene Dosimeter Badge<sup>37</sup>

<sup>37</sup> The badge in Figure12 has a range of 0.5 to 450 ppm-min. The SafeAir badge worn by the exposed employee had a range of 0.9 to 100 ppm-min.

Immediately after the operator was sprayed, he called for assistance on the SLM unit public address phone in the phosgene shed. A co-worker who responded to the call for assistance noticed the victim's phosgene dosimeter badge (Figure 13) was discolored, indicating an exposure. The co-worker directed the exposed worker to a plant truck to transport him to the plant's medical center for assessment and treatment. As they drove to the medical center, the two workers were met by the Shift Supervisor and the exposed worker was transferred to the shift supervisor's vehicle to complete the trip. While en route to the plant's medical center, the front gate guard was radioed and advised to call Metro 9-1-1 and request that an ambulance respond for a medical emergency. The exposed worker, while at the medical center waiting for the ambulance, chose to wash his face and hands, but there is no evidence or record that he was placed in a safety shower to wash off, as instructed by the emergency procedures, or that any decontamination activity took place beyond his washing his face and hands. He was given a change of coveralls to put on in exchange for the work clothes he was wearing at the time of exposure. The gate guard called Metro 9-1-1 at 1:59 p.m., requesting transport for a medical emergency patient to the hospital. The 9-1-1 dispatcher asked if there was a chemical release; however, the gate guard, who was unaware of the situation, responded that there was no release and that the response was for a medical emergency. As part of the Metro 9-1-1 emergency response protocol, the dispatcher asks for specific information to ensure that responders are as informed as possible prior to arrival at the scene. At 2:03 p.m., an ambulance was dispatched from the Kanawha County Emergency Ambulance Authority (KCEAA).

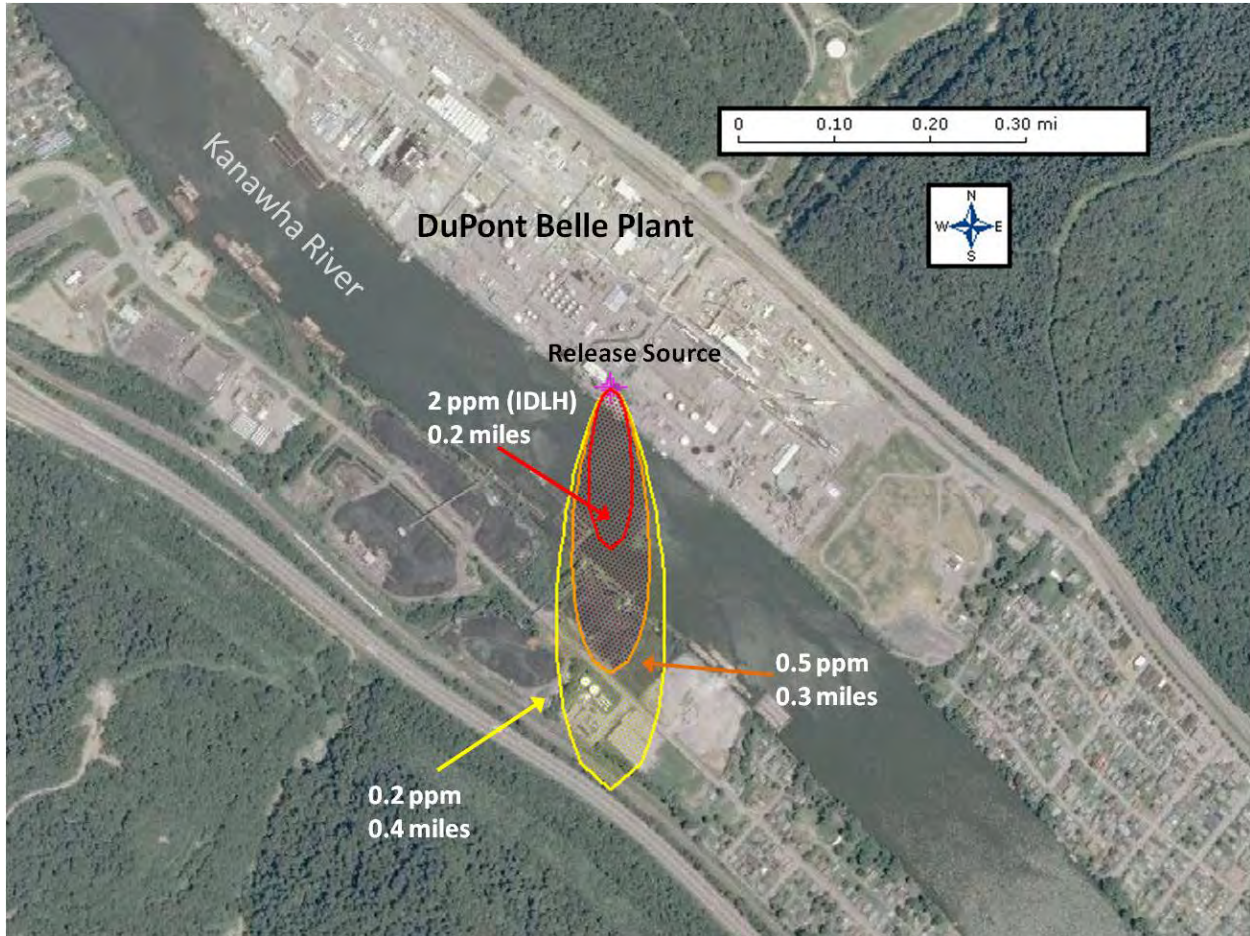
Figure 19. ALOHA estimate of phosgene concentrations with MARPLOT GIS overlay

The ALOHA program generated a display of concentration “threat zones” over a distance downwind from the source of the release. Using the U.S. EPA MARPLOT program, threat zones are displayed over a satellite map of the area using a graphical information system (GIS) interface (Figure 19).

The release estimates from the ALOHA program are based on the weather conditions recorded at the Charleston Yeager Airport around the time of the January 23, 2010 phosgene release, but may not accurately represent atmospheric conditions at the plant. The ALOHA program also does not consider the topography or terrain surrounding the plant. The fence line monitors south and southwest of the phosgene shed recorded phosgene concentrations between 0 and 0.27 ppm, suggesting phosgene vapor may have traveled south of the DuPont Belle plant fence line toward the river. The ALOHA threat-zone overlay in Figure 19 displays a model of the worst case release conditions indicating IDLH concentrations of phosgene could have been present on the Kanawha River shortly after the release and lower concentrations could have traveled across the river. There were no reports of odors or exposure symptoms from the community on the afternoon of the phosgene release incident.
