INVESTIGATION REPORT

STERIGENICS

ONTARIO, CALIFORNIA AUGUST 19, 2004

REPORT NO. 2004-11-I-CA ISSUE DATE: MARCH 2006

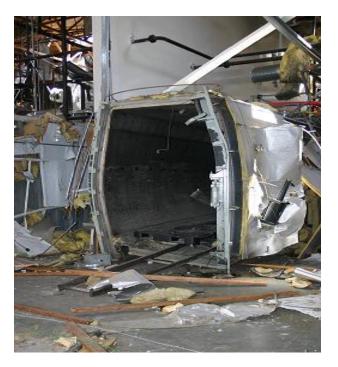
Figure 1 Facility Damage

On August 19, 2004, an explosion inside an air pollution control device and medical products sterilization chamber at Sterigenics International, Inc., in Ontario, California, injured four workers and severely damaged the facility (see Figure 1). Neighboring businesses were evacuated for several hours and operations at the Ontario facility were disrupted for 9 months.

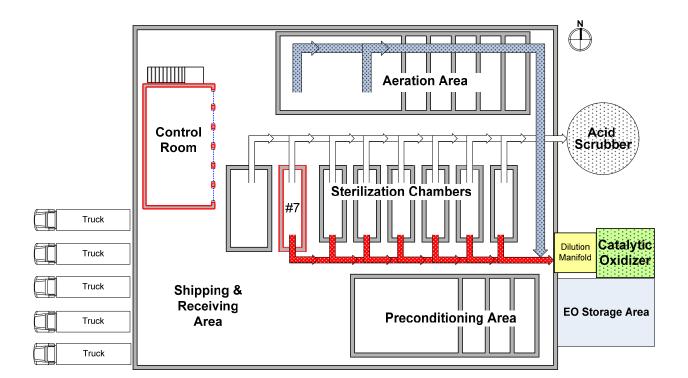
Figure 2 Ontario Plant Layout

The explosion occurred when maintenance personnel entered a password to override computer safeguards, allowing premature opening of the sterilizer door. This caused an explosive mixture of ethylene oxide (EO) to be evacuated to the open-flame catalytic oxidizer¹ (oxidizer) by the chamber ventilation system. The oxidizer is used to remove EO in compliance with California air quality regulations. When the EO reached the oxidizer it ignited and the flame quickly traveled back through the ducting to the sterilizer where approximately fifty pounds of EO ignited and exploded. Figure 2 is an illustration of the facility floor plan and location of key equipment involved in the explosion.

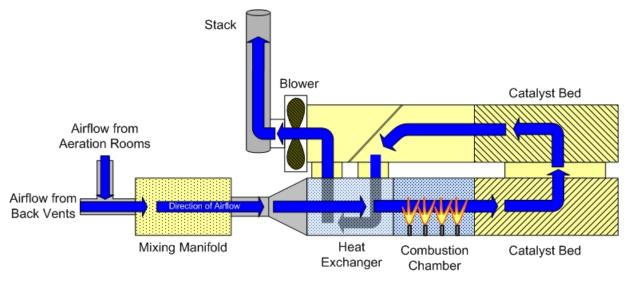
Figure 7 Diagram of Catalytic Oxidizer

The oxidizer has several safety features focused on preventing damage to the oxidizer, but none of these features prevent high concentration chamber exhausts from igniting. Likewise, there is nothing associated with the design of the oxidizer or ventilation system that can detect or stop a flame front from traveling from the oxidizer back to a chamber.
