U.S. CHEMICAL SAFETY AND HAZARD INVESTIGATION BOARD

INVESTIGATION REPORT

ALLIED TERMINALS, INC.— CATASTROPHIC TANK COLLAPSE

REPORT NO. 2009-03-I-VA

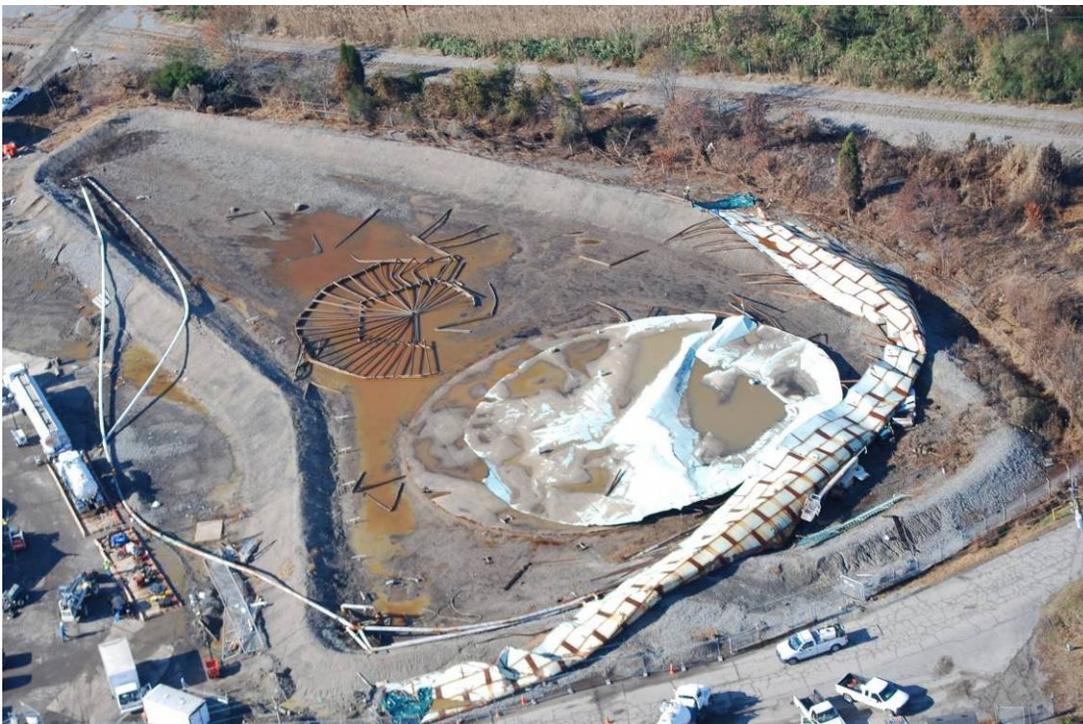
Figure 1. Allied collapsed tank and neighboring business.

On November 12, 2008, at about 2:20 pm, a 2-million-gallon nominal capacity liquid fertilizer tank catastrophically failed at the Allied Terminals, Inc. (Allied) facility in Chesapeake, Virginia (Figure 1). The tank split open vertically and nearly instantaneously released about 2.1 million gallons of liquid fertilizer. A welder and his helper were working on the opposite side of the tank as it collapsed. Both sustained serious injuries due to the collapsing tank and immersion in the liquid fertilizer. Employees from a neighboring business (shown in upper left of Figure 1) rescued the two workers.

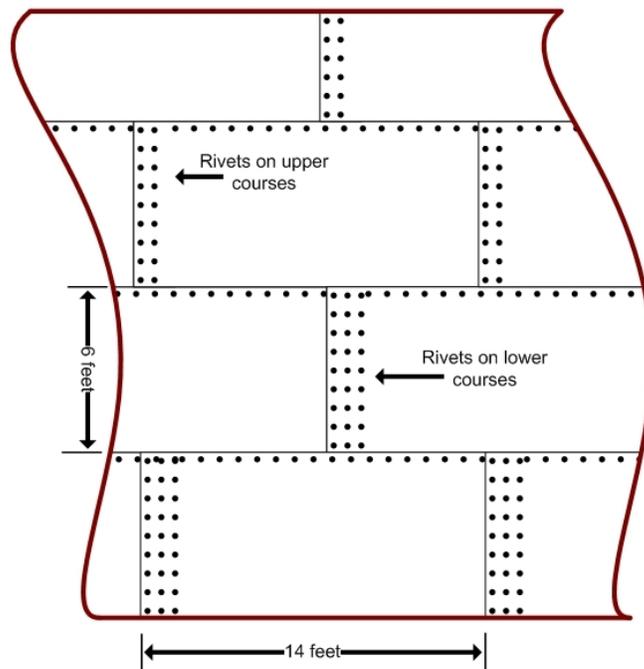
Figure 7. Tank 201 design prior to modification.

Tank 201, originally designed and constructed in 1929 for petroleum product storage, was 116 feet in diameter and about 30 feet high. The shell was constructed of overlapping riveted plates, each approximately 6 feet high and 14 feet long. The plates were joined end to end to form six rings (courses) that were stacked to form the tank. A single row of rivets joined the courses horizontally, while three vertical rivet rows joined the plate ends on the bottom two courses and two rows joined the plate ends on the upper four courses (Figure 7). Overlapping welded plates were used on the bottom and the cone-shaped roof. A second tank bottom was added inside the tank prior to Allied's purchase of the facility.

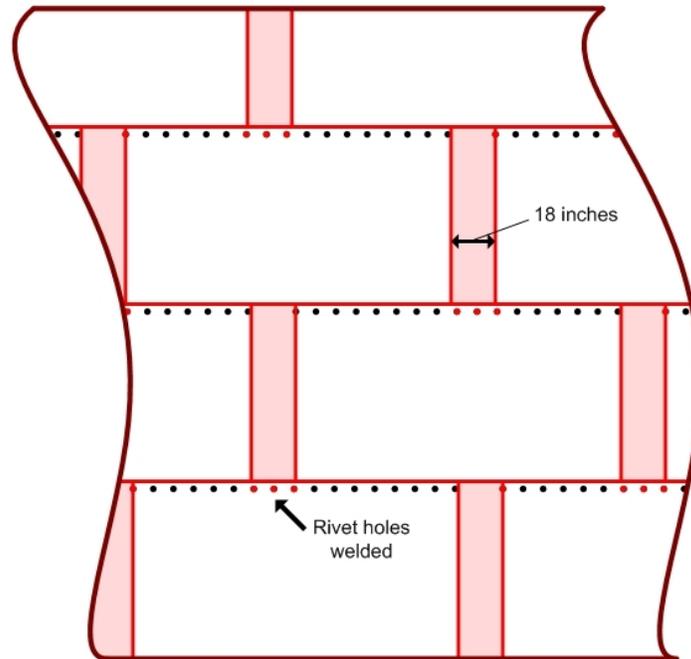
Figure 8. Tank 201 modification design.

The liquid fertilizer stored in Tank 201 weighed more per unit volume (density) than the petroleum products for which the tank was designed (about 11 pounds per gallon for the UAN 32 solution compared to 6 pounds per gallon for petroleum products). To increase the usable capacity of the tank, Allied contracted G&T to remove 18-inch wide sections of the shell plates containing the vertical riveted joints and replace them with butt-welded plates,¹⁴ following the requirements of API 653 (Figure 8). Allied intended this modification to strengthen the joints and permit a higher maximum liquid level, and contracted G&T to perform the same modification on three similar tanks: Tanks 202, 205, and 209.

Following the modifications, Allied paid a non-destructive testing company to examine the welds for defects using spot radiography.¹⁵ However, Allied paid for the examination of only the lower two courses of Tanks 202 and 209. The upper courses of Tanks 202 and 209 and the entirety of Tanks 201 and 205 were not radiographed prior to returning these tanks to service. The radiography performed identified multiple weld defects in the lower courses of both 202 and 209.¹⁶
