BETA LAB No.M10198- LS3 TOP	TESORO REFINING AND MARKETING COMPANY ANACORTES REFINERY 10200 W. MARCH POINT ROAD T91WA4428 ANACORTES, WA 98221	CUSTOMER P.O. No.: 4501667904
PART: 6600-E HEAT EXCHANGER LS 3 TOP PART 15		DATE: SEPTEMBER 20, 2010
PAGE 14 OF 53

LABORATORY REPORT-LS3 TOP

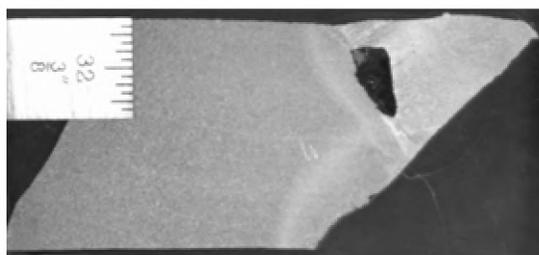
15 M-3

Figure 14. Macro photographs of the samples evaluated in this report with matching samples. In these photographs O.D. is on the top.

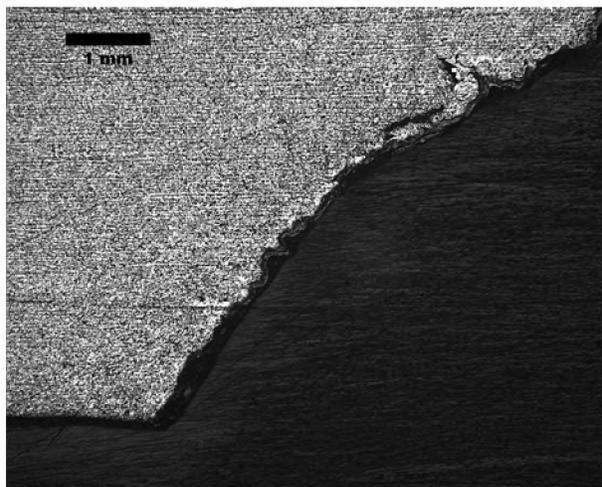
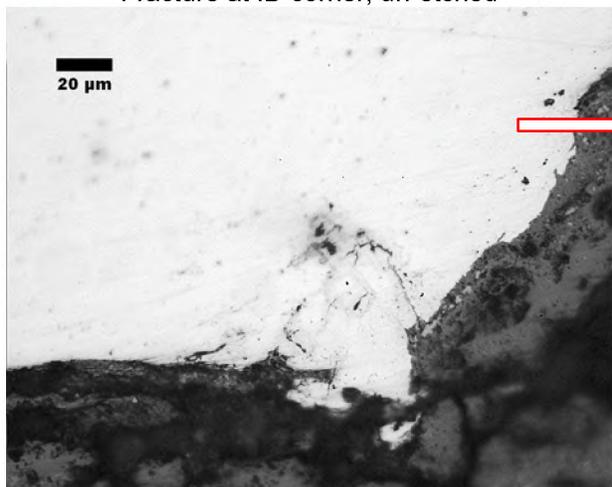
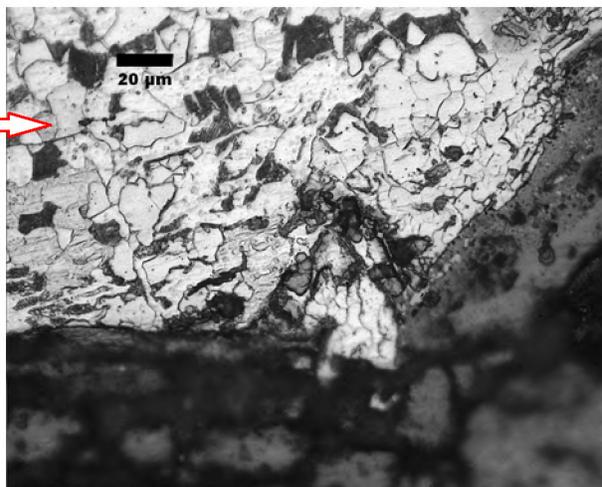
Figure 15

Fracture at ID corner, un-etched

Same as at left, etched

Same as above at higher magnification

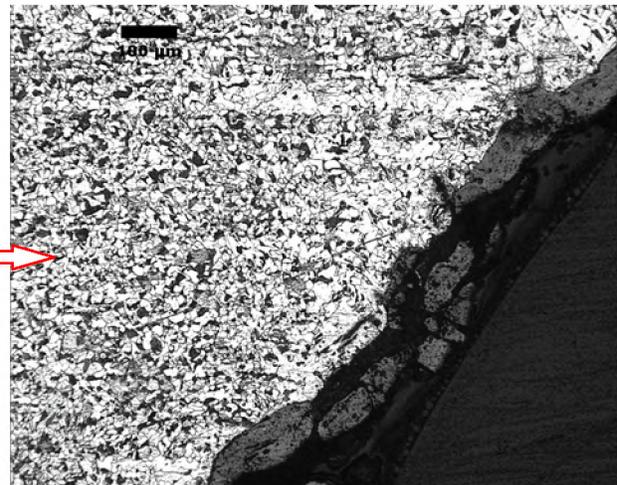
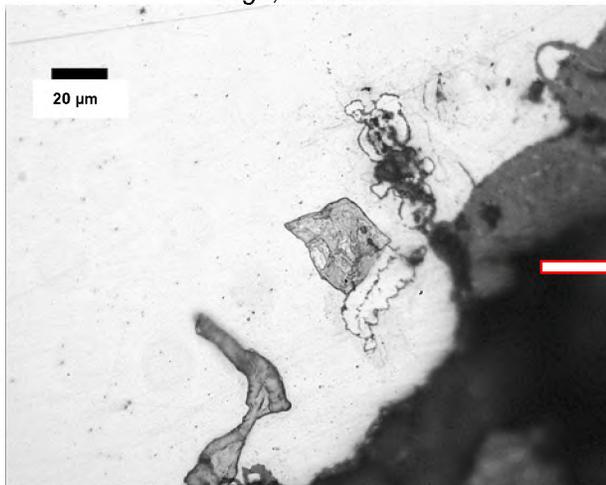
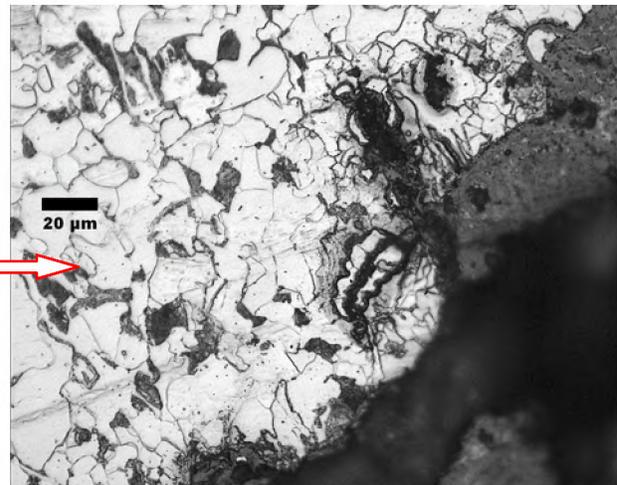
Figure 16

One field up from the ID corner along the fracture edge, un-etched

Same as at left, etched

Same as above at higher magnification, un-etched

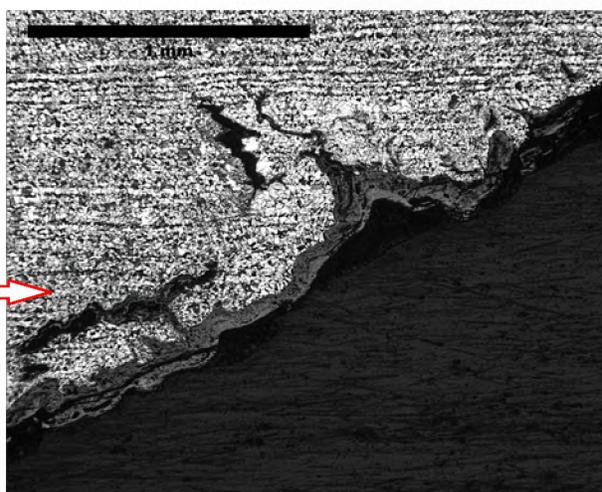
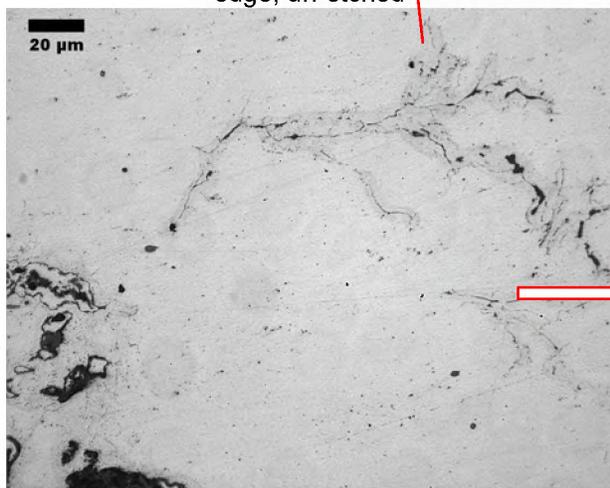
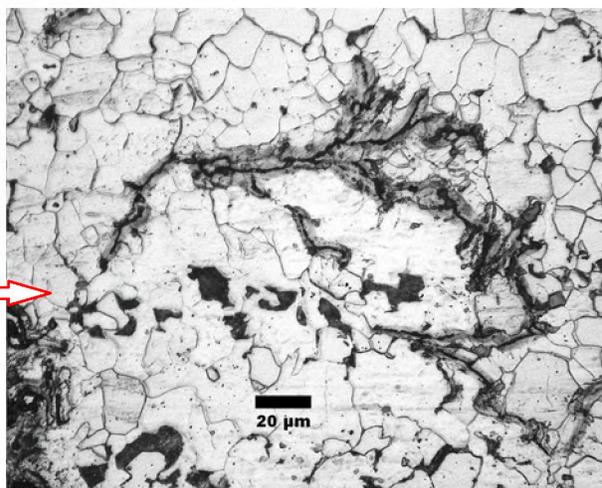
Figure 17

Two fields up from the ID corner along the fracture edge, un-etched

Same as at left, etched

Same as above at higher magnification, un-etched

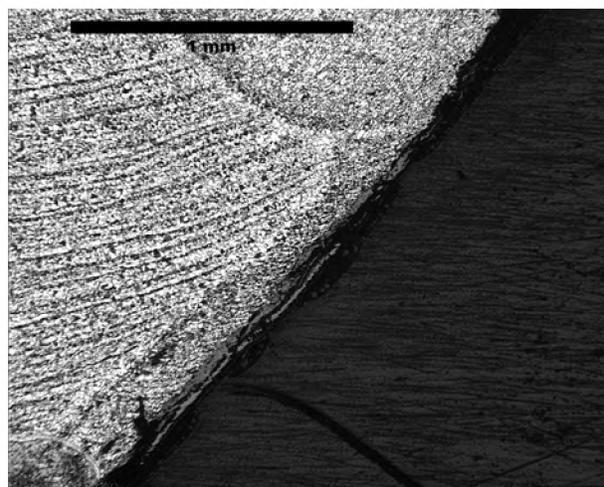
Figure 18

Area at HAZ and Weld Metal, un-etched

Same as at left, etched

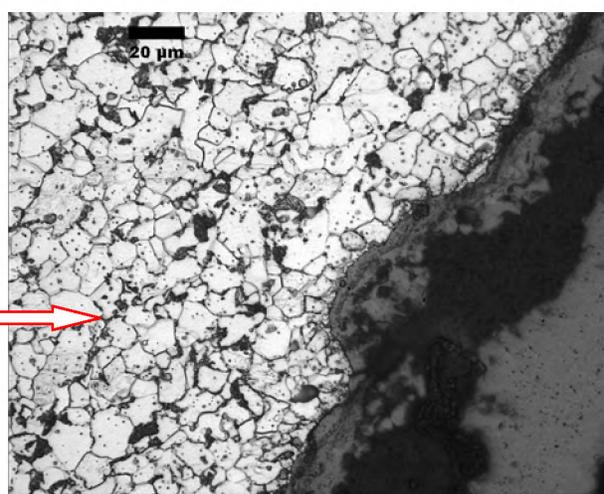
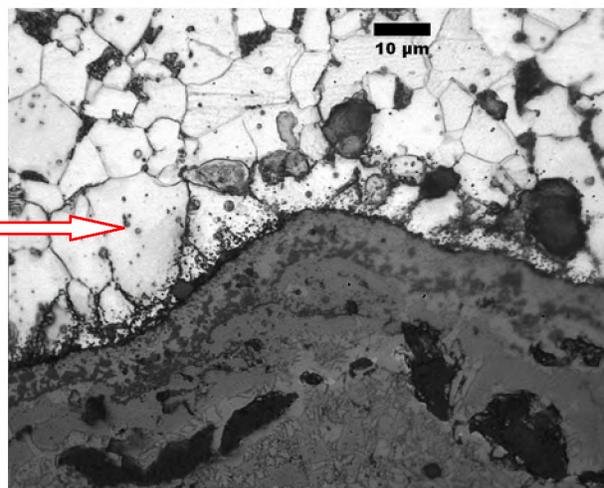
Figure 19

Approximately mid-wall along the fracture edge, un-etched

Same as at left, etched

Area at fracture edge near OD, un-etched

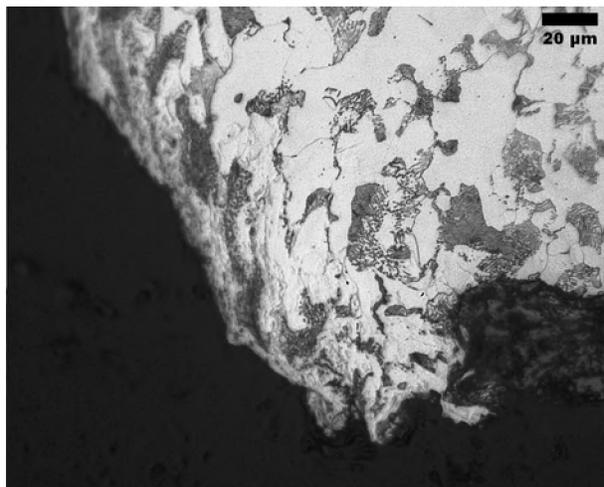
UPPER ARROW OFF
Figure 20

Base Metal at ID corner at the cut. Un-etched

Same as at left. Etched

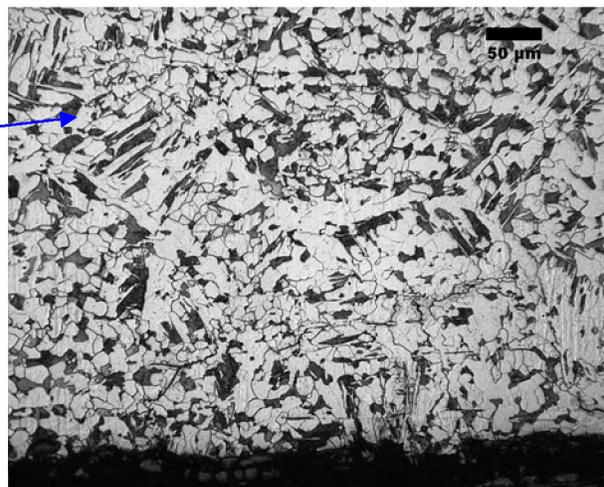
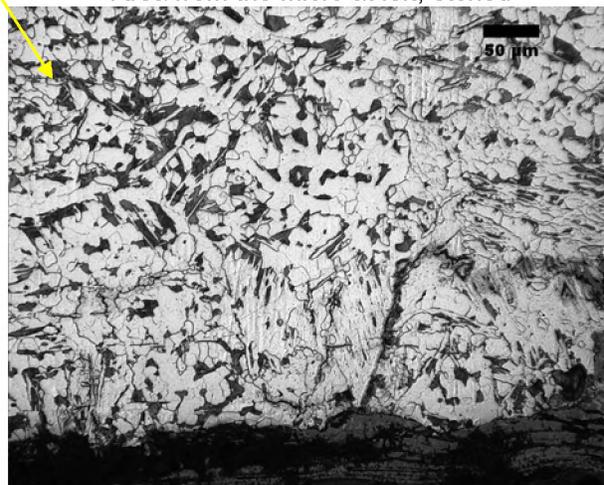
Figure 21

Area near the crack, un-etched

Area from the micro at left, etched
