U.S. CHEMICAL SAFETY AND HAZARD INVESTIGATION BOARD

INVESTIGATION REPORT

VAPOR CLOUD DEFLAGRATION AND FIRE

BLSR OPERATING, LTD.

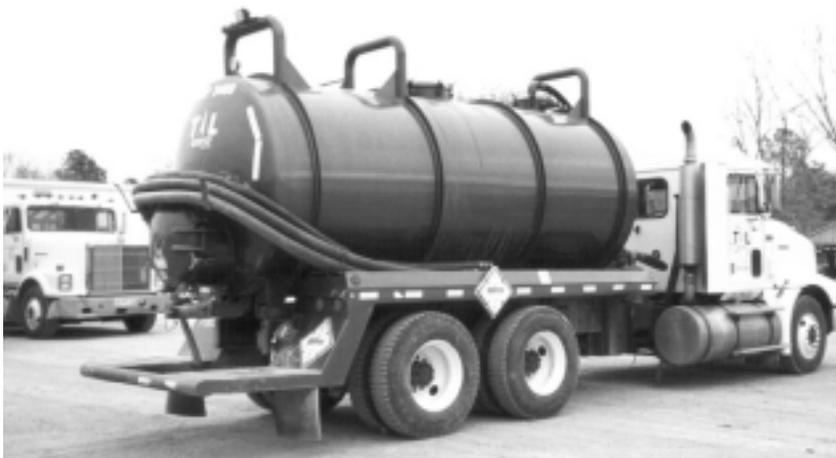
Figure 1 shows a typical 50-barrel vacuum truck, similar to the two that were destroyed in the January 13 incident. T&L management stated that the trucks were not authorized to transport flammable liquids; this was confirmed by truck tank manufacturing records (Section 5.4).

Figure 1. Typical vacuum truck used to haul oilfield waste liquids.

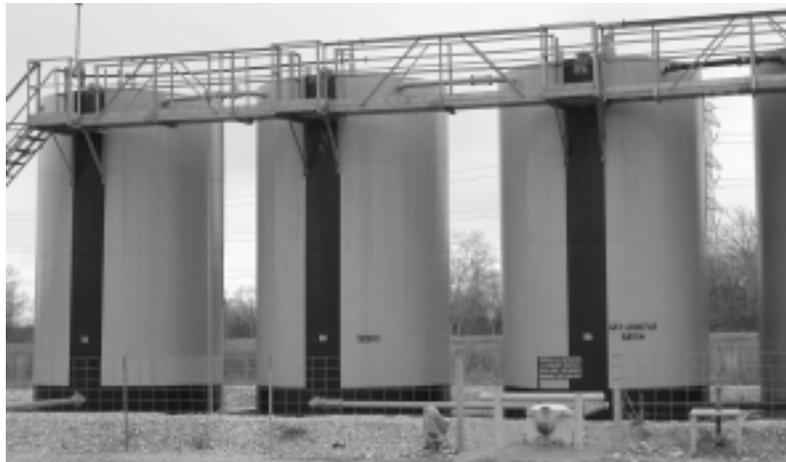
Condensate consists primarily of hydrocarbon liquid with trace amounts of contaminants, including water, paraffin, sand, and other materials. It is stored in aboveground storage tanks (Figure 2), where resident time provides further separation of the liquids and remaining entrained solids. BS&W settles to the bottom of the tank, and the lower specific gravity condensate floats on top.⁸

Figure 2. CJ Waller lease water and condensate storage tanks.

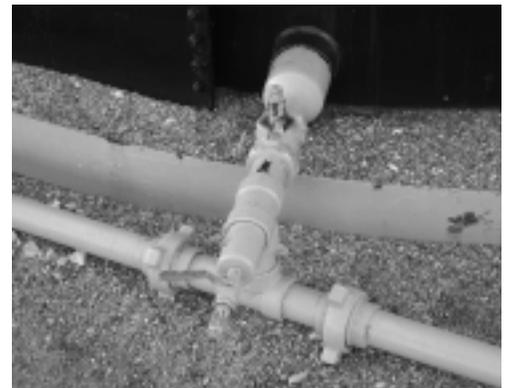
Figure 3. Condensate tank drain manifold and valves.

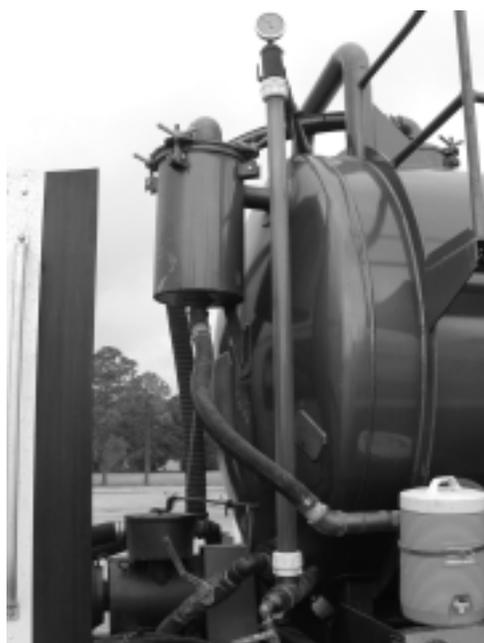
Figure 4. Typical vacuum truck tank sight gauge.

All T&L drivers and other waste hauler drivers interviewed by CSB stated that they were clearly instructed to avoid removal of condensate when removing BS&W from the storage tanks. However, the ability to avoid condensate removal is dependent on the technique the driver uses to measure the storage tank contents. Some waste hauler drivers report that they use a gauge line¹² to “color cut”¹³ the contents of the storage tank, providing an actual measurement of BS&W removed. Other drivers use the gauge line only to measure the total height of condensate plus BS&W in the storage tank before and after removal of the liquid. Some drivers use the sight gauge mounted on the truck tank (Figure 4) to estimate the amount of liquid removed from the storage tank.

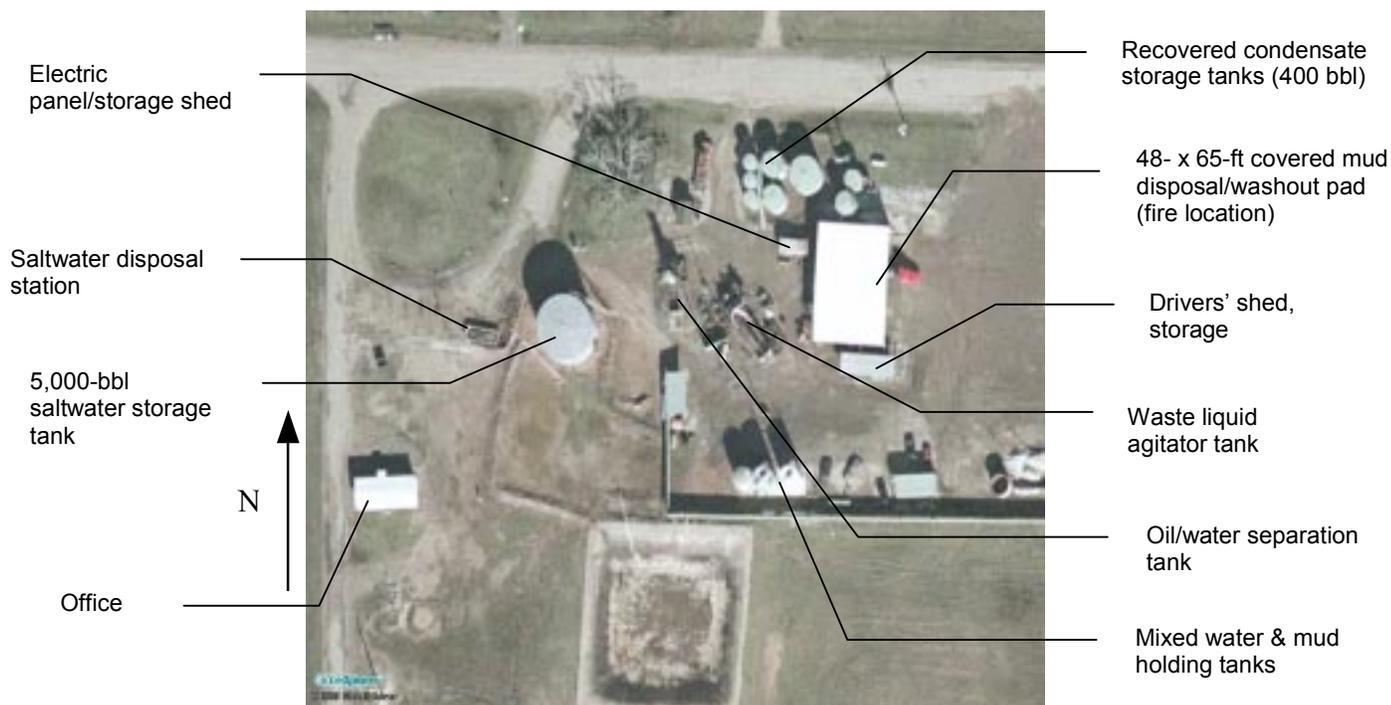
Figure 5. BLSR facility layout.

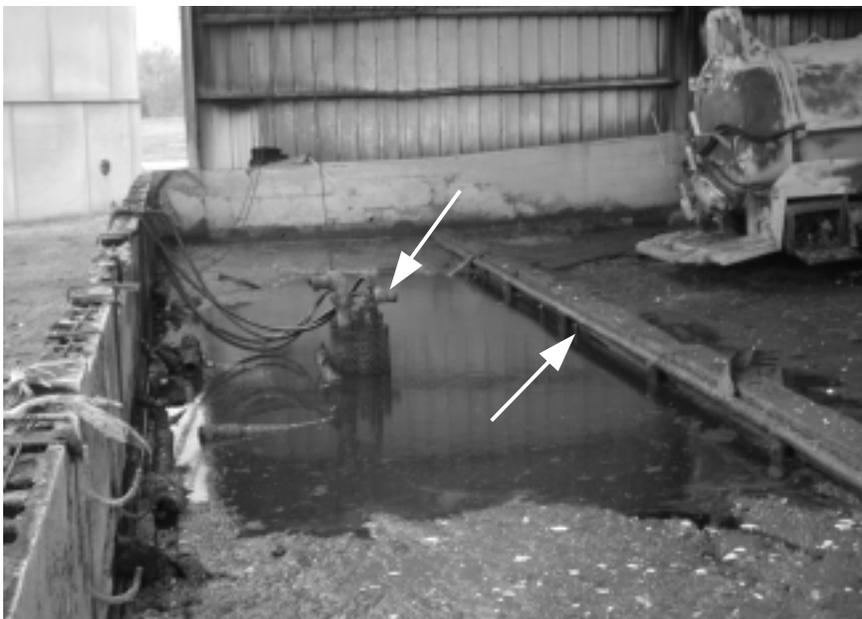
Two hydraulically operated lift pumps (Figure 6) transfer the waste liquids through polyvinyl chloride (PVC) pipes to an open-top waste liquid agitator tank located 40 feet west of the pad, or to the mixed water and mud holding tanks located about 70 feet south of the pad (Figure 5). Flexible hoses connect each pump to the PVC transfer pipes. Additionally, the pump discharge can be connected to a PVC header on the inside west wall of the pad to recirculate the liquid and further dilute the mud. Significant volumes of waste liquid, including potentially flammable BS&W, typically accumulate when offloading onto the concrete pad; the sump pumps have a lower flow capacity than multiple draining vacuum truck tanks.

Figure 6. Pad area hydraulic sump pumps and wooden stop beam.

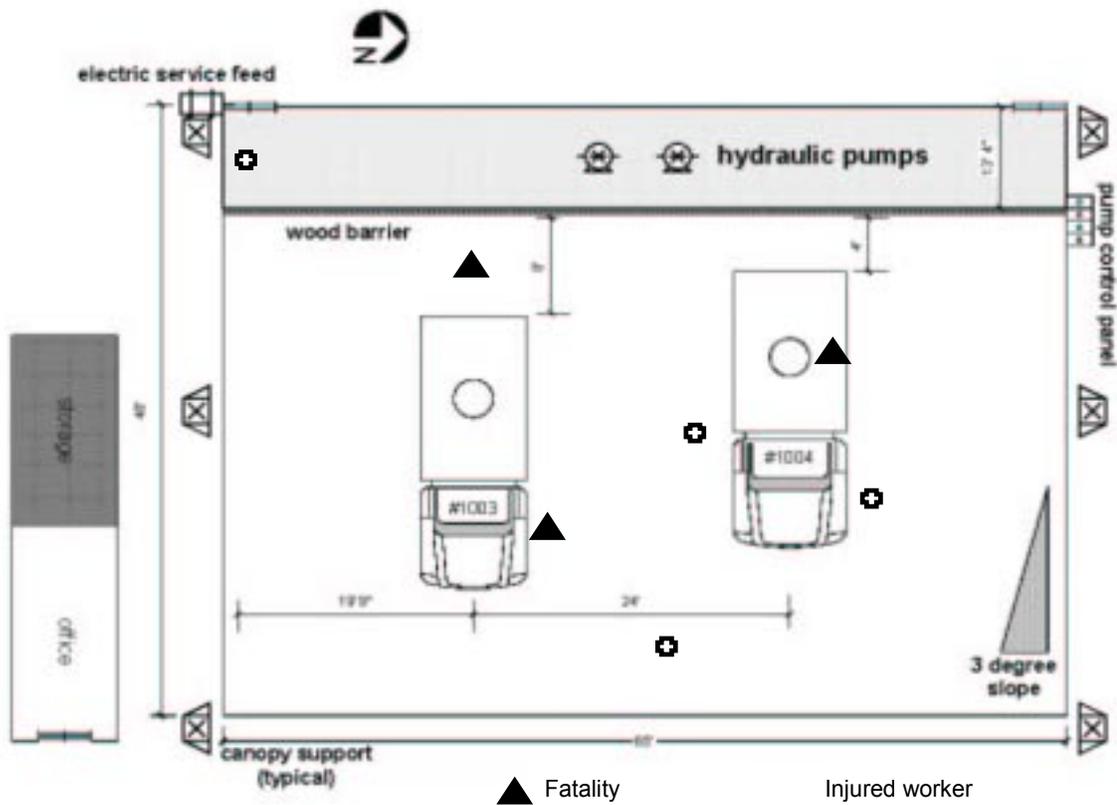
A 220-volt electrical service feed and circuit breaker box are attached to the southwest canopy support. Fluorescent lights attached to the canopy ceiling were used for nighttime operations. Droplights were suspended from the canopy. A large radial fan attached to the canopy was used as needed to vent noxious vapors during washing operations. With the exception of the droplights, none of the electrical conduits, fixtures, or boxes were certified for use in a flammable environment.

Figure 7. Layout of mud disposal and washout pad, with T&L vacuum trucks positioned as on January 13, 2003.

The trucks arrived at BLSR within a few minutes of each other. Each driver backed onto the mud disposal and washout pad to unload BS&W and have the truck tanks rinsed out. The trucks were approximately 16 feet apart and equally distant from each side of the pad (Figure 7). Based on the service work order recovered from the drivers' shed and the vehicle license plate, the truck parked on the north side was #1004; the truck parked on the south side was #1003.

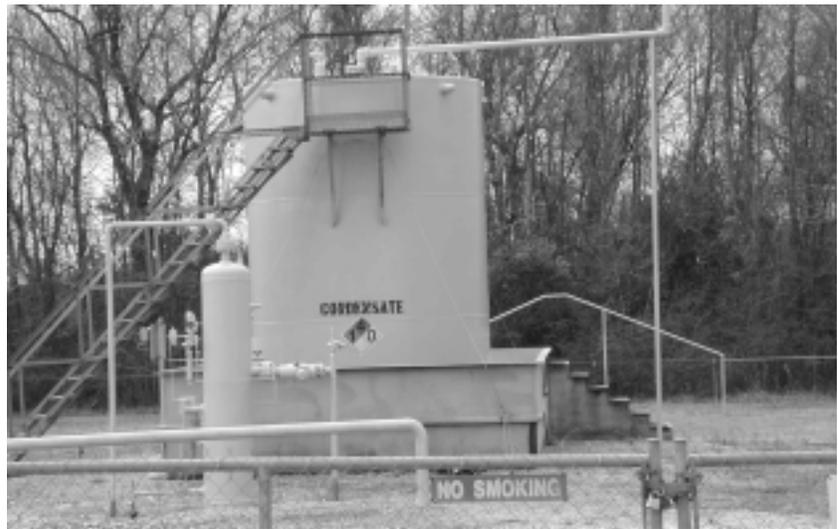
CSB observed that the condensate storage tanks at two gas pipeline metering stations in the area, owned by a gas transmission pipeline company, were labeled with the National Fire Protection Association (NFPA) hazard diamond displaying a flammability rating of 4 (very volatile flammable liquid; Figure 12).

Figure 12. Condensate storage tank located at gas regulator station.

BLSR management reports that drivers have actually delivered condensate to the disposal facility when they thought they had collected water or BS&W from a well site storage tank; they had inadvertently removed saleable product liquid by drawing from the wrong tank. Proper storage tank labeling might help prevent future occurrences of this dangerous and wasteful practice.

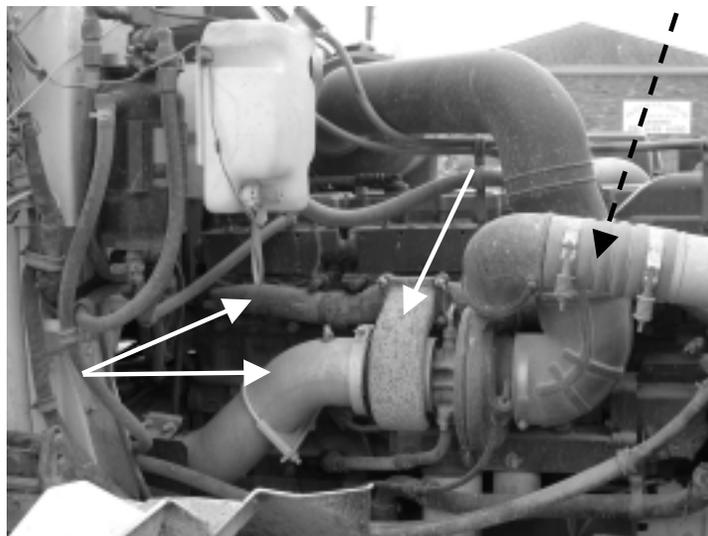
The T&L truck engines were not equipped with overspeed protection devices in the intake or exhaust systems. Eyewitness accounts of the over-revving are clear evidence that the air intake system was drawing in flammable vapor prior to the deflagration. Eyewitnesses reported hearing loud backfiring from one of the engines. Examination of the truck engines and debris confirmed that the metal elbow on the south truck engine (Figure 15) separated from the turbocharger housing—which is a positive indication that the engine backfired through the intake system, potentially igniting flammable vapor.

One witness also reported that the hood on the south truck lurched up just before the vapor ignited, suggesting a high-pressure impulse around the engine. The elbow and attached short piece of flexible hose (dark arrow in Figure 16) were recovered and showed no fire damage, providing further evidence that the fitting had come off and fallen to the ground before the fire ignited and destroyed the engine.³²

Figure 16. Diesel engine exhaust and intake system.

³²For comparison, evidence suggests that either the north truck engine did not backfire, or the pressure wave from a backfire was not sufficient to blow the fitting off the turbocharger. A portion of the elbow was still attached to the turbocharger housing, and the remainder of the elbow and flexible hose was destroyed.
