U.S. CHEMICAL SAFETY AND HAZARD INVESTIGATION BOARD

FINAL INVESTIGATION REPORT

CHEVRON RICHMOND REFINERY PIPE RUPTURE AND FIRE

CHEVRON RICHMOND REFINERY #4 CRUDE UNIT RICHMOND, CALIFORNIA

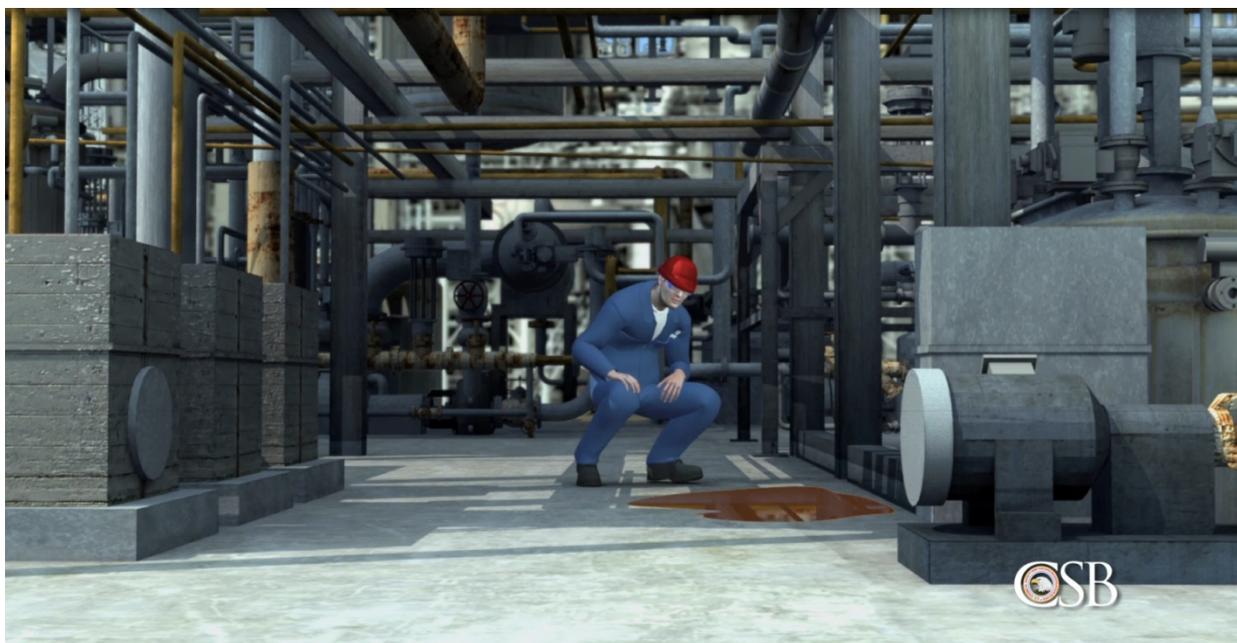
At approximately 3:50 p.m. on August 6, 2012, an outside operator performing routine checks of piping and equipment found an 18-inch puddle of what appeared to be a diesel-like material on the refinery concrete pad (Figure 6). Identifying that the leak was occurring from overhead, the operator observed intermittent drips as they accumulated on the underside of an insulated pipe 14 feet above ground level. The leaking pipe was identified to be a portion of the 4-sidecut piping that originated on the Crude Column. Visually analyzing the piping, the operator determined that the line could not be isolated from the process.

Figure 6. CSB animation depicting operator identifying the leaking 4-sided pipe.

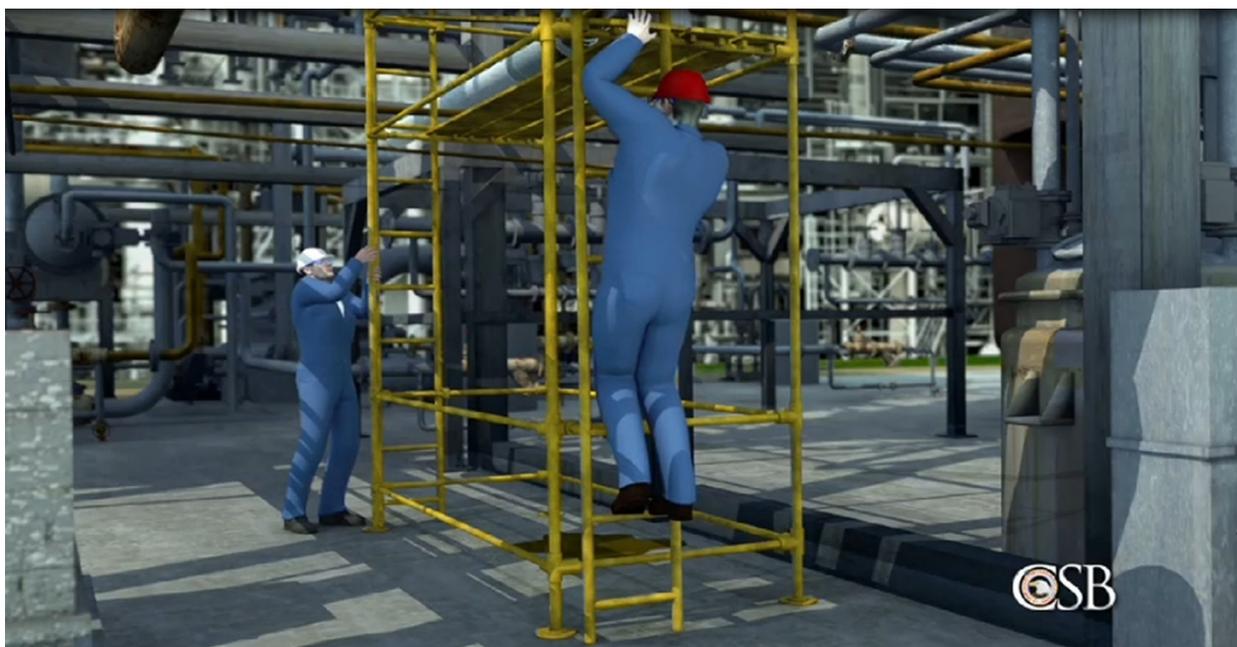
Contractors arrived at the scene to build the scaffold (Figure 10). During a pre-response safety meeting consisting of the Incident Commander, a safety officer, firefighters, and key operations personnel, one group of firefighters operating a hose was directed to spray the scaffold builders should an incident occur, and the other group of firefighters operating the second hose was directed to spray the pipe if needed. Three scaffold contractors then built the scaffold beneath the leaking 4-sidecut pipe.

Figure 10. CSB animation of contractors erecting scaffolding beneath the leak location.

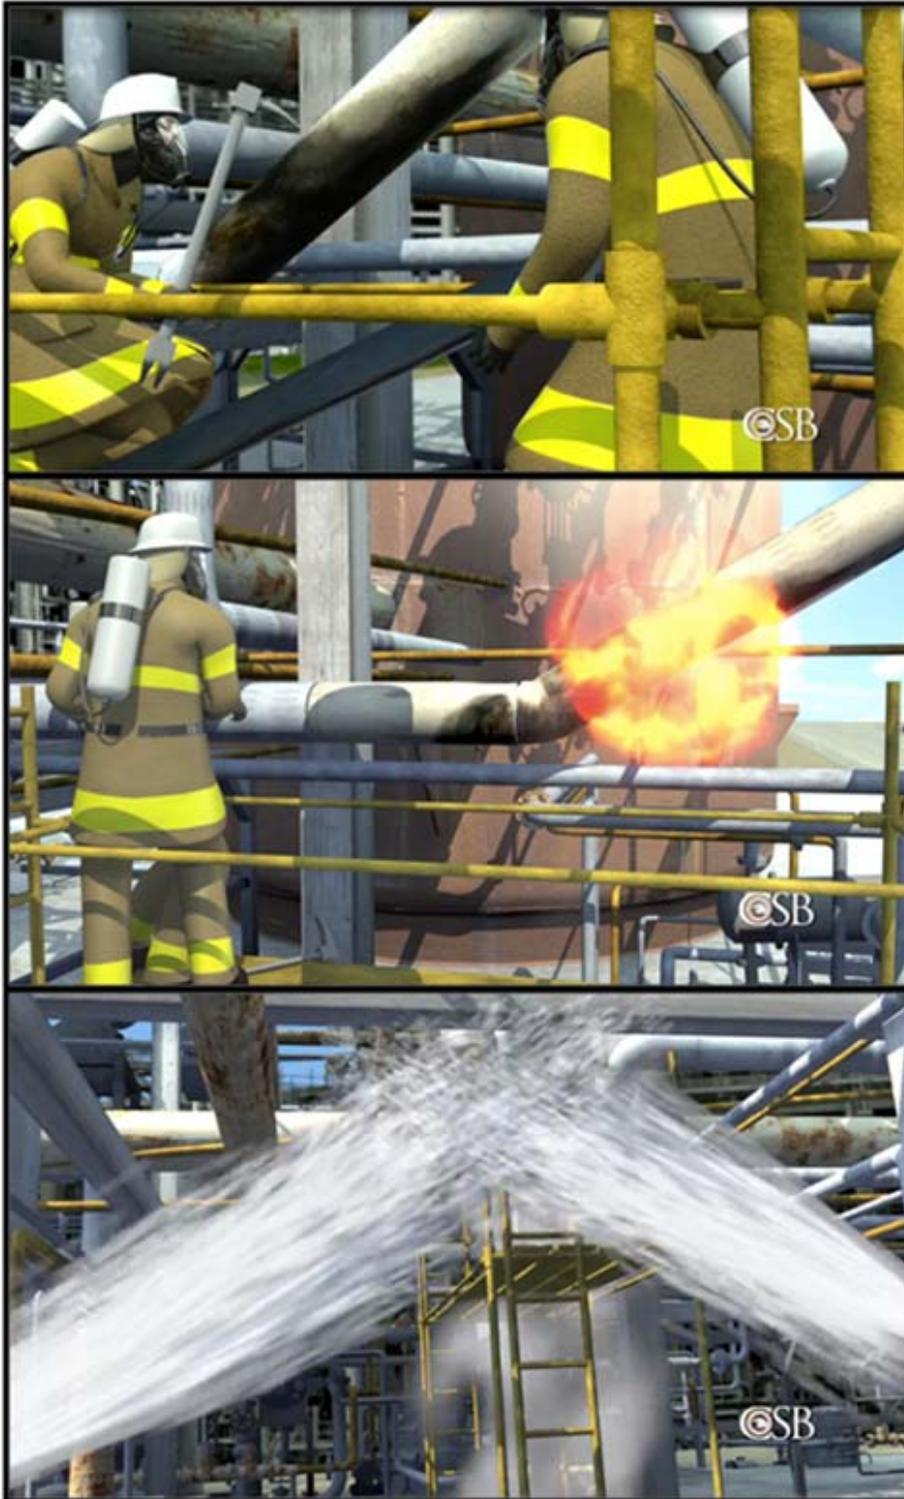
As the firefighters were removing the sheathing of the 4-sidecut line (shown in Figure 7), white hydrocarbon vapor visibly began to emerge from under the now-exposed insulation material. The firefighters continued to remove the sheathing despite the formation of hydrocarbon vapor. During the continued sheathing removal, insulation that was soaked with hot 4-sidecut hydrocarbon autoignited once exposed to oxygen—only feet from the firefighters. The hose teams immediately put out the fire, and both firefighters quickly came down from the scaffold (Figure 11).

Figure 11. CSB animation of firefighters attempting to remove the 4-sidecut insulation, the resulting fire, and fire extinguishing.

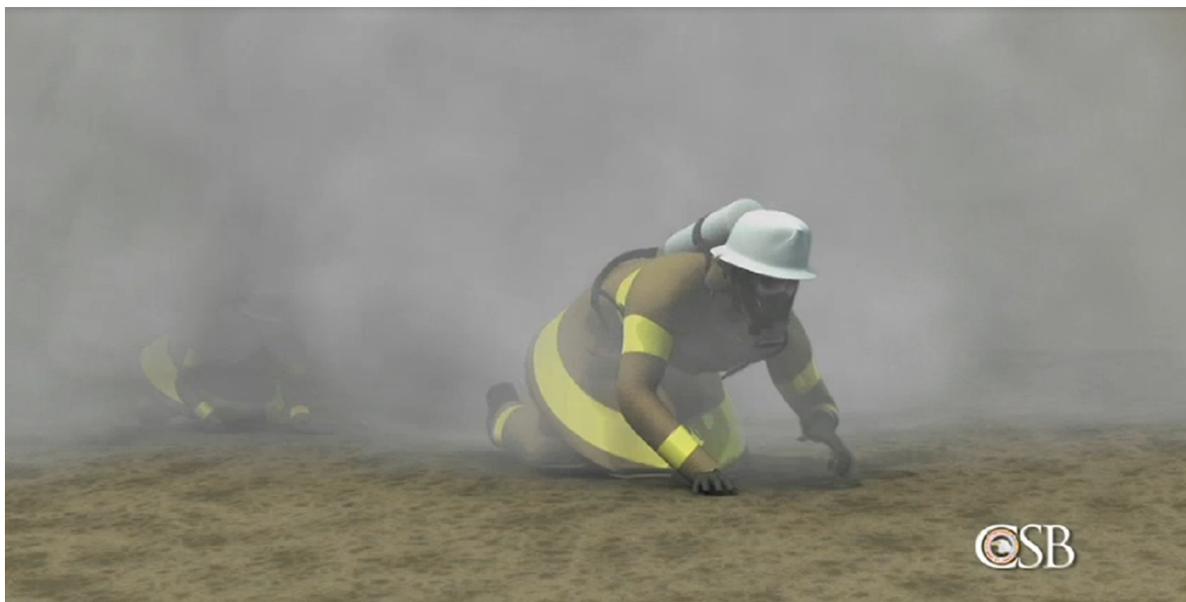
Each person engulfed in the cloud began working their way out of the vapor cloud. Several of the firefighters operating the two hoses dropped to their hands and knees to follow their hose lines to safety, feeling their way out of the cloud (Figure 12).

Figure 12. CSB animation of firefighters who dropped to their hands and knees to escape the vapor cloud.

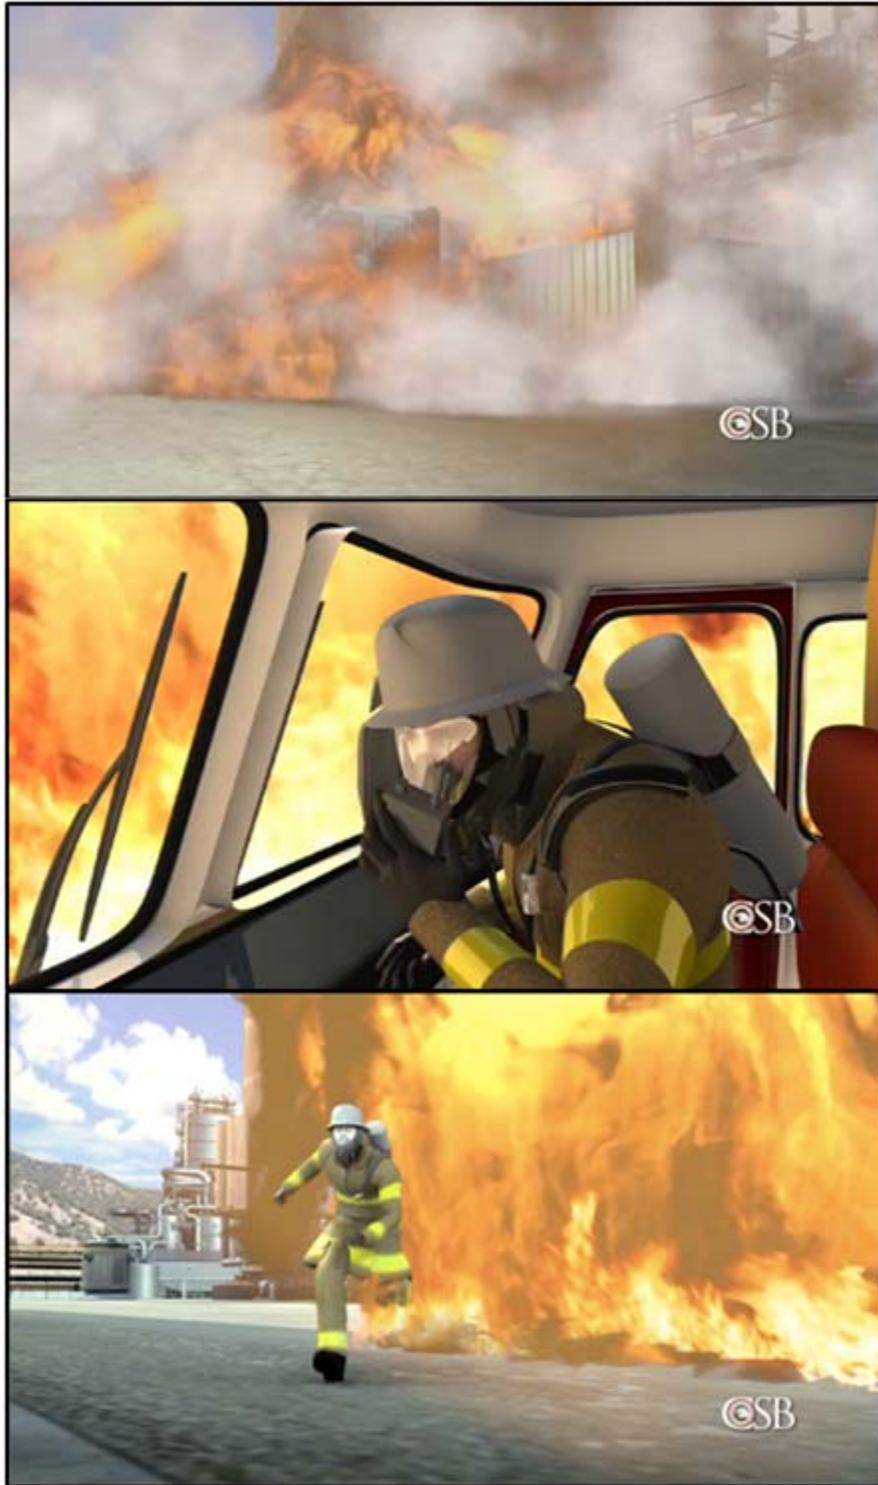
At approximately 6:30 p.m., two minutes after the large vapor cloud formed, the light gas oil ignited.⁵³ Eighteen employees safely escaped from the cloud just before ignition. One employee, a firefighter, was inside a fire engine that was engulfed in the fireball when the light gas oil ignited (Figure 13 and Figure

Figure 13. CSB animation of firefighter who was inside the fire engine when the light gas oil ignited.

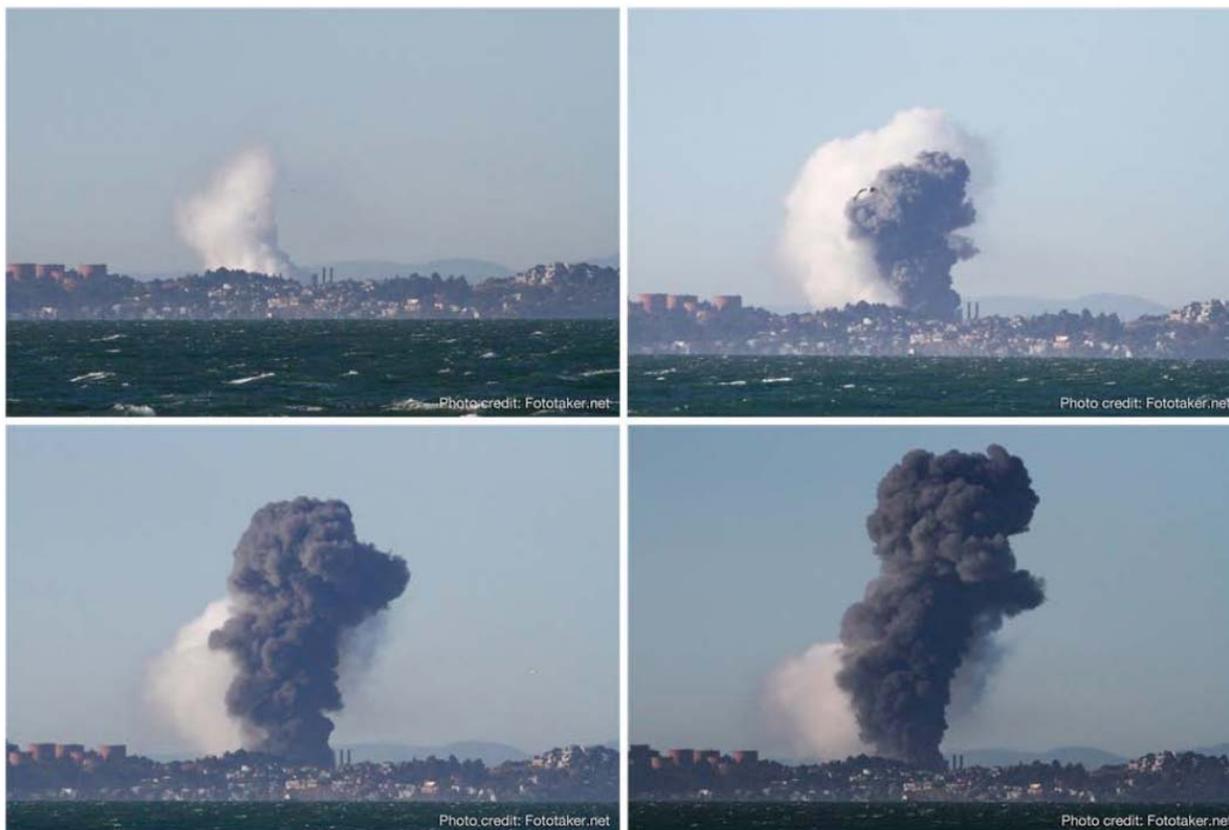
Figure 15. Initial vapor cloud formation (white cloud) and subsequent ignition (black smoke) as seen from a pier in San Francisco, California.⁵⁷

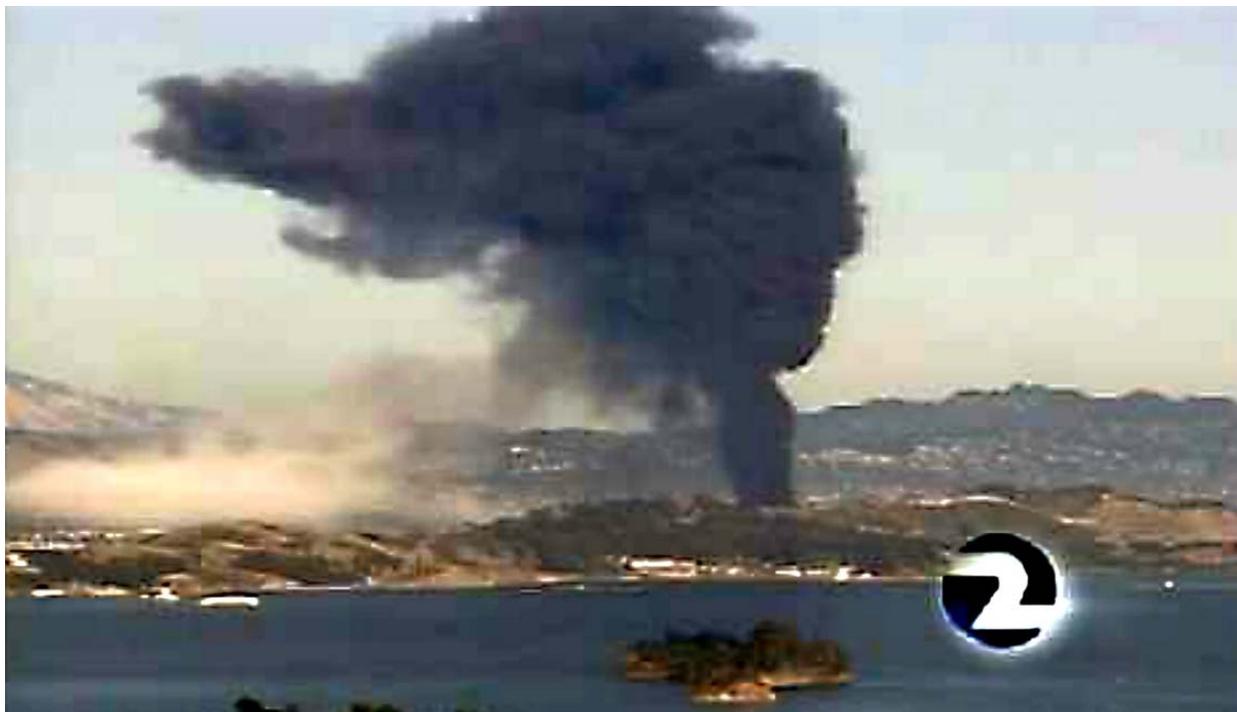
Figure 16. Vapor cloud and ignition seen from Marin County.⁵⁸

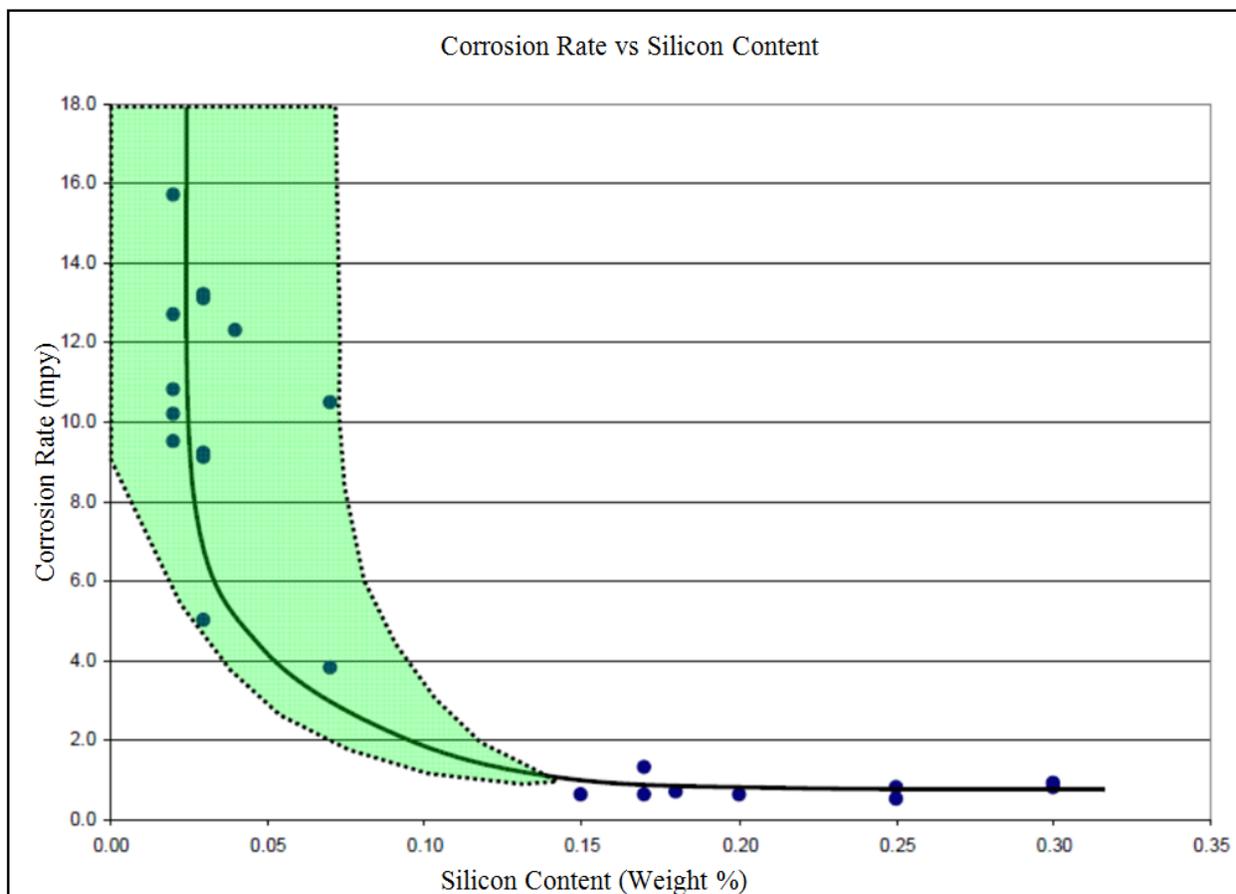
Sulfidation corrodes carbon steel at a much faster rate in comparison with its effect on other materials of construction, such as steels with a higher chromium content. This issue is discussed in depth in the CSB's Interim Investigation Report of the August 6, 2012, Chevron incident.⁶⁵ In addition to its naturally faster rate of sulfidation corrosion when compared with higher chromium steels, carbon steel can also experience significant variation in corrosion rates due to variances in silicon content, a component used in the steel manufacturing process. Carbon steel piping containing silicon content less than 0.10 weight percent can corrode at accelerated rates,⁶⁶ up to 16 times faster than carbon steel piping containing higher percentages of silicon. Figure 17 shows how carbon steel corrosion rates can greatly vary depending on silicon content.

Figure 17. Graph of sulfidation corrosion rates with respect to silicon content in carbon steel. This graph shows how corrosion rates increase in carbon steel containing decreasing percentages of silicon. This information can be found in Annex C of *API RP 939-C*.⁶⁷

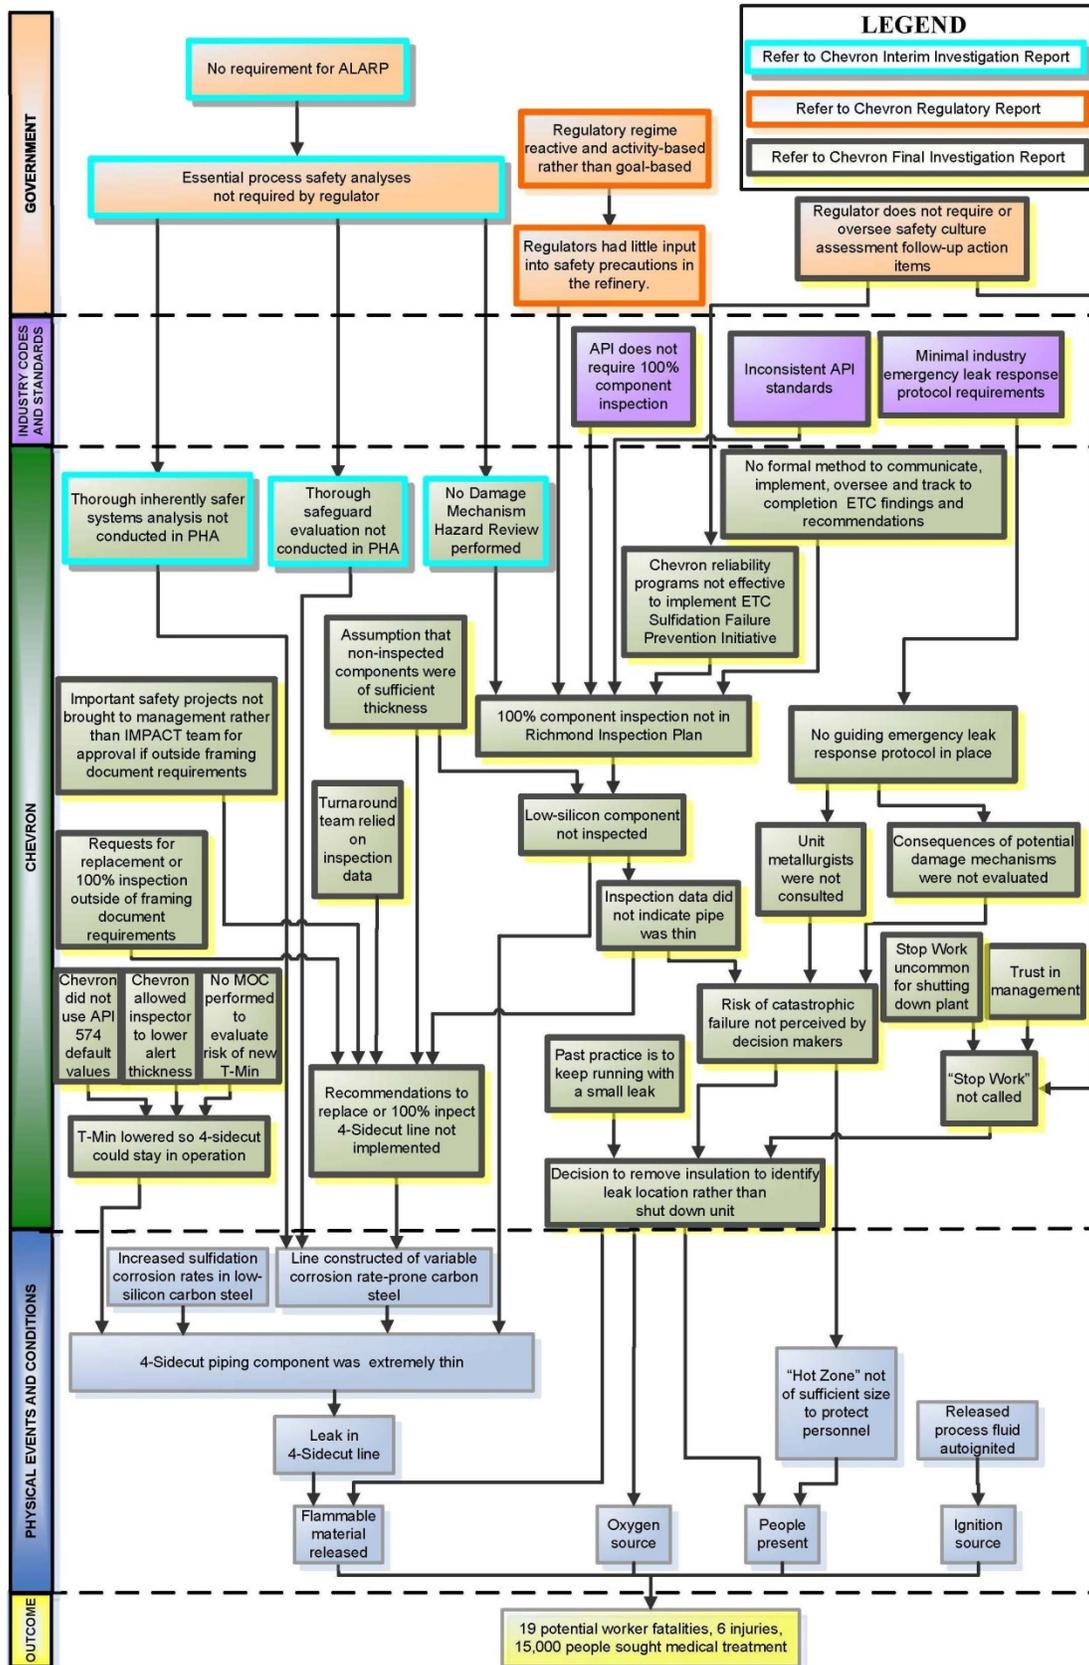
The CSB investigation team developed an accident map (AcciMap)¹¹⁴ for the Chevron investigation (Figure 24). The AcciMap is a multilayered causal diagram that depicts immediate causes¹¹⁵ as well as higher level contributing causes at the corporate, governmental, and regulatory levels. This diagram includes five levels:

Figure 24. Acci-Map of August 6, 2012, Chevron Refinery Fire.

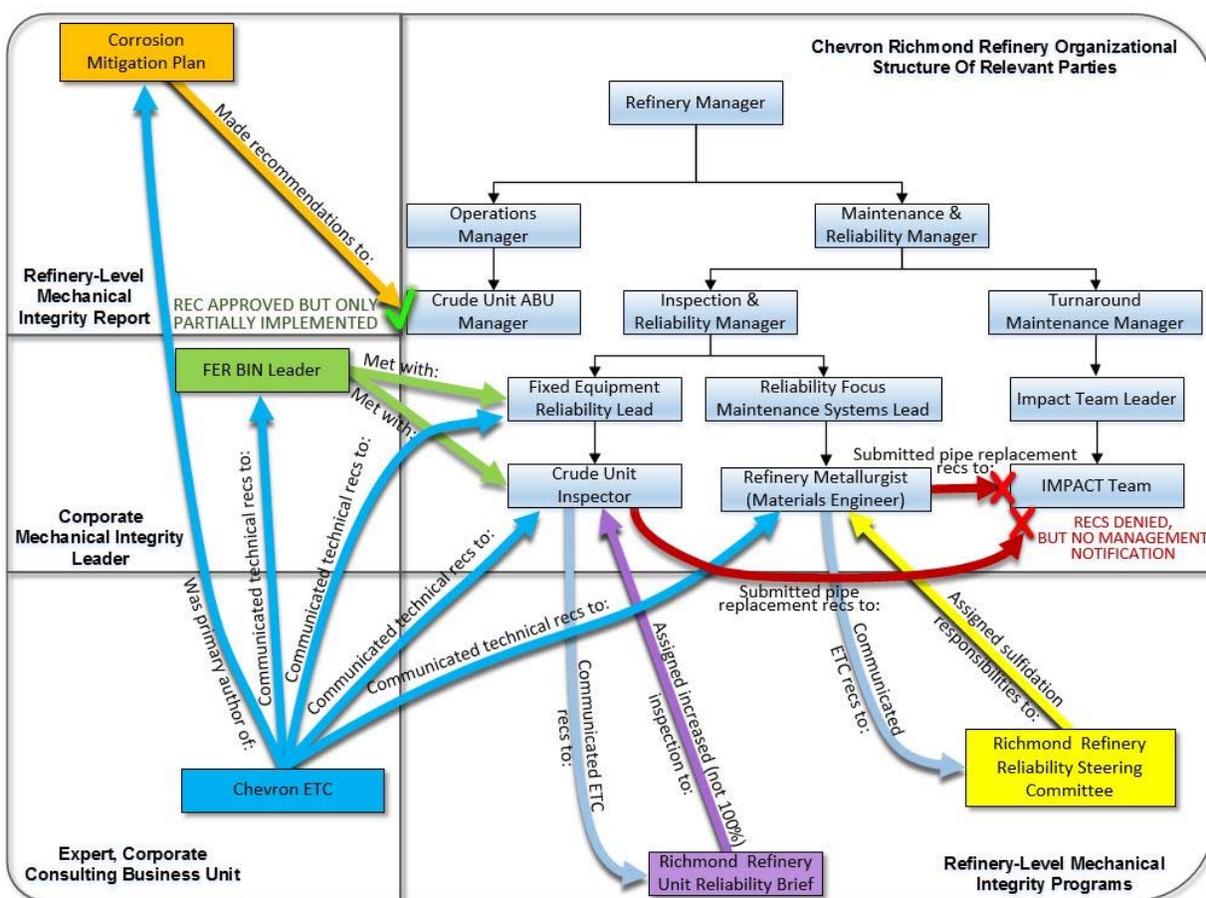
In the ten years prior to the incident, a small number of Chevron personnel with knowledge and understanding of sulfidation corrosion made recommendations to increase inspections or upgrade the material of construction in the 4-sidecut piping. Their recommendations were not effectively implemented. The process to implement important, safety-critical projects within the Chevron Richmond Refinery was not fully effective. As discussed in the following sections and depicted in Figure 25, a combination of (1) reliance on a turnaround management program that depended on only a fraction of necessary data to make important process safety decisions, (2) an unsuccessful bottom-up approach—with no management oversight or accountability—for implementing a crucial safety program, and (3) no formal method to track to completion the Chevron expert group's findings and recommendations ultimately caused these recommendations to not be implemented.

Figure 25. Organizational decision-making schematic showing attempts to have carbon steel 4-sidecut piping 100 percent component inspected or replaced with a higher chromium steel alloy. Attempts failed due to lack of accountability and lack of authority to ensure recommendation implementation, and a rigid turnaround planning process that could not approve the 4-sidecut piping replacement recommendations.

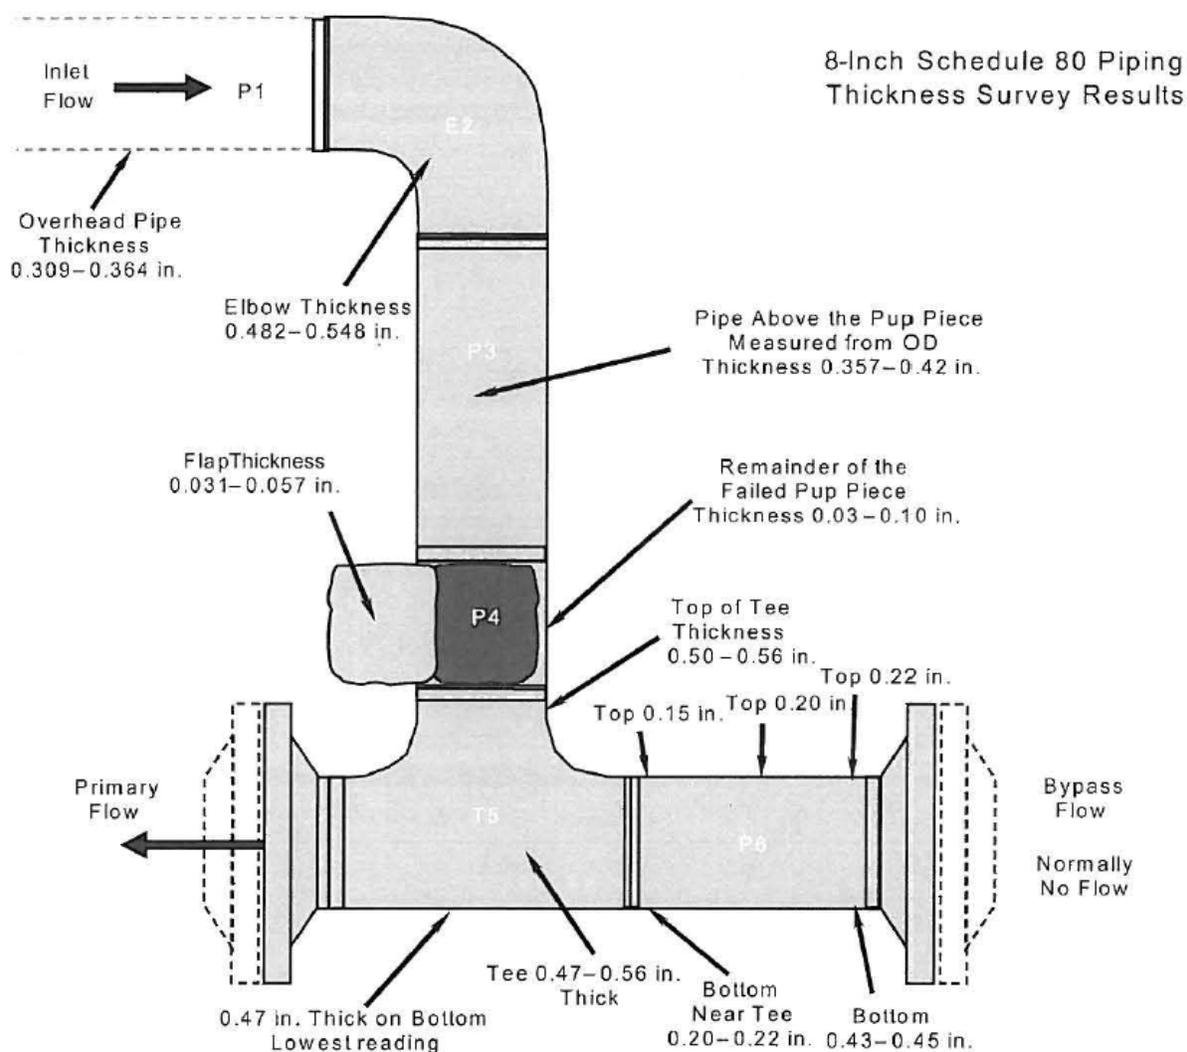
NOTE 1 in. = 25.4 mm and there may be a flow regime effect.

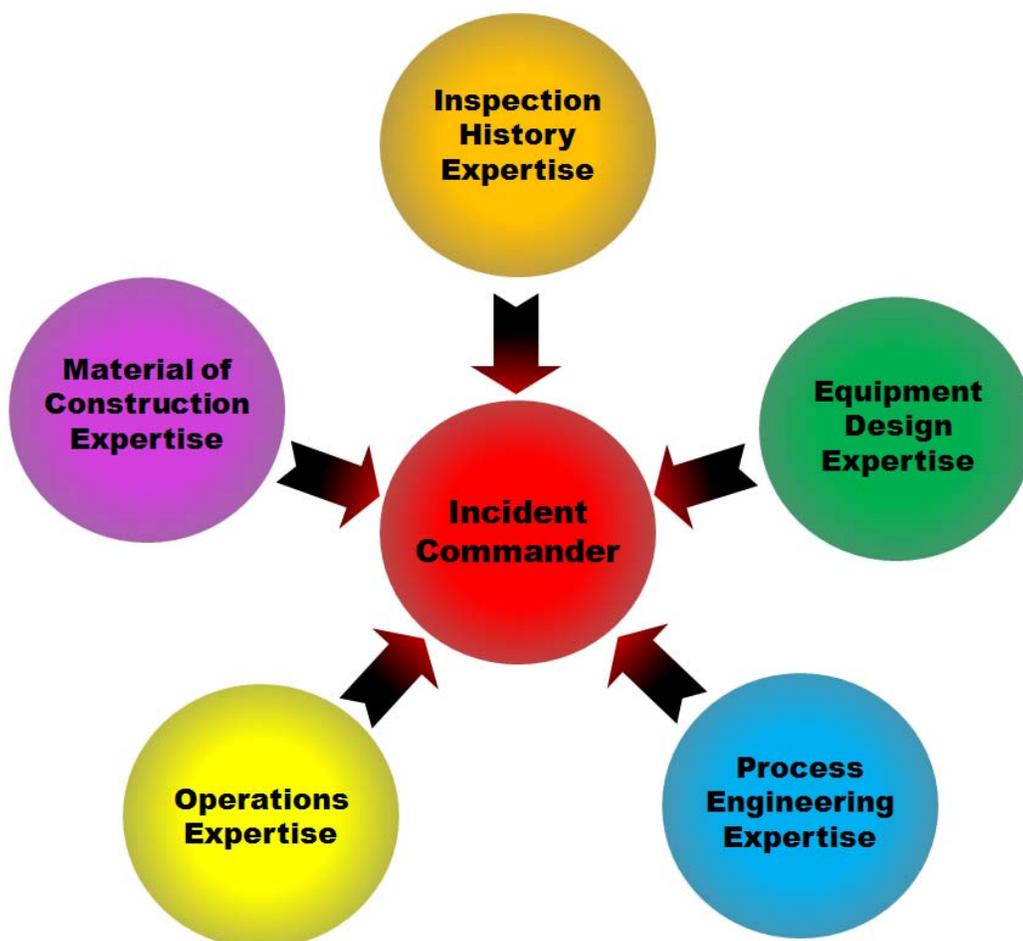
Figure 42. Ideal communication flow to Incident Commander during refinery process fluid leak incident. In industrial process fluid leak emergency situations, it is essential that various personnel with different areas of expertise communicate their relevant knowledge to the Incident Commander.
